SMAIC
STATE MARINE ACCIDENT
INVESTIGATION COMMISSION

FINAL REPORT

**m/y Mietus II
and m/v Begonia S**

**Collision of vessels at the Baltic Sea
on 4 November 2018**

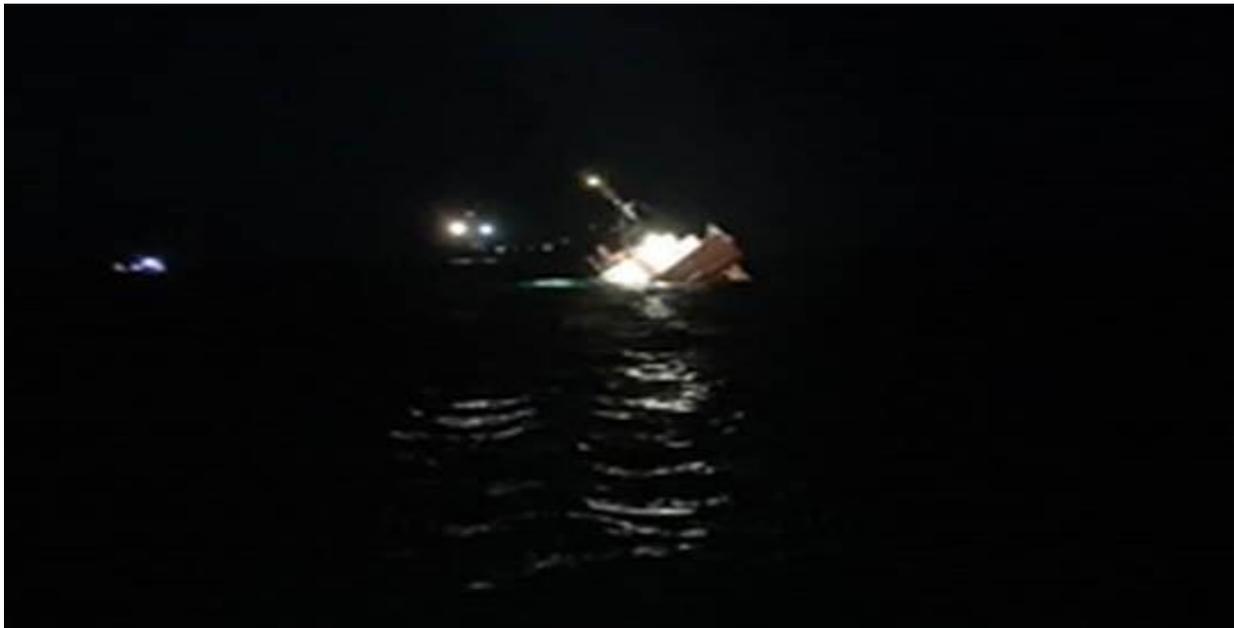
Photograph 1: "Mietus II" capsizing after the collision

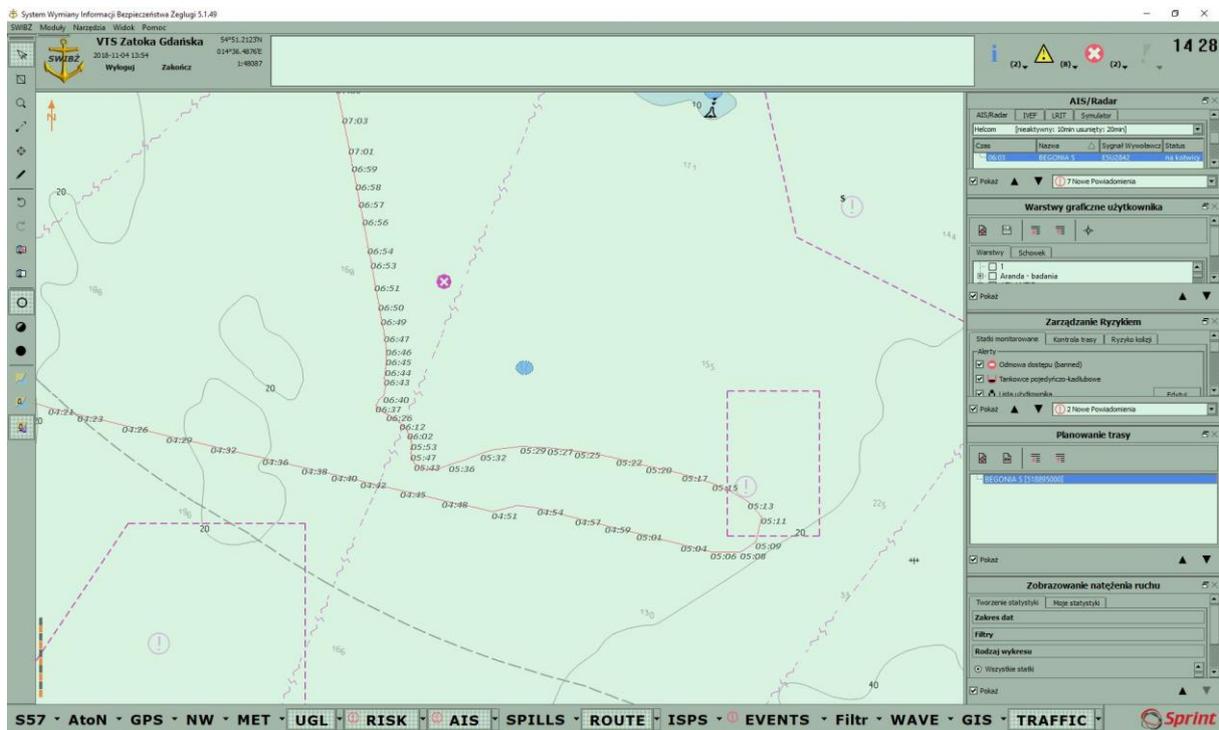
Figure 1: The route of „Begonia S” on 4 November 2018

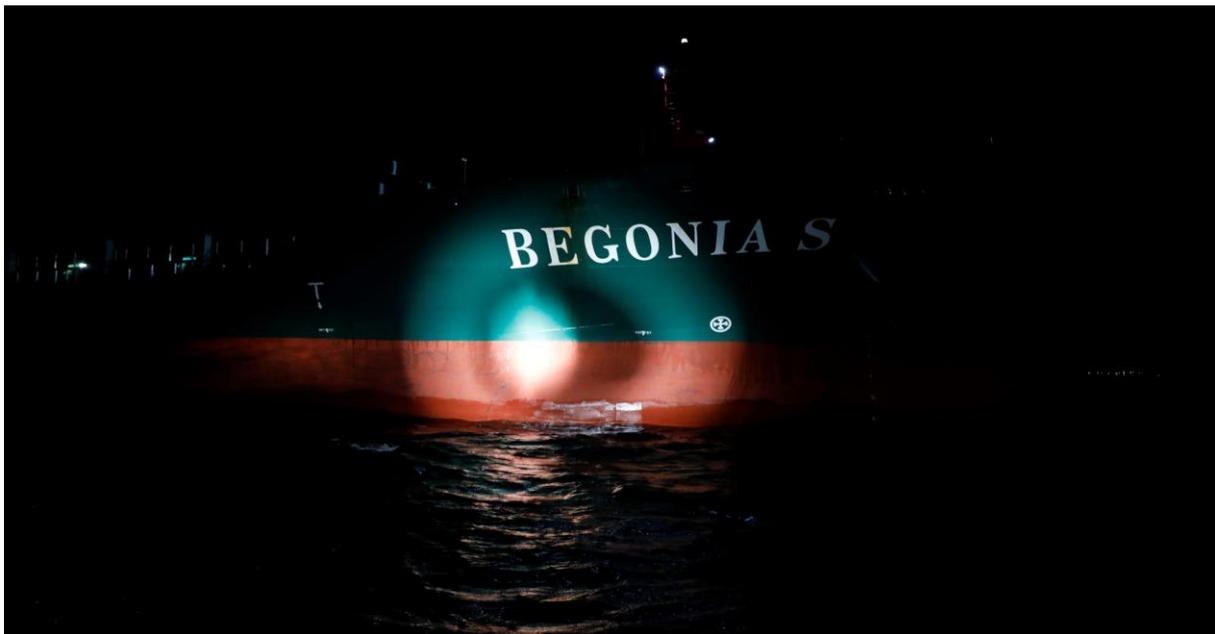
Photograph 2: Place of impact of the bow of „Mietus II” into the hull of “Begonia S”³

³ On the hull above the waterline one can see stains of liquid from a damaged bow railing

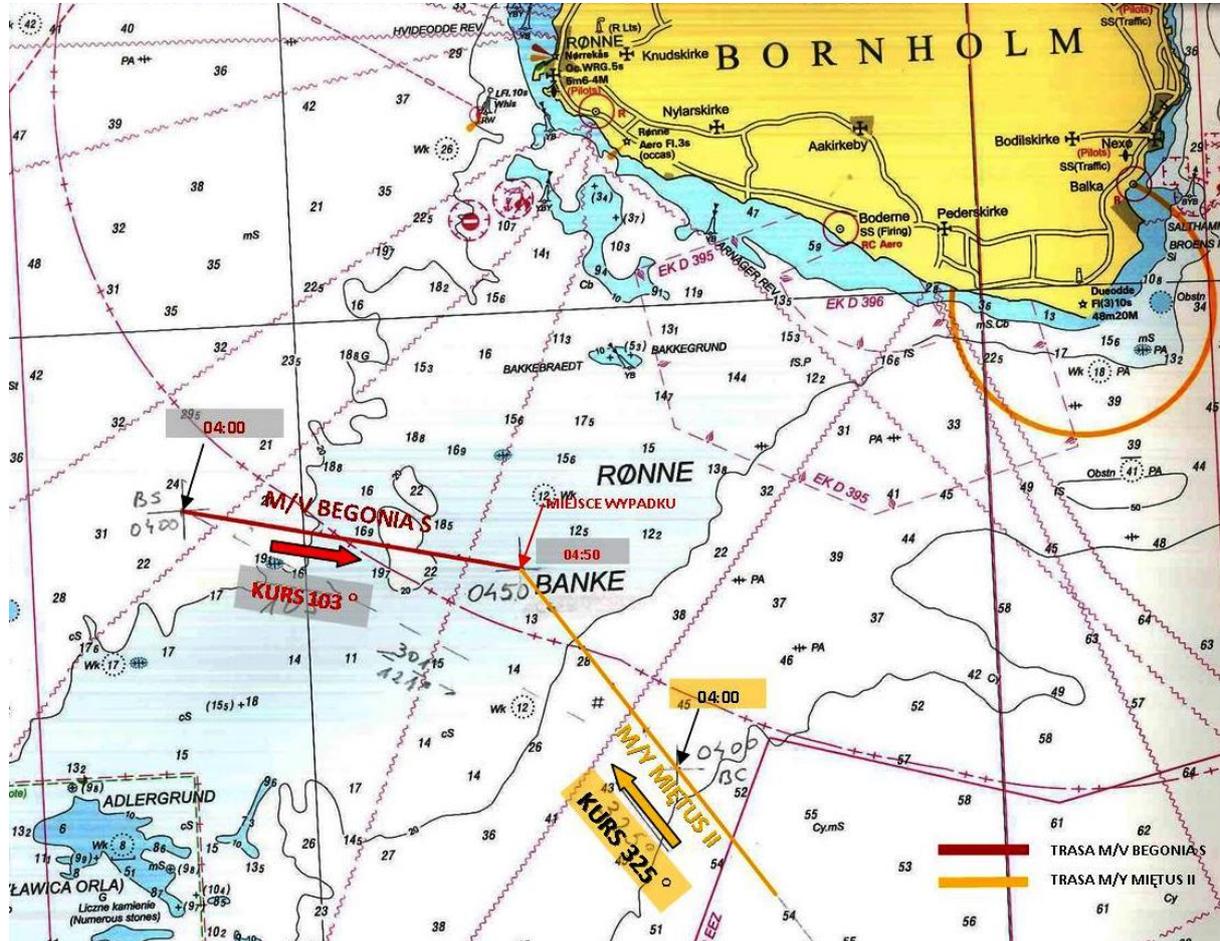
Figure 2: Routes of vessels until the collision

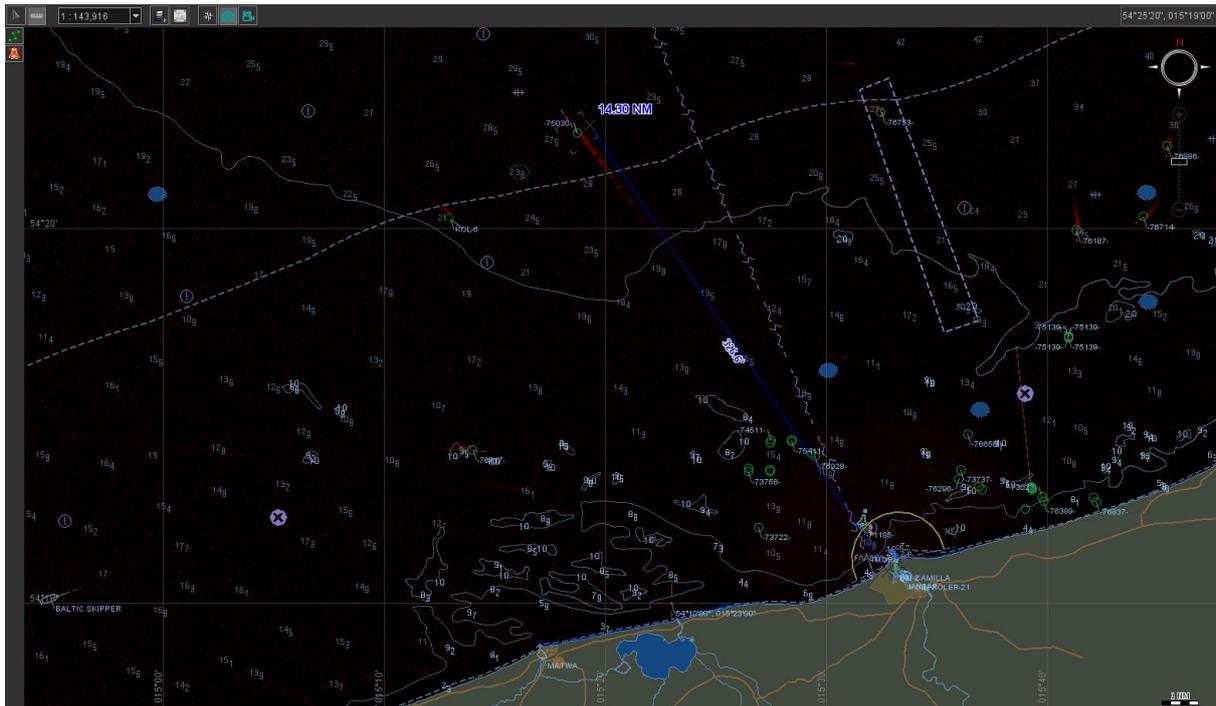
On *Mietus II*, which had a radar set at 3 NM with an extended centre of the radar image and relative motion northward, the echo of *Begonia S* was detected from the moment the echo entered the range set by the watchman, i.e. at a distance of about 4 NM. On *Begonia S*, where both radars were set on the 6 NM range with extended centres of radar images, oriented northward, the echo of the yacht was not detected by the watchkeeping officer, neither before nor after the collision. The vessel's radar antennas were 25-30 m above sea level during the voyage. There were no restrictions on radar observation in the sectors from the bow to the starboard traverse. The impulse power of the installed radars was 25 kW ensuring full detection of sailing vessels. The Commission analyzed the radar image from the shore radar, whose antenna is located at a height of about 28 meters above sea level, and the pulse power is similar to the radars of the vessel. On the day of the departure to sea, *Mietus II* was visible on the shore radar screen until it moved more than 14.3 NM away from the radar. It should therefore be assumed that there was a technical possibility of detecting the yacht on the radar screens of *Begonia S*.

Figure 3: „Mietus II” on the coastal radar while going to sea

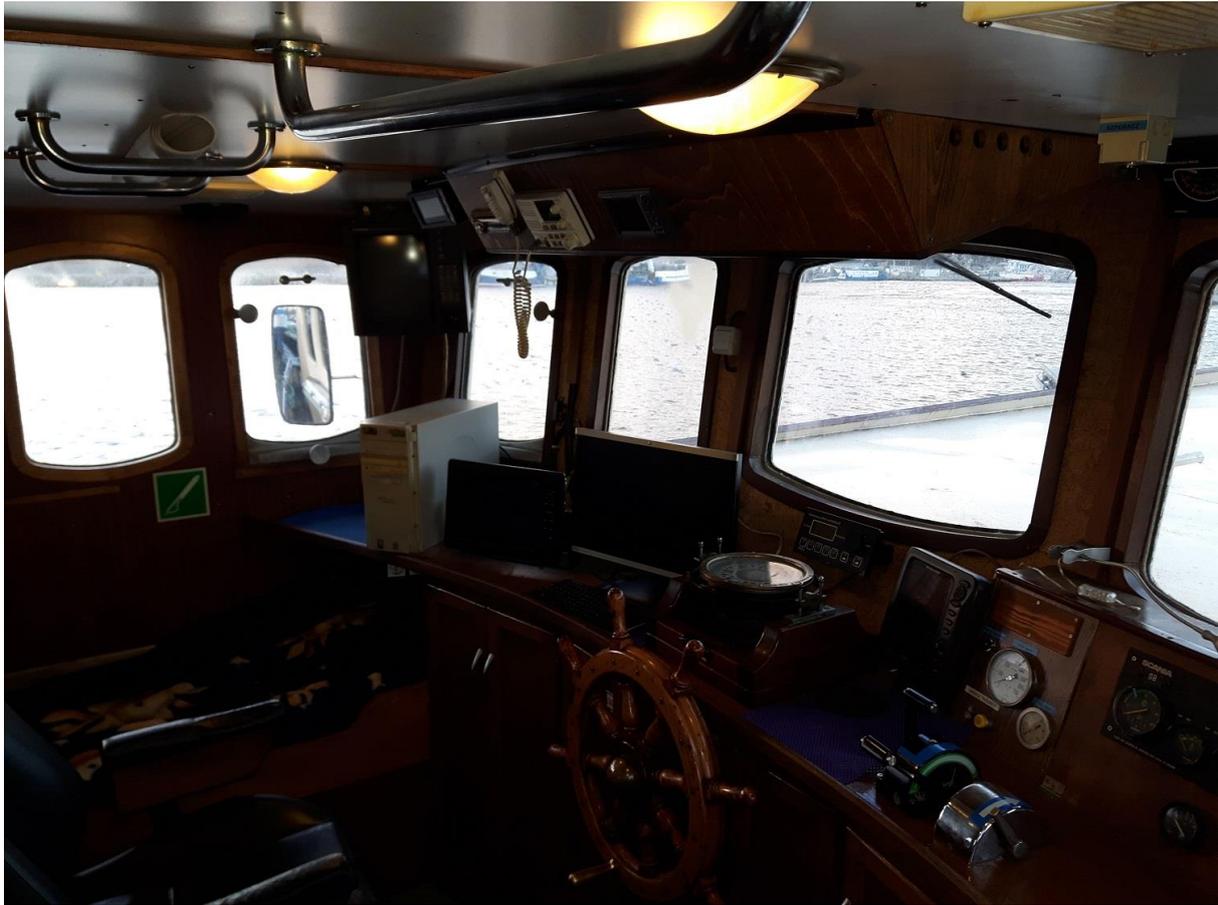
On *Mietus II*, since 02:30 the observation and control over the yacht had been conducted by the helmsman. From the control place, an unlimited observation towards the bow and to both sides, as well as the ability to observe the radar screen and other devices were ensured. At night the decks were darkened and only at the stern, at the back of the superstructure there was a light illuminating the entrance to the toilet. The explanations of the crew submitted to the Commission confirm that the visual and radar observation were correct and allowed for an early detection of the approaching *Begonia S*.

Photograph 3: The bridge of „Mietus II”

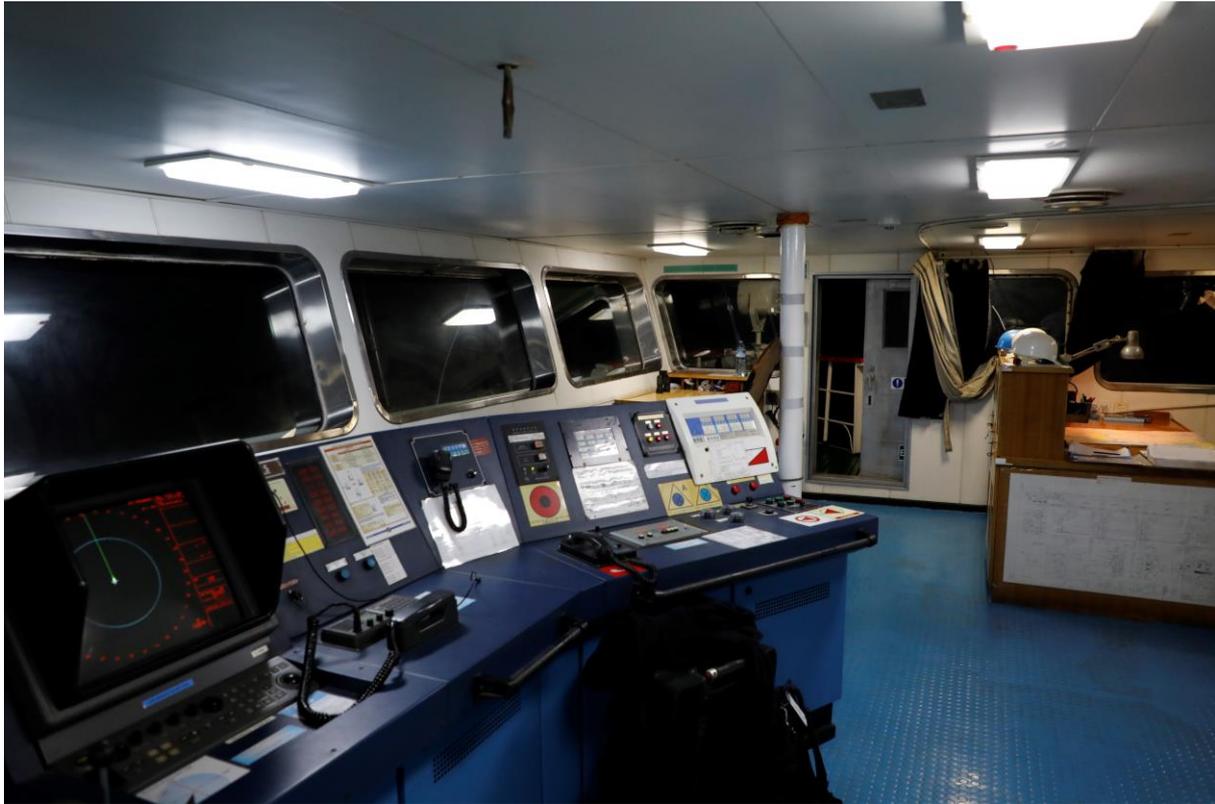
Photograph 6: The bridge on starboard of „Begonia S”

In that place, the distance from the front windows of the bridge is about 1.5 m. The watchkeeping officer on the bridge was combining observation with other watchkeeping duties. He was not conducting continuous visual and radar observation. ARPA was set for manual echo acquisition and therefore could not detect and track the echo of *Mietus II* even if it was visible on the radar screen. It is a mistake not to use the possibility of automatic radar echo acquisition as a support for the navigator in detecting and assessing the risk of collision with other vessels. During the watch, the watchkeeping officer was comparing information obtained from the automatic identification system (AIS) with the radar image, finding vessels signaled by AIS on it. The lack of continuous radar observation by a suitably qualified officer meant that the weaker echoes could go unnoticed.

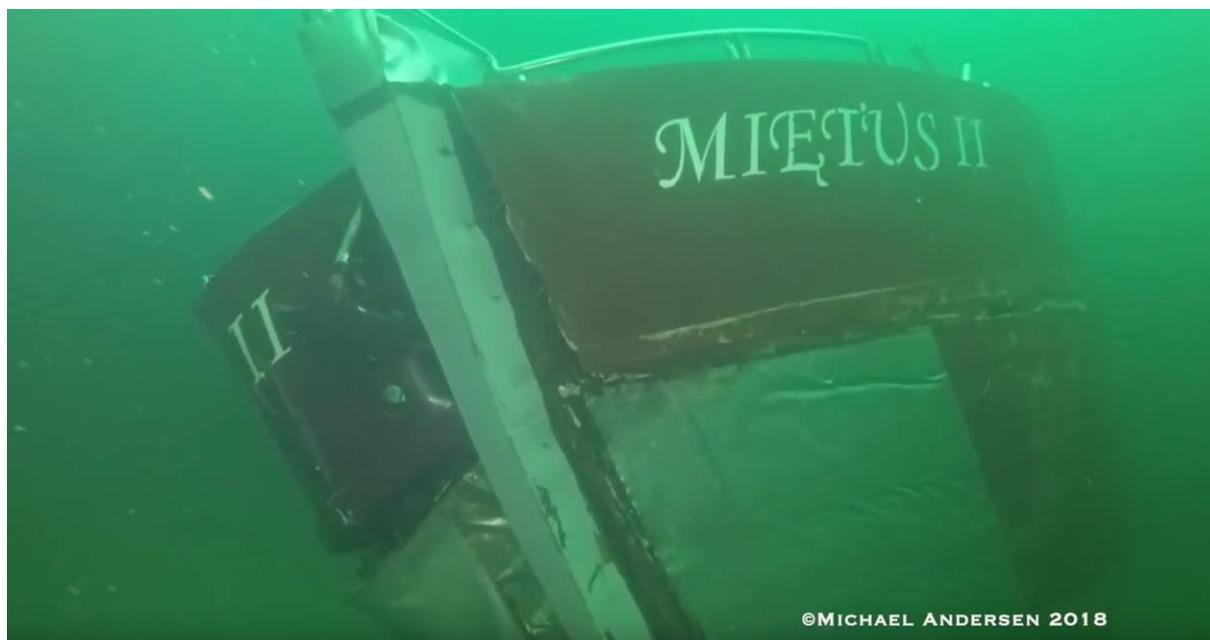
Seeing the inevitability of collision, the helmsman of *Mietus II* had started the turning manoeuvre with the automatic steering system switched on. When the skipper was woken up, he switched the control system from automatic to manual and put the rudder hard to starboard. Just before the collision, the yacht was in the middle of a sharp turn to starboard. The watchkeeping officer of *Begonia S*, after noticing the yacht right at the bow, put the rudder to port. It should be assumed that due to the mass of the vessel and the associated inertia, there was no significant change in the course of the vessel until the moment of collision. The effect of the collision of two hulls was significantly minimized due to the fact that the yacht managed to change its course by about 50° to starboard before hitting the vessel's bow. At the original courses of both vessels, the resultant approach speed was about 17 kn. At the time of a significant change of course by *Mietus II*, this speed decreased to the yacht's own speed, and was further reduced as a result of entering circulation. It should be estimated that the impact on

the hull occurred at a speed of about 5 - 6 kn. This situation protected the wooden yacht from complete destruction of its hull structure at the moment of impact.

Photograph 7: Damage to the bow of „Mietus II”
