Report on the grounding of  
m/v FAST JEF on November 11, 2019

Vessel grounded when leaving the port during maneuvering outside the fairway.

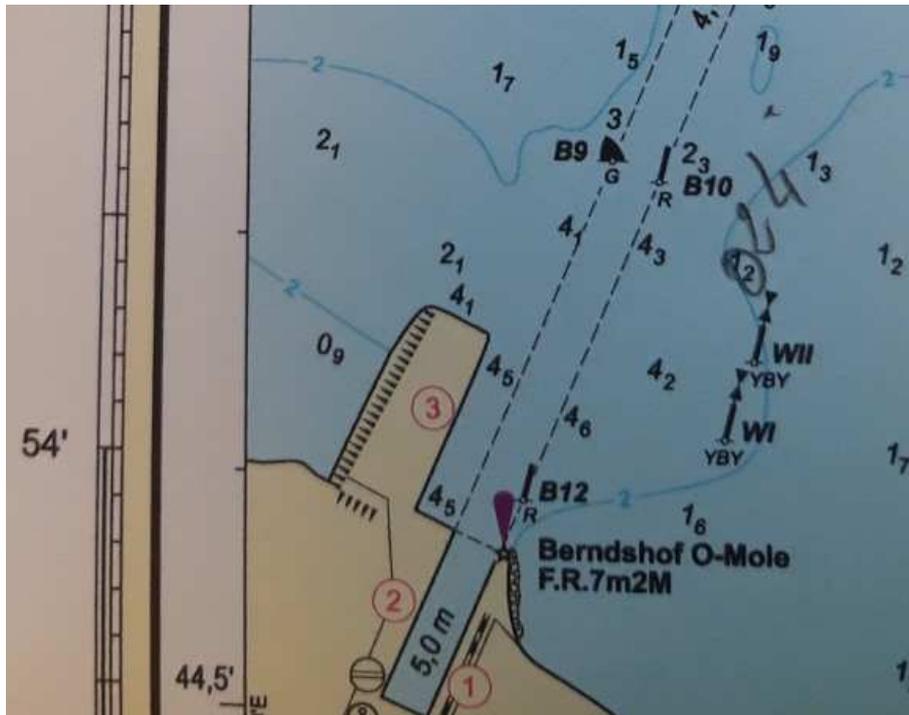
Figure 3 - BSH 1513 – Port of Ueckermünde

The chart used on board was outdated. Edition 2009 of the chart was in use, but the latest version was published in 2016.

The undepth where the vessel grounded, was also visible on the chart edition 2009.

Navigation chart *BSH 1513 - Peenestrom, südlicher Teil und Kleines Haff* was outdated.

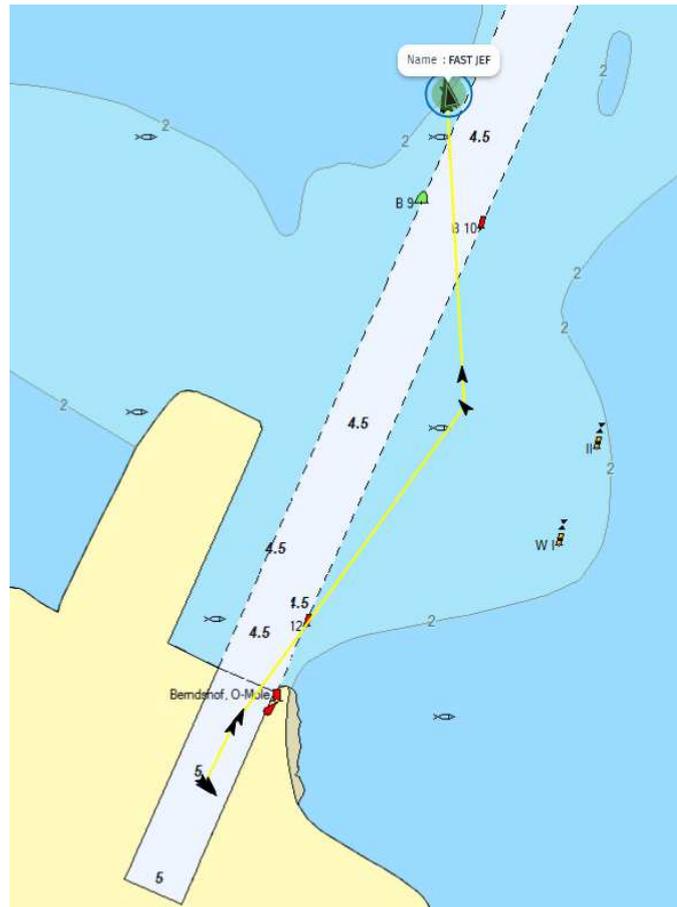
*Figure 4 – Grounding position*

The vessel passed buoys B9 and B10 and crossed the western boundary of the fairway where she grounded at 1525 in position N 53° 44,7' E 014° 05,9'.

The speed at that moment (SOG) was 4.2 knots.

The vessel could not come afloat immediately and had a list of 4 degrees over SB. All ballast tanks and bilges were sounded, no water ingress was noted. Soundings around the vessel showed that she was stuck at height of hatchcovers 4 and 5. The ballast tanks in that position, ballast tanks N°2, were empty. At 1540 ballast tanks N°3 on PS and SB were emptied. The vessel came afloat by own means at 1650.

During inspection, slight intends to ballast water tank number 2 had been noticed.

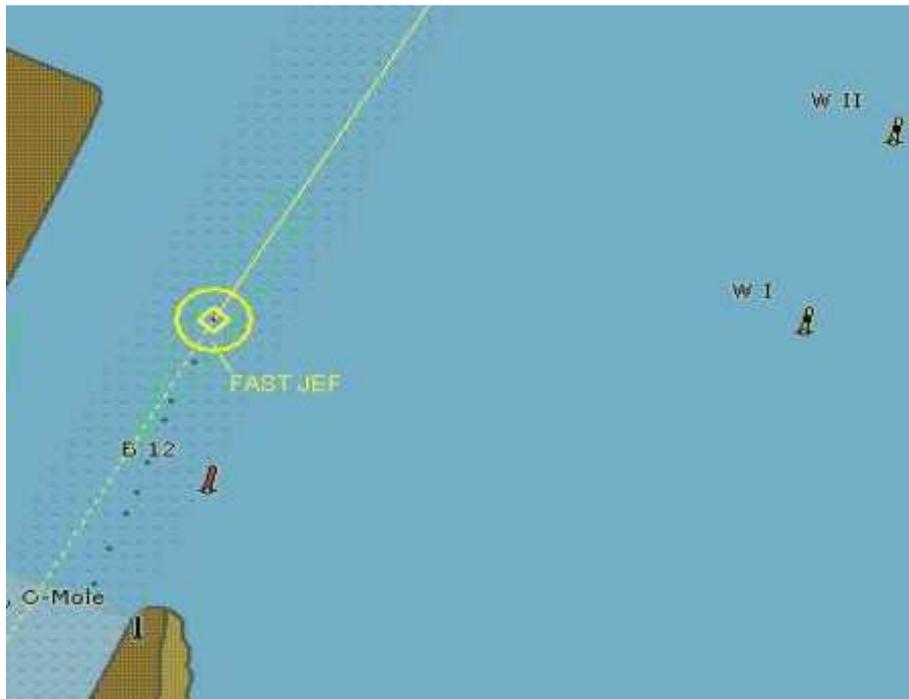
Figure 6 - M/v FAST JEF leaving port

Turning 180° inside the port of Ueckermünde was not possible, so the vessel had to sail astern passing buoy B12 to turn inside the turning circle towards cardinal buoys WI and WII, see Figure 6.

A SE 3-4bft wind was blowing the vessel towards the green side of the fairway.

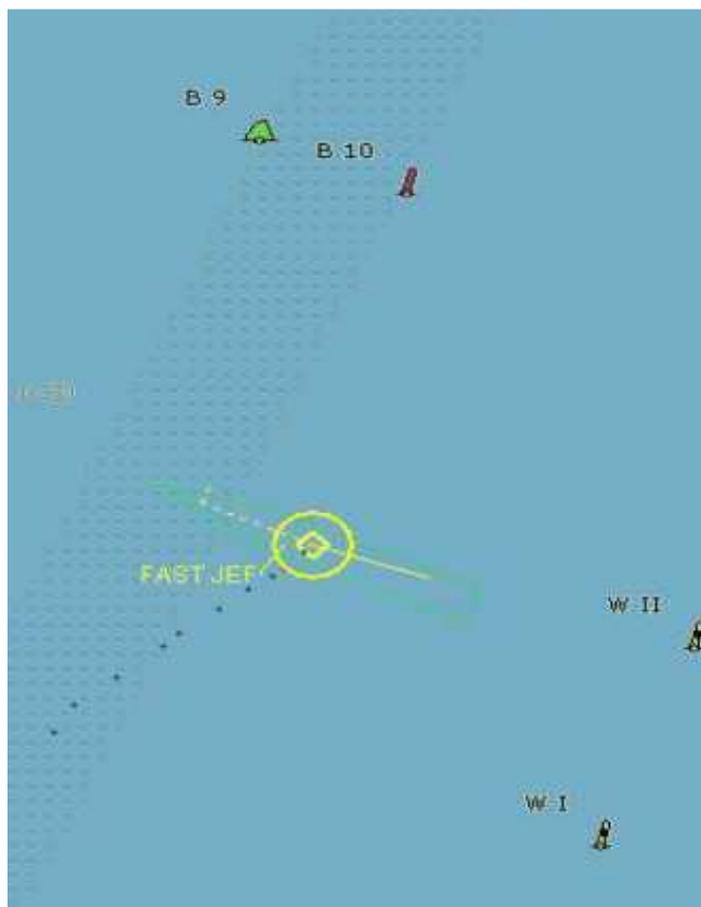
Figure 7 - M/v FAST JEF turning circle

Once turned against the wind and towards the buoys, the vessel had to sail ahead (wind in the back), turning inside the fairway towards a course of 024°.

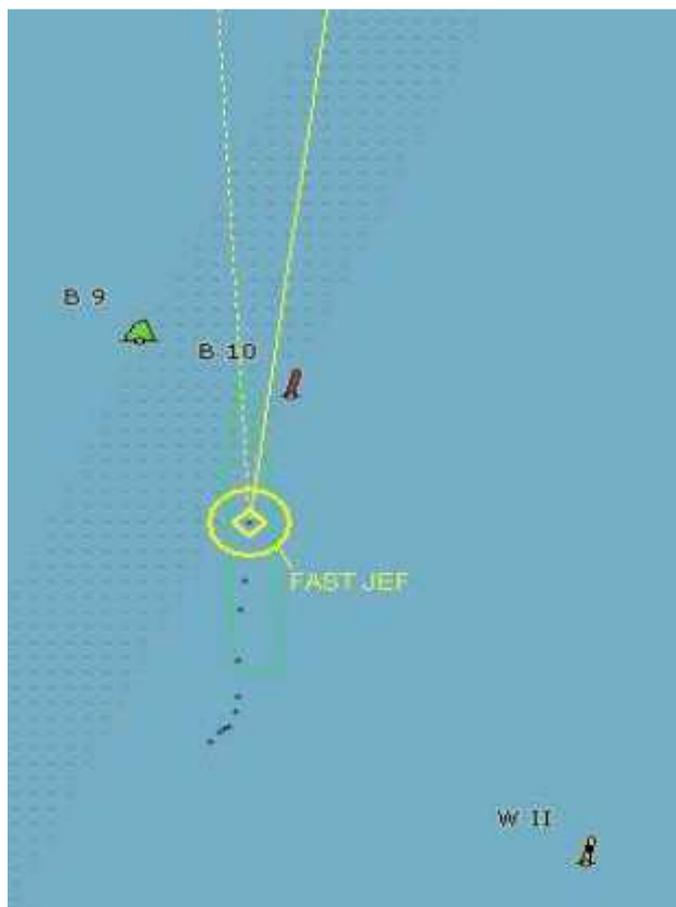
Figure 8 - M/v FAST JEF entering the fairway

M/v FAST JEF entered the fairway just in front of buoy B10, having a speed of 2.9 knots and a course of 7°, see Figure 8.

When entering the fairway, m/v FAST JEF had altered the course more to PS. Wind was coming in on SB aft quarter (SE 3-4bft.).

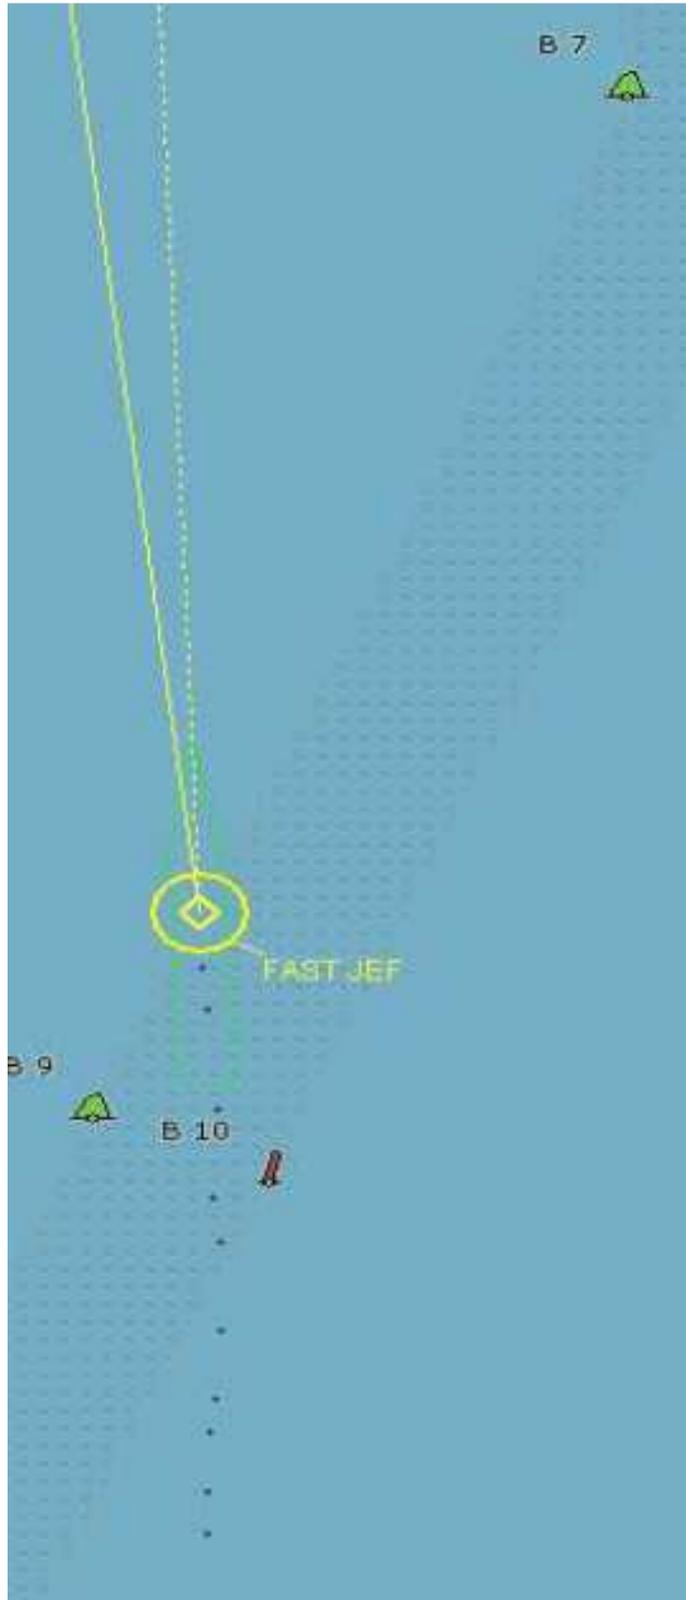
Figure 9 - M/v FAST JEF grounding

M/v FAST JEF ended up on the other side of the channel where the depth was indicated to be 1.5m (chart datum) only.

Her speed at that moment was 4.2 knots (SOG), her course 353°, see Figure 9.

The vessel was in minimal ballast condition and so more vulnerable to the wind blowing the vessel towards the green side of the fairway.

The appreciation of the effect of the wind on the vessel in ballast condition in combination with the available navigational information caused the grounding of the vessel.
