FINAL REPORT

STATE MARINE ACCIDENT
INVESTIGATION COMMISSION

**Very serious marine casualty
of a fishing cutter
*JAS - 57 Magdalena***

Death of a crew member due to electric shock

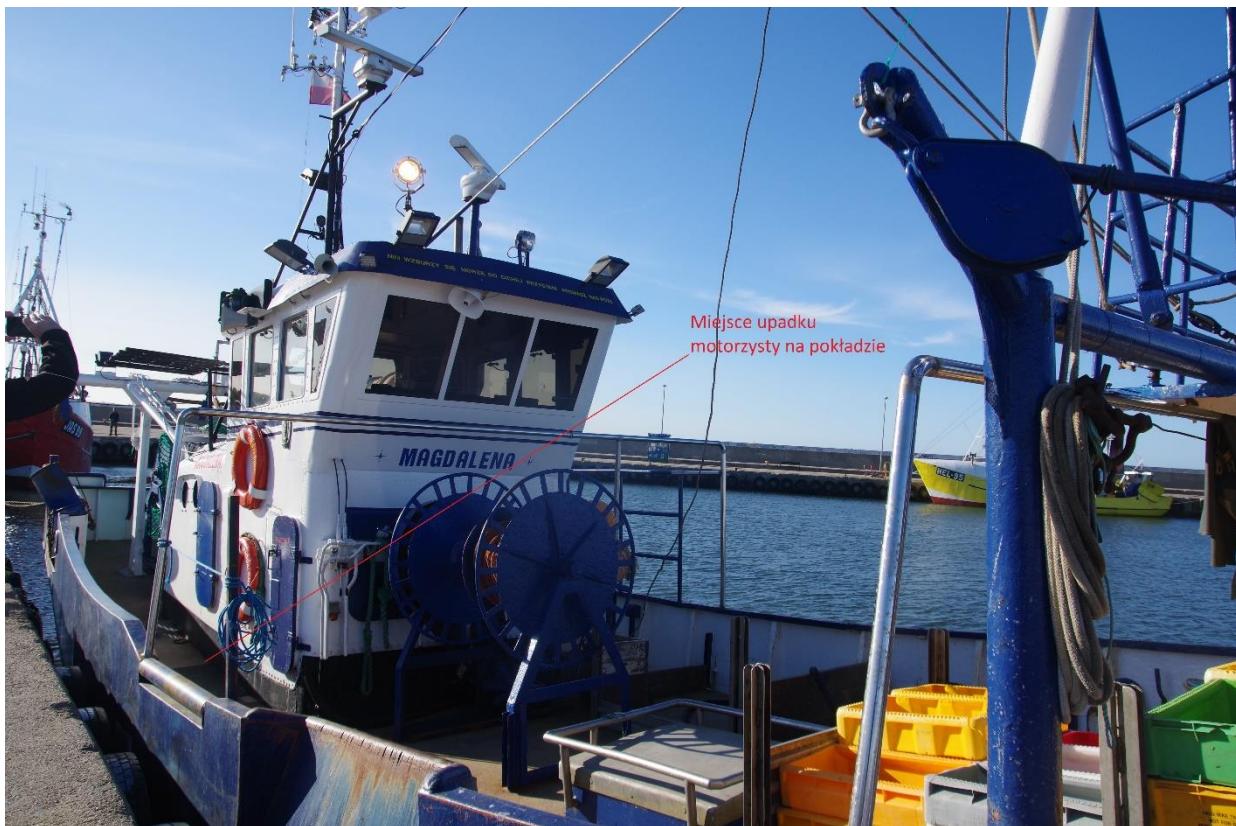
Figure 1: The place where the victim fell on deck

Hearing the scream, the crew members at the bridge ran out onto the deck and noticed the motorman lying between the superstructure and the side at the exit of the engine room. The victim was holding a coil of the extension cord. The operator snatched the cord from the victim's hands and dumped on the deck. The skipper, seeing at first the signs of losing breath and consciousness and then the lack of breath and heartbeat, began to resuscitate the motorman. The operator instructed the electrician to call for help, and joined the resuscitation himself. The emergency medical team arrived after about 10 minutes and took over the rescue of the victim. SAR members joined the life-saving action supporting the ambulance rescuers. At 01:12 the doctor declared the motorman to be dead.

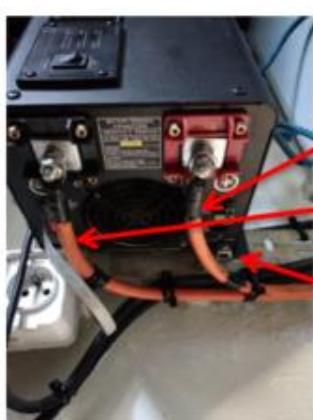
Figure 2: Connection of accumulator batteries with the converter

Power Sinus 3000 24V converter

**Connecting cables with the 24VCD
accumulator batteries**

Lack of earthing

The arrangement of the components of the electrical system allowed errors and mistakes to be made during its operation. This was due to the lack of current drawings/connection diagrams of the electrical installation components. Part of the wiring was not permanently attached. There were deficiencies in unambiguous marking and description of the purpose of electrical circuit components. Electrical sockets with different electrical parameters (230VAC/ 24VDC) were of the same type. Installation of the converter, apart from the lack of earthing made it possible to access electrically conductive parts. Therefore, the protection of electrical circuits against direct contact was not ensured.

The electrical installation was not made in accordance with the norm PN-HD 60364-4-41:2009 concerning low voltage electrical installations, protection to ensure safety and protection against electric shock.

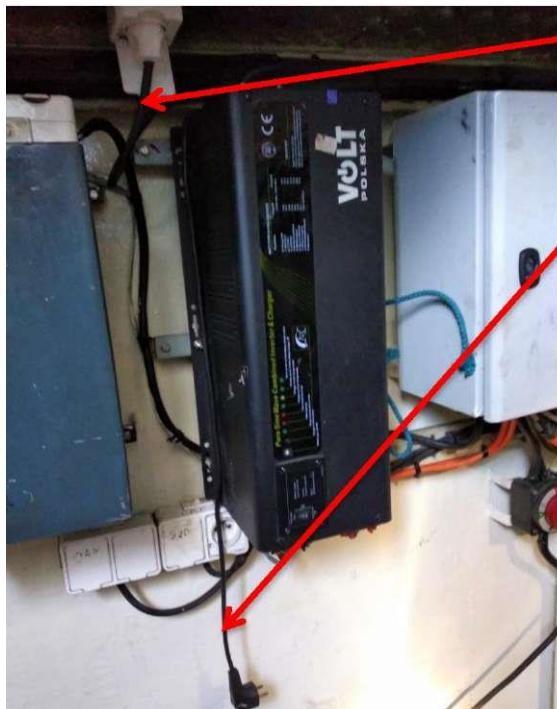
Figure 3: Instalation of electric cords

Installation of electric cables, no fixing of the cables, ambiguous marking, possibility of erroneous connections.

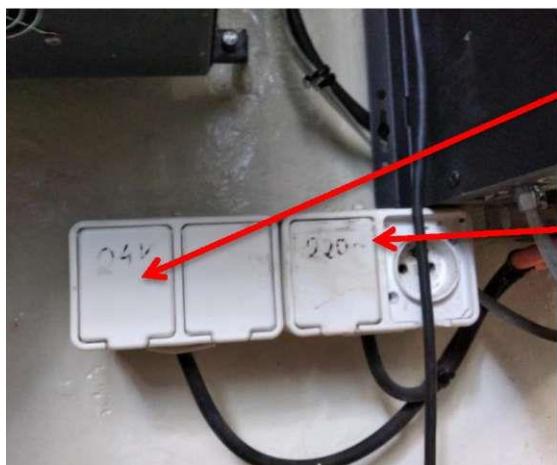
Figure 4: Installation of electric sockets 24VDC i 230VAC

24VDC sockets, 230VAC sockets
Sockets are of the same type so there is possibility of erroneous connection

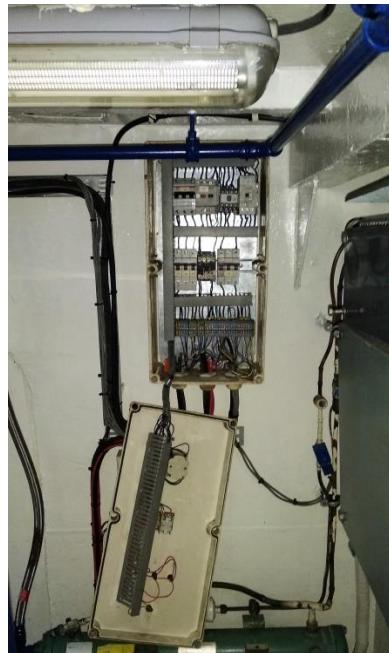
Photograph 4: Switchgear of the cold store

In the opinion of the Commission, one of the key factors in the investigated casualty was the state of insulation of the cutter's electrical installation. Consistent information of all witnesses confirms that several attempts to switch on the 440V 50Hz power supply from the shore in Władysławowo were unsuccessful due to the operation of the RCCB. At that time it was assumed that the reduction of insulation resistance applies only to the installation of the cooling system. In fact, there were other places indicating the possibility of reducing the state of insulation of the installation. Incorrect installation of a fluorescent lamp could be an example.

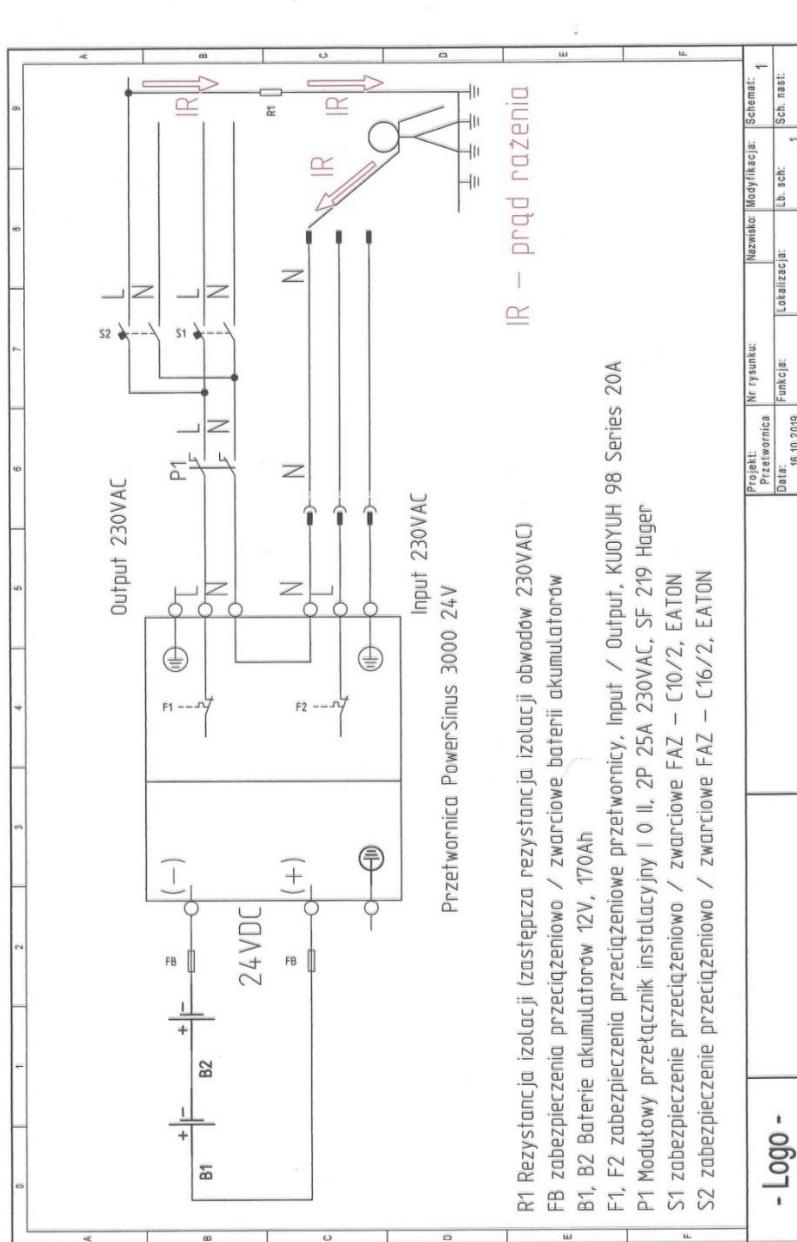
Figure 5: Electrocution of the crew member – a schematic diagram

After switching on (intentionally or accidentally) the converter to work in the Power Saver Off mode, by switching the switch on the converter's housing or switching the switch on the LCD panel located on the cutter's bridge, the converter started working in the inverted mode. It has properly generated voltage at its 230V, 50Hz output terminals (Output 230V). The 230V power supply selection switch on the bridge that was turned on to the converter position (Figure 9) caused the supply of power to the damaged 230V circuits. Damaged insulation of electrical circuits caused the appearance of phase voltage marked "L" on the steel-aluminum structure of the cutter.

At the same time, the crew member was carrying a cable connected to the converter's input terminals. After leaving the engine room, he touched with his hand one of the poles of the plug, the unshielded pin of the plug connected to the converter's "N" terminal. During this time he was standing on a wet mat lying on board in front of the exit from the engine room. Damaged insulation of the electric system of the cutter caused that the crew member suffered an electric shock.

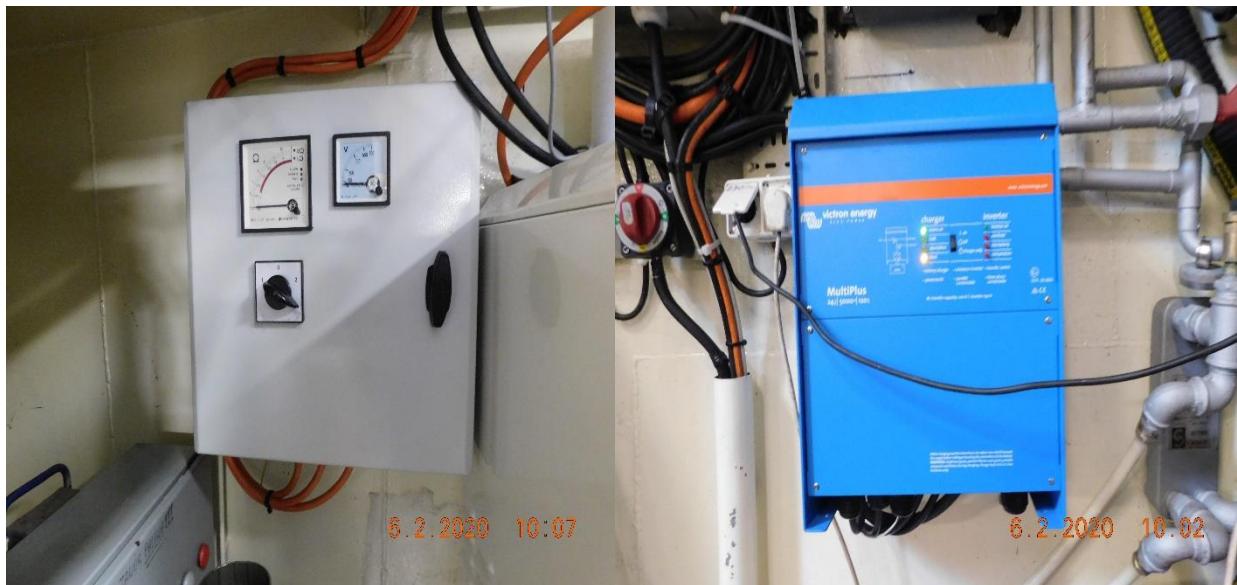
Photograph 6: New devices installed on the JAS 57 cutter

During an additional visit of the investigative team on board a cutter on 6 February 2020, it was found that a new converter had been installed, the installation had been repaired and an additional device to measure the state of insulation of the cutter's electrical installation had been installed.

Recognizing the steps taken by the operator under the supervision of the classifier and the National Labour Inspectorate, the Commission withdrew from issuing recommendations in that respect.

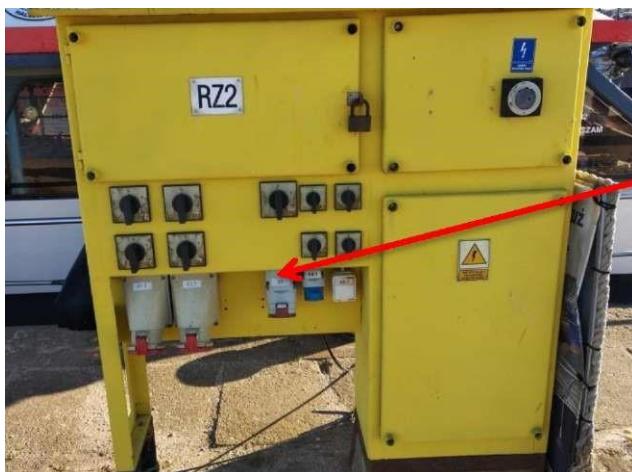
Figure 6: Power terminal, the port of Władysławowo

Power supply socket to which the JAS 57 Magdalena cutter was connected on 29.05.2019.

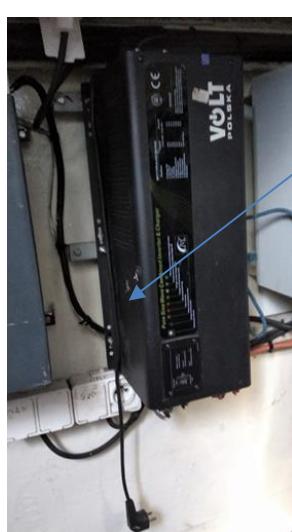
Figure 8: Power Sinus 3000 24V converter

The cable to which a three-wire extension cord was connected to supply power to the converter from the 230VAC source at the wharf of the port of Jastarnia

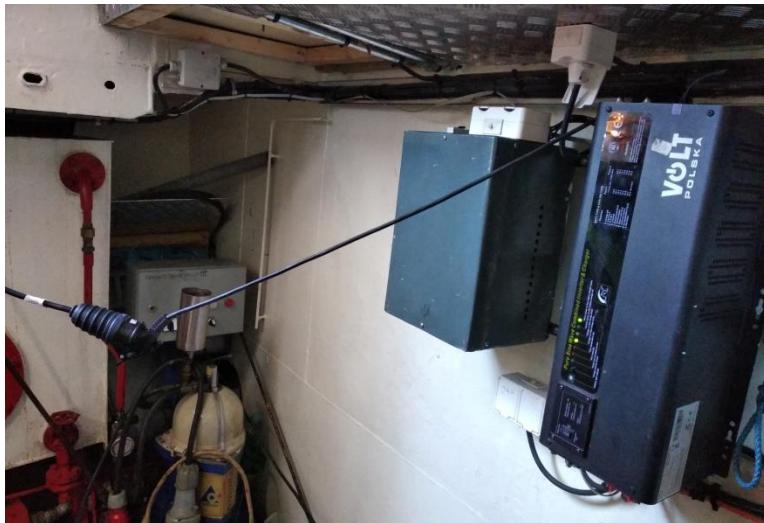
Figure 10: Connection of the converter to the shore power supply

This is the way the crew of the JAS 57 cutter connected 230VAC source to the Power Sinus converter. The cable lead through the waterproof door leading to the engine room of the vessel.

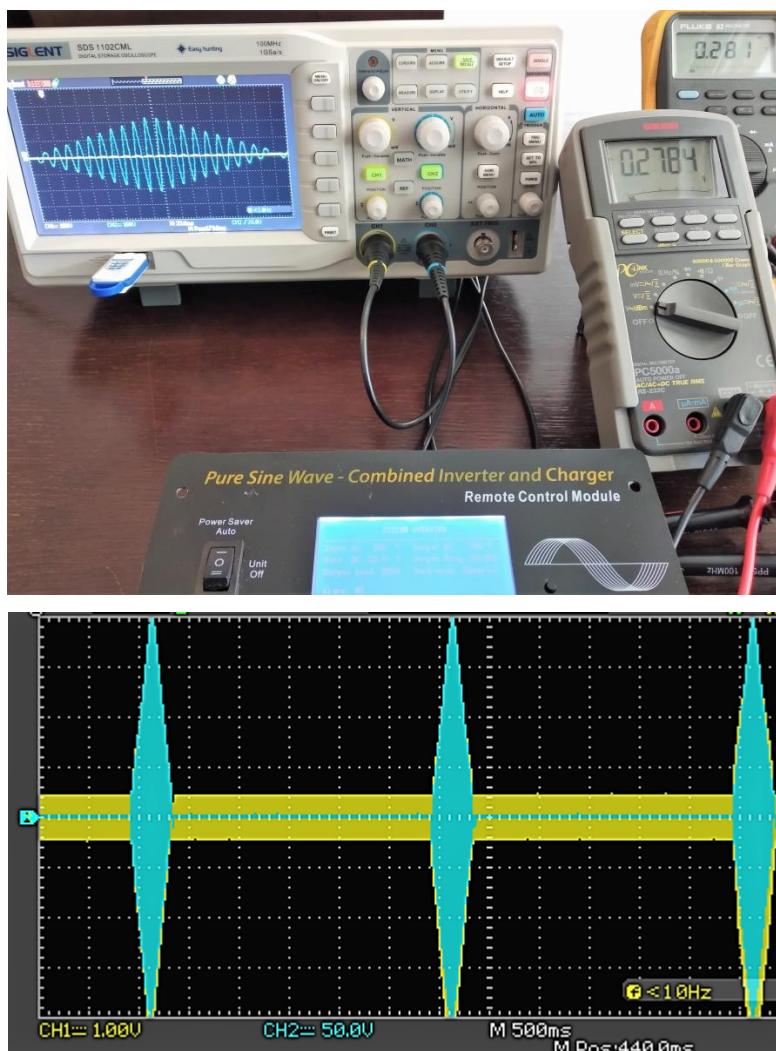
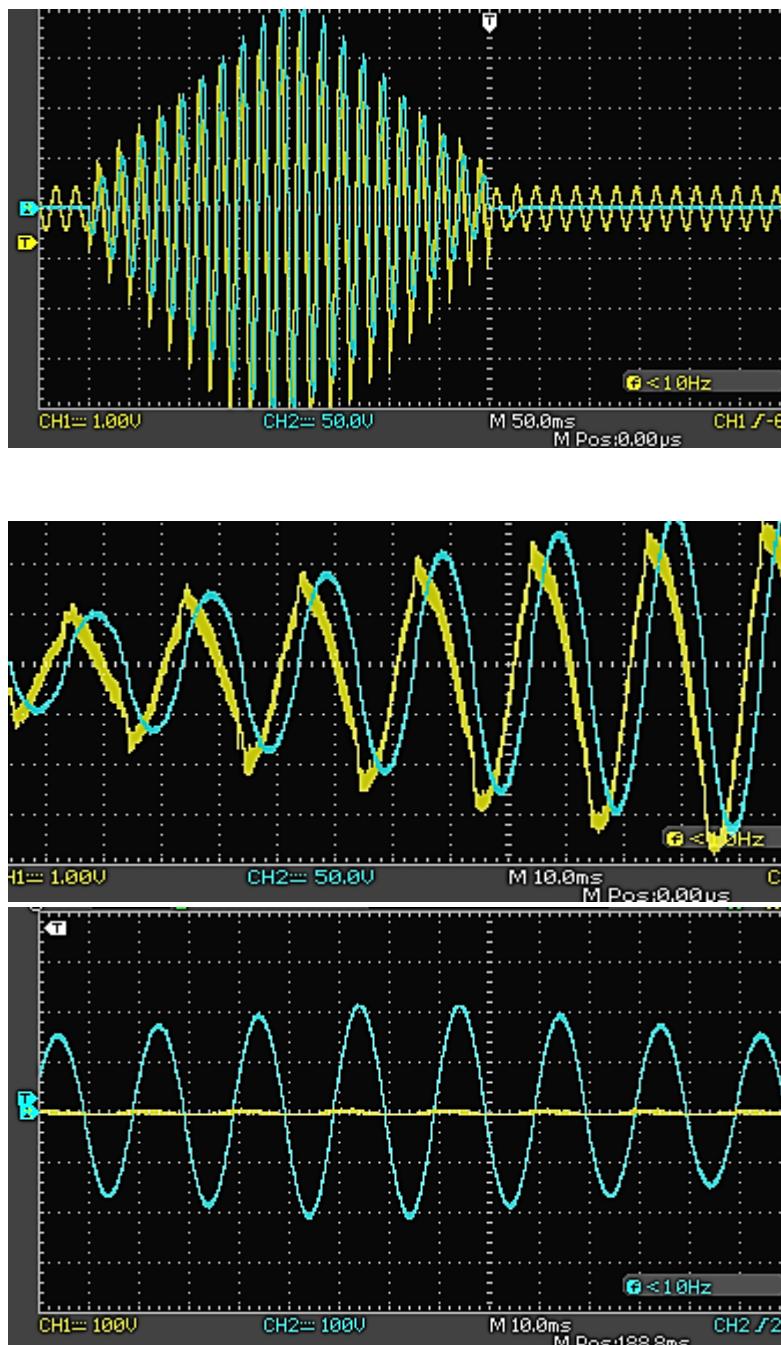
*Photograph 16: Results of the Power Saver Auto operation mode,
U input = 0VAC, U output = Variable*

Repeated attempts to force transient states involving switching the converter on and off and connecting variable loads, in the Power Saver Auto operation mode did not cause any voltage signals at the converter's input that could cause electric shock. Maximum input voltage amplitudes do not exceed 5V, the duration of these signals is about 400ms.

Conclusion: no voltage on the input terminals of the converter in the Power Saver Auto operation mode was found that could have caused electric shock.

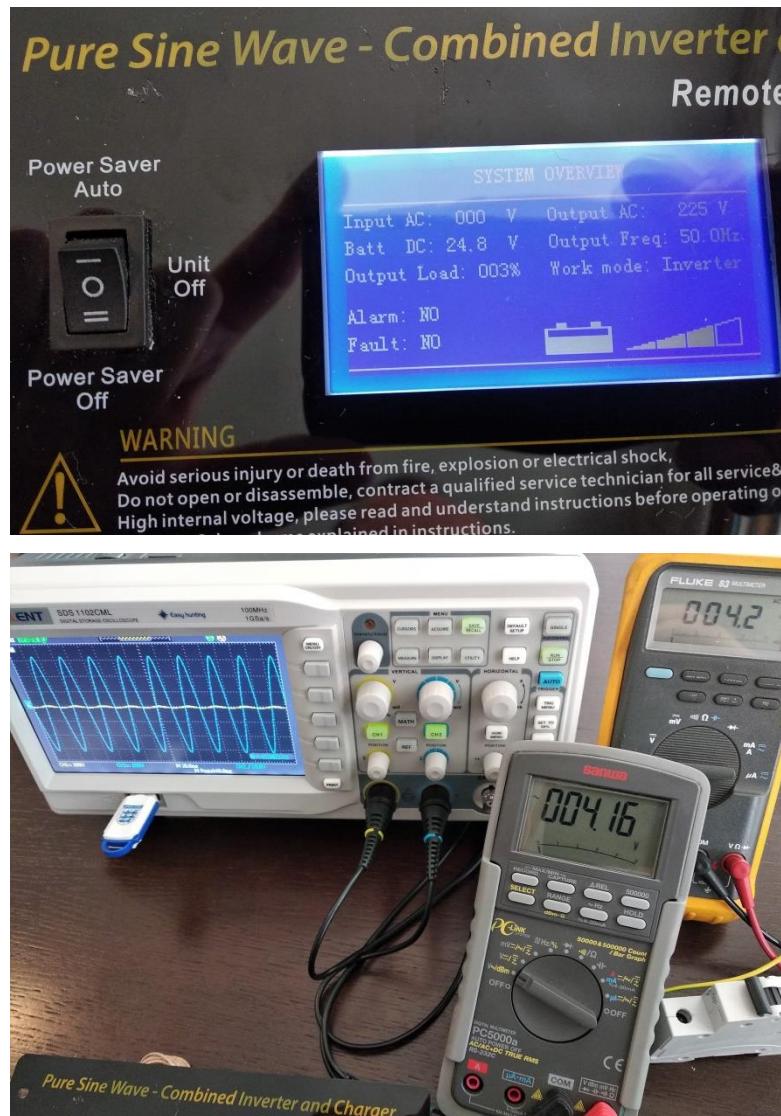
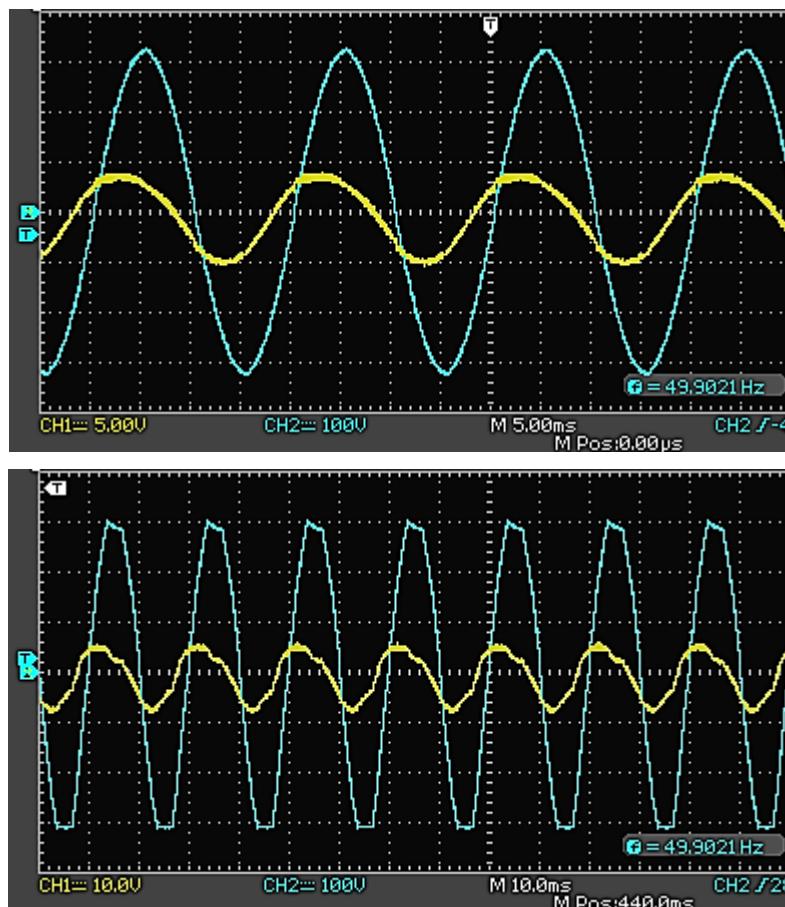
*Photograph 17: Results of the Power Saver Off operation mode,
U input = 0VAC, U output = 230V, 50Hz*

Repeated attempts to force transient states involving switching the converter on and off and connecting variable loads, in the Power Saver Off operation mode did not cause any voltage signals at the converter's input that could cause electric shock. Maximum input voltage amplitudes do not exceed 8V. This occurs in states when a loaded converter generates distorted output voltage. When the load is minimal, the observed input voltage have effective values indicated by both digital multimeters at ca 4V. These values are confirmed by waveforms recorded on the oscilloscope.

Conclusion: no voltage on the input terminals of the converter in the Power Saver Off operation mode was found that could have caused electric shock.
