FINAL REPORT

24/19

**Fishing cutter UST-31
and fishing cutter Ancilla WŁA-68**

**Collision of fishing cutters in the Baltic Sea on
April 17, 2019.**

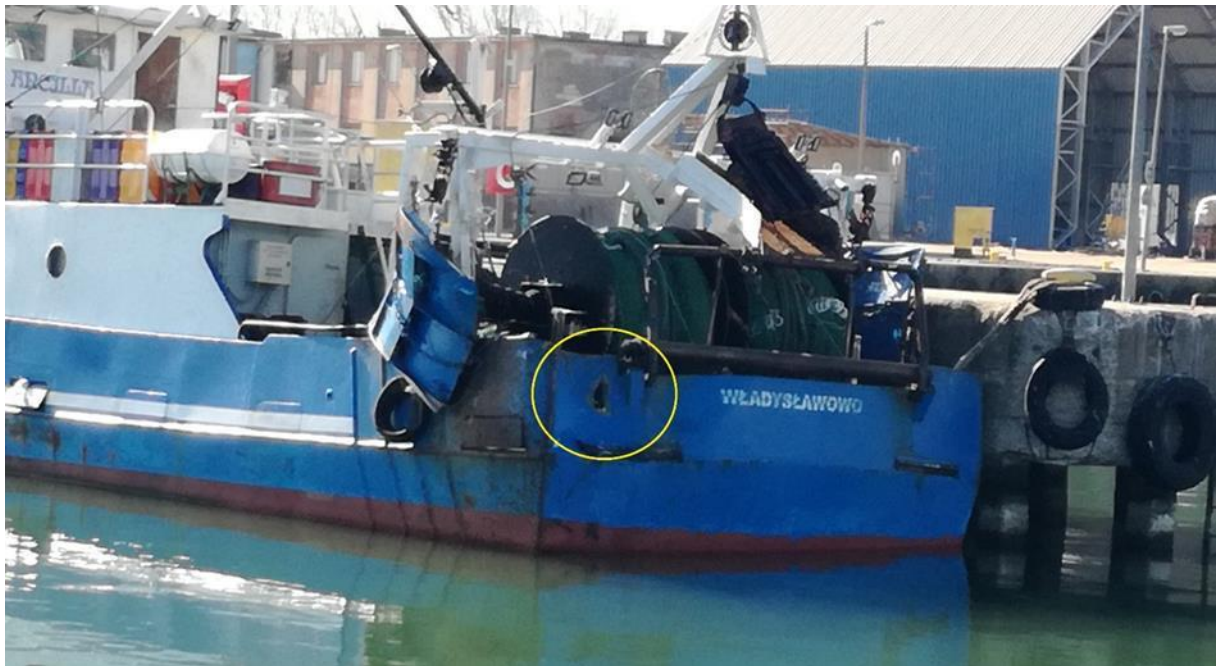
Consequences of the accident for the ship: WŁA-68 - dent of the bulwark ¹ on the stern [photo 3, photo 4]
UST-31 - dent of the bow [photo 5].

Photograph No. 3 Damage to the fishing cutter Ancilla WŁA-68

[photo 3, photo 4] and one of the crew members suffered a wrist sprain as a result of the collision shock. Due to the fact that the technical condition of the unit did not threaten its safety, after conducting work on board at approx. 06:45 a.m. Ancilla WŁA-68 independently returned to the port in Władysławowo.

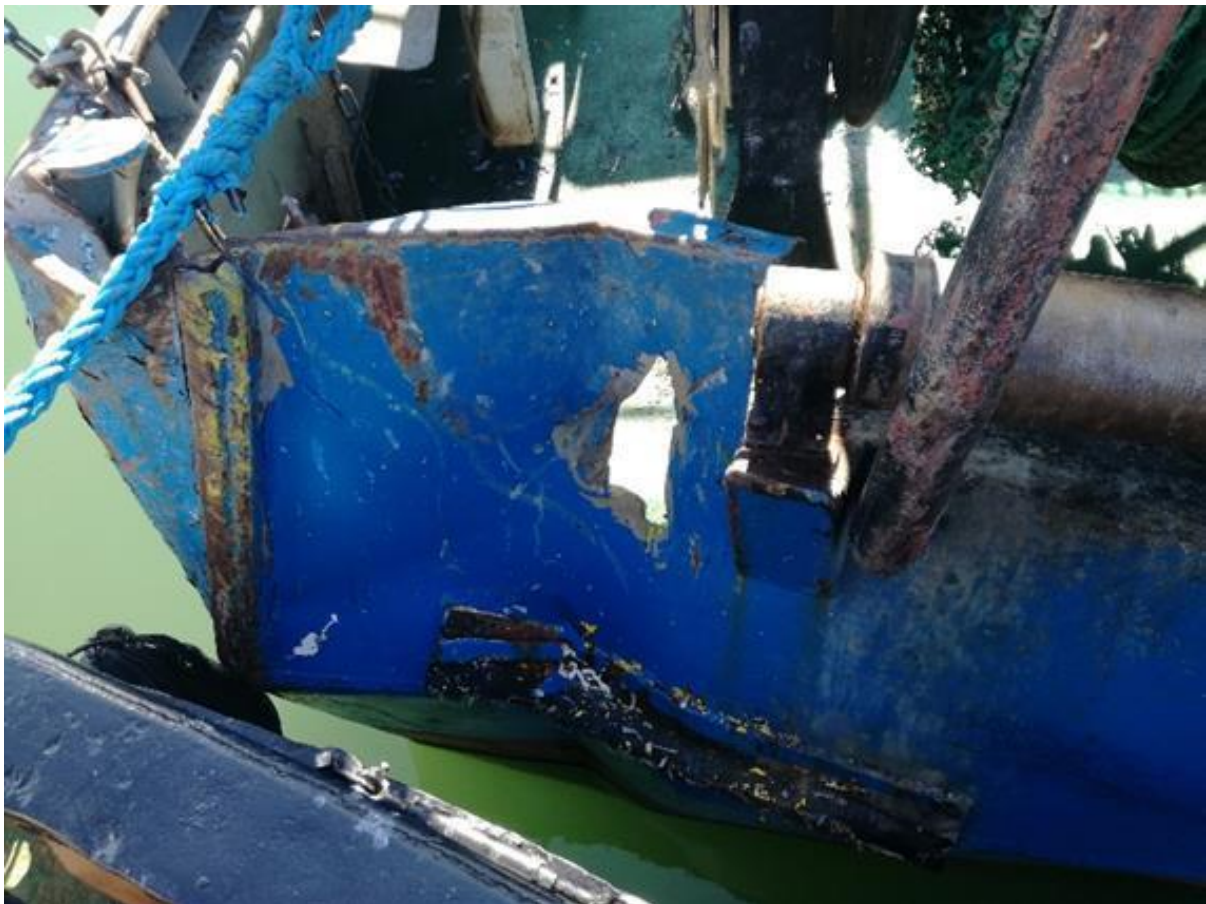
Photograph No. 4 Damage to the fishing cutter Ancilla WŁA-68

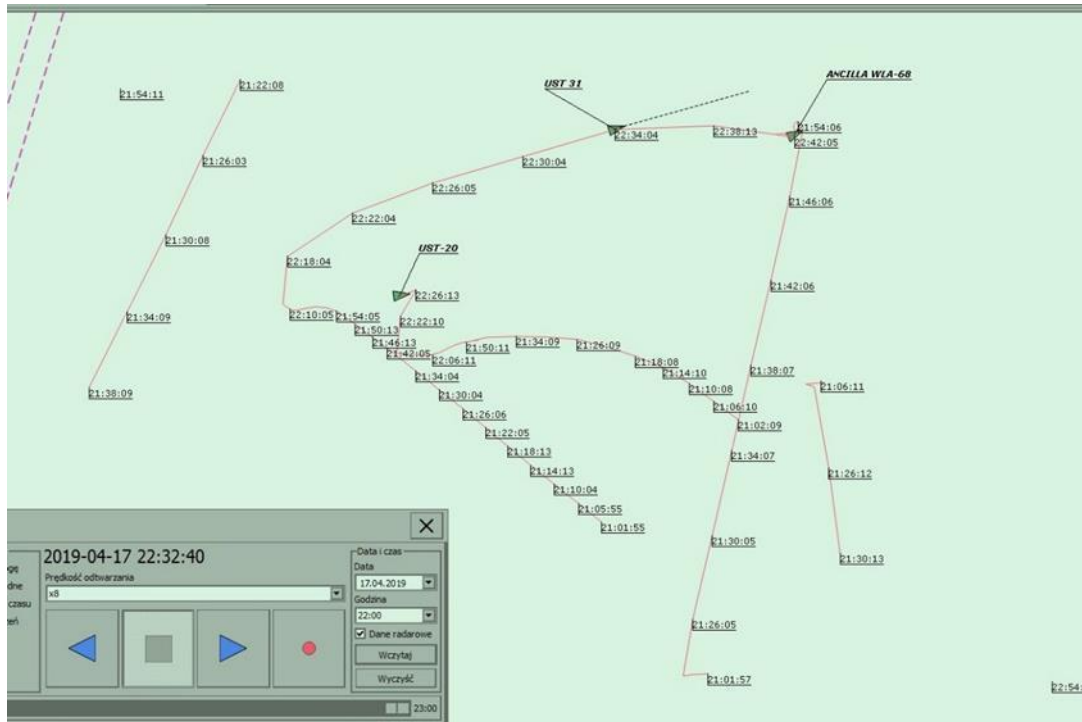
Illustration 2 Partial route of UST-31 and Ancilla WŁA-68 units on April 17, 2019

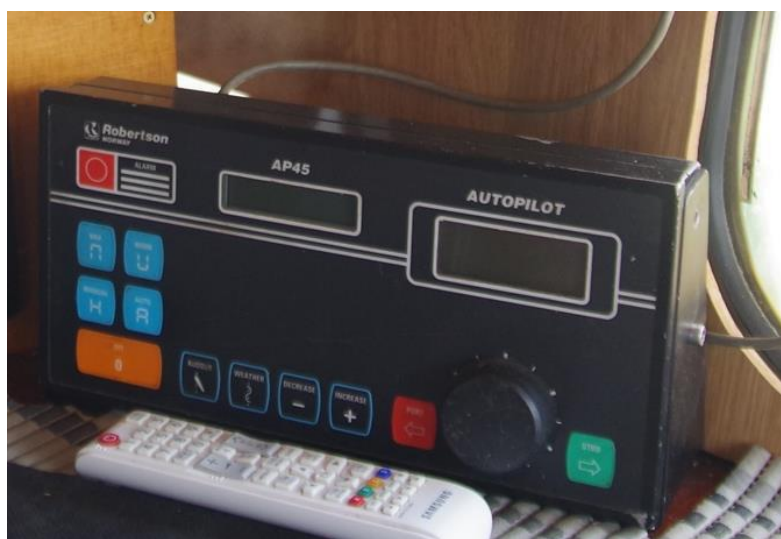
on the autopilot [photo 6] from automatic to manual and definitely change the course to the right. These actions did not cause the expected change of course and the UST-31 unit hit the stern of the Ancilla WŁA-68 cutter. As a result of the collision, the bow part of the UST-31 cutter was slightly damaged (photo 5) and the bulwark on the aft of the WŁA-68 cutter [photo 3, photo 4]. None of the cutters suffered a leak in the hull and none of them filled with water.

Photograph No. 6 Autopilot of fishing cutter UST-31

According to the Commission, the action to avoid collision taken by UST-31 was not in line with Regulation 8b, as the course change was not decisive and large. The skipper was gradually changing course using the autopilot. Based on experience and practice, Regulation 8 requires that small, consecutive course changes are avoided. Such indecisive action may not be noticed in time, and additionally the use of autopilot slows down the unit's response time to a given course change.
