STATE MARINE ACCIDENT  
INVESTIGATION COMMISSION

# FINAL REPORT

# 89/19

**Pushed train: Atlant 1  
pusher tug and Ułan 72  
barge**

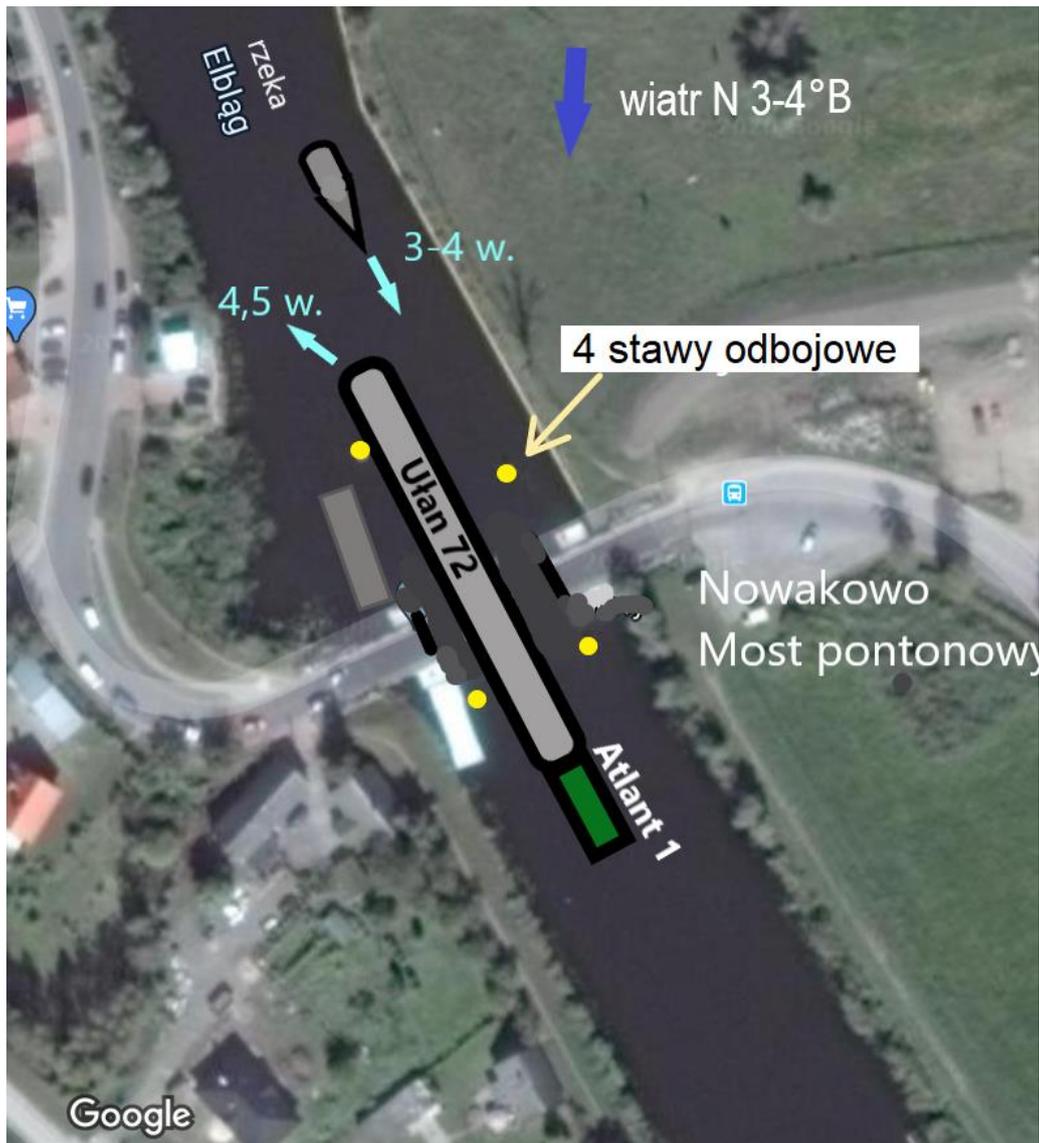
*Fig. 1 - Site plan of the pushed train crossing the open pontoon bridge in Nowakowo and the barge hitting the dolphin. (source: the figure was drawn on the photo derived from the Google Maps application)*

At about 7:12 PM the port side of the barge (15 m from the bow) hits the dolphin behind the bridge causing a sudden sideways movement of the barge, and the captain observer standing on the bow close to the coaming of the partially open cargo hold loses his balance, staggers and falls into the empty cargo hold falling from a height of 3.10 m to the steel bottom of the cargo

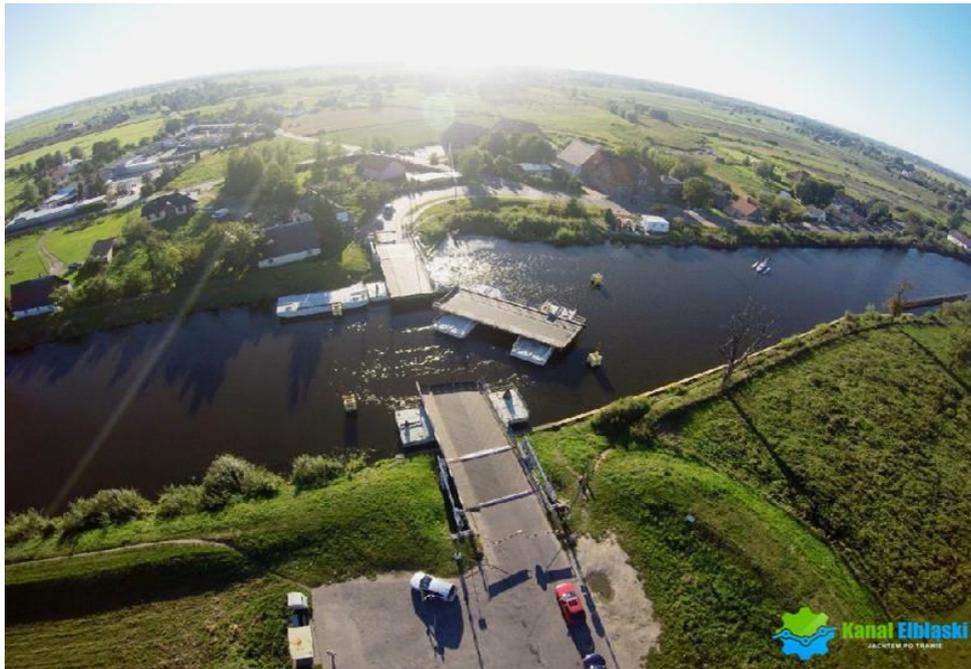
*Pic. 1 - The bridge in Nowakowo during the opening. Four dolphins the train sailed between can be seen in yellow colour (source: <https://kanal-elblaski.pl>)*

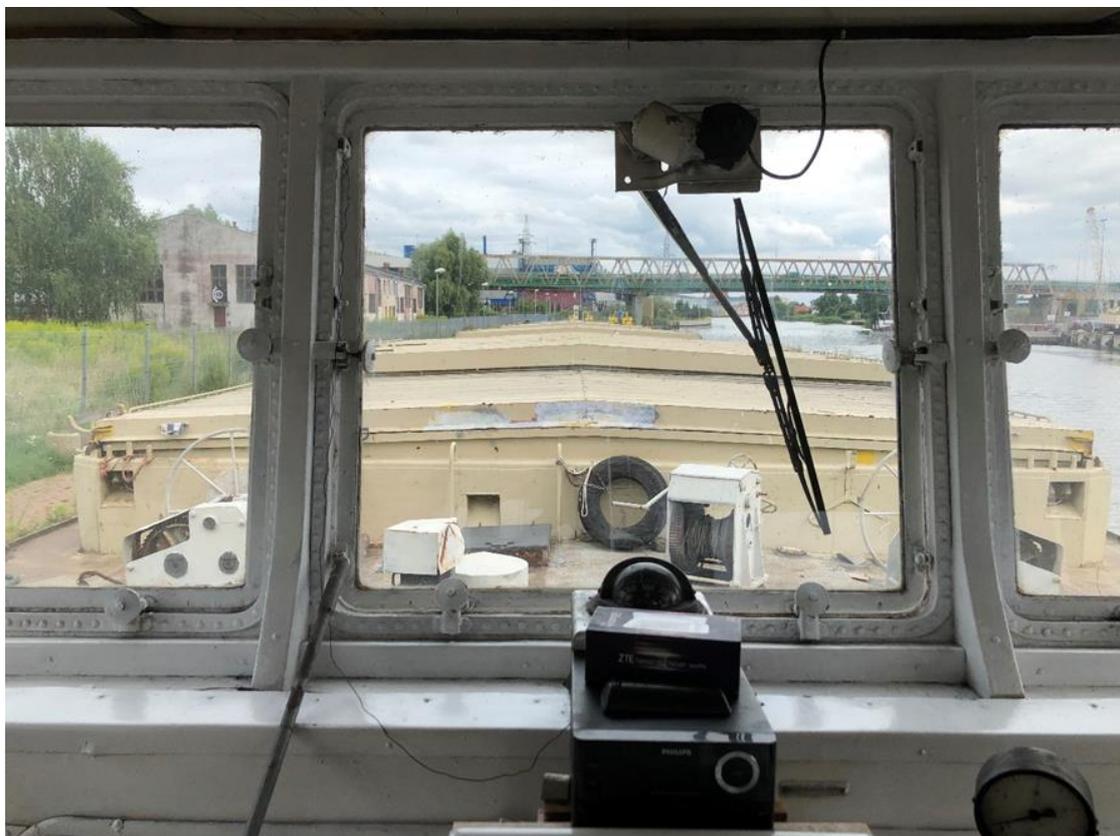
*Pic. 3 - View from the bridge of the Atlant 1 pusher tug towards the bow of the Ulan 72 barge.*

The unloaded, emerged Ułan 72 barge obscured the visibility from the bridge in front of the bow of the barge, covered the visibility sector to about 60 m, hence it was necessary to show, with hand signs and using UHF radio, the required manoeuvres and information about obstacles when passing in difficult places to navigate by an observer from the bow. Such a place is the crossing between the pontoons of the bridge in Nowakowo. This procedure is described in the Ordinance of the Director of Office of Inland Navigation in Gdańsk – “When sailing in difficult sections of the waterway marked with signs B.8, B.9a, B.9b on ships and pushed trains the length of which exceeds 86 m the observation post at the bow part must be kept. The observer should have a constant connection with the wheelhouse. Vessels approaching difficult stretches of waterways should transmit a radio message at the designated frequency for the ship to ship connection informing about their position.”<sup>2</sup>

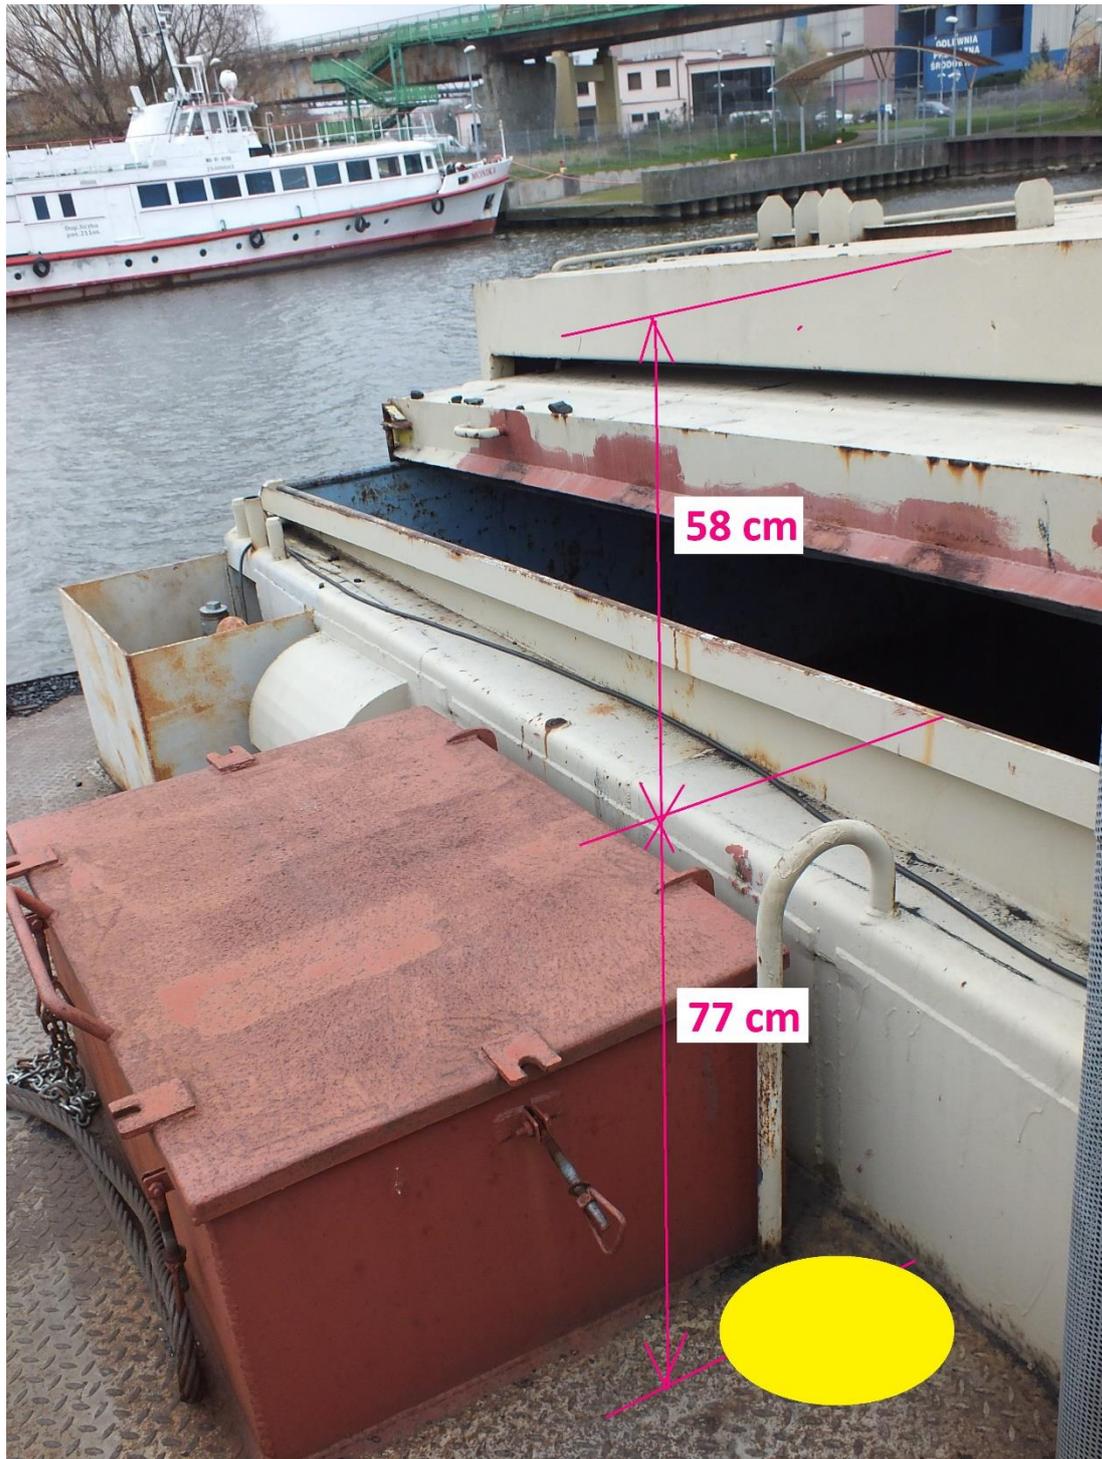
*Pic. 4 - A place at the bow of the Ulan 72 barge by the coaming of an open cargo hold where the captain observer was standing (marked in the photo with a yellow circle).*

the wheelhouse of the pusher was at the bow, very close to the low coaming of the cargo hold. At this point, the working height of the coaming from the deck is 77 cm. Shortly before the accident, the captain observer stood with his feet on the coaming which, during the violent lateral movement of the barge being the result of hitting the dolphin, was the cause of the captain losing his balance and falling into the cargo hold.

As a result of the investigation carried out the Commission established that the cause of the accident was an inadequately secured place from which the captain observer provided information to the captain steering the pushed train.

The Commission recommends that each time an observer is dispatched to the bow of the barge on a pushed train the cargo hold should be closed from the bow side to prevent the observer from falling into the cargo hold. If such a position is to be close to the cargo load such cargo load must be closed all not partially open.
