PAŃSTWOWA KOMISJA BADANIA
WYPADKÓW MORSKICH

FINAL REPORT

112/19

**Yacht thrown onto the beach after overturning
on the approach to the port of Klaipėda
on 15 September 2019**

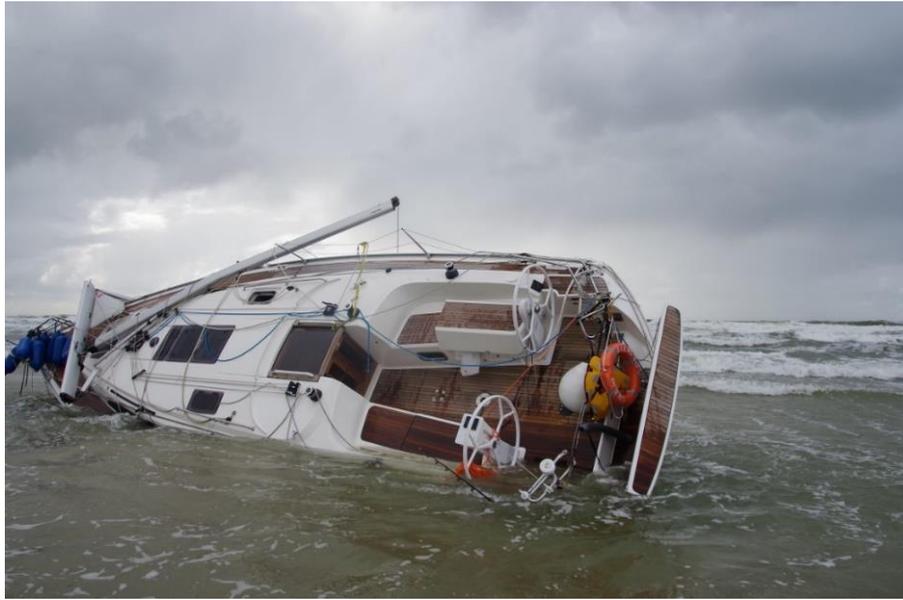
Photograph 1. The “Lilla W” yacht on the beach on 17 September

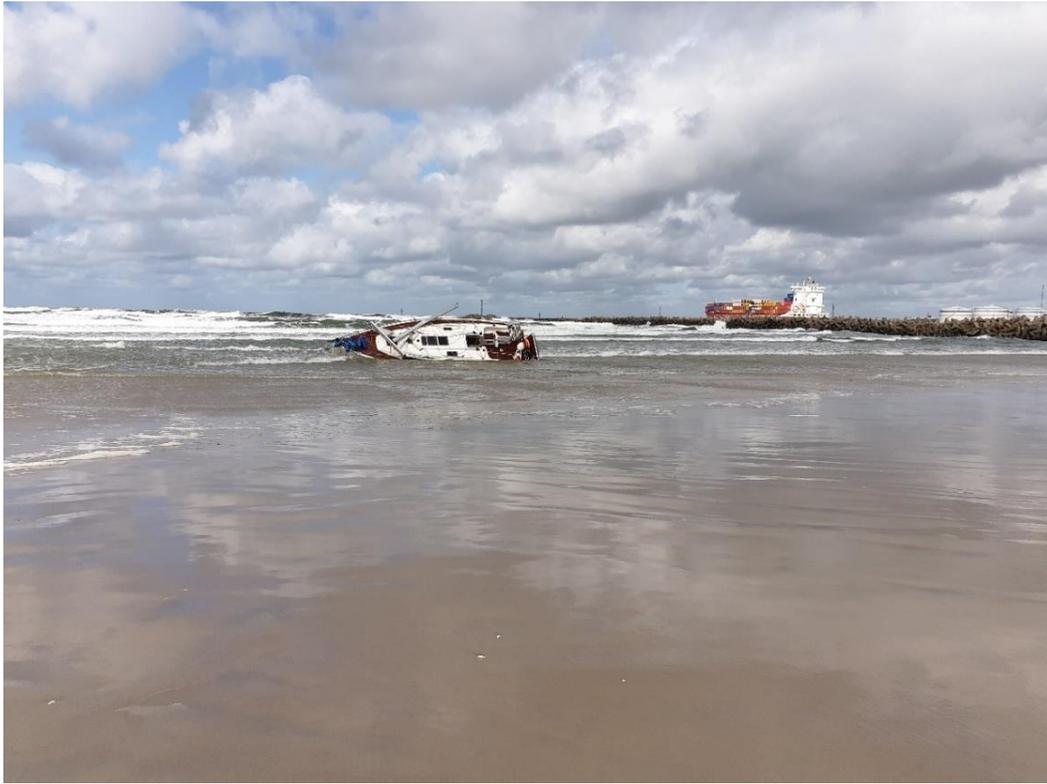
Photograph 4. The “Lilla W” yacht on the beach on 17 September with a visible breakwater

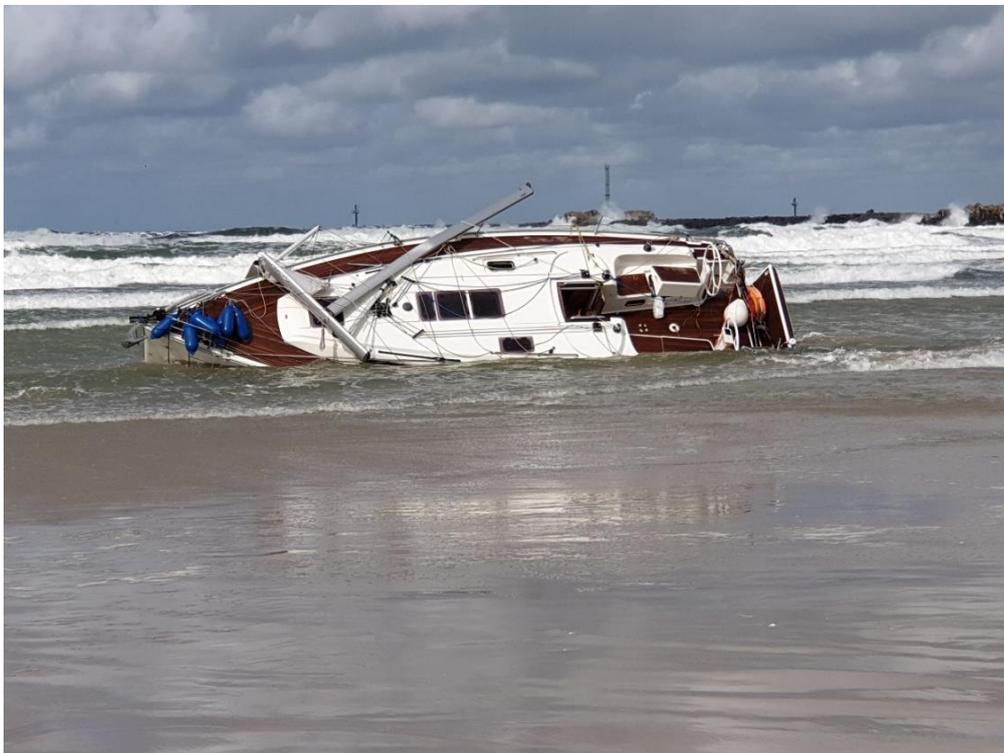
Photograph 5. The “Lilla W” yacht on the beach on 17 September

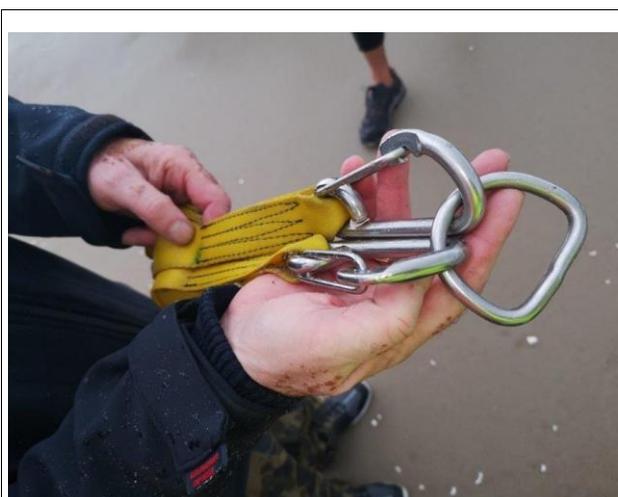
One of the crew members harness broke, but it is not known which element failed. In the water, the lifejacket twisted around her neck.

Photograph 7. Ring pulled out from harness A
(photo by Lars Krogius Baltic Ltd.).

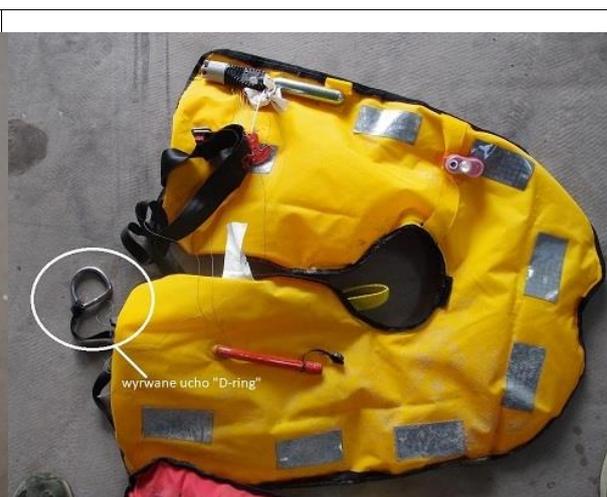
Photograph 8. Ring pulled out from harness B
(photo by the SMAIC).

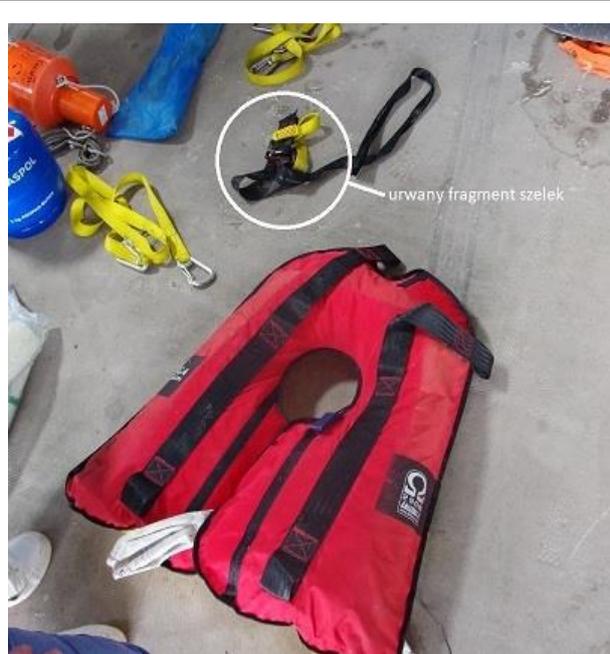
Photograph 9. Fragment of the harness torn off (photo by the SMAIC).

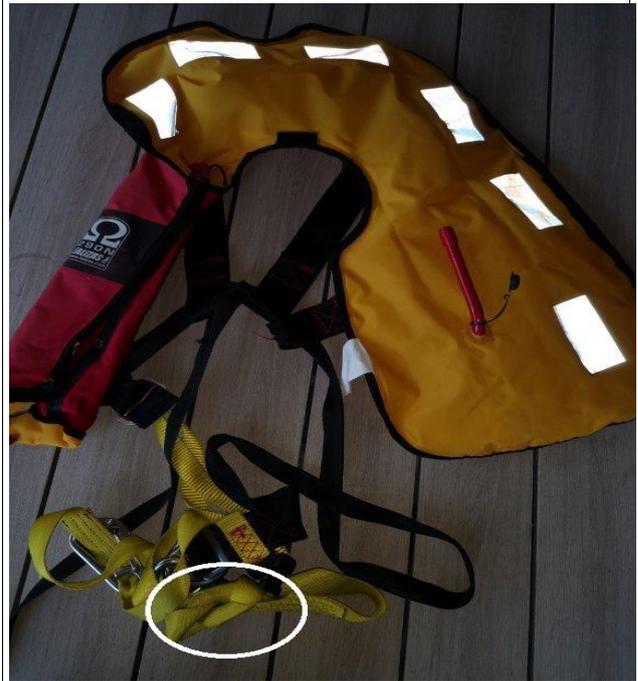
Photograph 10. The strap tied with a knot (photo by Lars Krogius Baltic Ltd.).

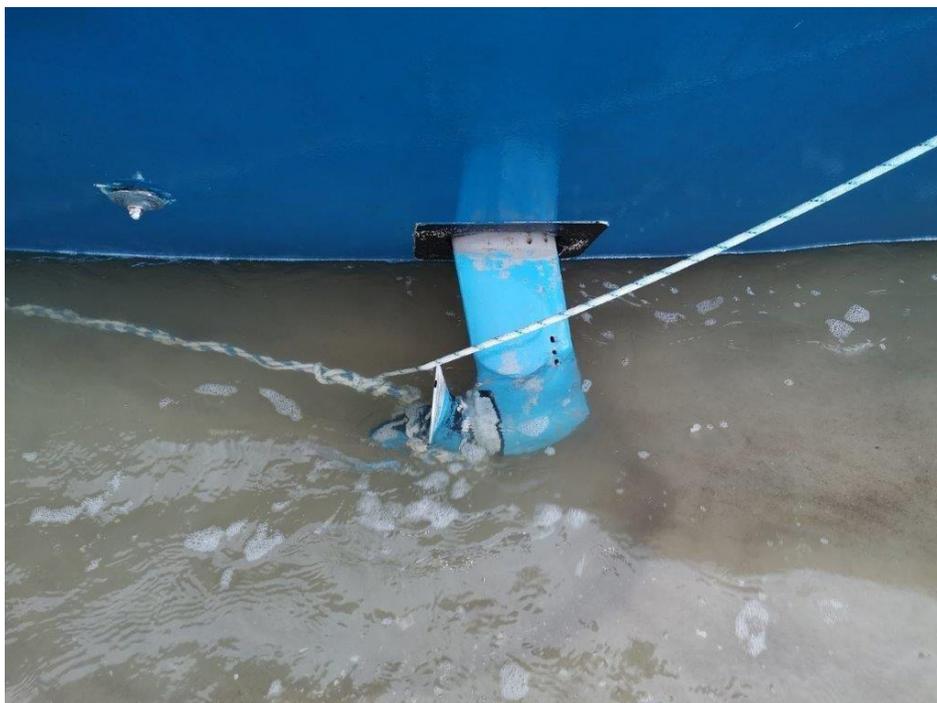
During the manoeuvre to approach the man overboard started by the 2nd mate after the captain's fall, the engine stopped because the ropes of the running rigging wound on the propeller, taken from the cockpit by the same wave that took the captain. The loose ends of the sheets of the furled sails were hung on the corresponding capstans as loose coiled lines, ready for use. The yacht was equipped with bags or lockers to protect slack ropes from being swept or washed away by wind or waves, but the action of a very large wave could protrude the ends of the ropes from the bags.. Initially, the erected dodger provided certain cover, but the wave also took the entire dodger, easily tearing the frame tubes from the fittings that fastened them to the cabin roof. Tightly closed bags, permanently attached to the hull, give a chance of avoiding significant sections of slack ropes from falling overboard, but in this case the ends of the ropes may have been placed in the bags hurry and carelessly. In this particular case, it is doubtful whether the efficient engine of this power, which the "Lilla W" had, would have allowed the inexperienced crew remaining on board to move away from the surf area, effectively taking two people who fell out first from the water. Nevertheless, as the immobilisation of the engine with the ends of ropes falling overboard is always a serious risk and a frequent cause of accidents, taking effective measures to prevent this situation is an

Photograph 11. Ropes of the running rigging blocking the propeller (photo by Lars Krogius Baltic Ltd).

1. The Commission recommends strengthening the cockpit table mount in the Bavaria 37 Cruiser model and in any other type of yacht.
2. It is recommended to equip yachts with tightly closed bags, more resistant to breaking or tearing, permanently attached to the hull, where loose ends of ropes can be stowed, thus preventing large sections of slack ropes from falling overboard, getting caught in the engine propeller and, consequently, immobilising it.

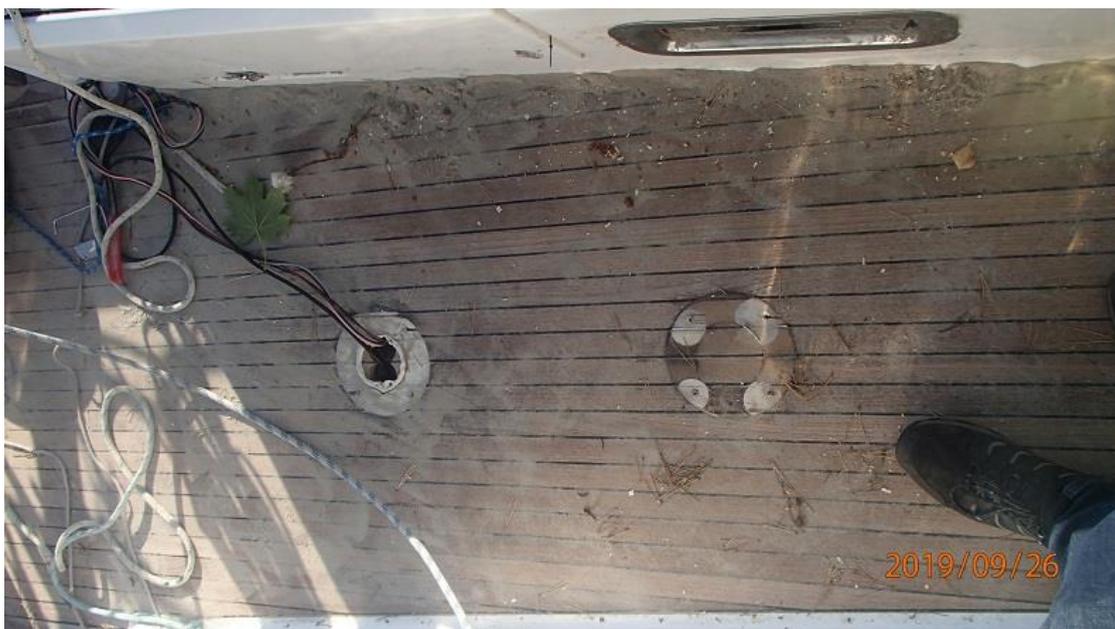
The table mounted centrally along the cockpit, broke too easily under the pressure of successive waves and the crew in the cockpit during sudden heels. A navigation plotter and a magnetic compass, covered with a stainless-steel bail from the top, were mounted on the table.. The 2nd mate was taken overboard by the wave as he was strapped into the bail of the compass with his safety harness strap. The 2nd mate found himself in the water not attached to the yacht, but it is not known which parts of the harness and/or the attachment point did not withstand the pull. It should be noted that the cockpit table, apart from its obvious function, is not only a structure which serves as a place for the installation of navigation devices – the plotter and magnetic compass – but it is also of great importance for the safety of the crew, providing a point of support for people and dividing the open space of the spacious cockpit, limiting the possibility of a fall and the momentum of a person losing their balance or grip. Therefore, the structure of the table should be strong enough to withstand a fall with the whole weight of one or even more people, e.g. when the yacht is significantly listed. The use of a few relatively thin screws is certainly insufficient from this point of view.

Photograph 12. Traces of screws securing the cockpit table (photo by M. Cesnauskis).

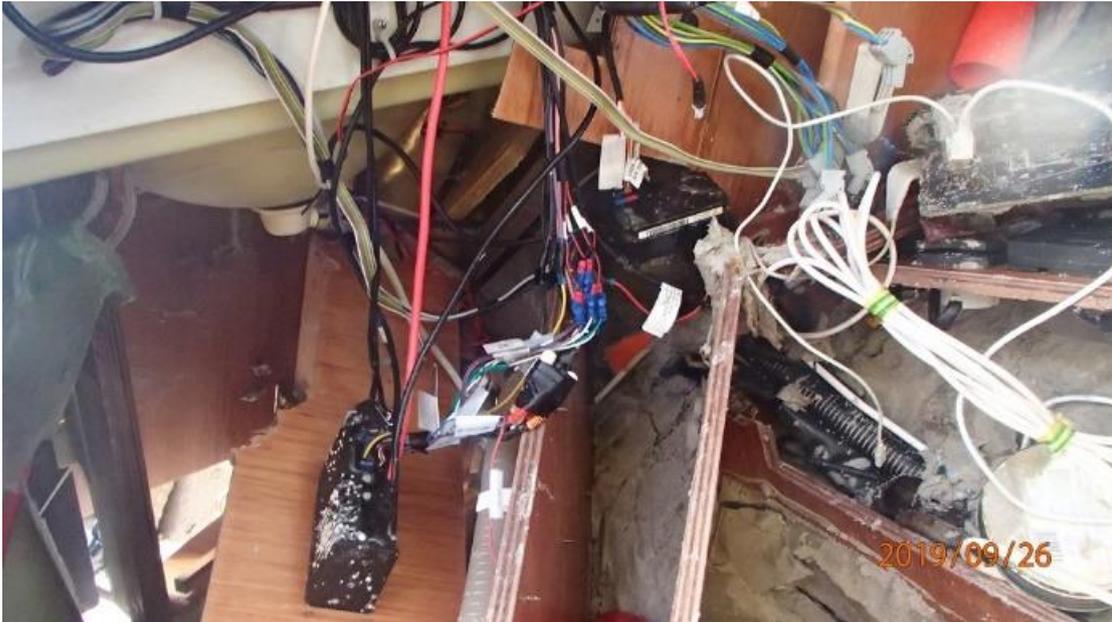
The impossibility of transmitting a DSC Distress signal may also be due to the fact that the first violent attack of the surging wave and falling overboard of two crewmembers was a shock for the crew and in such conditions it was difficult to act rationally, and in addition the VHF transmitter could already be damaged then, because after the next waves and finally the yacht capsized, all radio and navigation equipment was completely destroyed, which can be seen in the photo below.

Photograph 13. Radio and navigation station after the accident.

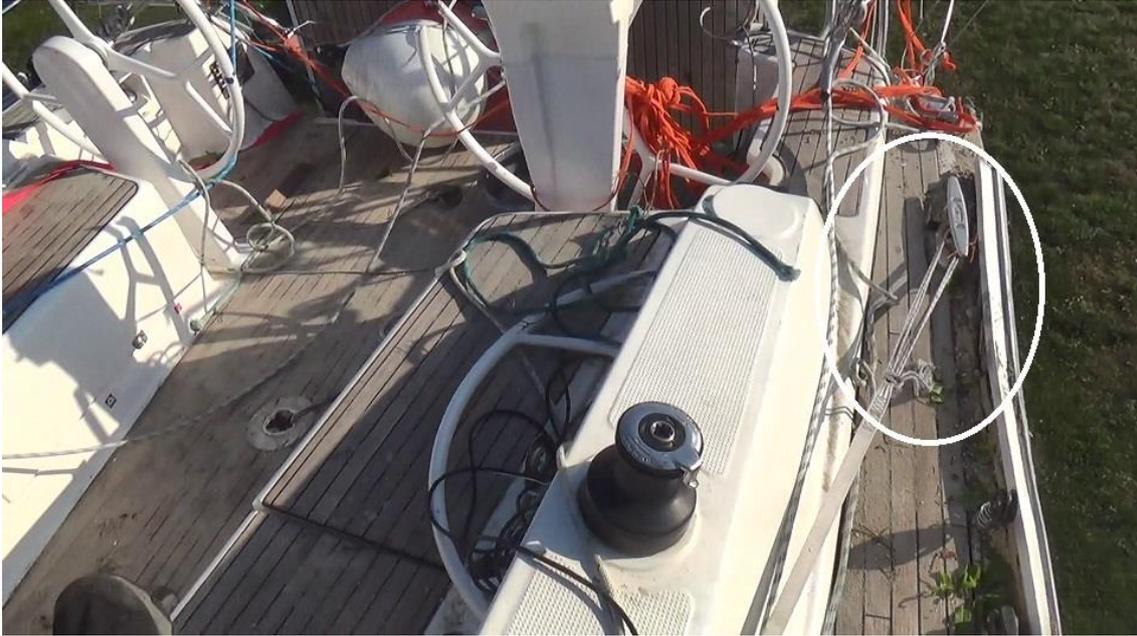
2. The method of securing jackstays running on the deck from the bow to stern was questionable. While the durability of the braiding itself, used instead of the steel cord, does not raise any objections, the use of 3-4 mm synthetic cord folded three times (tied with a knot) instead of an appropriate strap or hook may not be sufficient and certainly significantly reduces the strength of the whole. For example, the *World Sailing* regulations for regatta yachts require the use of 1x19 steel ropes with a diameter of at least 5 mm or equivalent. According to the same regulations, a traveler made of synthetic cord can be used to fasten a taut lifeline cord provided that the length of the traveler cord is no more than 10 cm and it is replaced frequently enough.

Photograph 13. Fastening of the jackstay on the stern (photo by M. Cesnauskis).

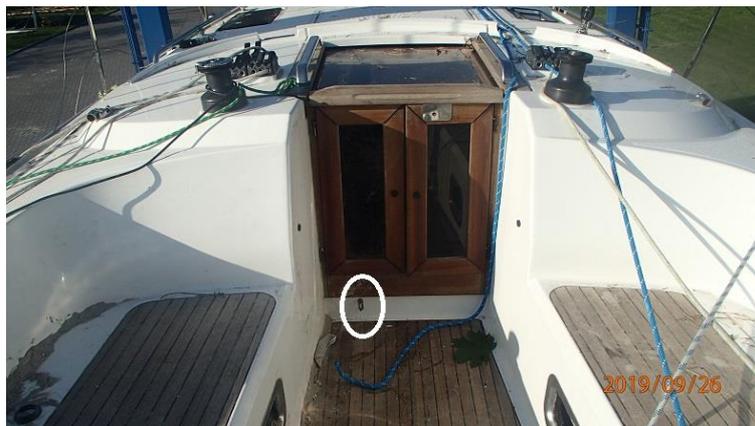
*Photograph 14. The harness ring, e.g., for those crossing the companionway
(photo by M. Cesnauskis)*
