**SIMPLIFI REPORT**

**123/19**

**Fishing cutter KOŁ 212**

**Evacuation of crew members from the flooded cutter  
on 21 October 2019 on the Baltic Sea.**

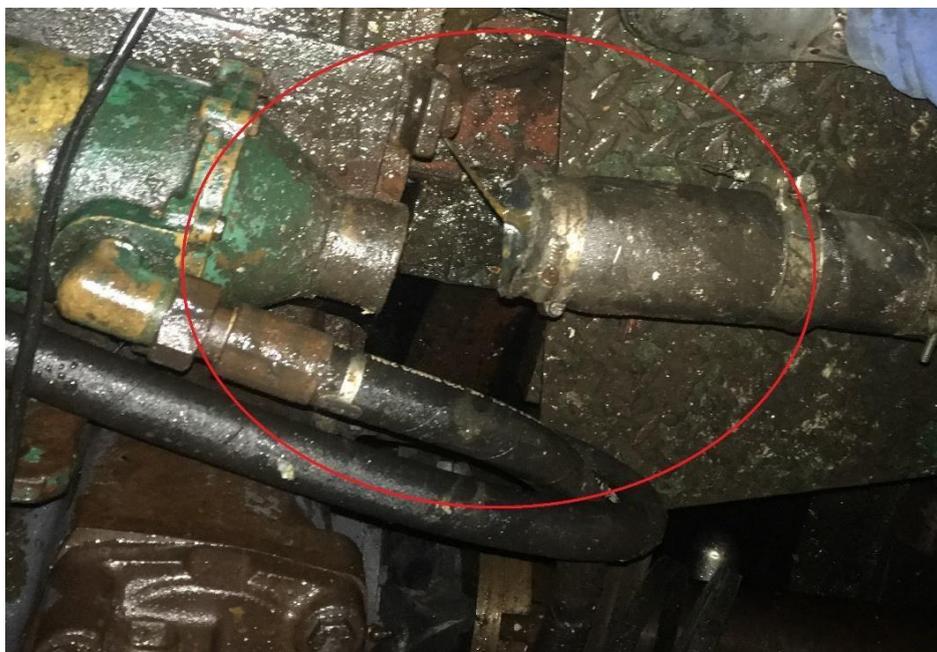
*Photograph 6. The immediate cause of failure on the cutter KOL 212.*

During the inspection on the fishing cutter KOŁ 212, it was clearly established that the cause of the investigated accident was the disconnection of a rubber coupler (rubber pipe with metal clamps) which connected the pipe draining water from the oil cooler overboard [Photograph 6]. The running engine powered the pump which was pumping water into the cooler. Due to the fact that the coupler slid off, the seawater from the oil cooler did not pour out overboard but flooded the engine room.

As a result of the investigation, the Commission established that the immediate cause of flooding of the cutter was a mechanical failure consisting in disconnection of a flexible coupler connecting the pipe discharging water from the oil cooler overboard. The rubber element was most likely disconnected as a result of a crew member stepping on it or other pressure (e.g. a cargo box). The running engine powered the pump which was pumping water into the cooler. Due to the unsealing of the outlet cooling water pipe, the engine room was flooded. Due to the short period of work on the vessel and, consequently, the lack of experience and operational knowledge of the vessel, the commander decided to evacuate the crew and leave the cutter without establishing the cause of the failure. During the event, the crew did not diagnose the cause of the failure.
