FINAL REPORT

139/19

„Hunter” and „Amelia Max” motor yachts

**Motor yachts collision in the Ławica Słupska on
December 20, 2019**

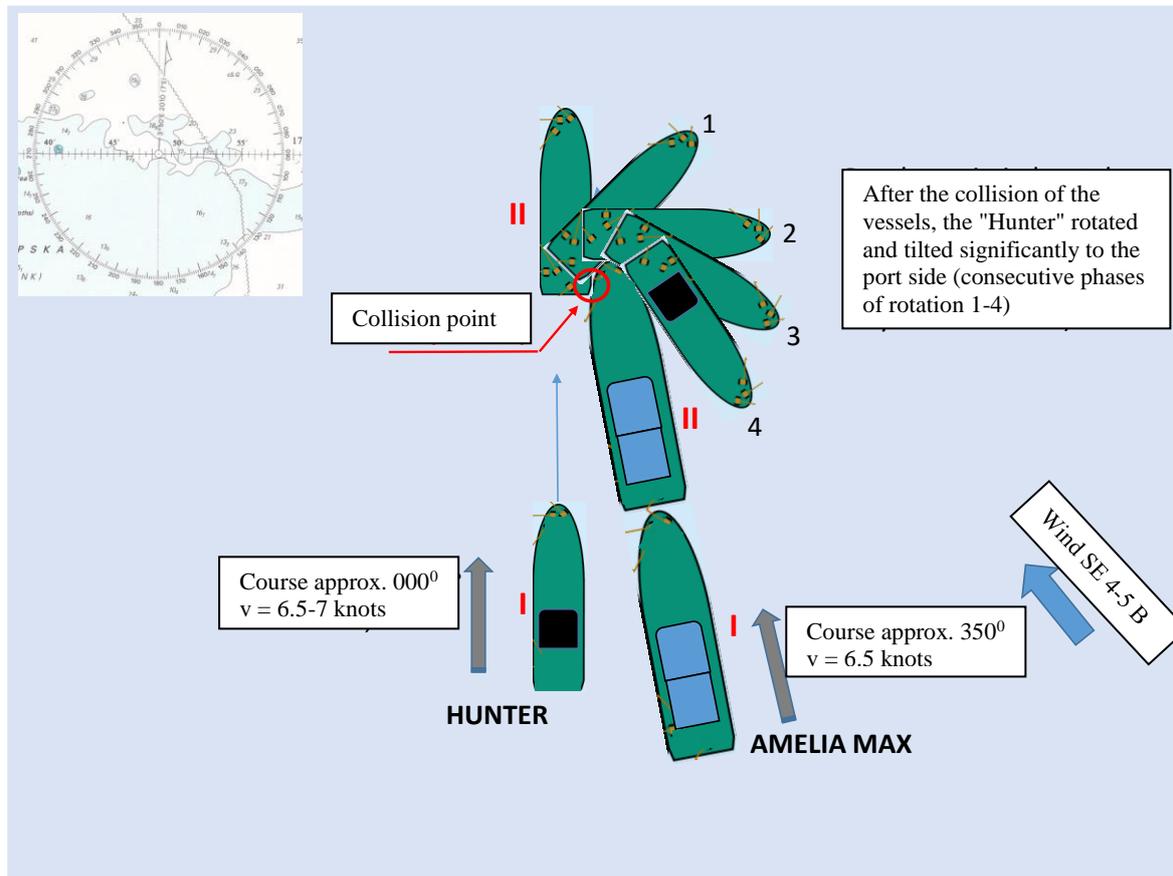
the stern. The vessels came closer to each other, then "Hunter" overtook the "Amelia Max" from the port side. Then, without warning, it cut across the bow to the starboard side of the "Amelia Max". Surprised by this manoeuvre the skipper of the Amelia Max yacht, using the 8 VHF channel, warned the skipper of the "Hunter" yacht that the passing distance was too small and dangerous. "Amelia Max's" yacht maintained a course of 350° and a speed of 6 knots while the "Hunter" sailed parallel to "Amelia Max" from the starboard side steering manually (no autopilot). At one point the two vessels came dangerously close to each other which forced the "Hunter's" skipper to make a decisive manoeuvre to the right and to make circulation behind "Amelia Max's" stern. After some time the "Hunter" yacht keeping the 350° course with a speed of 6.5 to 7 knots caught up again with "Amelia Max" being on its starboard side and then started overtaking manoeuvre. Meanwhile one of the anglers on board "Amelia Max" yacht while preparing fishing gear saw the approaching "Hunter" yacht from the port side. At one point he got concerned that both units were going too close to each other and neither of them changed course or speed to avoid getting too close to each other.² It was still dark at the time, just before dawn, but the contours of "Hunter" and its navigation lights were clearly visible from "Amelia Max's" deck. Angler also noticed that the lights were on in the helm of Amelia Max's yacht. He wanted to warn the skipper who was steering the yacht, but it was too late because at that point the "Hunter" yacht approached the bow of "Amelia Max's" yacht and at 7:27 AM both vessels collided. "Amelia Max" hit, with its bow, the stern section of "Hunter" from its starboard side, approx. 70 cm from the stern edge causing the Hunter to turn around sharply and a significant tilt to the port side. Anglers on board of the "Hunter" were forced to grab the railings or other deck elements for fear of falling down or falling overboard. On the "Amelia Max" yacht, just seconds before the collision, the skipper switched the engine to the "emergency full astern", but it was too late and it did not prevent the collision. As a result of the collision the "Hunter" rotated around the bow of "Amelia Max's" yacht landing at its starboard side. Vessels rubbed against each with their starboard sides and going in opposite directions the yachts moved away from each other. At the moment of the collision when the Hunter yacht was tilted to its port side, it was likely that the element of the stem of "Amelia Max's" protruding in the underwater

part hit the propeller of the "Hunter" yacht which resulted in tearing out and pulling out the propeller shaft from the coupling.

Figure 2. Successive phases of the vessels location in relation to each other (before and during the collision)

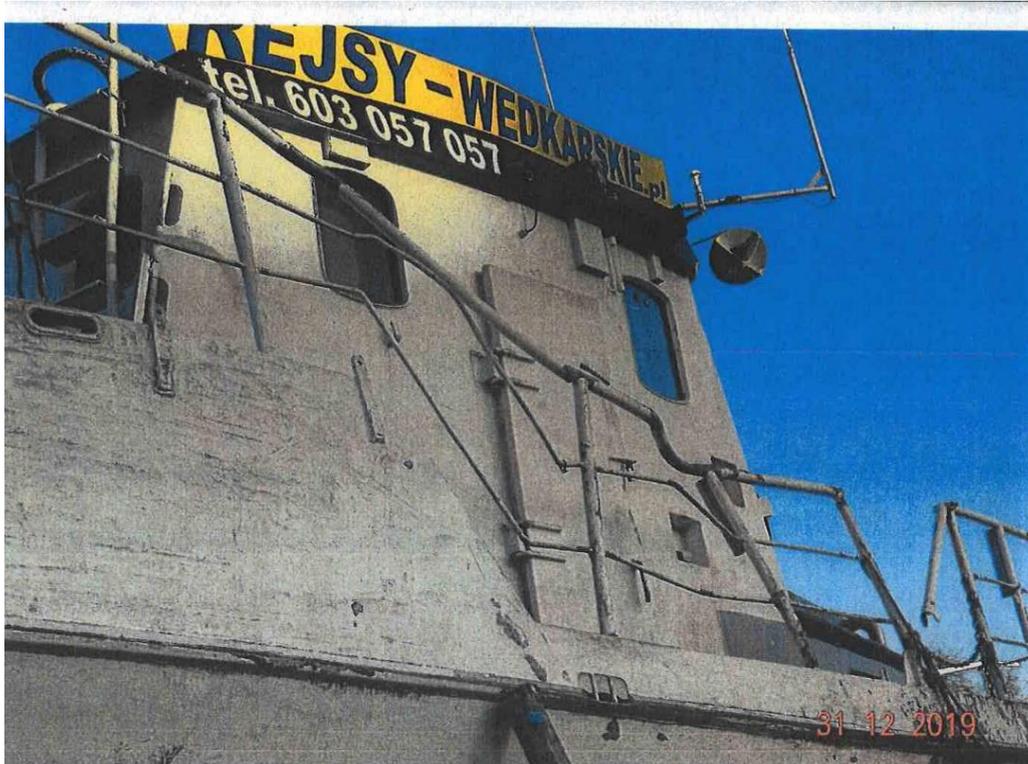
Picture 3. "Hunter" yacht - damage to the railings and starboard plating in the stern board section (next to bridge)

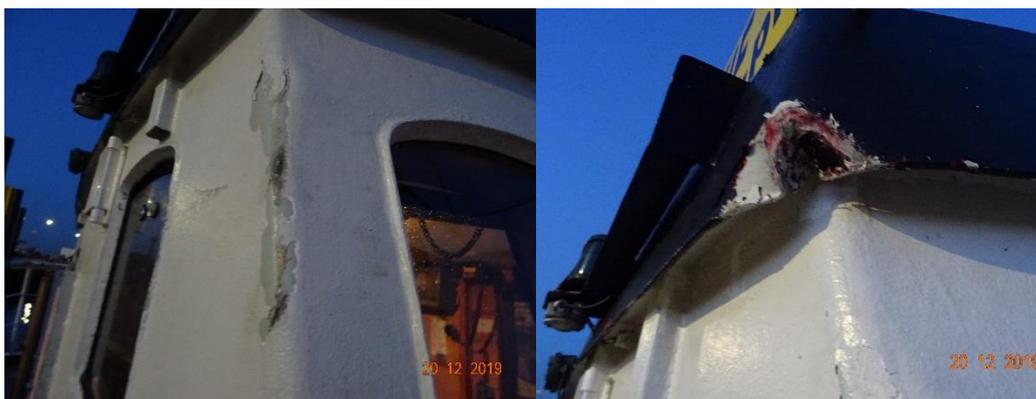
Picture 4 a and b. "Hunter" yacht - damage to the bridge from the starboard side of the stern board section.

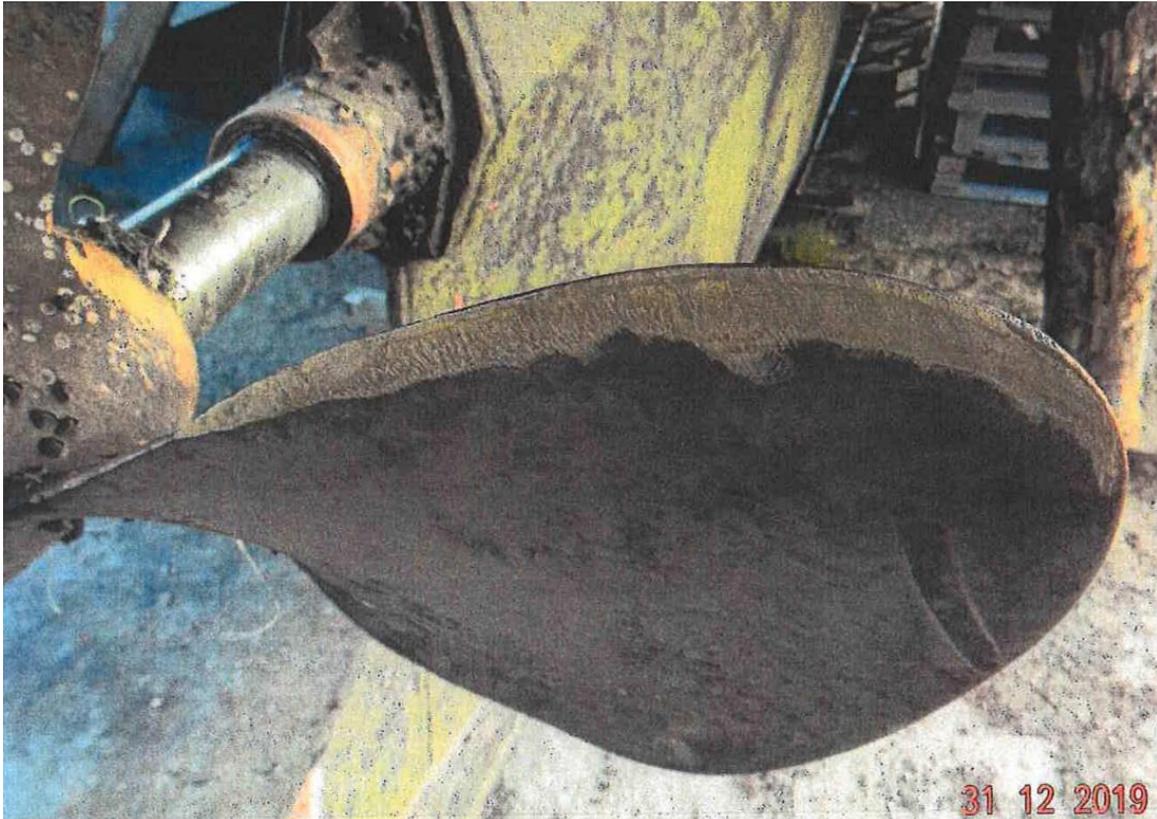
Picture 5. "Hunter" yacht, - damaged and pulled out, by 12 cm, propeller shaft.

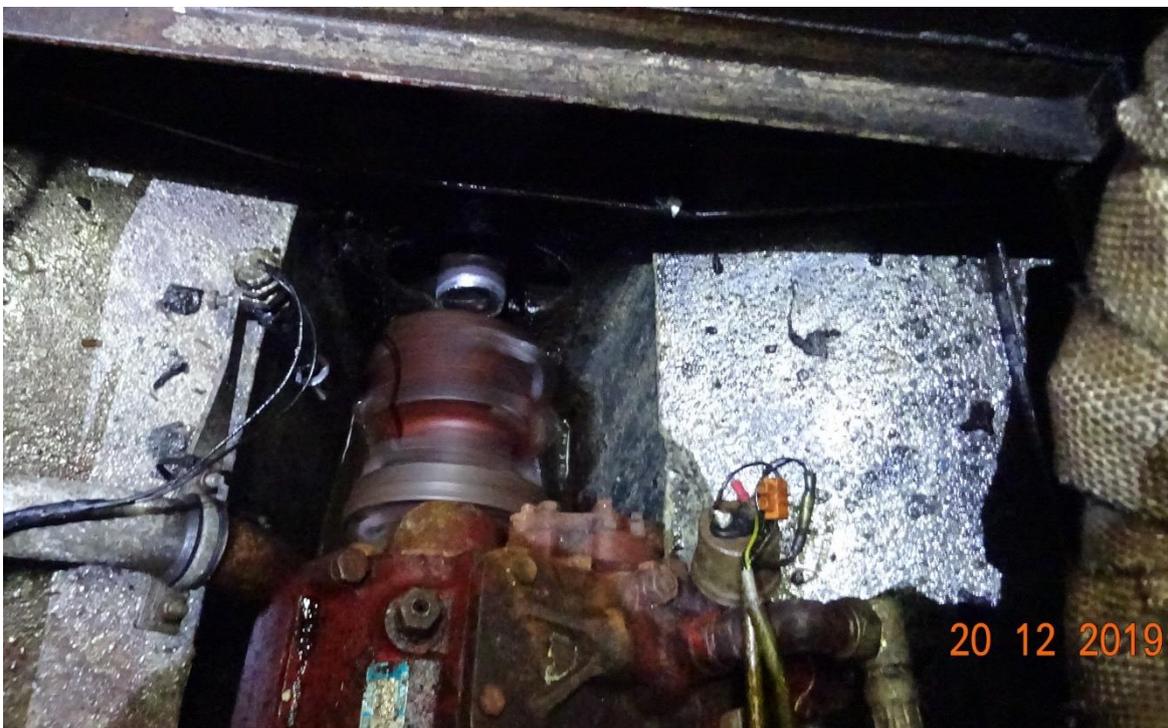
Picture 6. "Hunter" yacht - propeller shaft torn out from the coupling.

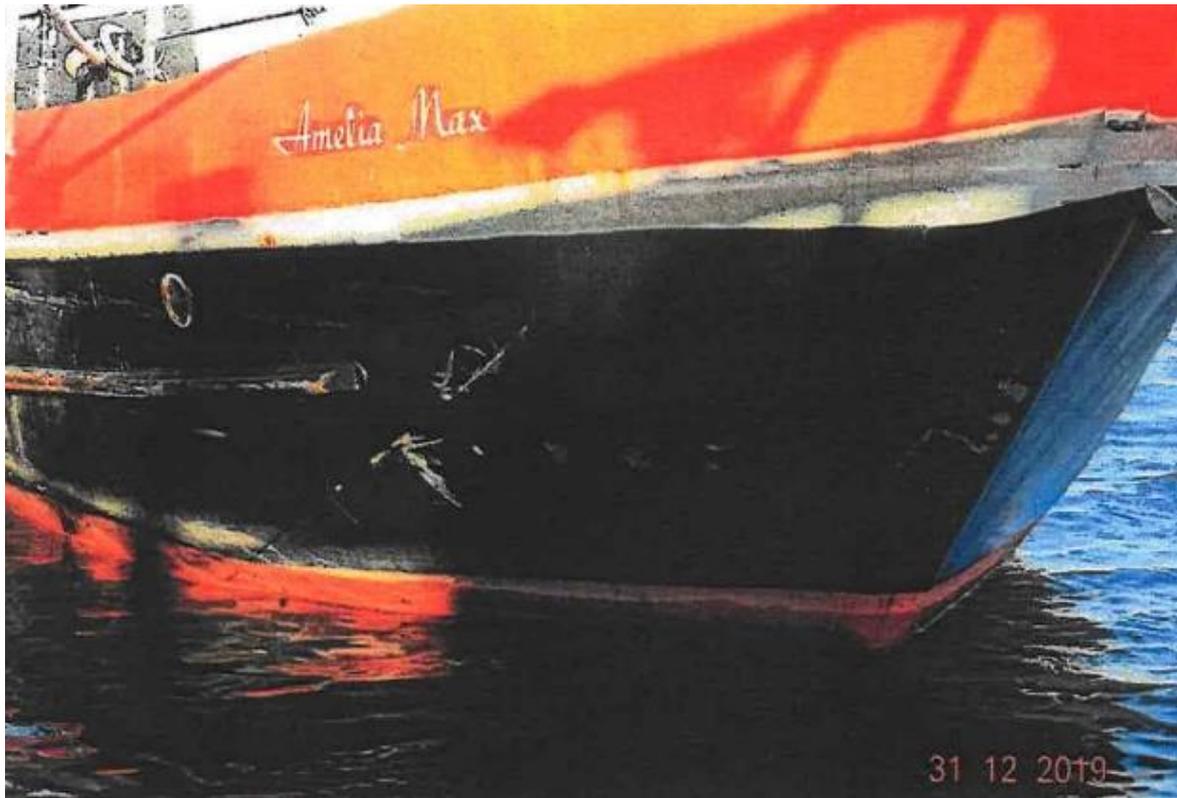
Picture 7. "Amelia Max" yacht - damaged bow and dents in the hull plating.
