SAFETY INVESTIGATION REPORT

REPORT NO.: 10/2021

MT MOUNT EVEREST

Serious injury to a crew member, during mooring operations in the port of Marsaxlokk, Malta 08 May 2020

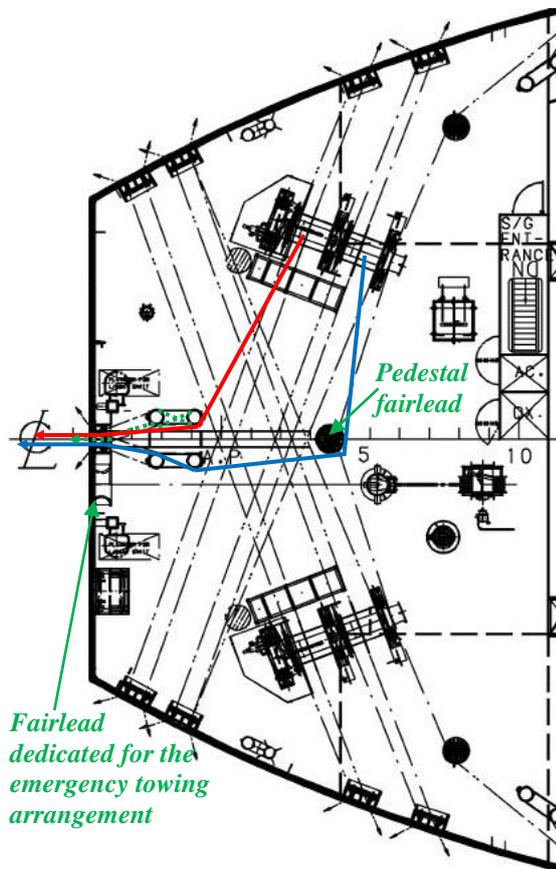
Figure 8: The stern lines (red, blue, and dashed green), as passed to the mooring buoys prior to the accident

Two of the three stern lines were passed from the port mooring winch (Figure 8), while the third stern line was a loose mooring rope, which was lightly wound around a mooring bitt (dashed green line in Figure 8), after it was secured on the mooring buoy. All three lines were passed through the centre fairlead on the vessel's poop deck (Figure 9). The master was not aware of the stern lines' configuration since it was neither visible from the bridge, nor was it reported to him by the third officer.

Whilst the crew members at the aft mooring station were heaving up on the two stern lines, which were on the twin split-drums, they noticed that these two lines bore unequal tension, with the aftermost line (red line in Figure 8) being tighter than the forward line (blue line in Figure 8).

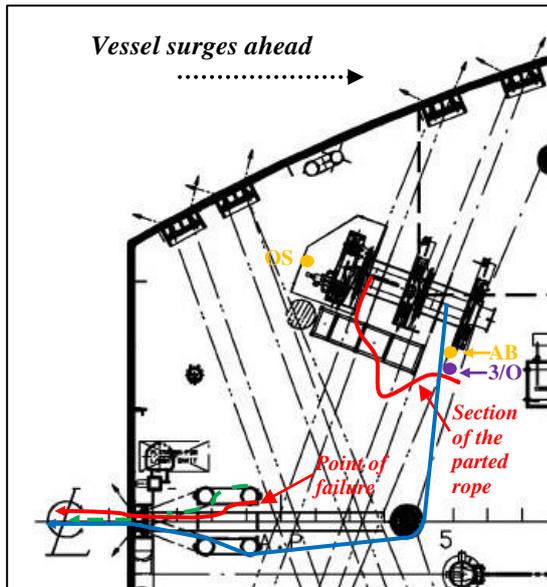
Figure 10: Dynamics of the accident

At around 1355, the section of the parted rope, which was spooled on the split-drum, snapped back towards the third officer (Figure 10), striking him first on his left forearm, followed by the left side of his head.

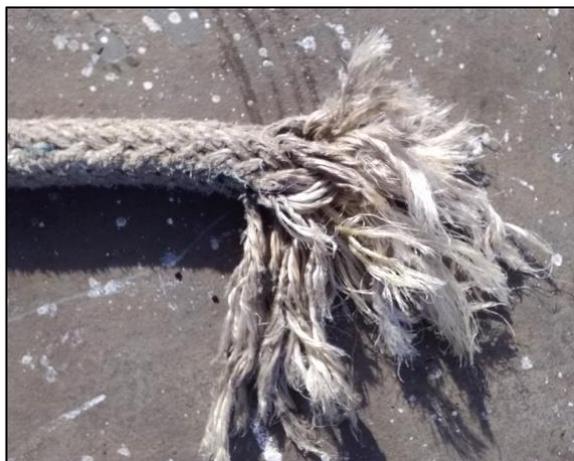
Figure 12: A section of the failed mooring rope

The mooring rope which had parted (Figure 12) had been received on board *Mount Everest* on 05 March 2015. The safety investigation was informed that following the receipt, this rope was stored in the vessel's forecabin storage space (Figure 13) and was first used in October 2019. It was kept on the same split drum of the aft mooring winch, until it parted.

Following the accident, a 15-metre-long section was sent to the rope's manufacturer for a breaking strength test. The test results revealed that this section of the rope had parted after approximately 188 seconds, when the test load had reached about 302 kN (30.8 mt).

Since no further tests or analysis (say, a microscopic analysis) were conducted on the failed mooring rope, the safety investigation was unable to ascertain the exact cause(s) of its failure. Nonetheless, the MSIU hypothesized that the strength of the mooring rope may have been reduced due to eventual deterioration of its external and/or internal fibres.
