PAŃSTWOWA KOMISJA BADANIA
WYPADKÓW MORSKICH

SIMPLIFIED REPORT

Tugboat “Uran”

**Tugboat’s bow hitting the XXX-lecia Quay in
Gdynia on 19 July 2020**

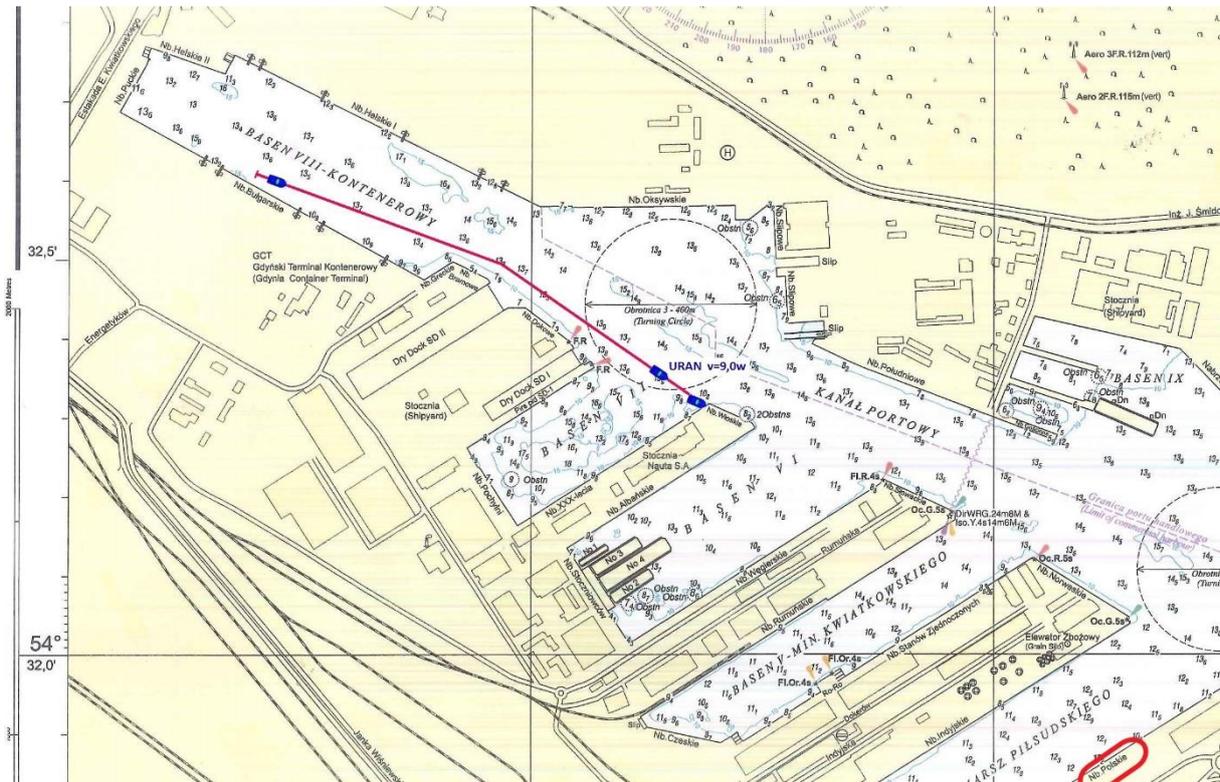
Figure 2. – The route of the tugboat Uran from the Bulgarskie Quay to the accident site
(part of the BA 2636 map)

On 19 July 2020 at approx. 02:40 a.m., after providing the towing service while mooring the container ship “Christopher” to the Bułgarskie Quay in the Port of Gdynia, the tugboat “Uran” started returning to its permanent berth at the Polskie Quay. The captain of the tugboat reported this fact on VHF channel 12 to the towing company dispatcher. The crew of the tugboat “Uran” consisted of three people: a captain, an engineer, and a senior sailor. The tugboat was steered by the captain with two joysticks for two independent Schottel thrusters (details of this type of propulsion are provided in 4.1 Mechanical factors). In addition to the captain, two other crew members were present on the bridge. Initially, the tugboat followed the course of approx. 110° along the route near the quays from its starboard, going past Bułgarskie, Bramowe and Dokowe Quays, increasing the speed to 9.0 knots. Passing the Bramowe Quay, the captain turned to the course of approx. 125°, at which the tugboat’s route continued to run close to the Dokowe Quay at a distance of about 35-40 m. The course of 125° directed the tugboat directly at the corner of the XXX-lecia Quay and Włoskie Quay. At a distance of approx. 12 m from the XXX-lecia Quay, the tugboat’s course slightly changed to approx. 113° and at this course, at about 02:45 a.m., the tugboat hit the quay with its bow at a constant speed of approx. 9.0 knots. Due to the last manoeuvre of turning left, the tugboat’s bow deviated to the left from the line perpendicular to the quay by approx. 33°.

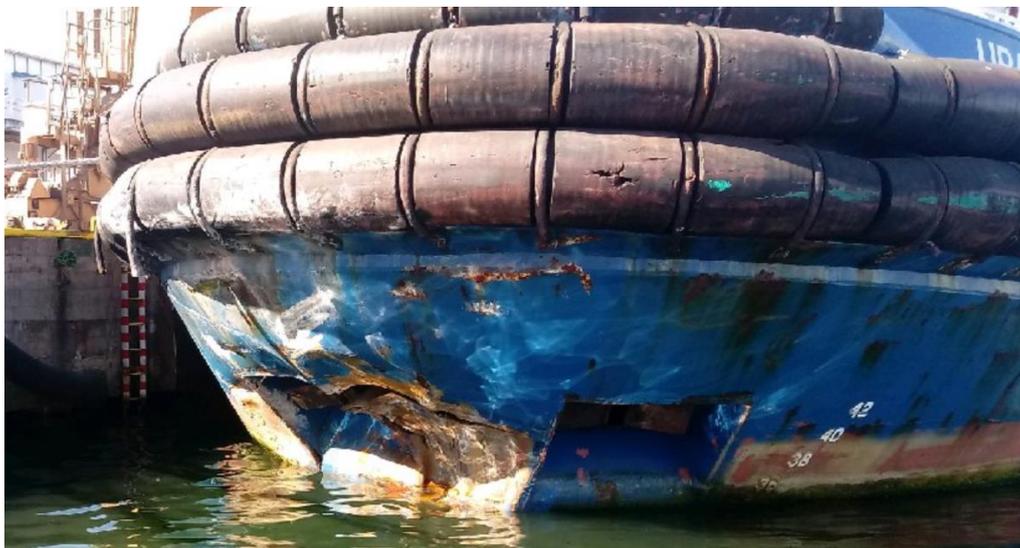
Photo 2. – Tugboat URAN, damage to the bow

receiving this information, the dispatcher notified the Port Authority in Gdynia of the accident. The damage to the tugboat's bow and the XXX-lecia Quay is shown in photos 2 and 3.

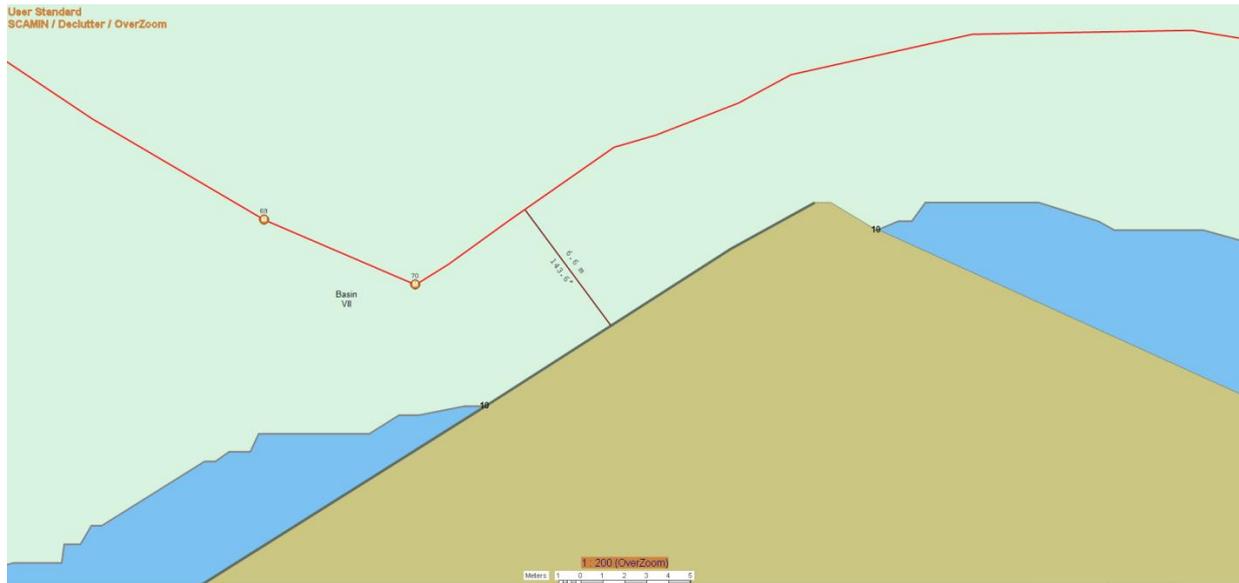
Figure 6. Measurement trace of the tugboat's GNSS antenna at the XXX-lecia Quay.

As shown in **Figure 6**, a slight change of the course to the left from 125° to 113.3° is visible from position 69.

A significant change of the antenna course from 113.3° to 54.8° is visible in position 70.

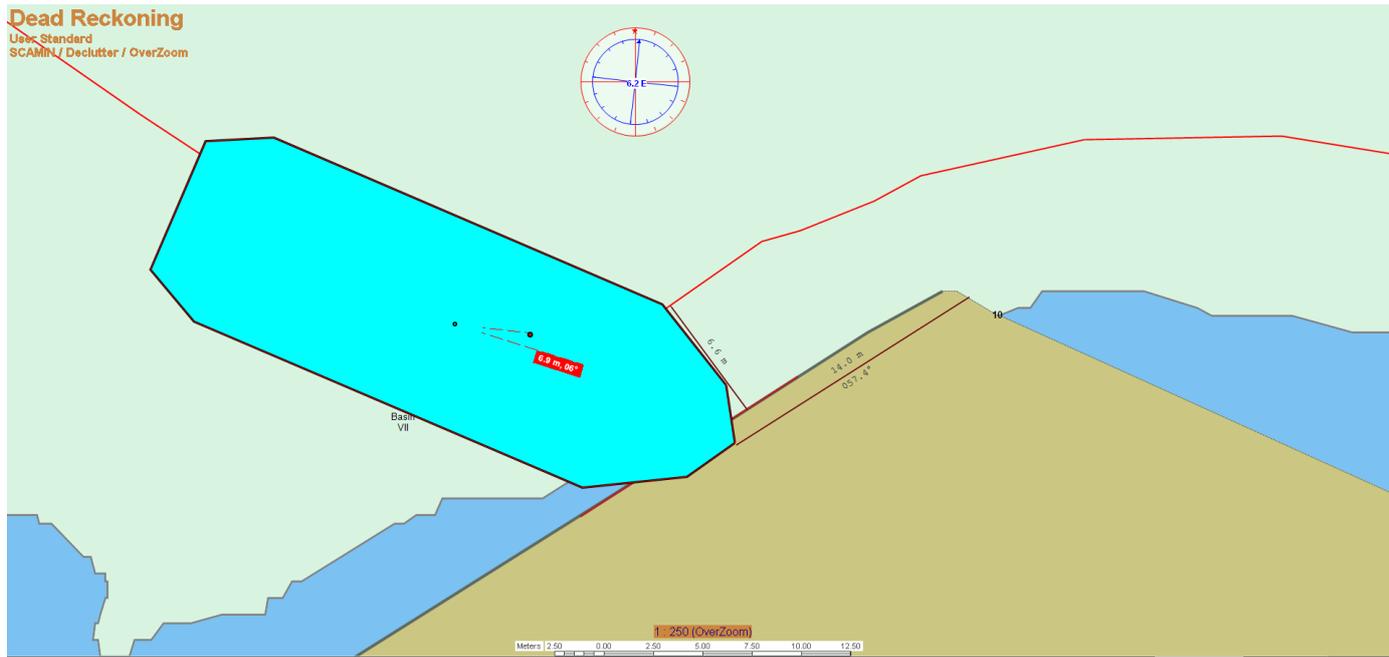
Figure 7. Place of the incident (00:44:52.6 UTC)

The tugboat's waterline was marked to scale on the graphical imaging. On this basis, the probable place of the incident was determined (**Figure 7**), identified at approx. $15\div 16$ m from the NE corner of the quay. The vessel probably hit the quay at an angle of about 56° , temporarily slowing down to 1.9 knots with the engines running all the time, bouncing off it and moving along the quay. This is evidenced by the distance of the parallel trace of the antenna from the quay ($6.6\text{ m} > 5.01\text{ m}$ (half the width of the vessel)) and long deep scratches on the chine. Subsequent measurements after the impact show that after bouncing and sliding off the quay the tugboat was gaining speed again.
