# FINAL REPORT

# 072/20

## **S/Y Gmina Police Sharki**

**The collision of the yacht with a buoy at the Wadden  
Sea on the day of 11 August 2020**

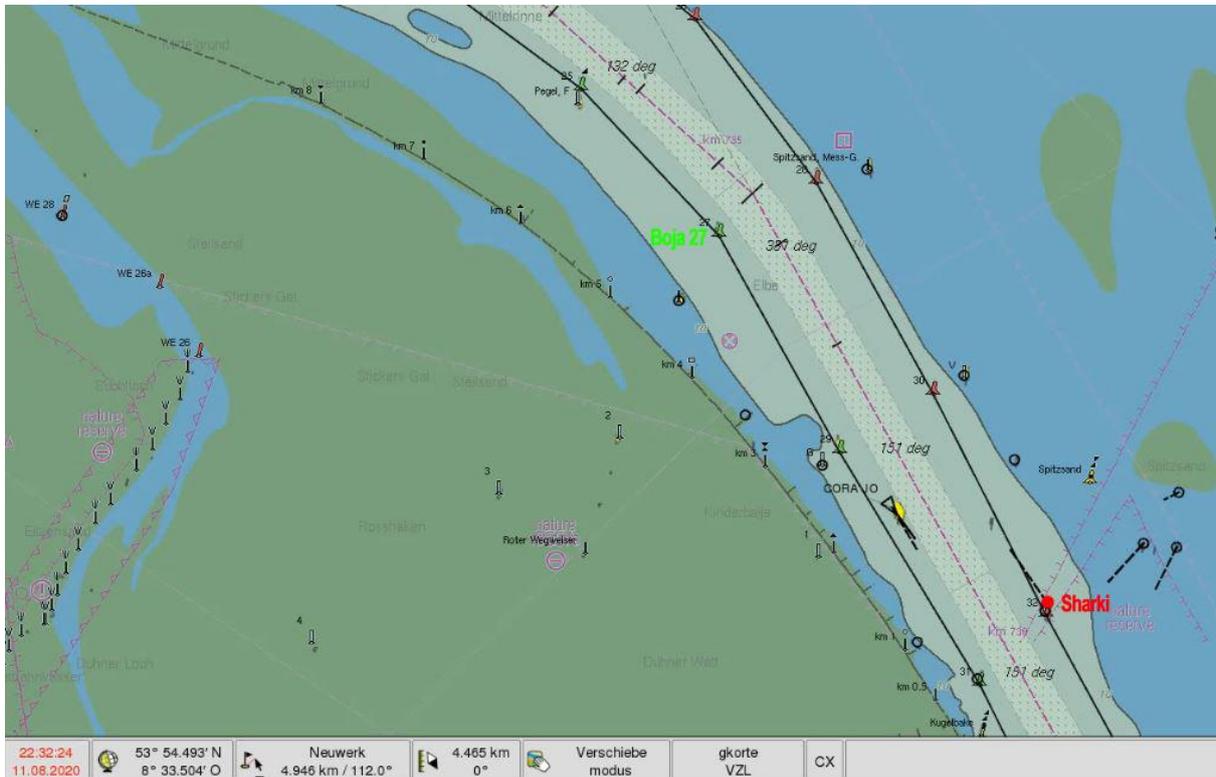
equipped with AIS that the nearest vessel was more than 4 NM away, he ordered the third officer to direct the yacht towards the buoy No. 27 glowing with a green light and visible on the other side of the fairway. The third officer, using the buttons on the autopilot panel changed the course by about  $20^{\circ}$  to port, keeping the indicated buoy a dozen or so degrees from starboard.

Figure 2: The beginning of the fairway crossing manoeuvre at 22:32

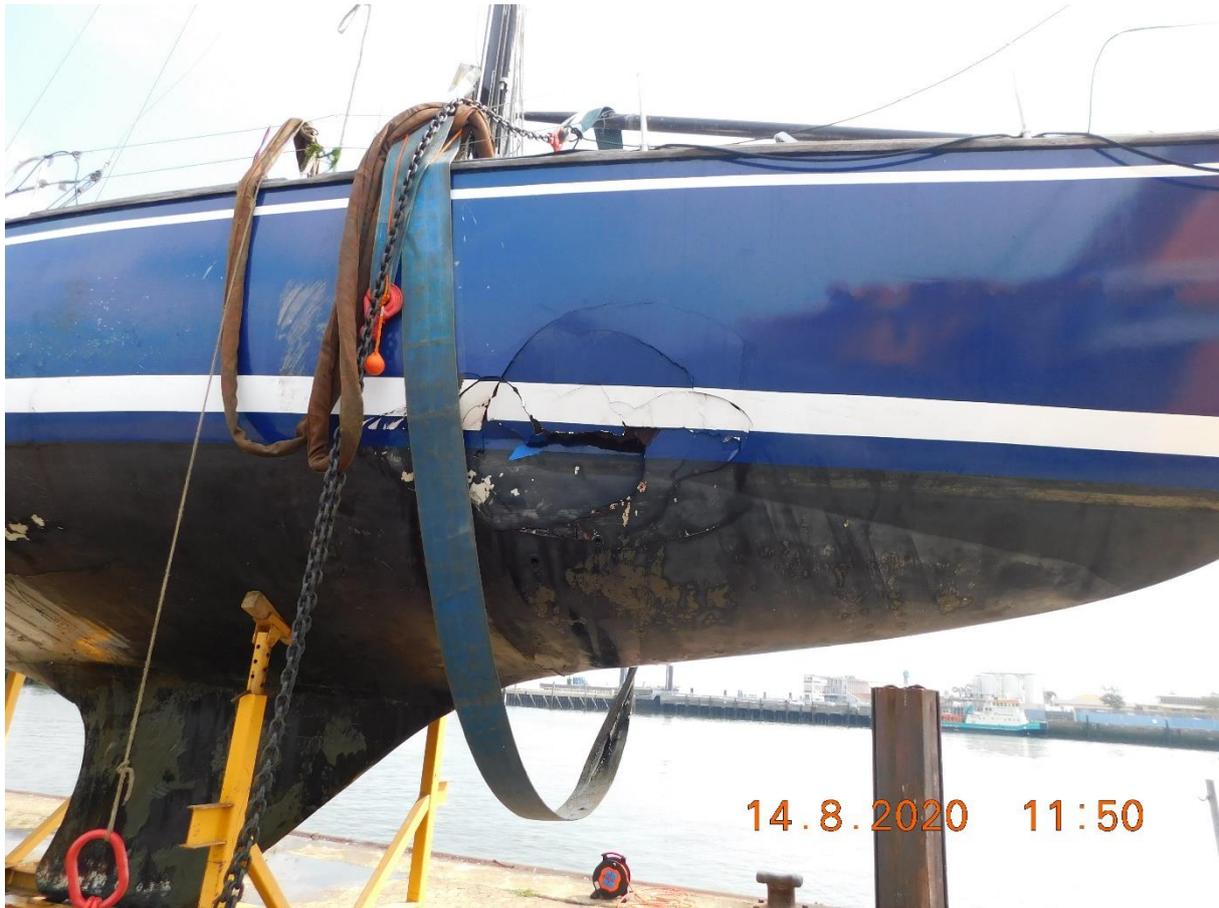
The yacht-master, while examining the potential damage, noticed an extensive unsealing of the starboard plating at a distance of ca. 2 m from the bow. He immediately went below the deck to the bow, where he noticed a large inflow of water. He returned to the cockpit. The engine

*Photograph 6: Damage of the yacht's starboard 1.15m x 18m in size*

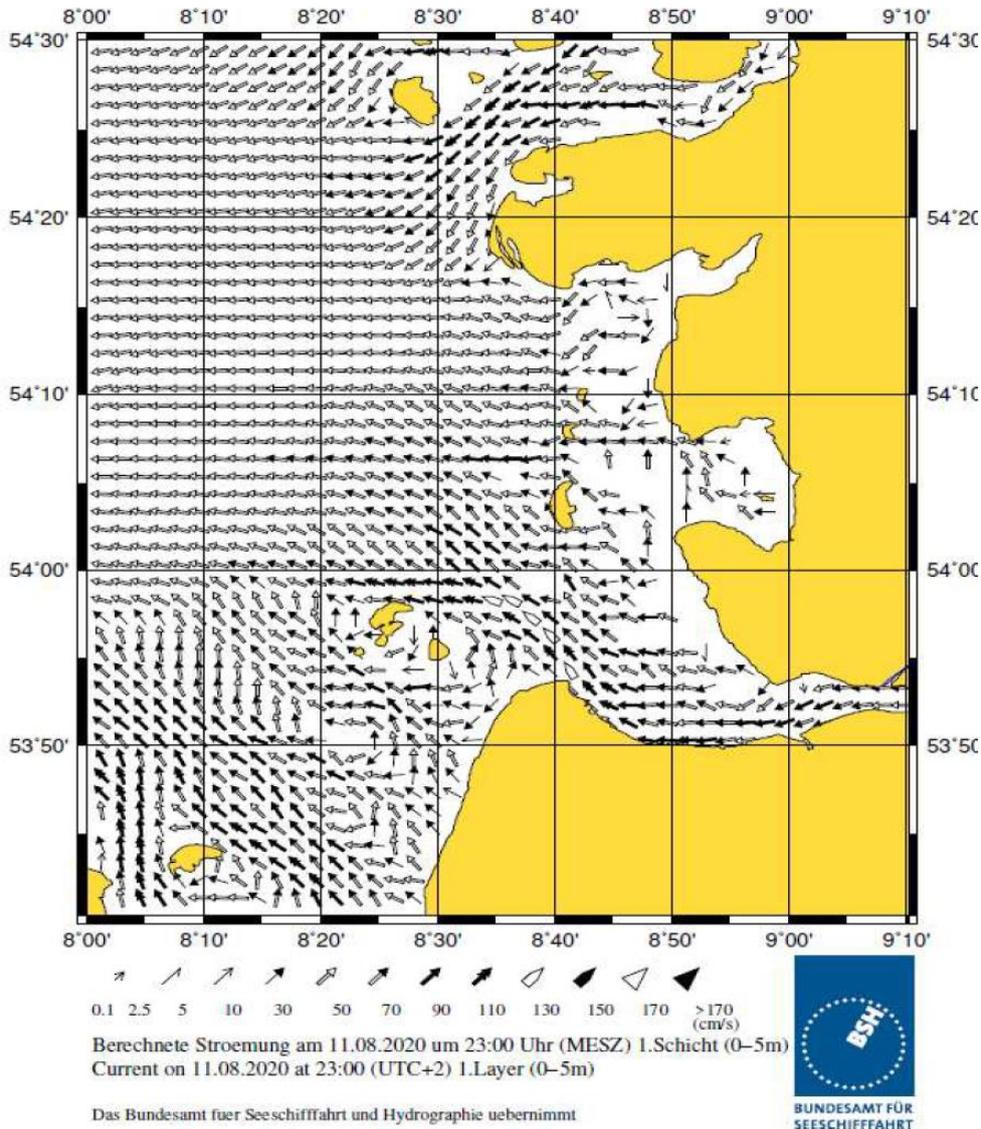
The actual values of currents were variable and ranged from 2 *k* at the buoy No. 32 up to 3.5 *k* near the buoy No. 27 and further. The flooded yacht was drifting between buoys No. 25 and No. 23 at a speed of ca. 3.5 *k*. It should be emphasized that the direction and speed of currents are approximate in the tables and do not take into account many aspects, including e.g. the precision of determining a specific place, weather conditions ( e.g. atmospheric pressure). The speed of the current on the shallow water will be different from that on the deepened fairway, which is important when crossing the fairway.

Figure 3: Directions and medium values of currents 11.08.2020 at 23:00 at the depth of 0 - 5 m<sup>14</sup>

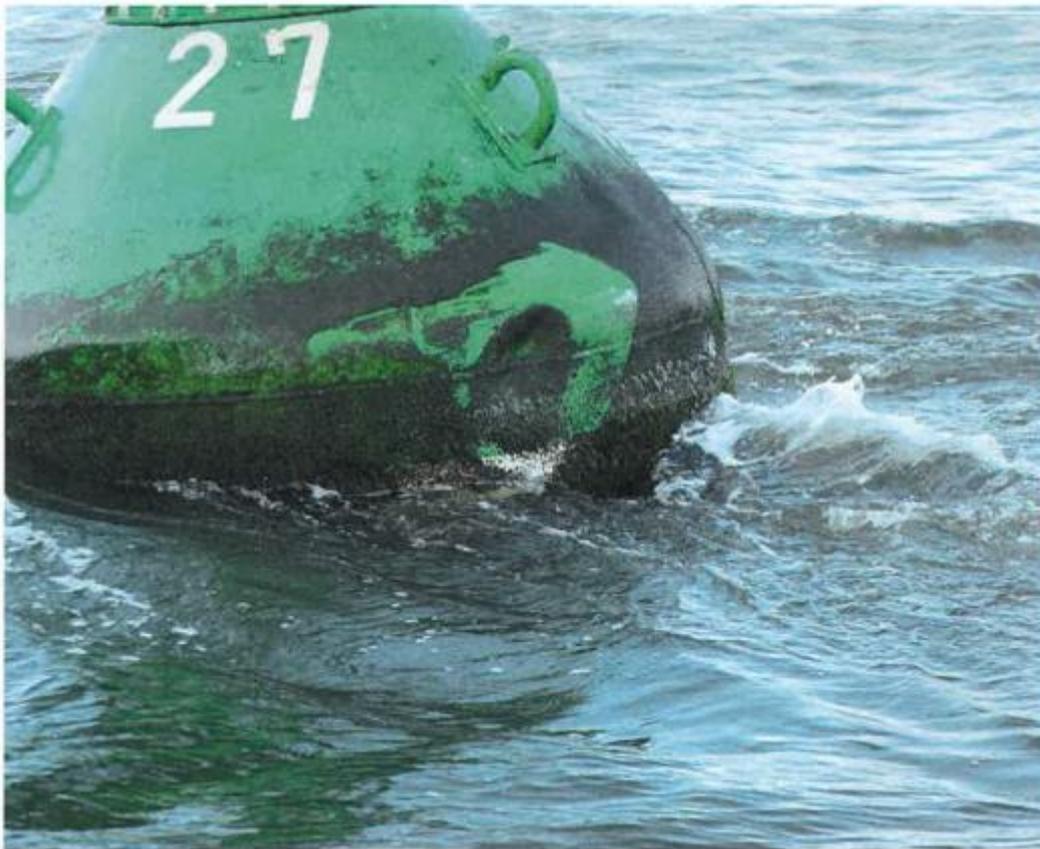
Photograph 3: Abrasions noticeable after the contact with *Sharki*<sup>15</sup>

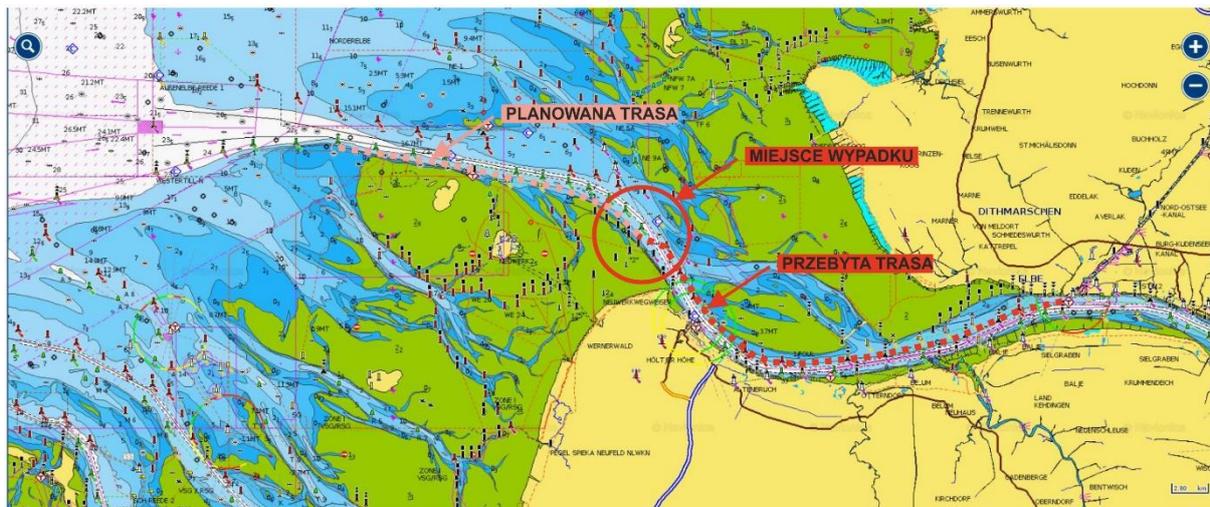
Figure 5: The route of *Sharki*

The planned route of *Sharki* went close to the buoys No. 27 and No. 25, so monitoring of her safe course was a primary matter and the duty of the yacht-master and the watch. In the opinion of the Commission, inadequate planning and monitoring of the voyage was the main cause of the collision of *Sharki* with the buoy No. 27 and sinking of the yacht as a consequence of this.

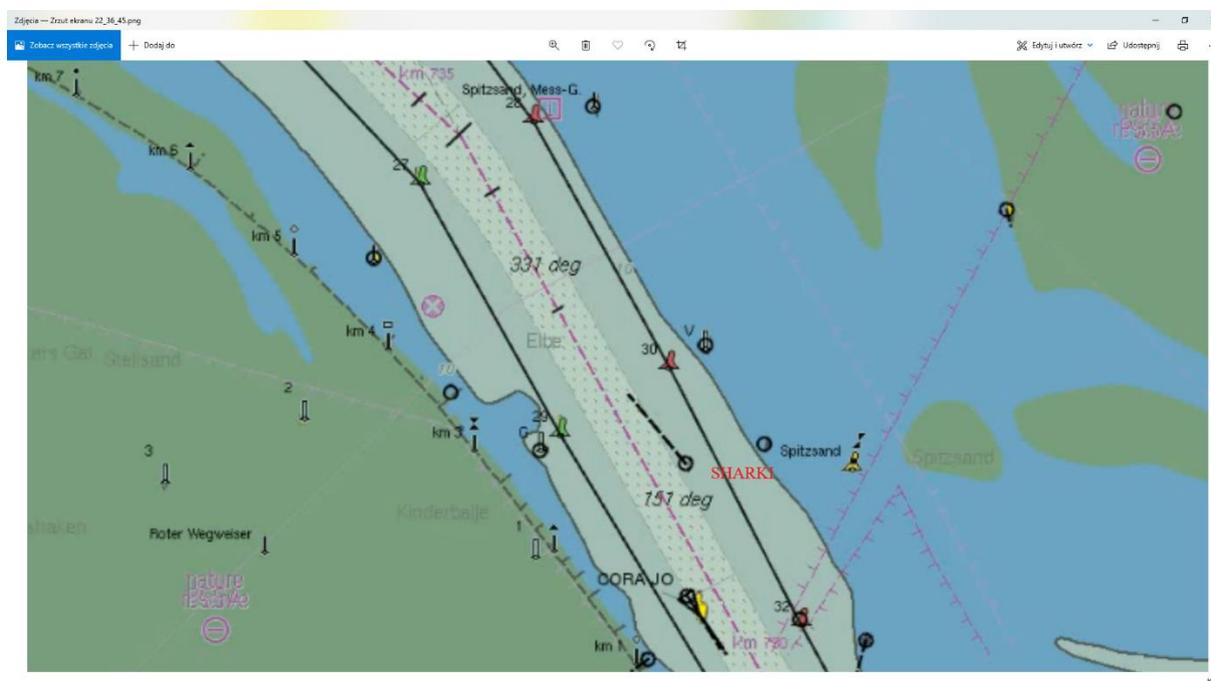
Figure 6: Position of *Sharki* at 22:36:45

After passing the buoy No. 32, a turn was made to intersect the fairway and pass the buoy No. 27 starboard. The assumed COG was  $318^{\circ}$  and the distance to be traveled was ca. 2.3 NM. The planned manoeuvre at no time disturbed the vessels navigating on the fairway, although it led to the passing of the buoy No. 27 at a distance well below 1 cable.<sup>26</sup> The Commission did not obtain any information on compass course (CC) which was set on the autopilot. The yacht

actually started to follow COG = 321°, which remained unchanged even at 22:36. The bearing for the buoy No. 27 at that point was 317°.

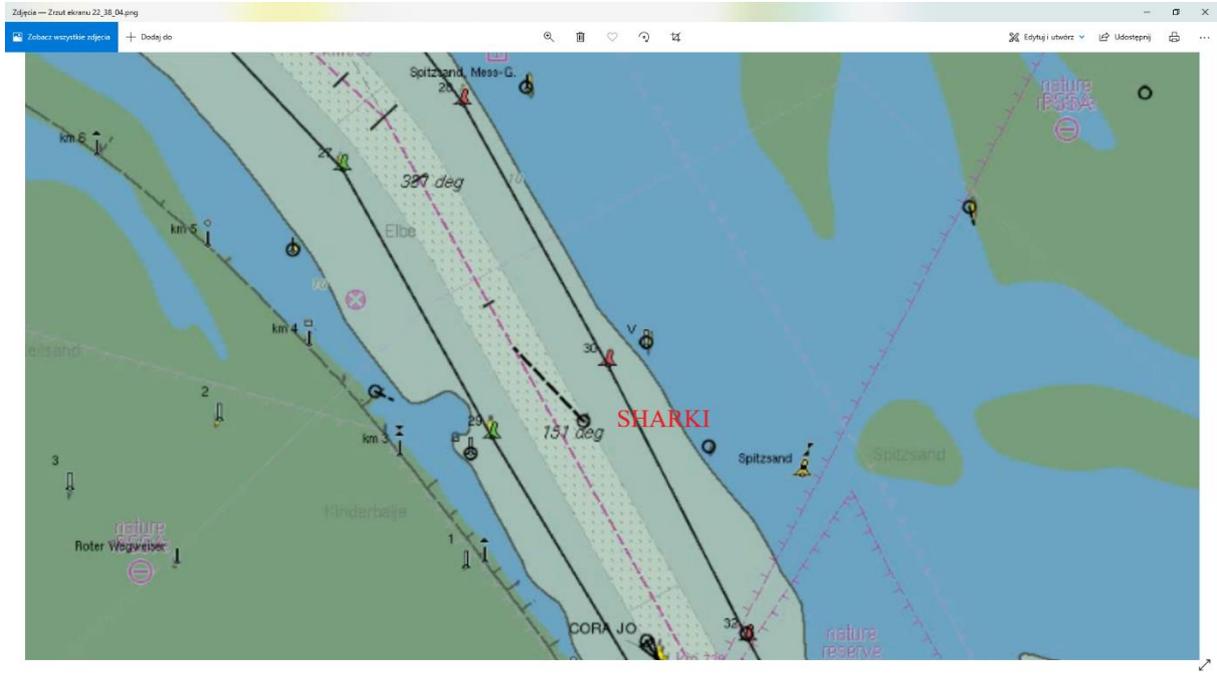
Figure 7: Position of *Sharki* at 22:38:04

The yacht was following the corrected course COG = 316° and was 1.3 NM from the buoy No. 27. The course correction was not sufficient as the course was equal to the bearing for the buoy. Sailors on board saw the buoy at about 10° from starboard.

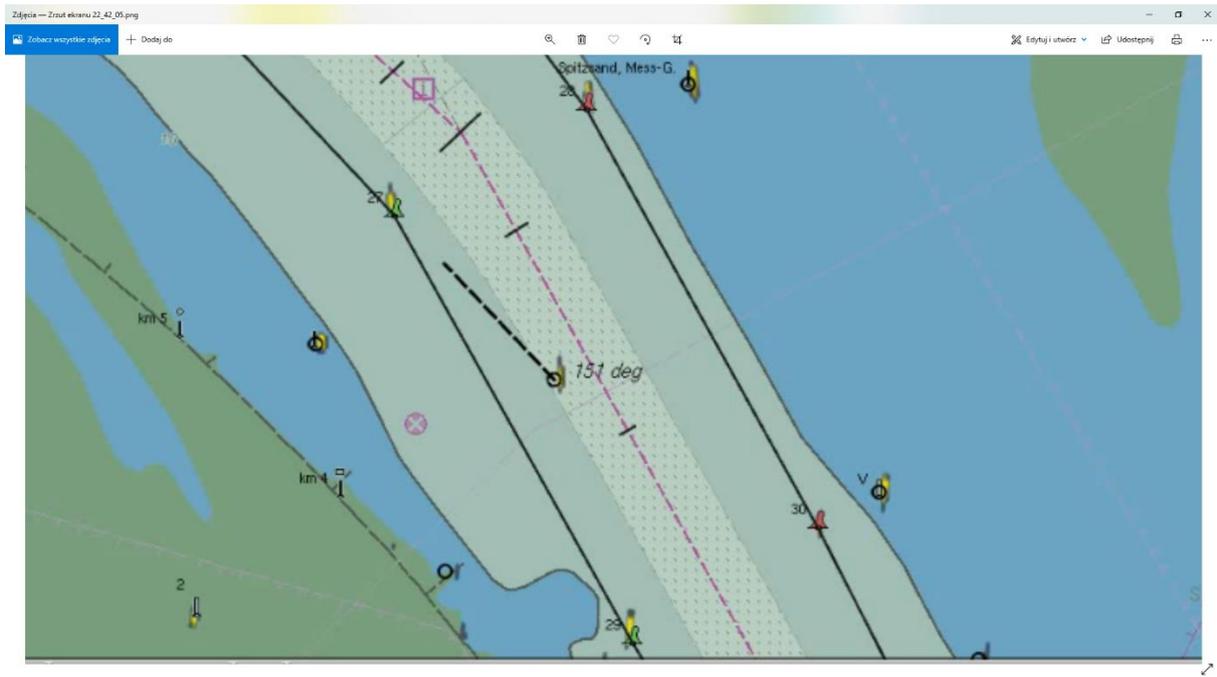
Figure 8: Position of *Sharki* at 22:42:05

The yacht followed the unchanged course of  $316^{\circ}$  and the distance decreased to 1000 m. The buoy was still at about  $10^{\circ}$  from starboard for the observers and despite the passage of 4 minutes the hazard of a collision with the buoy No. 27 had not been observed.

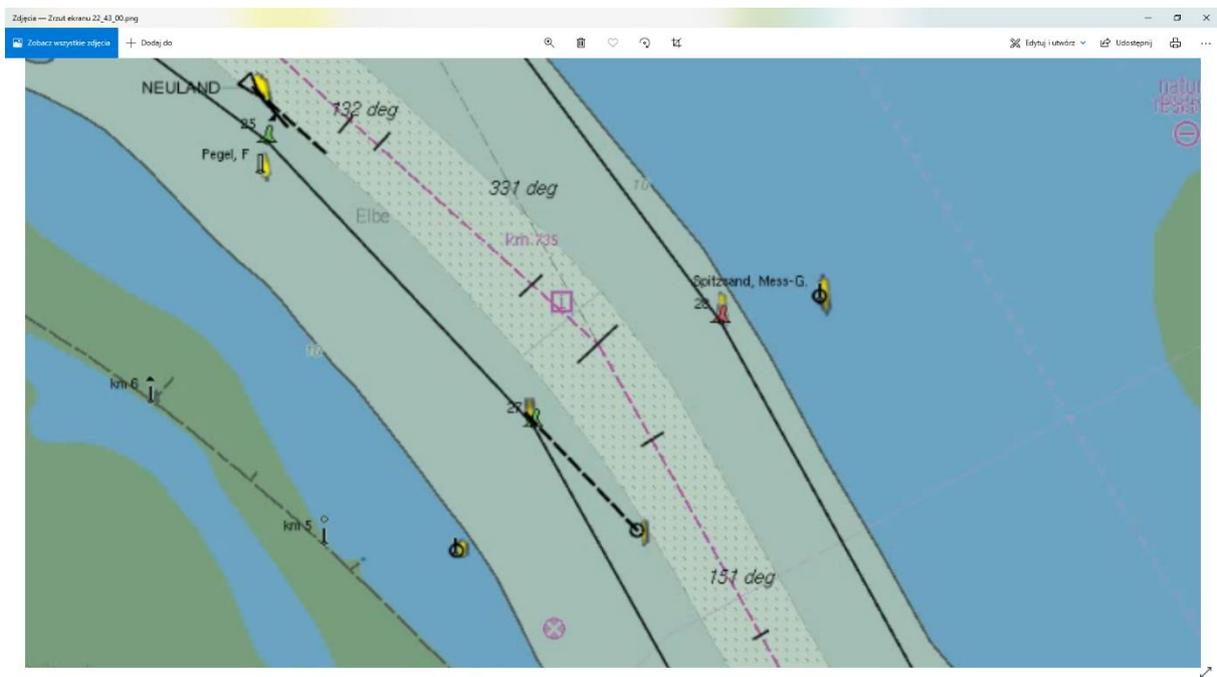
Figure 9: Position of *Sharki* at 22:43:00

COG changed to  $317^{\circ}$  and it was not caused by the manoeuvres of the crew but only by the increase in speed and/or direction of the current or wind. The distance to the buoy decreased to 660 m and was still seen from the cockpit at ca.  $10^{\circ}$  from SB.

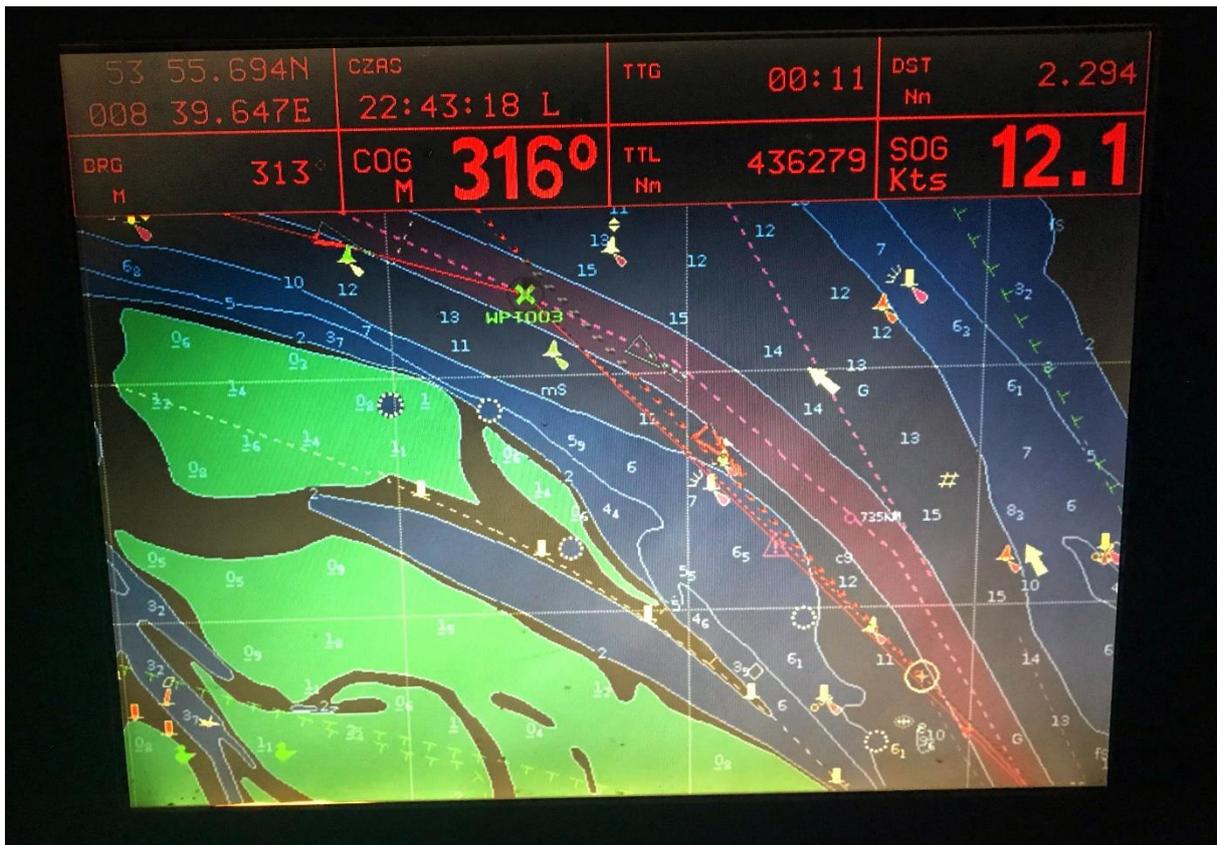
Photograph 5: Image from the plotter of *Sharki* at 22:43:18

The photo clearly shows the deviation of the yacht's route from the planned one and the decreasing distance to the buoy, the bearing of which slowly began to change to the bow. Only the crew of the third watch remained in the cockpit. The distance to the buoy was ca. 500 m.

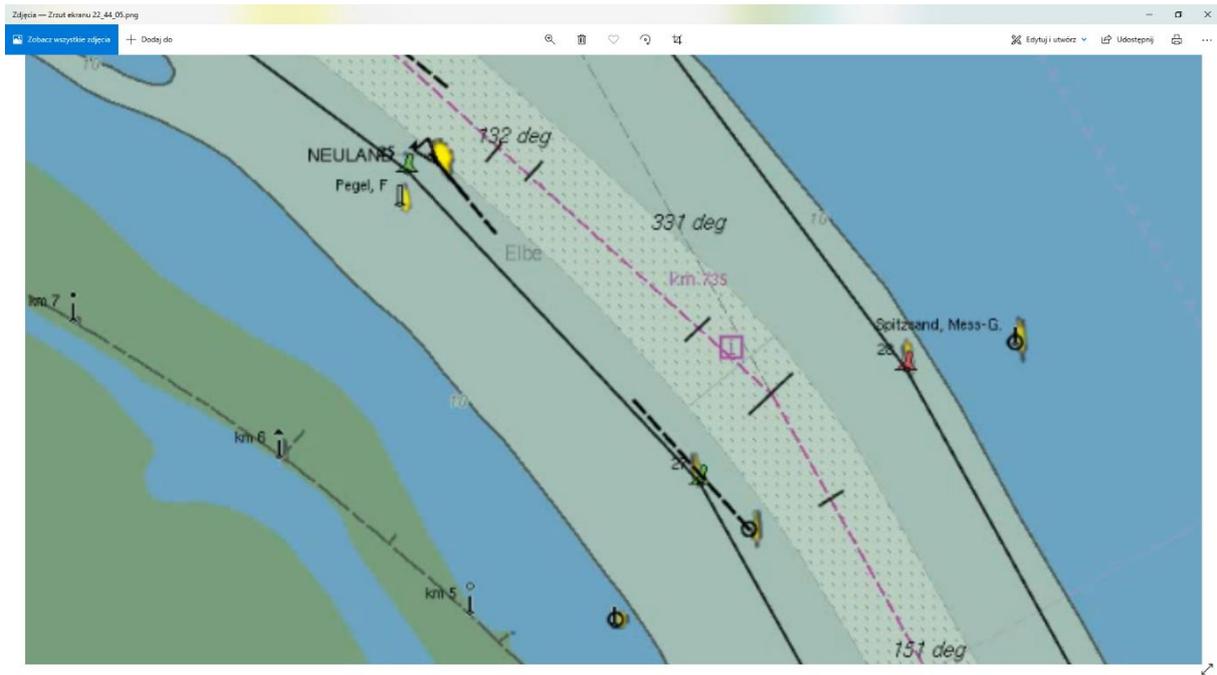
Figure 10: Position of *Sharki* at 22:44:05

Actual COG was  $319^{\circ}$  and the distance was reduced to 275 m. No response from the crew.

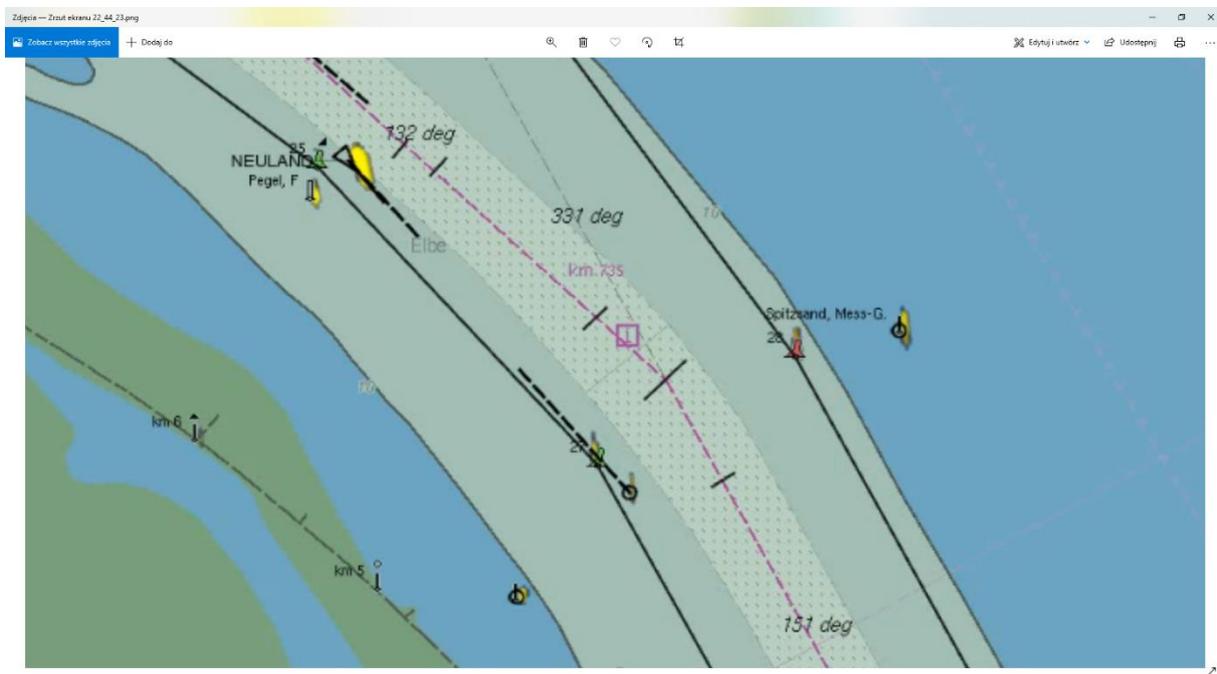
Figure 11: Position of *Sharki* at 22:44:23

The course was displayed unchanged and the distance decreased to ca. 170 m. At that course, the estimated CPA when passing the port side buoy was only a dozen or so meters and compared to the length of the yacht it was still a collision course.

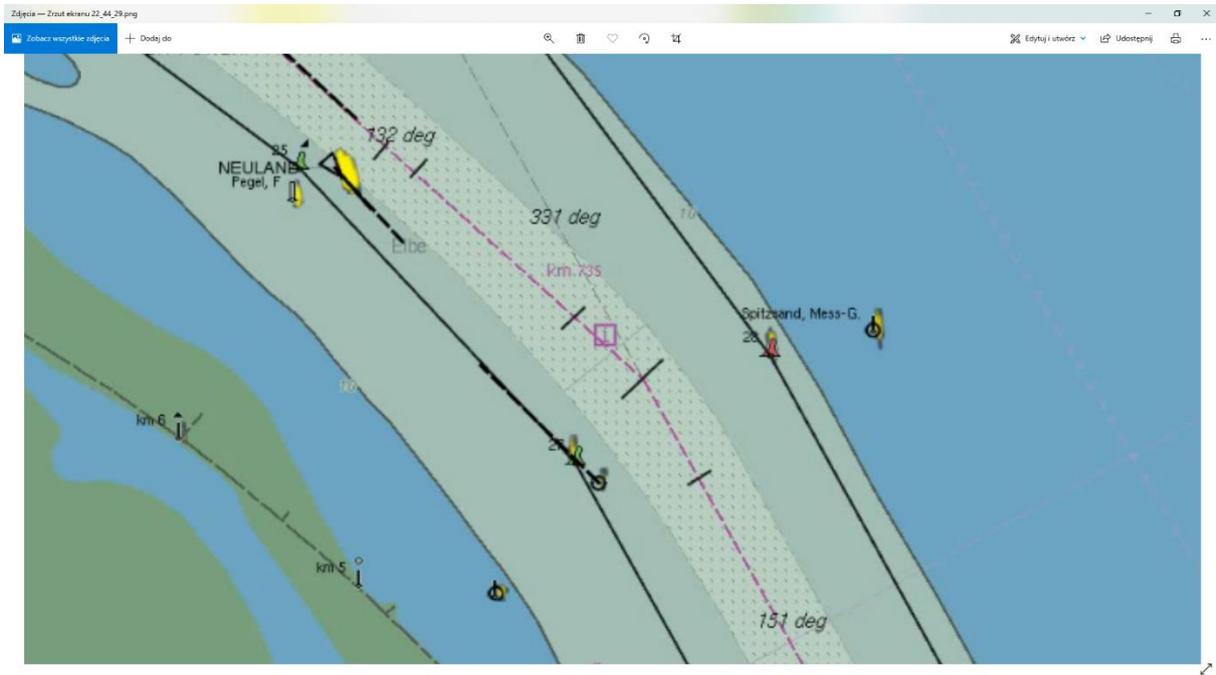
Figure 12: Position of *Sharki* at 22:44:29

A noticeable change of course to port which was sent by AIS over the past 6 seconds. A low value of change of the course when putting the rudder on the side indicated that the manoeuvre had started recently. In the yacht's position in Fig. 13, the distance between the yacht and the buoy No. 27 was ca. 120 m.

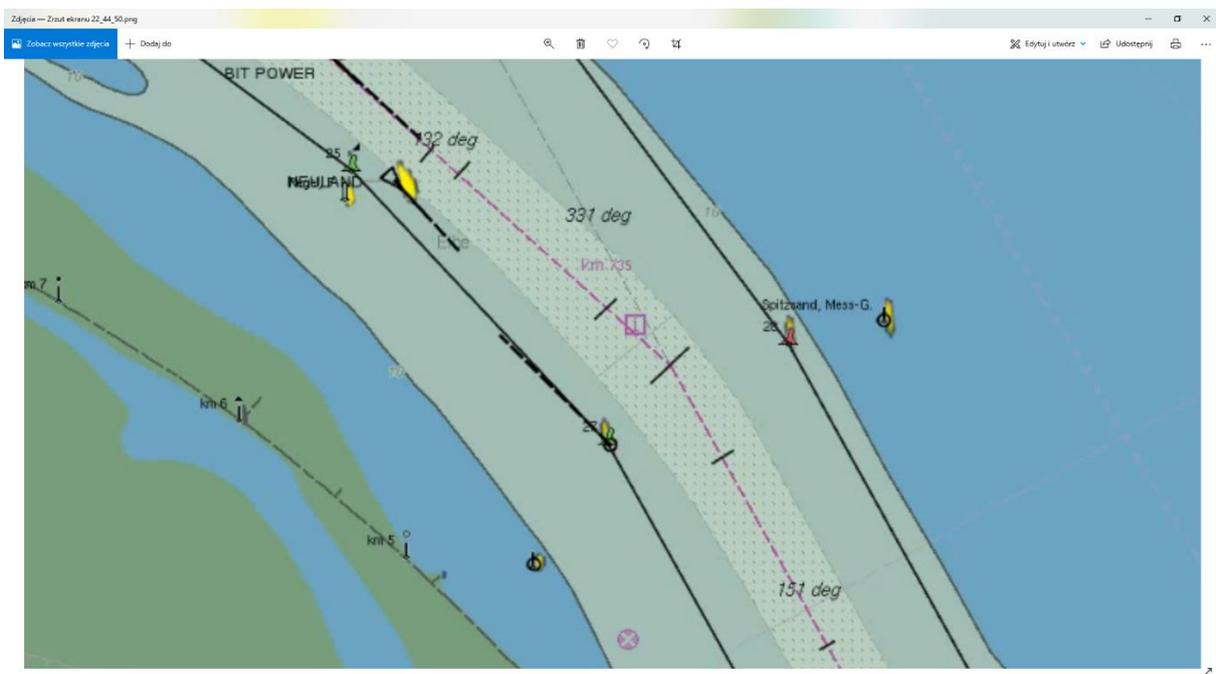
Figure 13: The moment of collision of *Sharki* with the buoy at 22:44:50
