MARINE SAFETY ALERT

May 20, 2022
Washington, DC

Safety Alert 07-22

UNEXPECTED DANGERS: LIFEBOAT REMOTE CONTROL WIRES

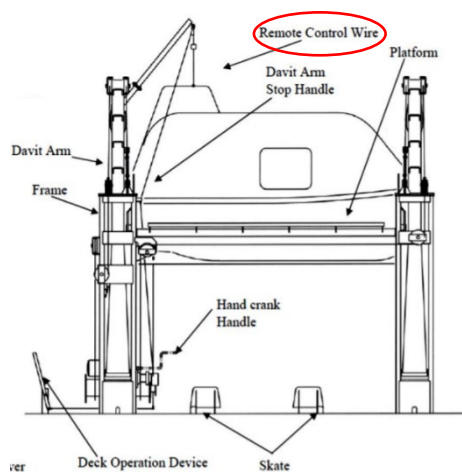
Figure 1 - Davit Launched Lifeboat Arrangement.
