FINAL REPORT

033/21

**M/V
New Leo**

The ship *M/V New Leo* scraping against the pedestal of the western beacon of Brama Torowa III in Zalew Szczeciński on 15 May 2021

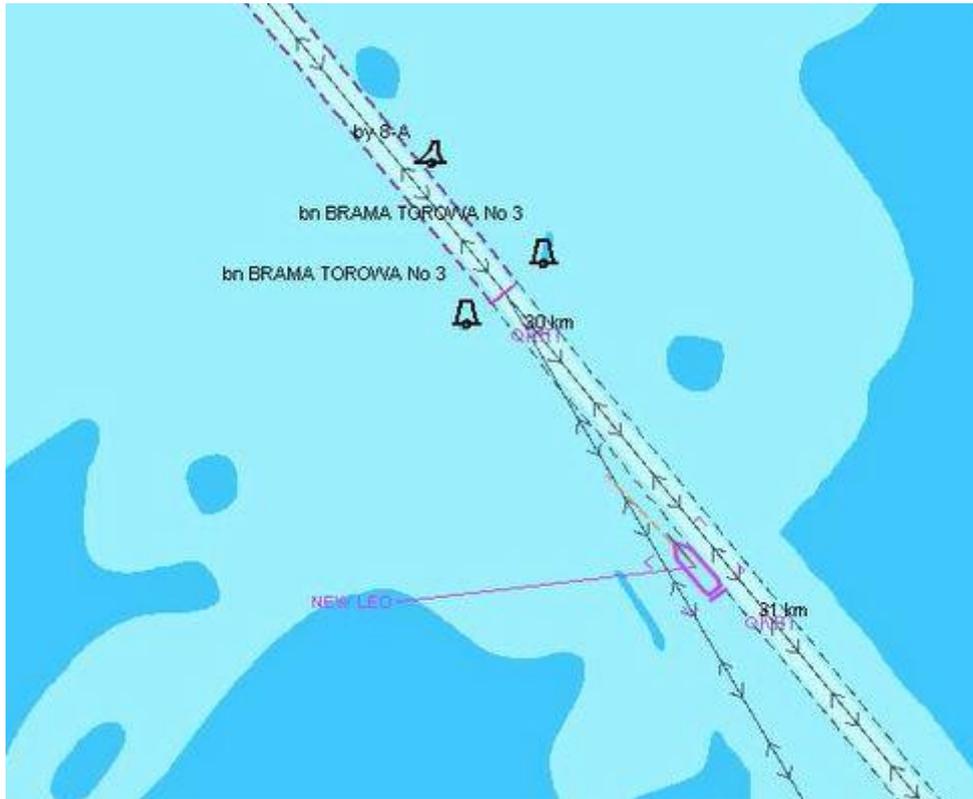
The heading of $321^{\circ} - 322^{\circ}$ was maintained until approx. 00:39, when the pilot noticed the navigational light of Brama Torowa III and rapidly changed the heading to 333° (Table 1).

Figure No. 1. A screenshot of a VTS playback recording.

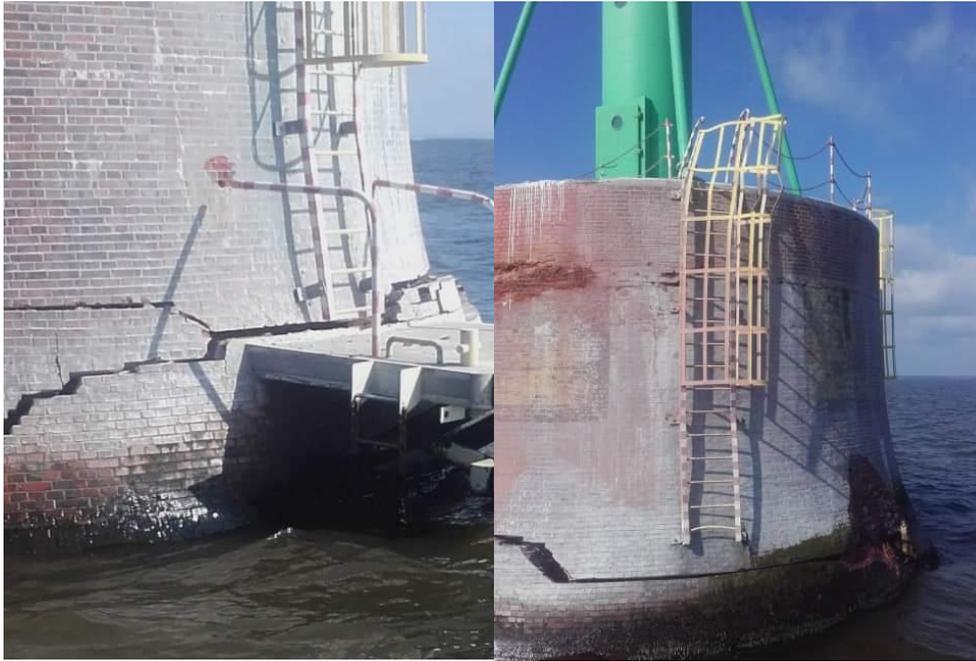
Consequences of casualty/incident: damage to the beacon structure (Photo No. 2), damage to the above-water part of the shell plating (Photo No. 3).

At 00:40, the ship *New Leo* scraped with the port side of its hull's prow part against the above-water part of the western beacon of Brama Torowa III and damaged it.

Photo No. 2. Damage to Brama Torowa III

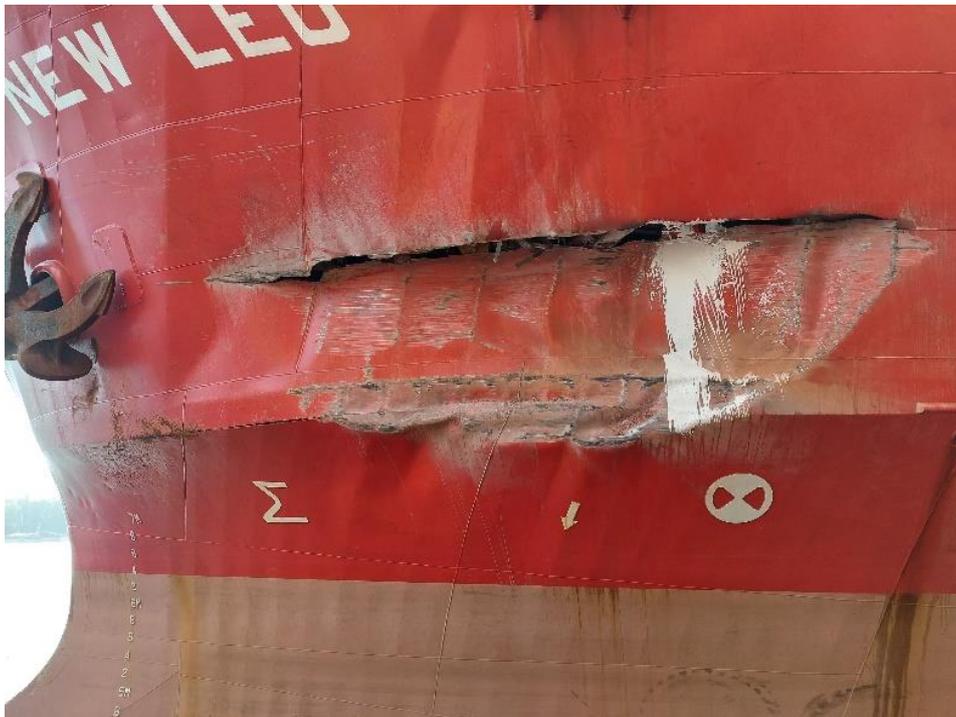
On 15 May 2021, at approx. 00:40¹, on her voyage from Szczecin to Saint Petersburg, the ship *New Leo* scraped against the pedestal of the western beacon of Brama Torowa III. As a result of the scraping, the ship's hull was damaged in the prow part. The damage was located above the water-line, which enabled the vessel to continue her voyage to Świnoujście, where she stayed until the repairs. The beacon structure was also damaged.

After the collision, the master came to the bridge and the autopilot was switched to the manual control. The second officer took over steering. At the same time, a crew member went to the ship's bow to estimate the damage. Using a VHF radio, he reported to the master that the ship's side was penetrated above the water surface.

Photo No. 3. Damage to the vessel m/v New Leo

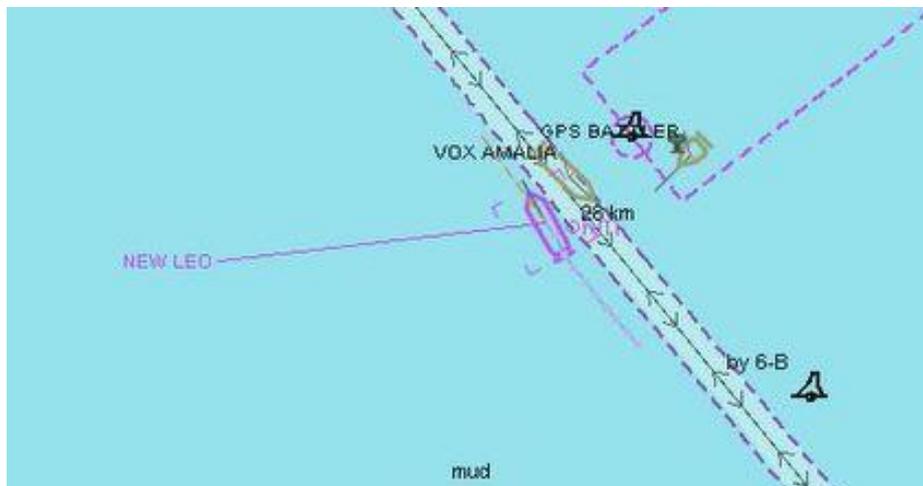
At the same time, the dredger *Vox Amalia* finished discharging the dredged material and started her voyage to Szczecin, passing the ship *New Leo*, that followed the course over ground (COG) of 326.6° at the speed of 8.7 kn.

Figure No. 2. A screenshot of a recording in the AIS of m/v New Leo.

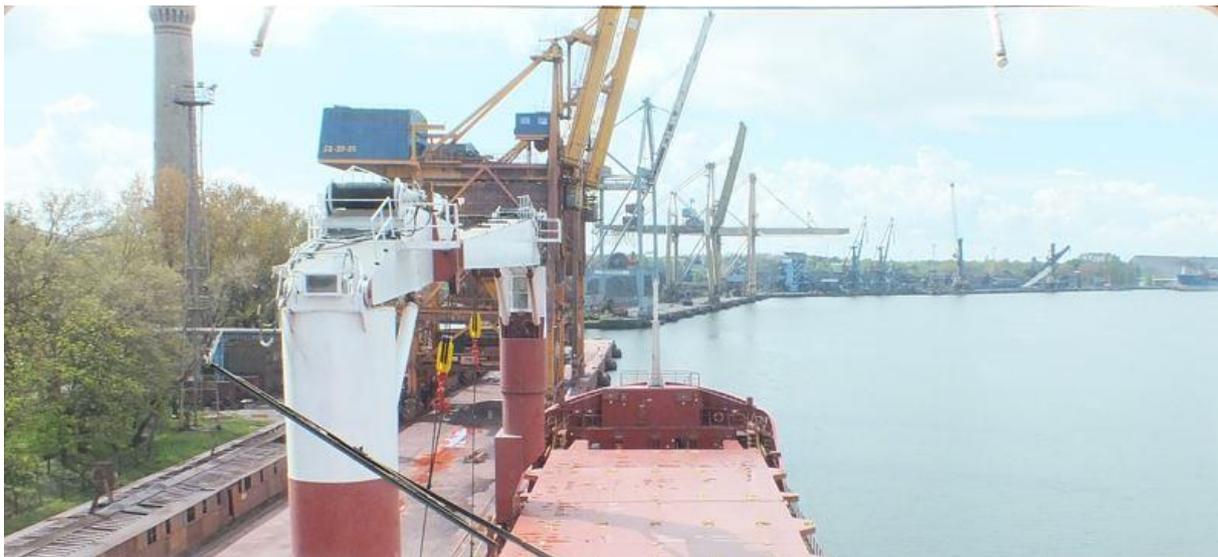
The vessel has two cranes that form an integral part of its structure. The cranes are on the port side and partially restrict the visibility in the port side sector. (Photo No. 4) The bow sector of visibility and starboard were not restricted in any manner.

Photo No. 4. The view from the bridge of m/v New Leo – the middle bull's eye window.

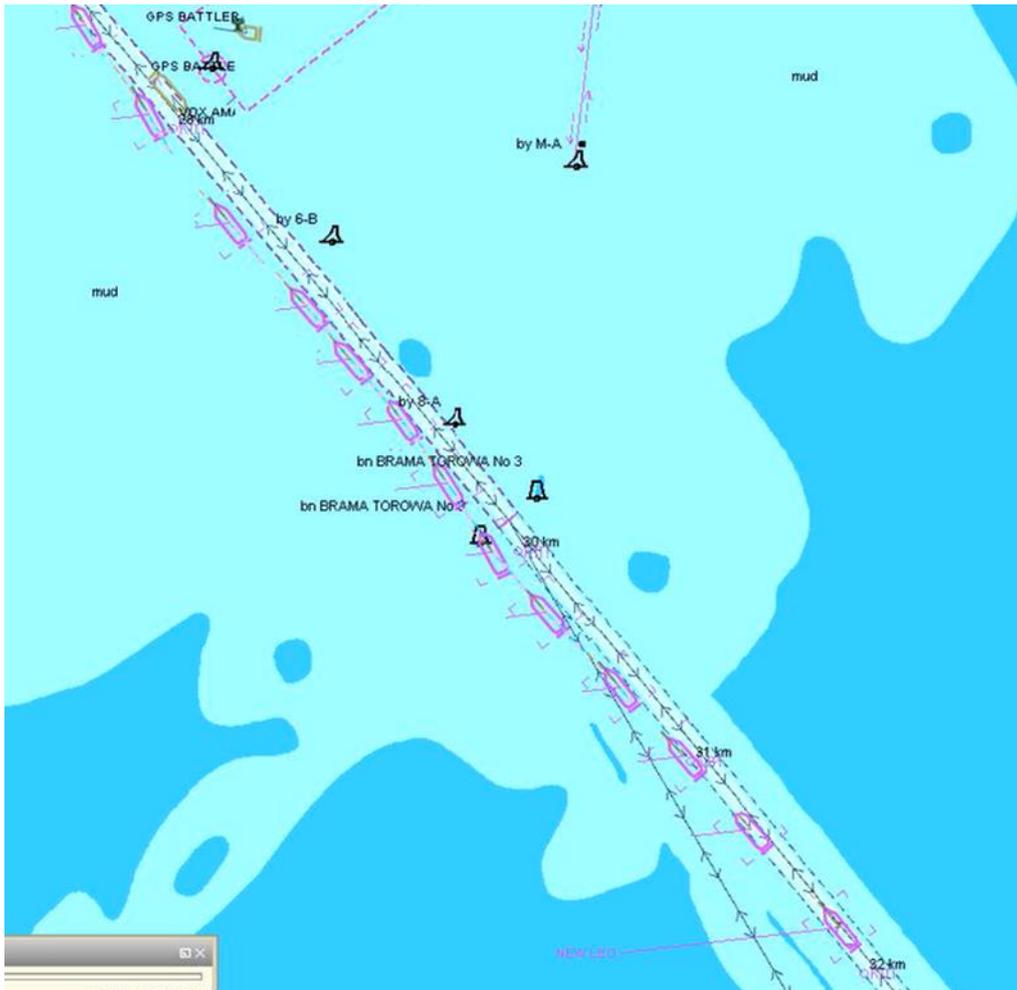
On the basis of materials obtained from the VTS, the vessel's movement was reconstructed according to entries in the AIS. Figure No. 3 shows the route of *m/v New Leo* on 15 May 2021 from 00:35 to 00:50.

Figure No. 3. Route of *m/v New Leo* based on the VTS playback recording.

It is presumed that the manoeuvre to pass by the dredger had been planned without taking into account the position of the western beacon of Brama Torowa III whose white navigational light could blend in with the lights of the dredger *Vox Amalia* and thus was hardly visible. The intermittent rainfall could also hamper its acquisition on the radar. In addition, schematism due to repetitive tasks and tedious work on numerous occasions cause absent-mindedness and
