FINAL REPORT

028/21

Sailing ship *Dar Młodości*
and
Tug boat *Fairplay IV*

Rupture of a tow line during mooring manoeuvres on
22 April 2021 in the port of Gdynia

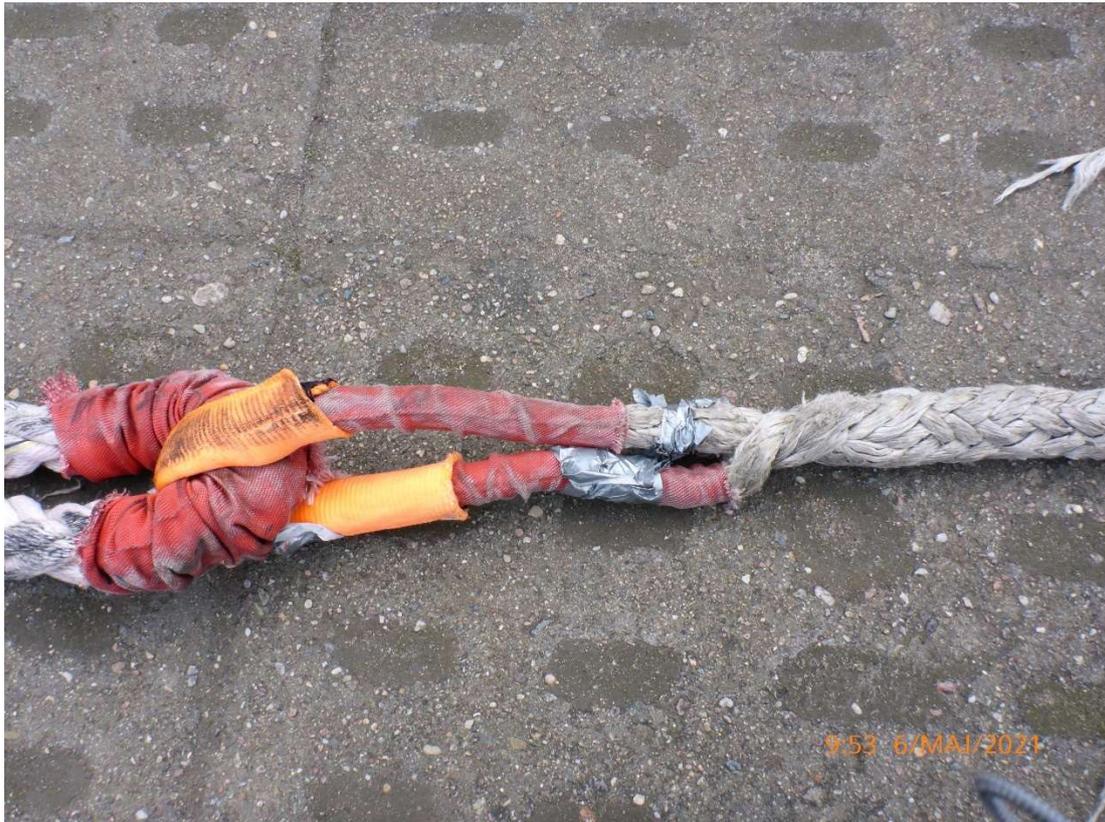
The ship was proceeding at the speed of 3 kn^2 and at 7:30 am she passed the beam of the entrance heads and then, reducing her speed, she proceeded to the corner of the Entrance Quay and Pomorskie Quay in the President Basin. At the same time, the tug boat followed the stern of the ship, with its loose tow line buoyant. The tow line passed from the tug boat to the stern was composed of 4 rope sections. The first section passed to the deck of the sailing ship was a polyolefin and polyester rope with a length of approx. 20 m and diameter of 56 mm, featuring an extensibility of 20% at full breaking load. It was deemed to be a sort of “spring” and protection on account of the low extensibility of the other rope sections used in the tow line. The other 3 sections, 5 m each, were made of HMPE³ rope with a diameter of 32 mm. The extensibility of the HMPE rope at full breaking load is barely 3%. The ropes were joined with each other in a permanent manner by interleaving rope eyes.

Photo 3 – The method of joining tow line sections.

selection of a polyester rope which is to compensate for any abrupt tension variations in HMPE ropes be consulted with the rope manufacturer.

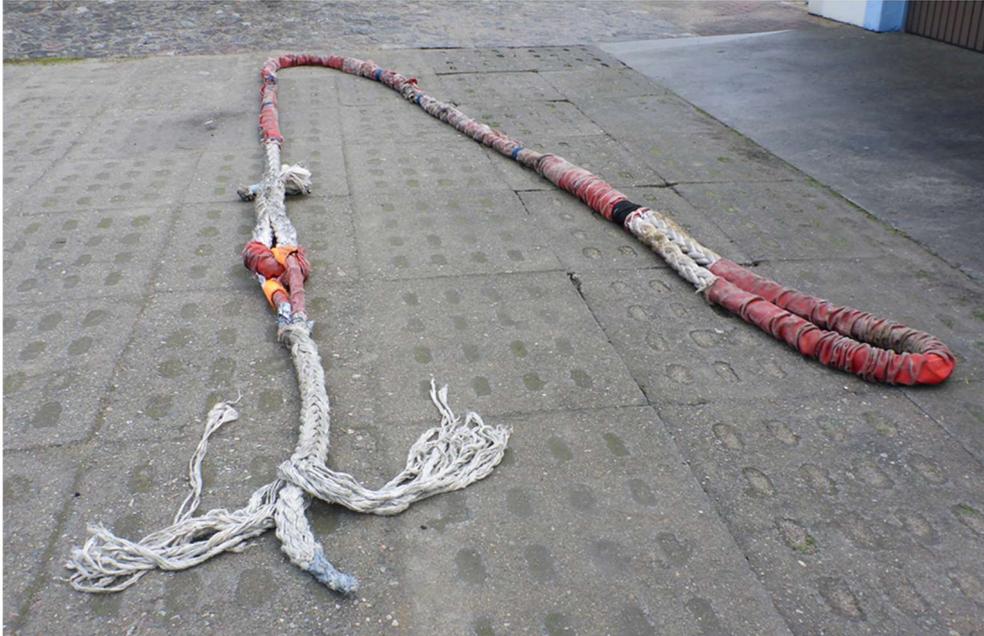
As it was planned to moor the ship with its starboard to the Pomorskie Quay, the pilot instructed the person controlling the tug boat to move to the port side of *Dar Młodzieży* and pull her stern away towards the interior of the President Basin so as to turn the ship's bow so that it should face the exit. At the time, the tug boat manoeuvres were conducted by an officer training under the supervision of the master. While conducting the manoeuvre as instructed, the person controlling the tug boat caused an abrupt tightening of the tow line⁴. The tow line ruptured where the eyesplice ended on the first tow rope after the “spring” rope.

Photo 4 – The rope section treated as a “spring” and the end of the ruptured tow line.

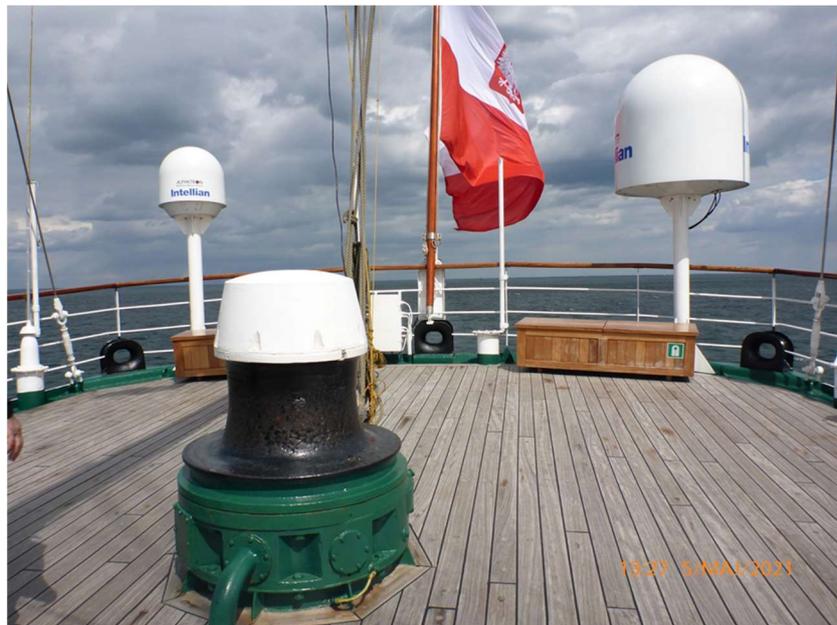
The crew at the manoeuvring station on the stern had previously received an instruction to move away from the operating tow line and they hid behind the superstructure on the stern, on both sides. The third officer in charge of the crew at the stern manoeuvring station, stood behind the capstan, which provided a shield, in order not to stand in the line of the operating tow line.

Photo 5 – The stern central chock and the capstan behind which the third officer stood during the tow line operation.

As a result of a strong spring action, the end of the ruptured tow line snapped back on aftdeck of the sailing ship and bouncing from the capstan with a great force, it hit the third officer standing behind the capstan on his chest. The victim fell from the force of impact and was dizzy. The ship doctor was called and provided first aid. The duty officer at the Harbour Master's Office in Gdynia was informed about the occurrence. At an instruction from the Harbour Master, an emergency response team was called in.

The State Marine Accident Investigation Commission recommends clear marking of snap-back danger zones for ruptured tow and mooring lines where nobody should stay during the operation of ropes under load.

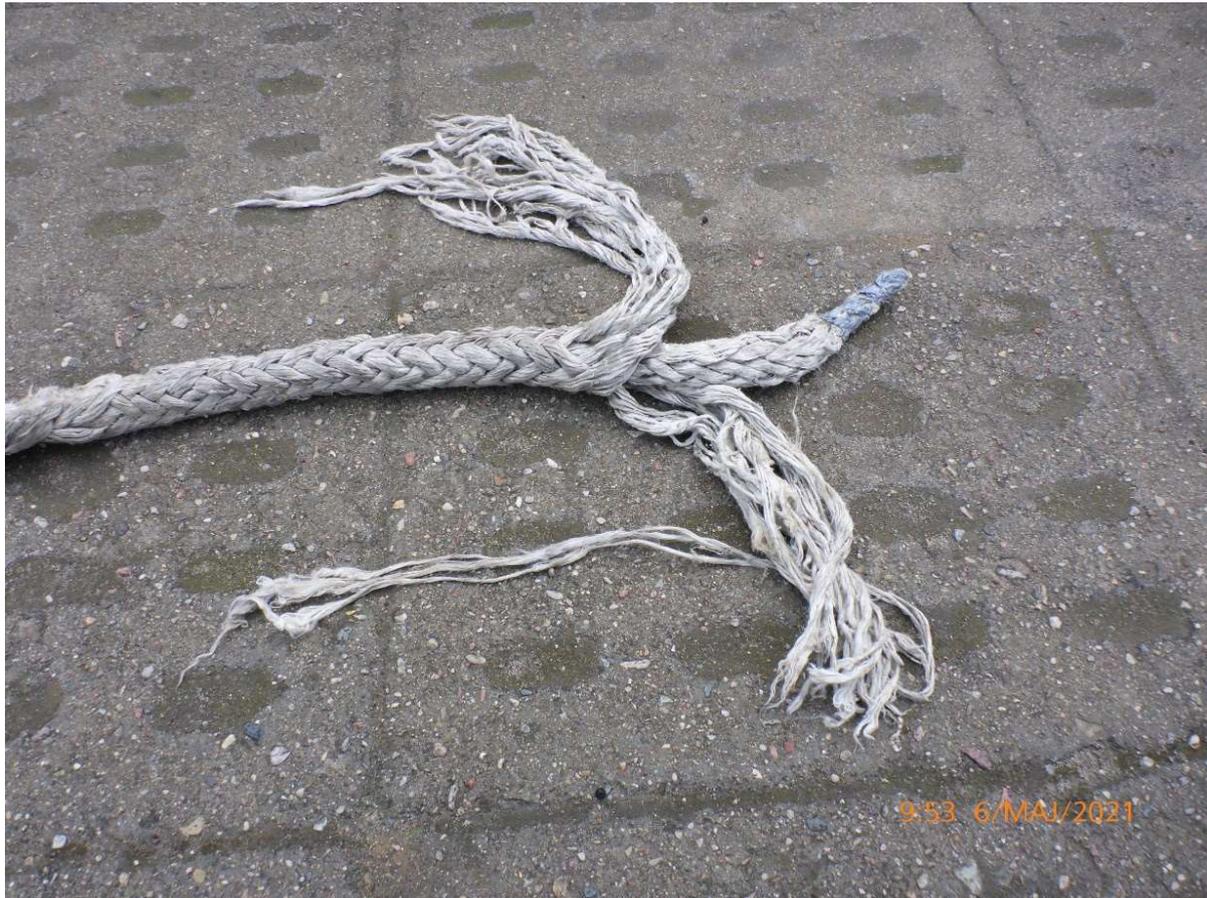
In the SMAIC's judgement, the rope sections used as the tow line passed to the sailing ship *Dar Młodzieży* showed damage caused by previous operation. Where the rope ruptured, i.e. at the end of the HMPE spliced loop and its junction with the rope used as the springing section, one could see damage and melting on strands. The damage was due to high temperature during the reciprocal movements of the rope fibres.

Photo 6 – The end of the damaged HMPE rope

The State Marine Accident Investigation Commission recommends that training be provided for those tasked with the technical condition evaluation of HMPE-type ropes operated on tug boats. In the SMAIC's judgement, ropes should undergo a condition check and qualification for further operation more frequently than once every six months. The SMAIC also recommends that the proper use of lines consisting of sections of joined spliced ropes and the

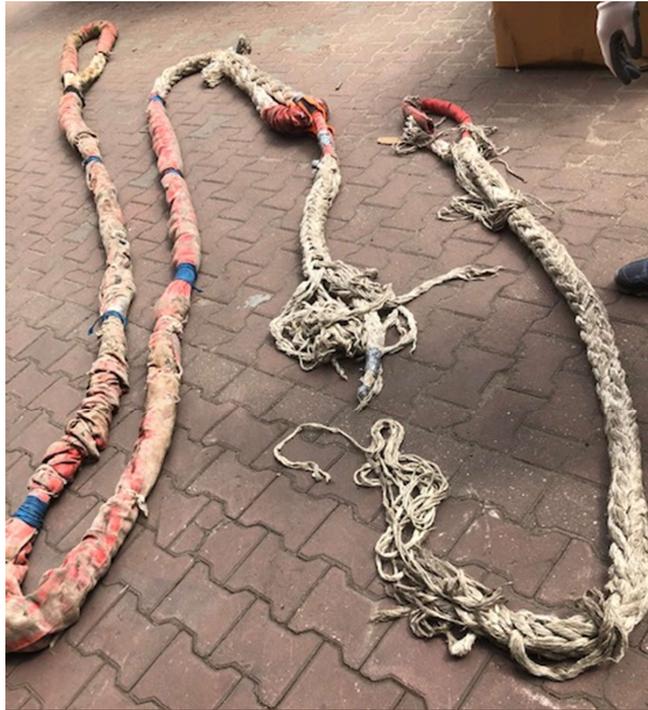
The other section of the ruptured tow line that was provided for visual inspection by the management of Fairplay Towage Polska Sp. z o.o. Sp. k. looked similar.

Photo 7 – A section of the ruptured tow line

The ends of interleaved ropes of the eye were not stitched in compliance with a technique recommended by rope manufacturers, which additionally increased the extent to which rope terminations slid against the core, thus raising the temperature due to friction¹².

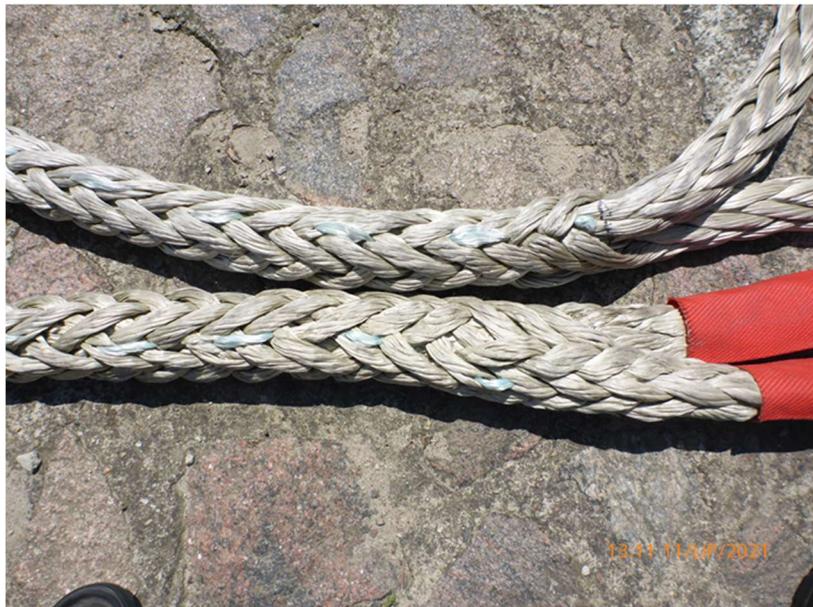
Photo 8 – A correctly spliced eye of an HMPE rope with visible stitches restricting the movement of spliced strands.

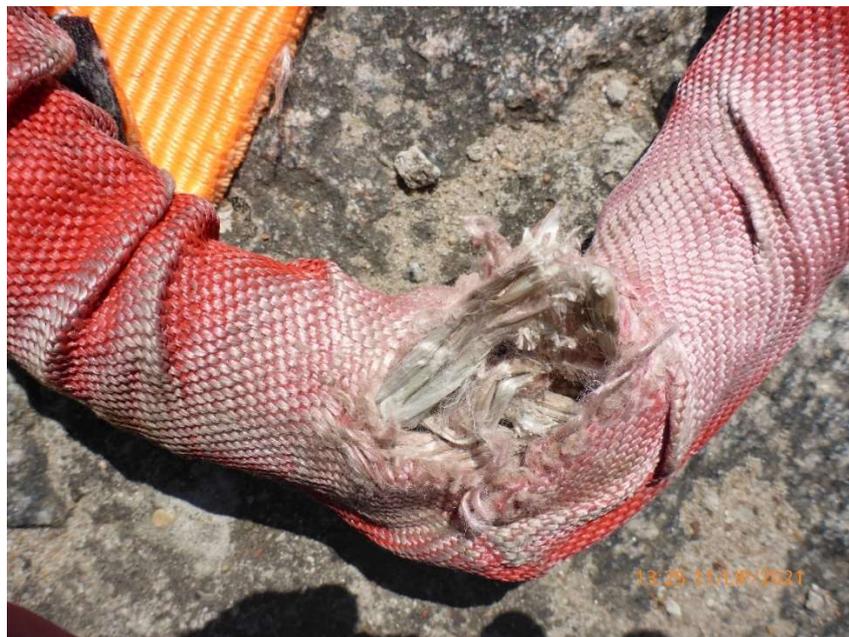
Fibre damage that disqualified the rope from use was visible under the rope's (yellow) sheath in the areas of intense rubbing of the ruptured end of the HMPE (tow) rope.

Photo 9 – Damage visible upon removal of the sheath from the rope eye.

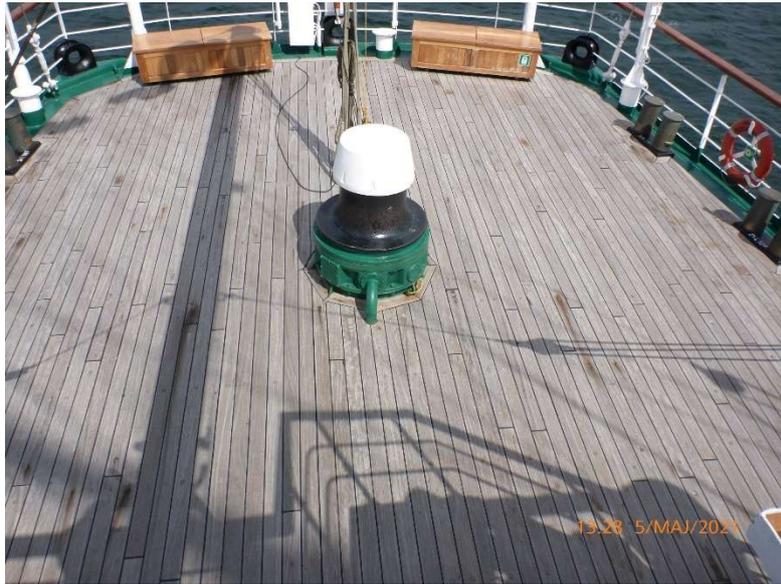
Aboard *Dar Młodzieży*, the third officer in control of the manoeuvres told the crew to leave the aftdeck after the tow line had been passed and hide behind the walls of the superstructure. He remained on the aftdeck and stood behind the capstan though.

Photo 10 – The deck of the sailing ship *Dar Młodości* with the capstan visible in the centre of the aftdeck

It was a highly insufficient protection against the possibility of being hit by the end of a ruptured rope. Watching the operating tow line, especially from that close, poses a great danger and does not contribute in any manner to the manoeuvres conducted. It is impossible to attempt to lurch away and not be hit by the ruptured rope because the ends of ruptured ropes reach the speeds of several hundred kilometres an hour. Luckily for the injured officer, he was hit by the end of the rope that had already bounced from the capstan he was standing behind.
