STATE MARINE ACCIDENT
INVESTIGATION COMMISSION

FINAL REPORT

m/s SMP Novodvinsk

**Grounding by a vessel passing the Świnoujście-Szczecin
Fairway on 12 January 2022**

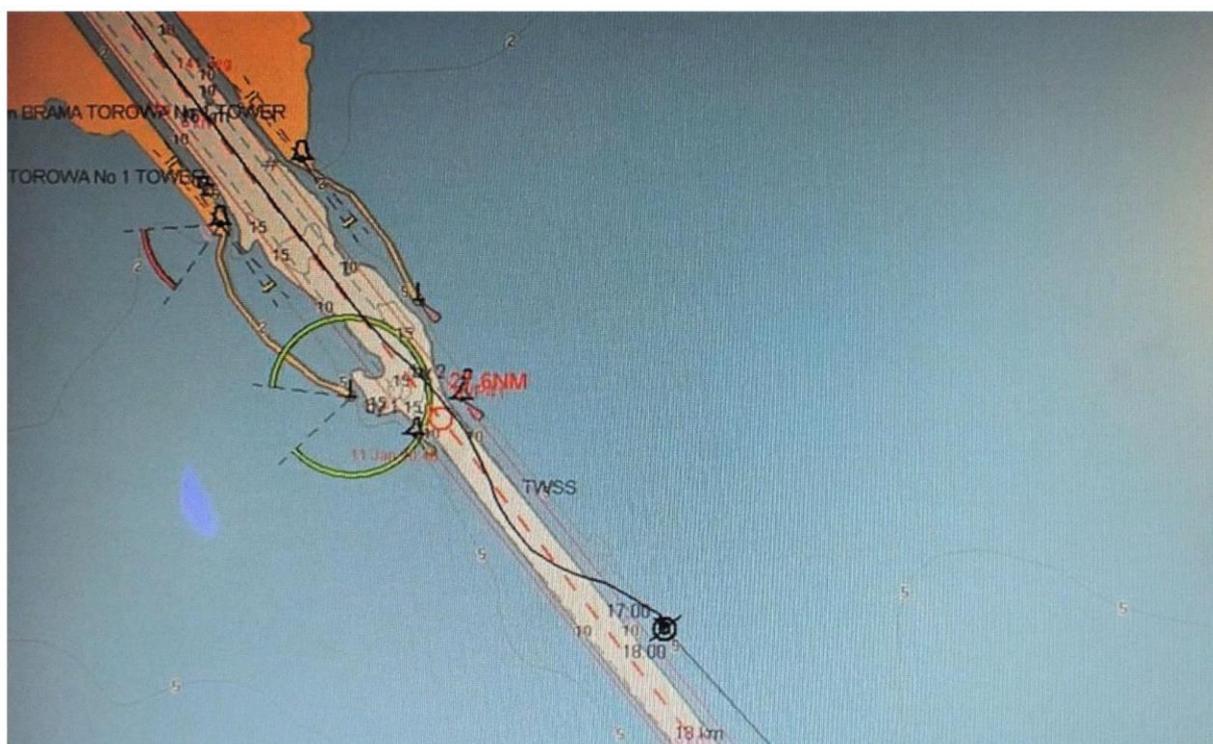
Photo 1. Image of vessel's movement and grounding area (ECDIS)

As the vessel drifted to the eastern side of the fairway, a course correction to the starboard side was made. As a result of this, the vessel found itself on the west side of the fairway, requiring a course correction to the port side, which was executed. The vessel began to turn rapidly to the port and as a result moved to the eastern side of the fairway. Attempts made to correct the course to the starboard,

including the use of the bow thruster, proved insufficient. The vessel drifted out of the fairway and went aground at 14:45 having COG of approximately 130°.

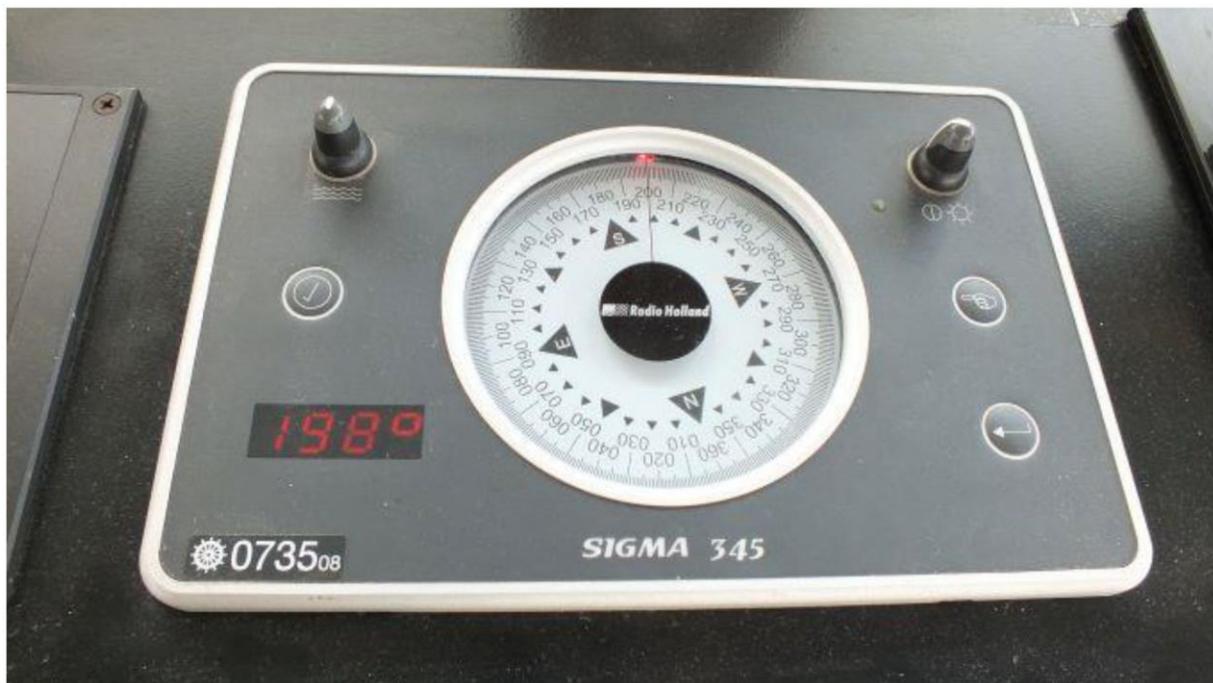
Photo 3. Magnetic compass repeater

Steering was manual with the helmsman using a magnetic compass due to a gyrocompass failure. Due to the position of the compass repeater on the panel, it was not possible for the master or pilot, who were observing the ship's movement on the ECDIS screens, to read the displayed compass course values. This lack of continuous course change information was significant to the unfolding of events and the accident itself.

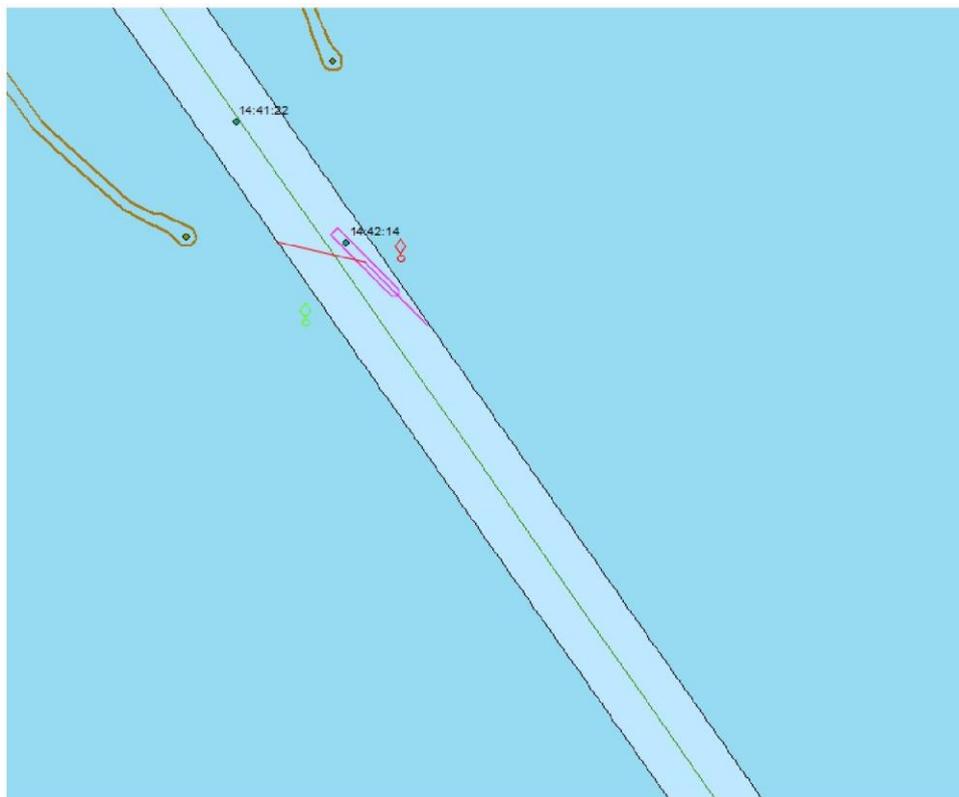
Figure 1. VTS at 14:42:14, COG = 135.4°, SOG = 8.7 kts, ROT = -0.7°/min⁵

The master and pilot watched the vessel's movement on the ECDIS chart and when the vessel was in the middle of the fairway the pilot ordered 'midships'⁶.

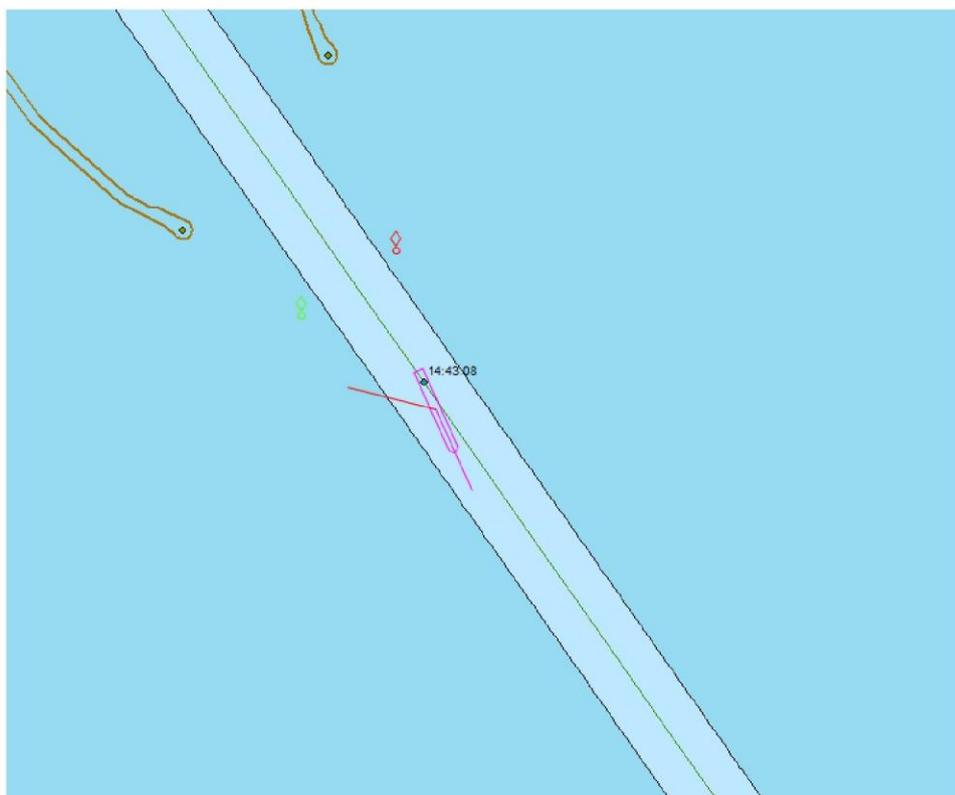
Figure 2. VTS at 14:43:08, COG= 156°, SOG = 8.94 kts, ROT = 15.2°/min

The further passing of the vessel to the starboard side of the fairway caused the pilot to react and give the command to helm – port 10⁷. The vessel braked the turn to the starboard and, according to the consensus account of witnesses, quickly began to change course to the port and proceed again towards the port (east) edge of the fairway.

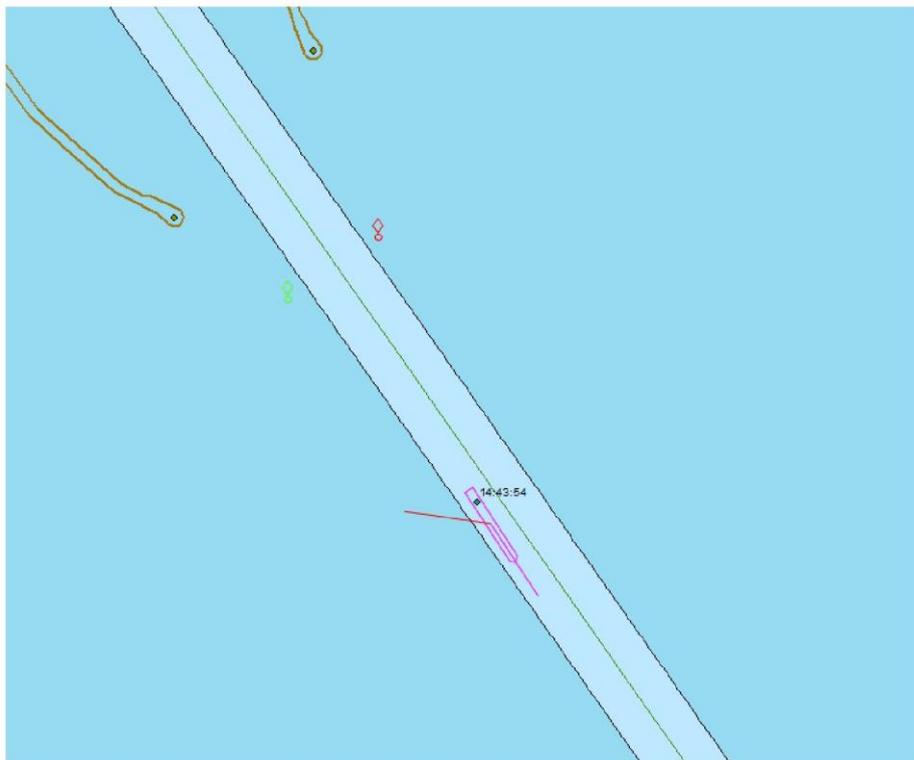
Figure 3. VTS at 14:43:54, COG = 147°, SOG = 7.97 kts, ROT = -53.1°/min

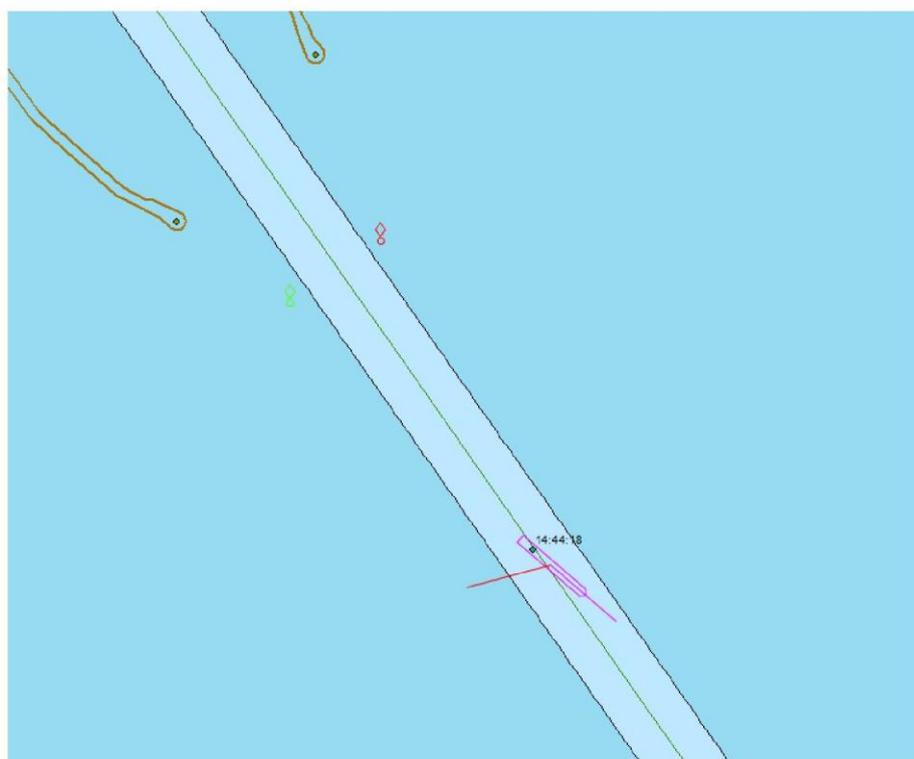
Figure 4. VTS at 14:44:18, COG = 131°, SOG = 8.16 kts, ROT = -39.3°/min

Pilot gave a command on the helm – starboard 15, and a moment later – hard to starboard. The vessel continued to make a port turn crossing the boundary of the fairway.

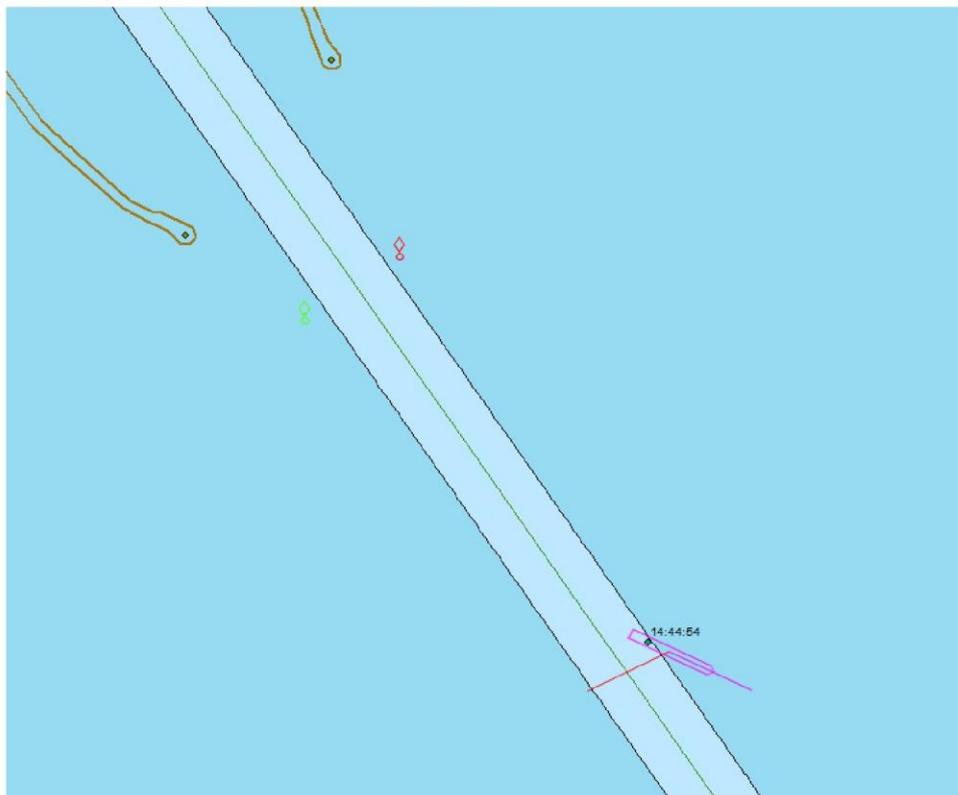
Figure 5. VTS at 14:44:54, COG = 115.3°, SOG = 7.97 kts, ROT = -20°/min

The pilot instructed to run the bow thruster to maximum starboard. The captain decided to set the propeller pitch to '0' and then to 'slow astern'. These actions were taken simultaneously. Being already off the fairway, the vessel started to change course to the starboard but finally grounded at 14:46.

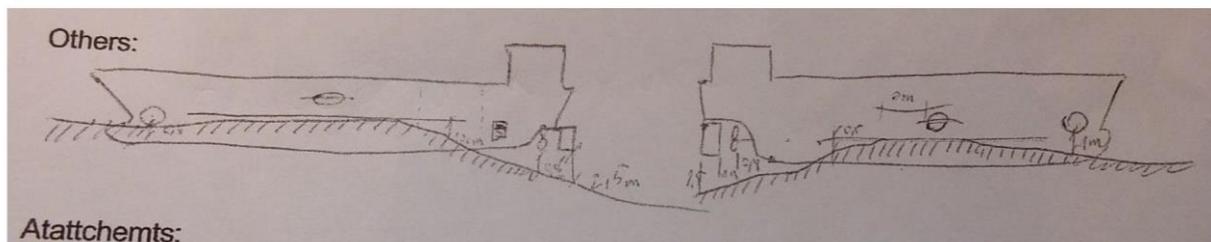
VTS and the operator were notified about the accident, and in the meantime a tank sounding and visual inspection of accessible parts of the hull was carried out. No hull unsealing as well as no water pollution was observed. Determined the draft of the vessel when aground – fwd 4.70 m and aft 4.30 m. On the same day, unsuccessful attempts were made to take the vessel from aground using the tug Centaur II. A diver's examination of the underwater part of the hull showed that the vessel's rudder and propeller were off the sand bank.

Figure 6. Sketch made by a diver showing location of vessel when aground

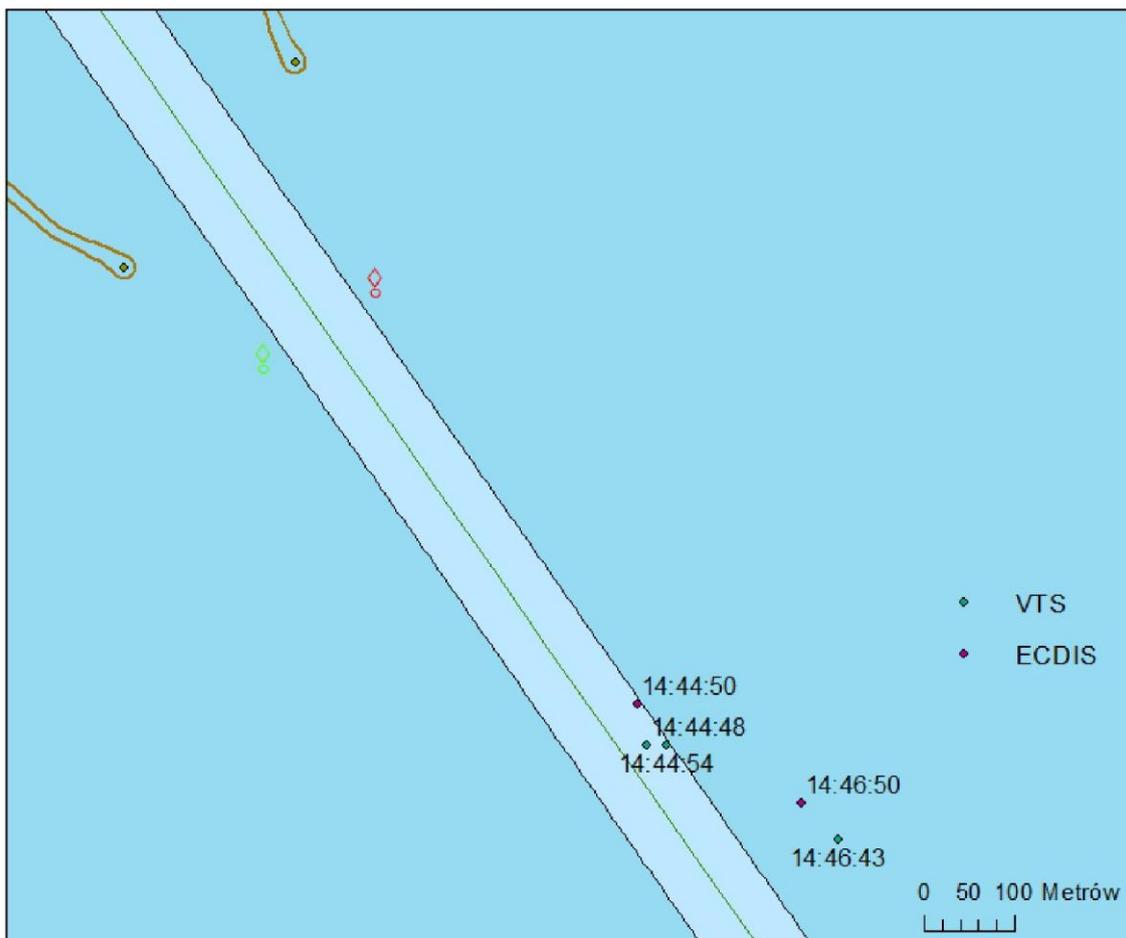
In addition, during the data analysis it was found that the vessel's positions as determined by the AIS system (available in the VTS) and those available in the ECDIS are offset from each other by approximately 40-50 m.

Figure 7. Example of position differences from VTS and ECDIS in the final stage of an accident

In section 4, Figure 7 shows the differences in position determination between the signal from AIS and on ECDIS. There is insufficient data to give a clear cause. The most likely one is that the signal is coming from different antennas that are referenced to a different location on board the vessel, i.e. badly entered offsets in the system. The probable cause could also be the aforementioned GPS smoothing, or a signal time offset (lack of synchronisation). The magnitude of this problem is minor in the case of classic navigation, but when navigation equipment becomes the only source of information, it increases significantly.

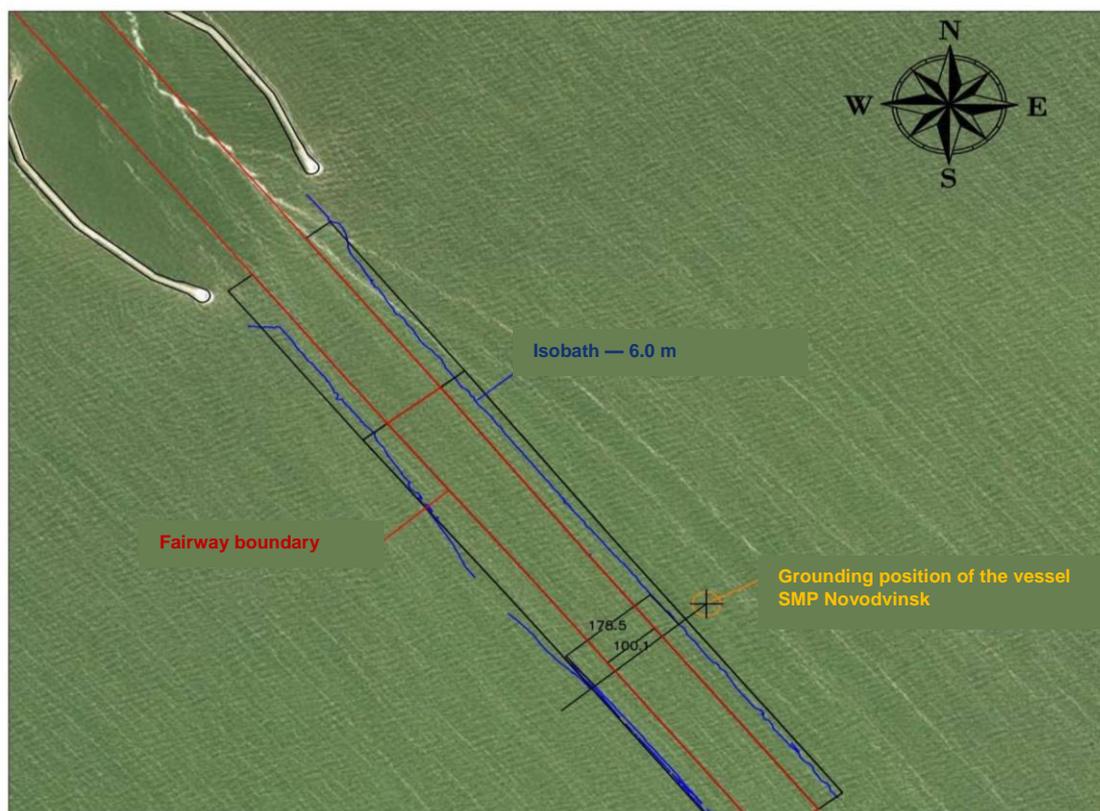
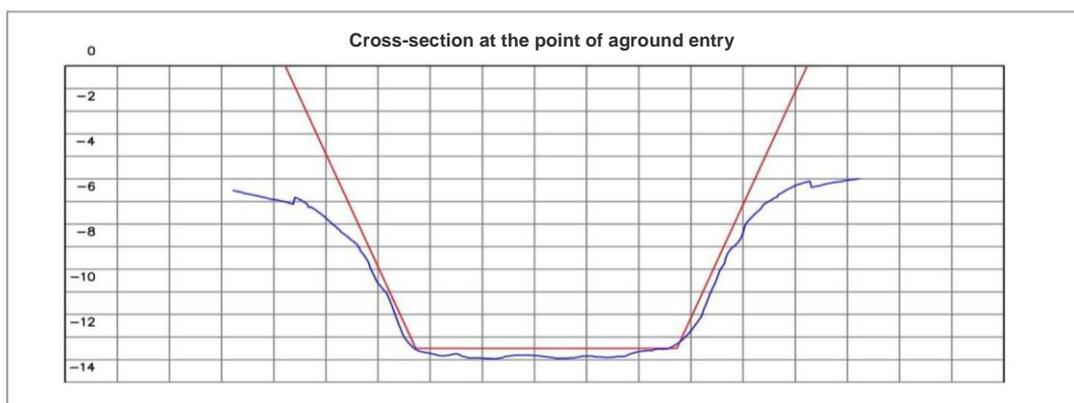
The fairway in the Szczecin Lagoon is 100 m wide with a depth of over 12.5 m, and the width of the fairway between the 6 m isobaths is 178.5 m at the point of aground entry.

Figure 8. Fairway characteristics at the point of grounding

the vessel's draught may have caused channel effects, while depth restrictions outside the fairway may have caused shallow water effects. In the case under analysis, the impact of these factors appears to be minor, but the occurrence of these adverse factors in the final phase of the accident cannot be ruled out.

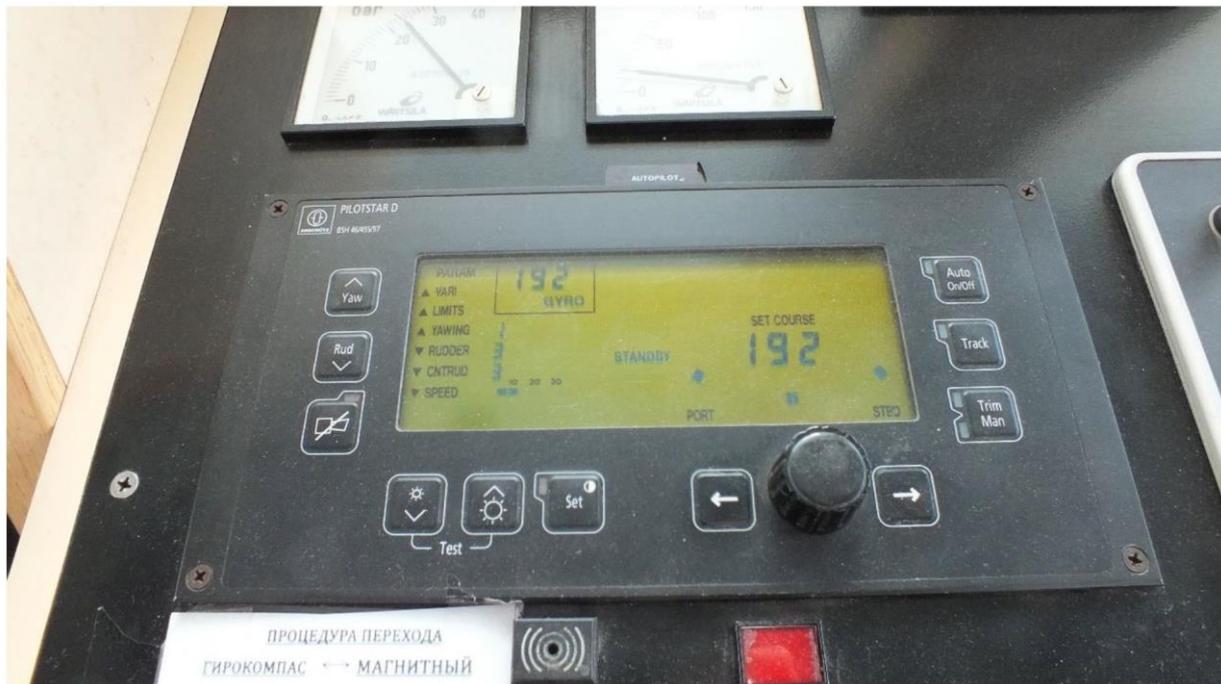
The gyrocompass failure also affected the control of the vessel. This was because the autopilot, linked to the gyrocompass, was not used. Despite the possibility of autopilot operation based on the magnetic compass signal, this option was also not used. The last annual inspection of the gyro-pilot was carried out on 8 July 2021 and confirmed the good condition of the gyrocompass.

Photo 6. Autopilot panel with visible below instruction for selecting gyrocompass or magnetic compass signal

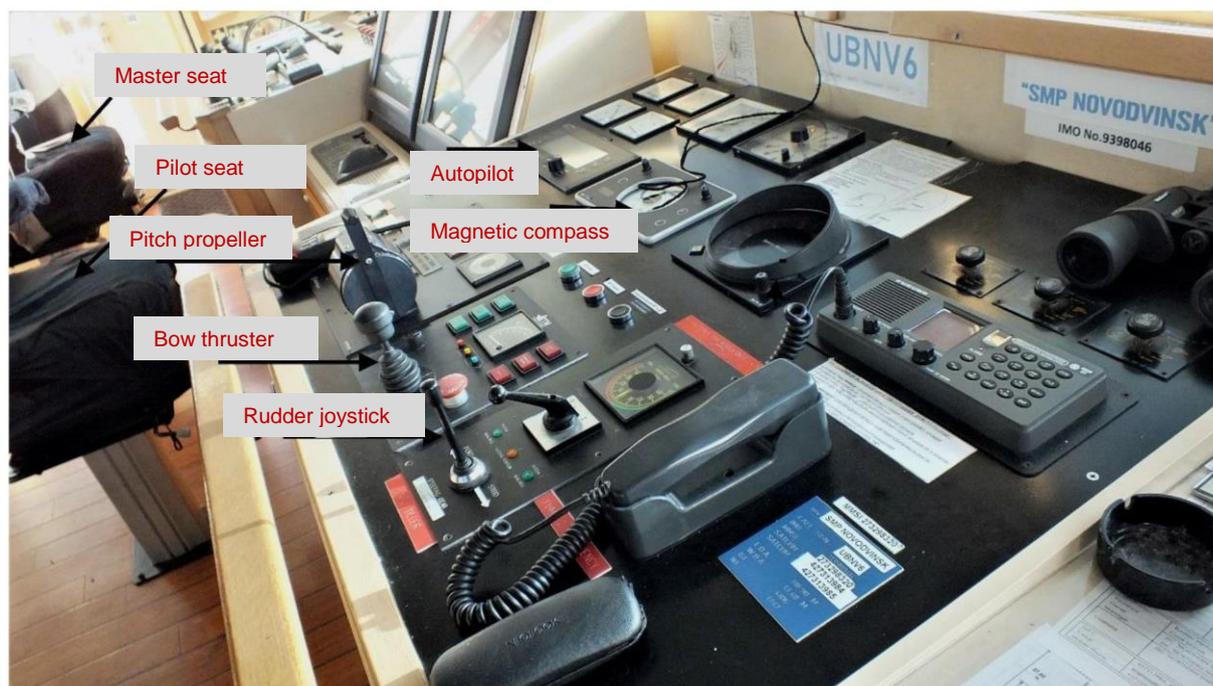
Figure 9. Control panel

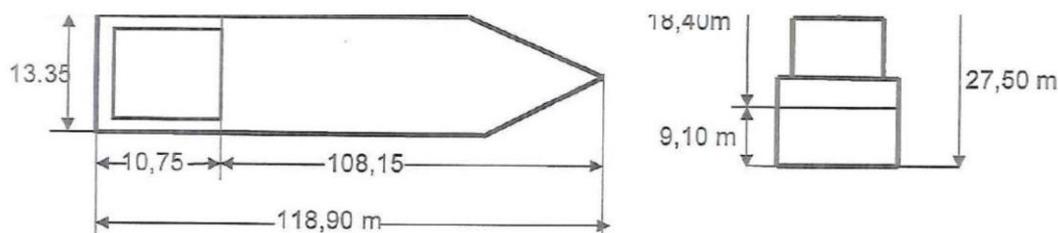
Figure 10. Part of the Pilot Card

The pilot identified another technical problem in his report, namely that the vessel slowly responded to the rudder. He suggested that there may have been some problems with the rudder, but this was not confirmed by crew members and there were no alarms related to this either. Given that the pilot personally checked the manual steering at the Świnoujście road and decided to continue the voyage, it is assumed that the rudder was working correctly and that any steering difficulties were due to the nature of the vessel in this loaded condition.

Type of rudder : Becker Flap/1	Hard-over to hard-over: one unit 38 sec. two units 19 sec.
Maximum angle: 45	
Bow thruster – yes 280 kW / 375 H.P.

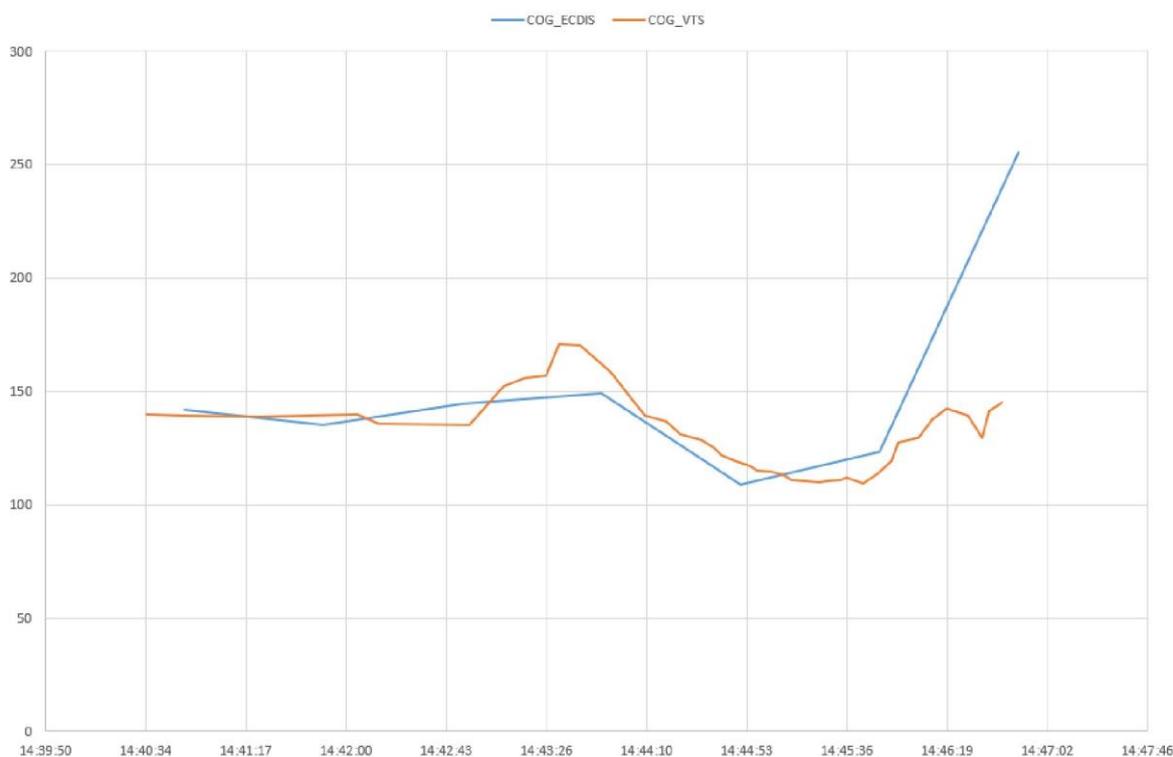
Figure 11 shows, for example, the differences in the determination of the COG course plotted in ECDIS and transmitted via AIS to VTS. In addition to the fact that the ECDIS course is only determined every minute, it is clear that the course transmitted by AIS has a certain lag in relation to the ECDIS course, of about half a minute. And yet both values are calculated for the same vessel using DGPS satellite positions. It is the different internal filtering algorithms that may be the cause.

Figure 11. Comparison of the COG course in ECDIS and VTS
