STATE MARINE ACCIDENT
INVESTIGATION COMMISSION

FINAL REPORT

**SAILING YACHT
'YACHTING'**

**Fall overboard of a sailing yacht crew member on
the Baltic Sea on 23 February 2022**

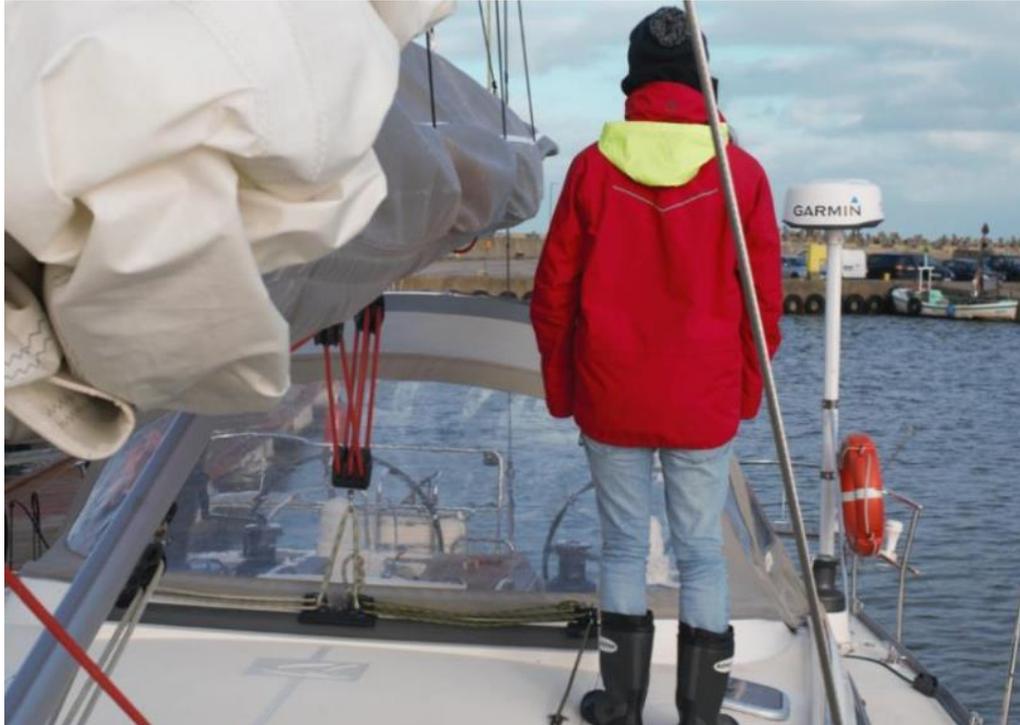
⁶ There are a few places around the mast that the crew member could have been connected without restricting access to work on the mast and boom.

Photo 2. Location of the sailor before falling overboard

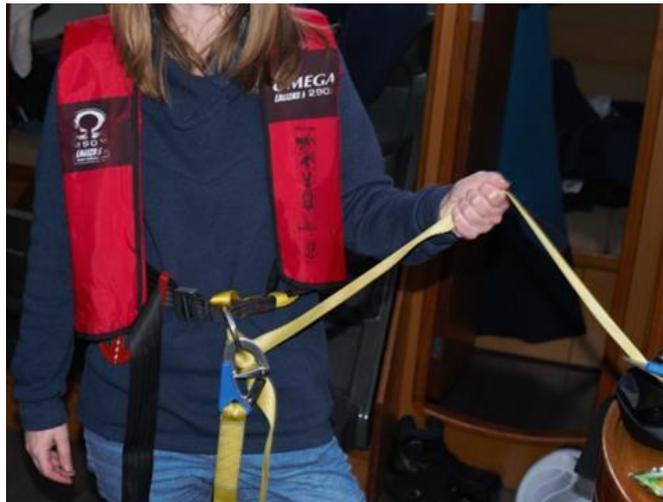
Photo 5. How the safety line should be secured to the handle on an inflatable lifejacket

- sailing yacht was not equipped with a lifeline and the inflatable lifejackets did not have a crotch strap to prevent the person from slipping out from the lifejacket.

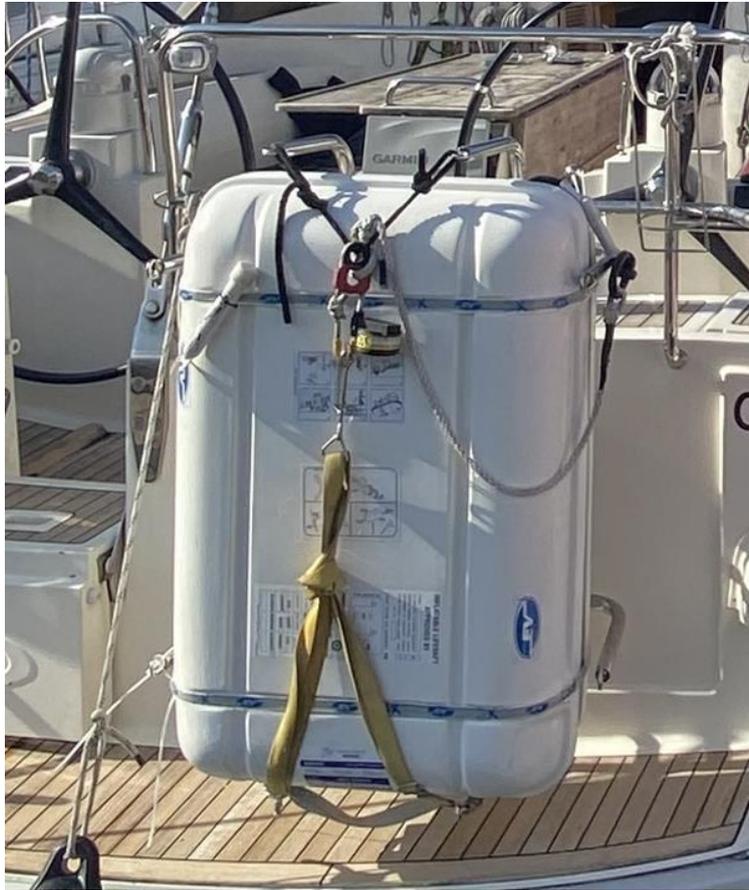
recommendation¹⁶, the straps holding the liferaft were attached via a hydrostatic releaser, but using a section of rope passing through the releaser's thimble tied up using 'reins' to the handle of the liferaft.

Photo 6. The method of securing the liferaft to the mismatched bed. The painter was probably not tied to the fixed part of the yacht.

The instructions for attaching the hydrostatic releaser state that it should be connected *'using a shackle to a firm point on the deck or bed of the liferaft'*.

The liferaft fell overboard. It probably did not open because the painter that should open the liferaft was not connected to the yacht.

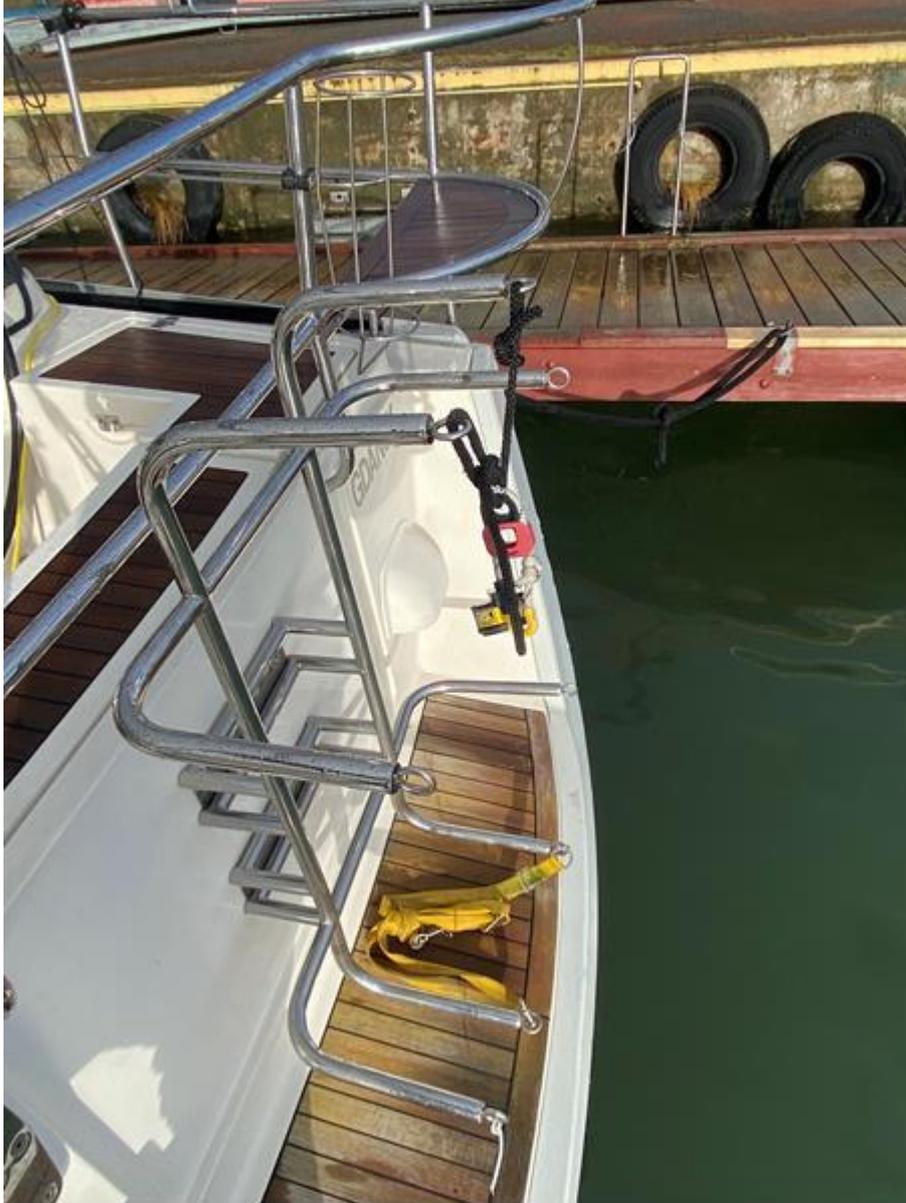
Photo 7. Photo taken after the yacht was brought into the port of Władysławowo. The hydrostatic releaser can be seen hanging, and below it the straps securing the liferaft together with the slip-hook are lying down.

From questioning of the crew, it appears that shortly before the accident the crew noticed the absence of the liferaft. This prevented the option of attempting to rescue the sailor, who had fallen overboard, by launching the liferaft close to him.

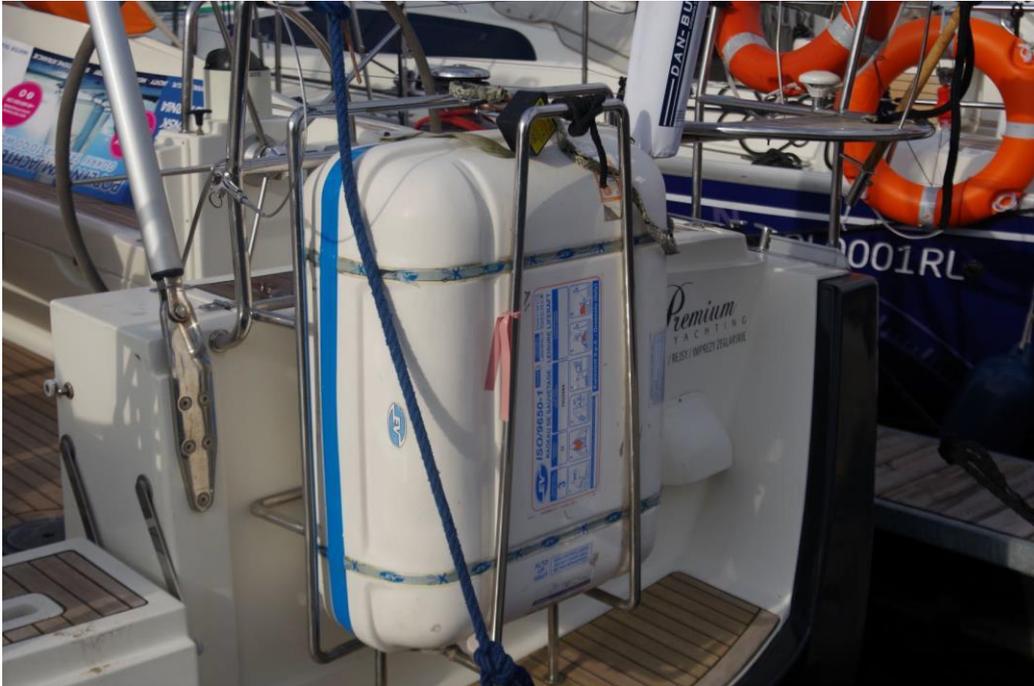
On the second Delphia 47 type sailing yacht offered for charter by Premium Yachting, the liferaft is properly mounted. Both the bed of the liferaft and the hydrostatic releaser fittings are done correctly.

Photo 8. The liferaft's bed is matching the size of the rigid container.

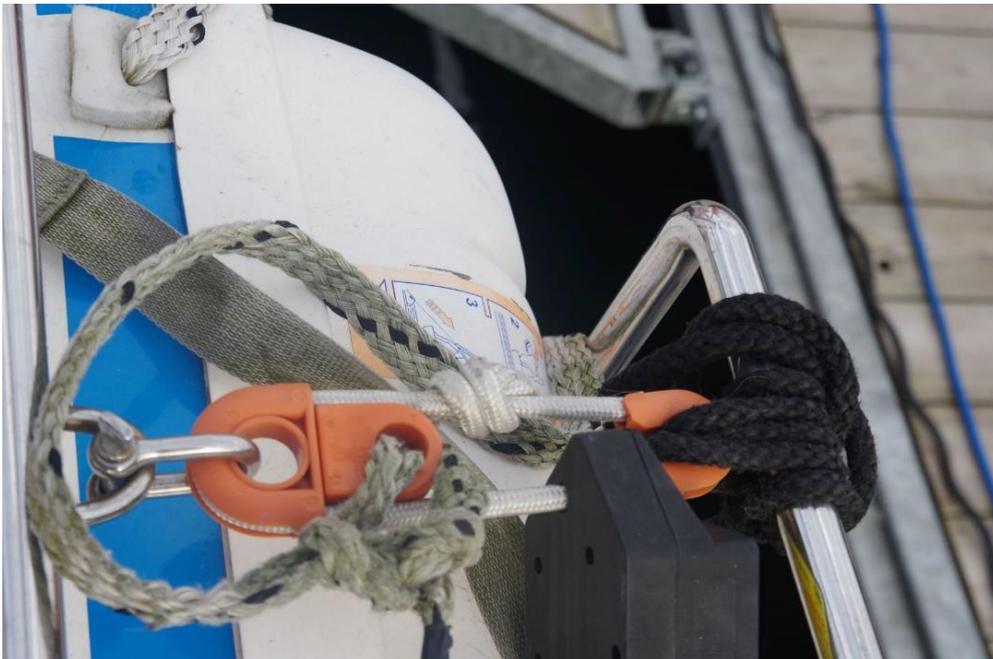
Photo 9. Correct fitting of the hydrostatic releaser.

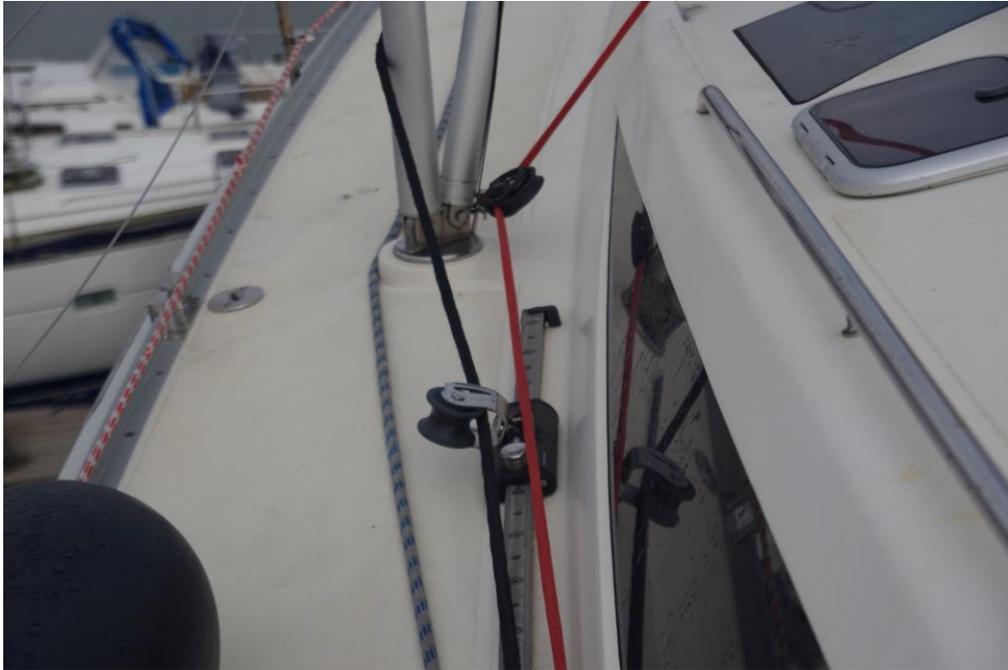
Another decisive problem for the safety of navigation was that the blocks installed on the sheet rails were too big in relation to the thickness of the sheet ropes.

Photo 10. Jib sheet block on port side

Despite being tied in figure-eight knots, the ends of the sheets were sliding through the blocks and crew members were forced to go out to the bow to grab the ends and put them back through the blocks. Unfortunately, the crew did not find a way to secure the ends of the sheets in such a way as to prevent them from repeatedly 'escaping' (the sheets should have been within reach of the watchkeepers located in the cockpit at all times).
