# SIMPLIFIED REPORT

## 044/22

**fishing vessel ALINA**

**Fire on board a fishing vessel in the exclusive  
economic zone of Mauritania on 29 May 2022.**

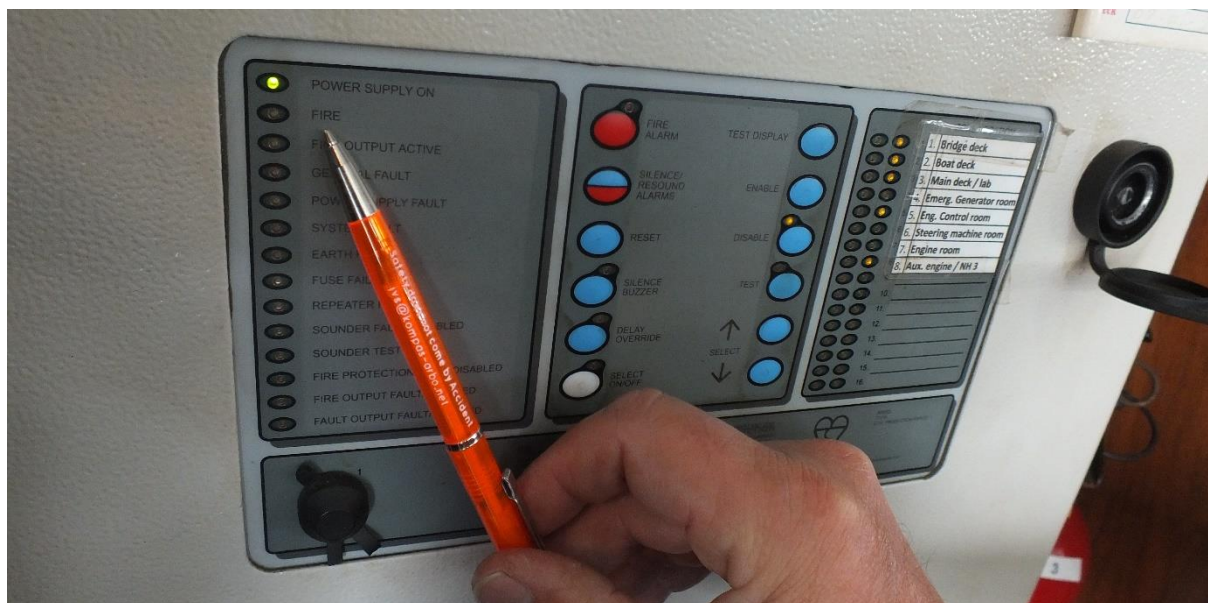
The fire detection and alarm system on this ship did not allow individual cabins or compartments affected by the fire to be identified<sup>3</sup>.

<sup>3</sup> The fire alarm system allowed the fire to be quickly detected and the affected deck to be indicated. It should be emphasised that the activated alarm applies to one monitoring loop, i.e. whichever of the detectors connected to one monitoring loop enters the alarm state, information about a fire on a specific deck (monitoring loop) will be displayed.

*Photo 3. Display of the fire alarm control panel*

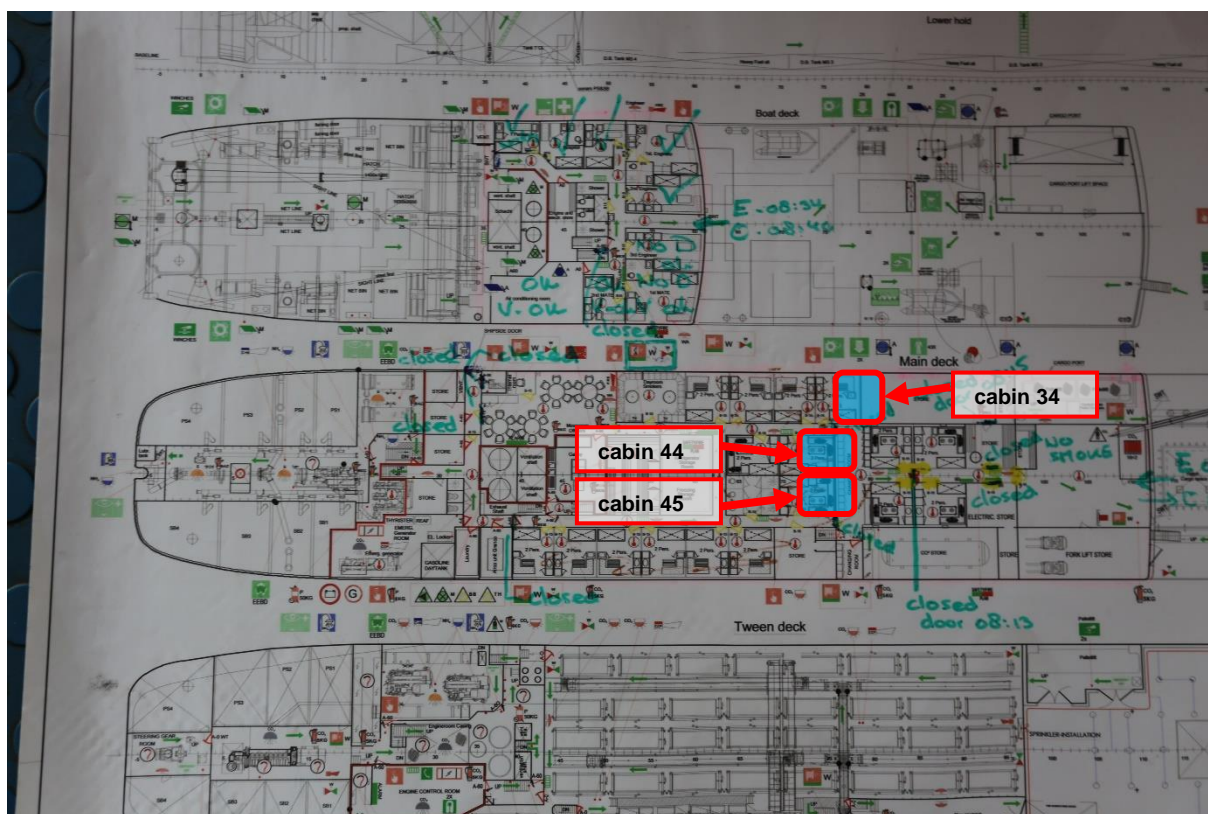
The fire quickly spread to other rooms and at approximately 0030 on 30/05/2022 it was found that 2 further cabins, nos. 44 and 45 located in the middle section between the two port and starboard corridors had already been on fire.

Figure 1. Fragment of the fire plan showing cabins 34, 44, and 45 on the main deck

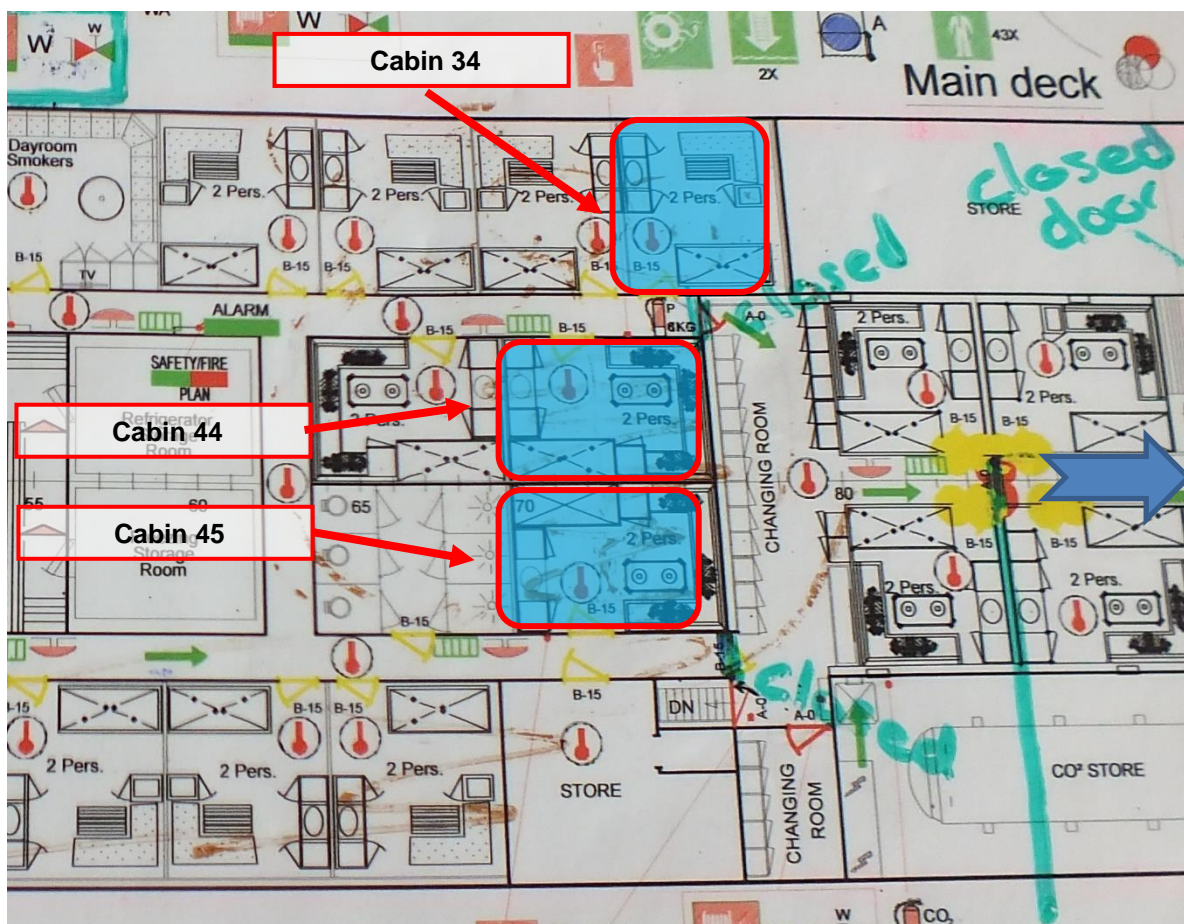
When examining the accident, the Commission did not manage to unambiguously establish the cause of the fire. Nevertheless, it was necessary to determine where the fire originated. The entire main deck was subjected to a thorough visual inspection. During this inspection it was clear that the most intense thermal damage was in cabins 44, 45 and 34. The location of these cabins on the fire plan is shown below.

Figure 2. Location of cabins 34; 44 and 45

As a result of the fire, several rooms and corridors adjacent to these three main deck cabins were also partially burnt, and the boat deck cabins were heavily sooted.

The destruction in these 3 cabins is disproportionately more intense than in the rest of the main deck. A small amount of combustible material survived in cabin 34, while solid combustible materials were completely burnt in cabins 44 and 45. Given the information received from a crew member, who took an active part in extinguishing the fire, it was not possible to reach the source of the fire (the starboard corridor towards the stern). In addition, it was explained that sailors left cabin 44 during the fire alarm. Meanwhile, nobody was in cabin 34 when the fire alarm system was triggered. This means that the fire must have started in cabin 34.

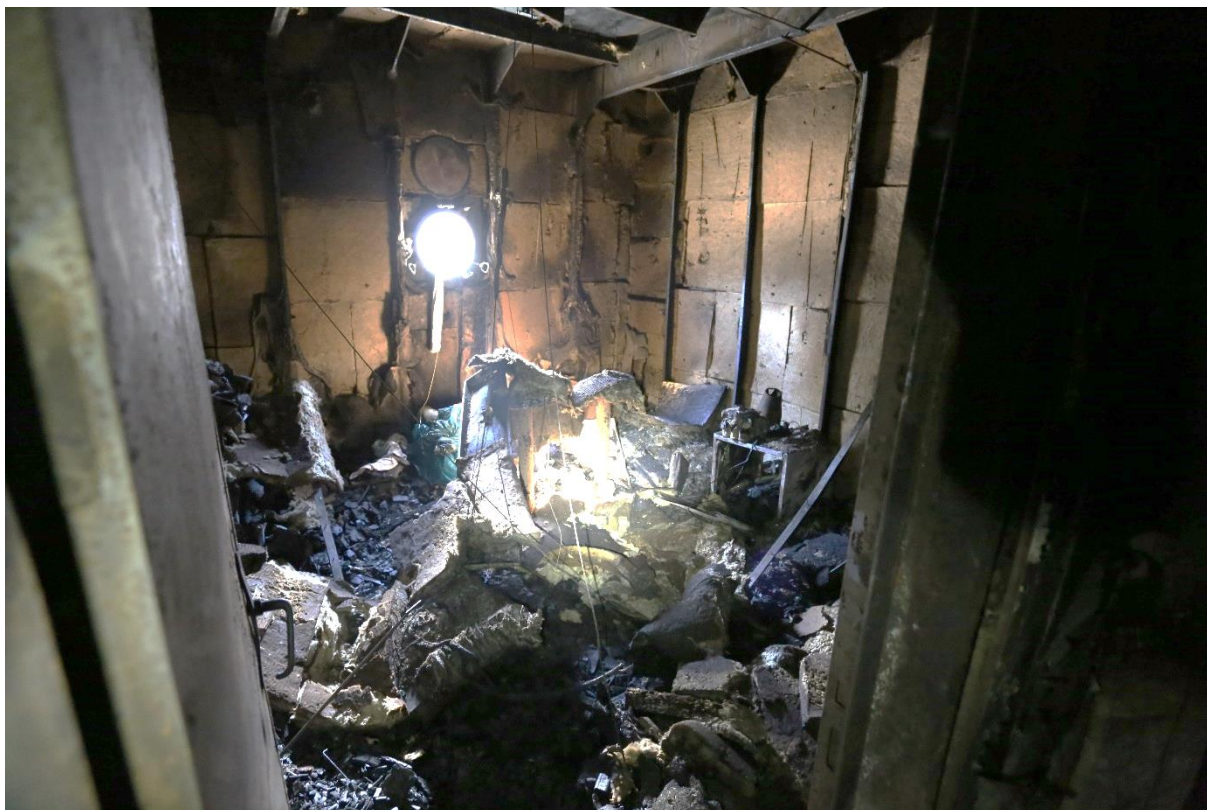
The fact that not all combustibles in cabin 34 burnt most likely results from the obstructed air (oxidant) flow in the initial phase of the fire. There is no doubt that the resulting combustion process in cabin 34 was determined precisely by the amount of air (oxygen) required to

*Photo 4. Intensely burnt interior of cabin 34*

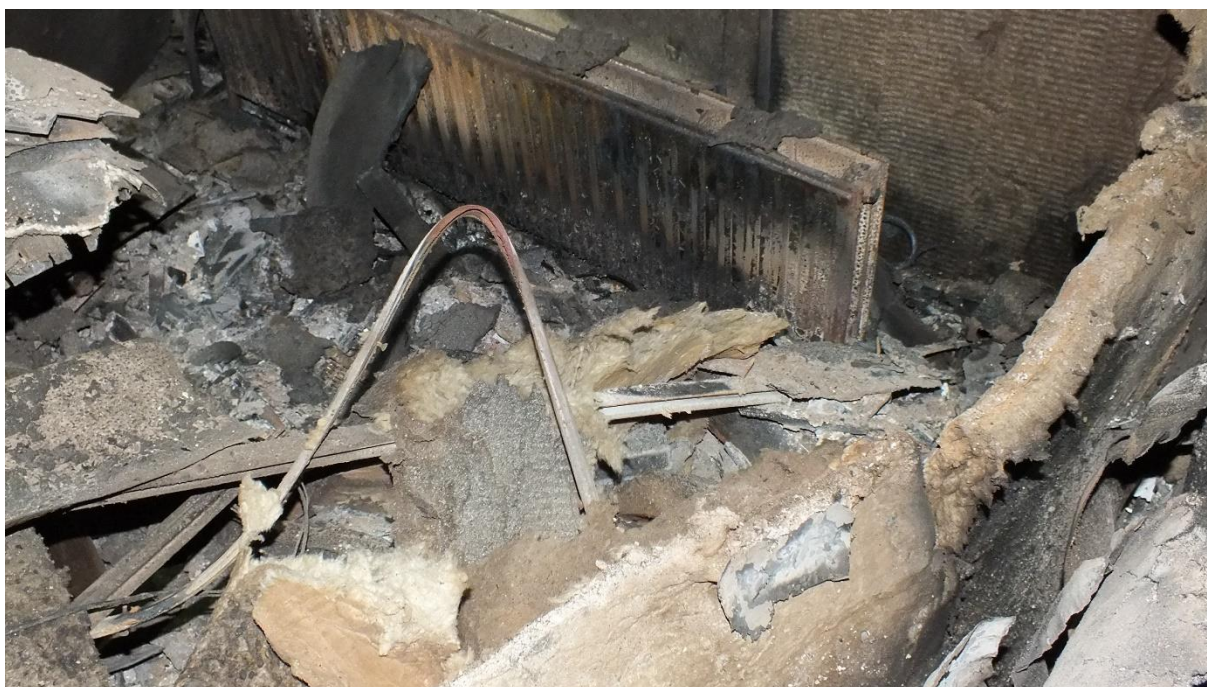
*Photo 5. Intensely burnt interior of cabin 45*

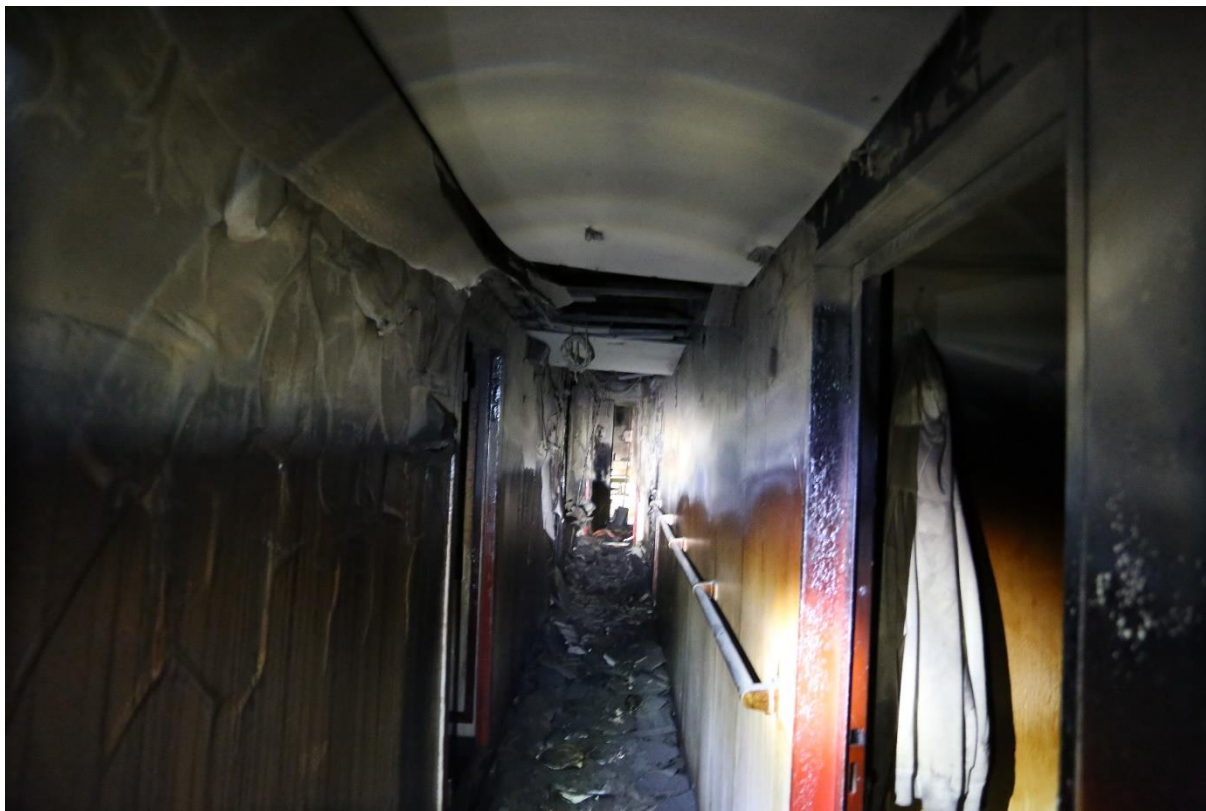
*Photo 6. Port side corridor – view towards the stern*

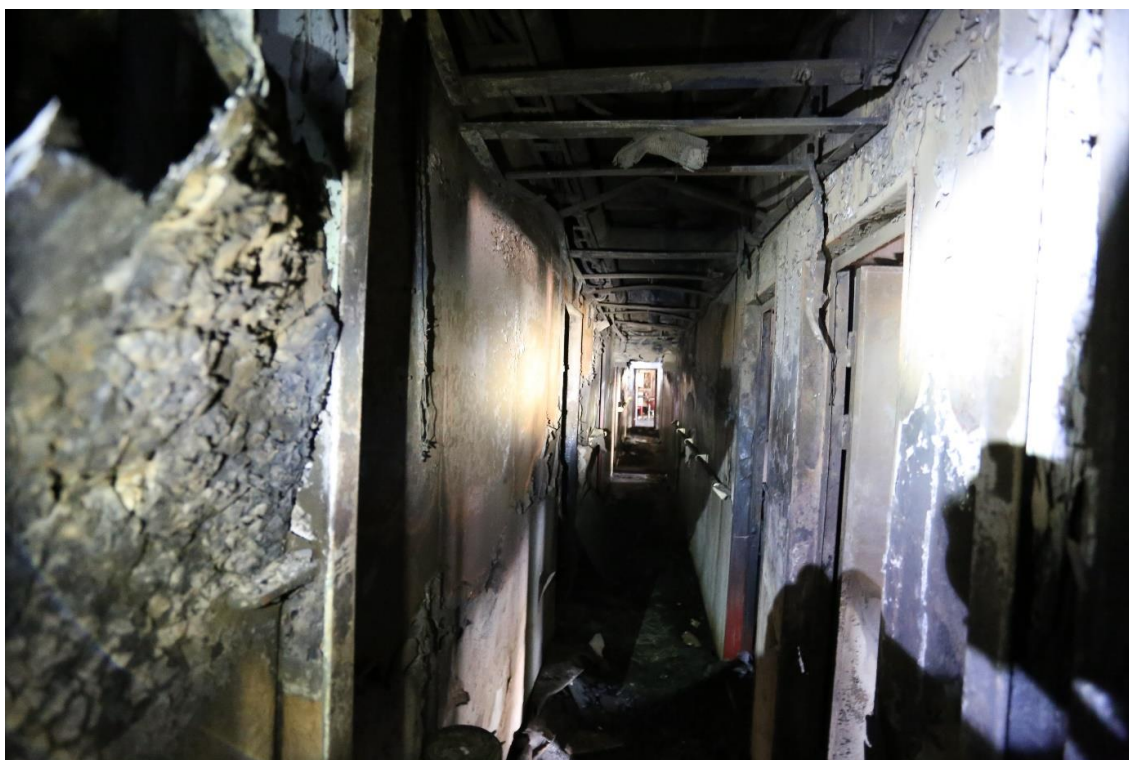
*Photo 7. Starboard side corridor – view towards the bow*

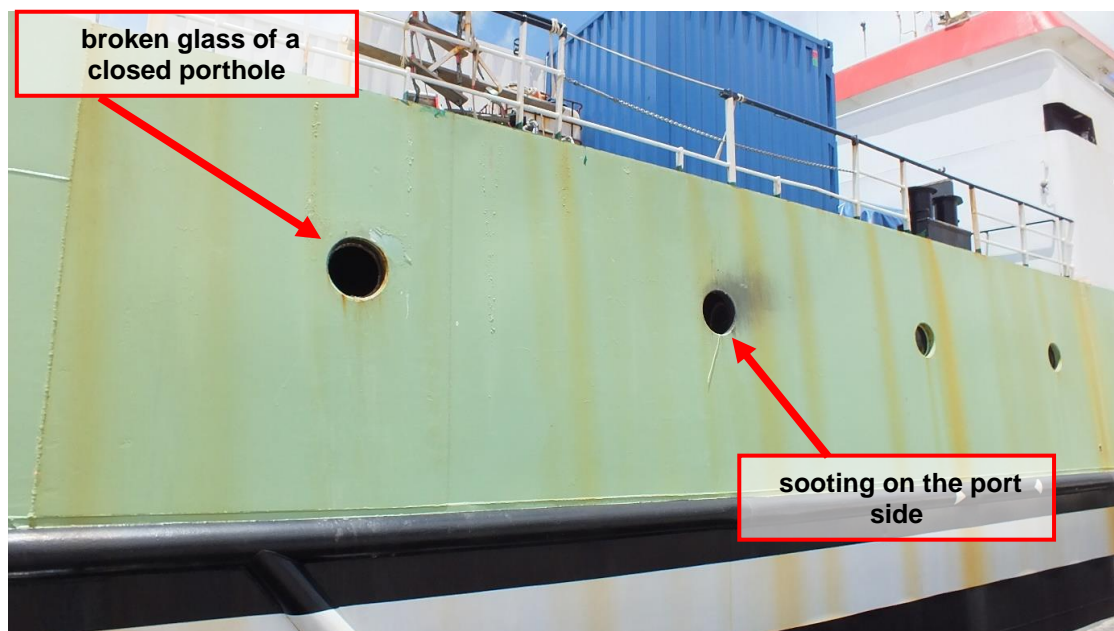
It should be emphasized that on the outside of the vessel a slight sooting was only visible at one porthole with no other signs of fire effect.

*Photo 8. Port side with visible sooting<sup>5</sup>*

<sup>5</sup> The visual inspection revealed only two areas of visible sooting and fire-related damage on the port side. These are the areas around two portholes of the main deck.

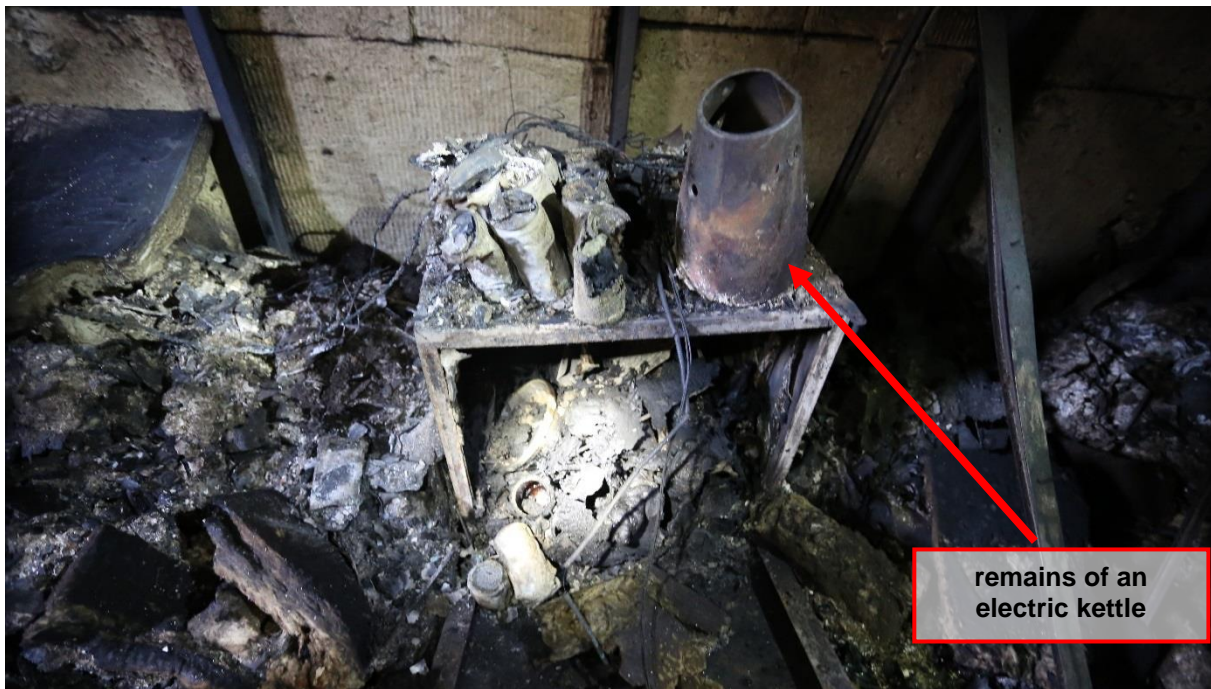
Given the fact that electrical appliances, other than phone and computer chargers, not belonging to the permanent equipment were found in most of the cabins, it was assumed that the most likely cause of the fire in cabin 34 was the ignition of a fire from an electrical appliance left running.

Among other things, the remains of an electric kettle were found in the site of the fire in cabin 34, as shown in photograph no. 9.

*Photo 9. Interior of cabin 34*

In the Commission's opinion, the ignition of the fire resulting from the use of electrical appliances or their failure could have been the direct cause of the accident in the form of initiation of the combustion process in cabin 34. Despite the ban on electrical appliances other than permitted phone and computer chargers, appliances (including kettles, fans) were found plugged into electrical sockets inside cabins. Arson was also considered as another cause of the fire<sup>7</sup>. However, during the conducted visual inspection and the analysis no information that could indicate the deliberate initiation of the fire was found.
