The Bahamas
Maritime Authority

Marine Safety Investigation Report

into a fall resulting in one fatality onboard
Curacao Pearl
on 10 June 2022

Date of Issue: 27 March 2023
Bahamas Maritime Authority
120 Old Broad Street
LONDON
EC2N 1AR
United Kingdom

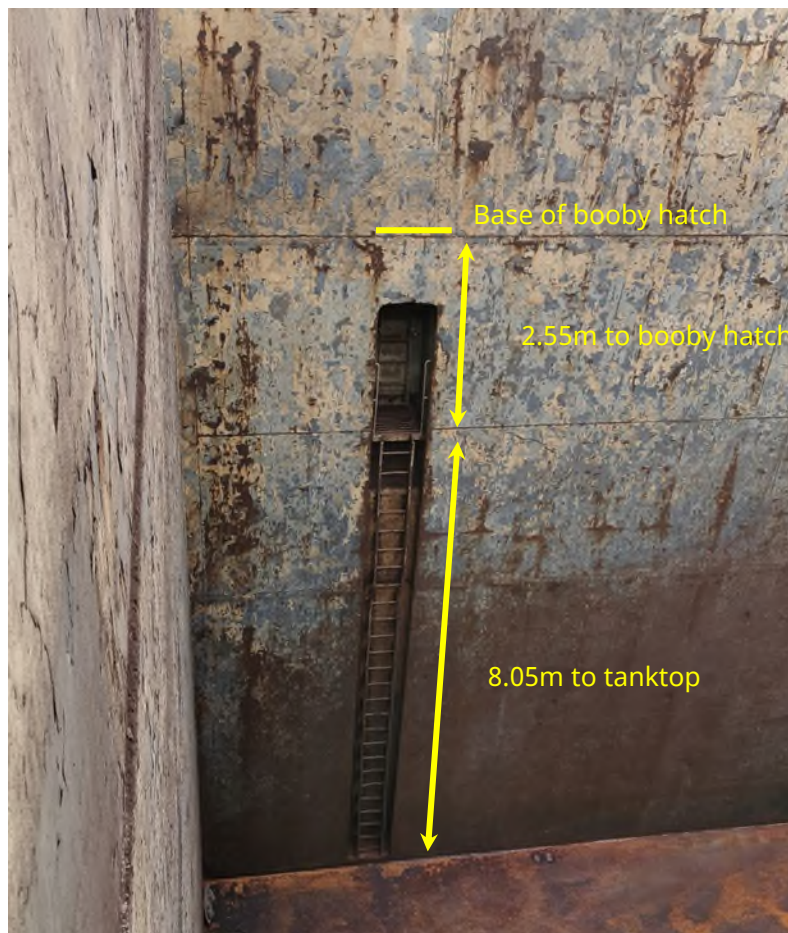
The cargo holds were accessed via a booby hatch located in the under-deck tunnels. A first ladder lead approximately 2.5m down to a resting platform. Access to the tanktop was then down a further 8m via a single ladder.

Access to hold 7, looking from forward

There was no fall protection built in to any part of the ladder structure but, despite their experience, neither the chief officer nor the bosun recognised the hazard of falling whilst they were accessing the hold or stood on the resting platform during the hose tests. Interviews with crew highlighted that the perceived risk of falling when going down in to a space was far less than associated with climbing to access an equivalent work site above deck.

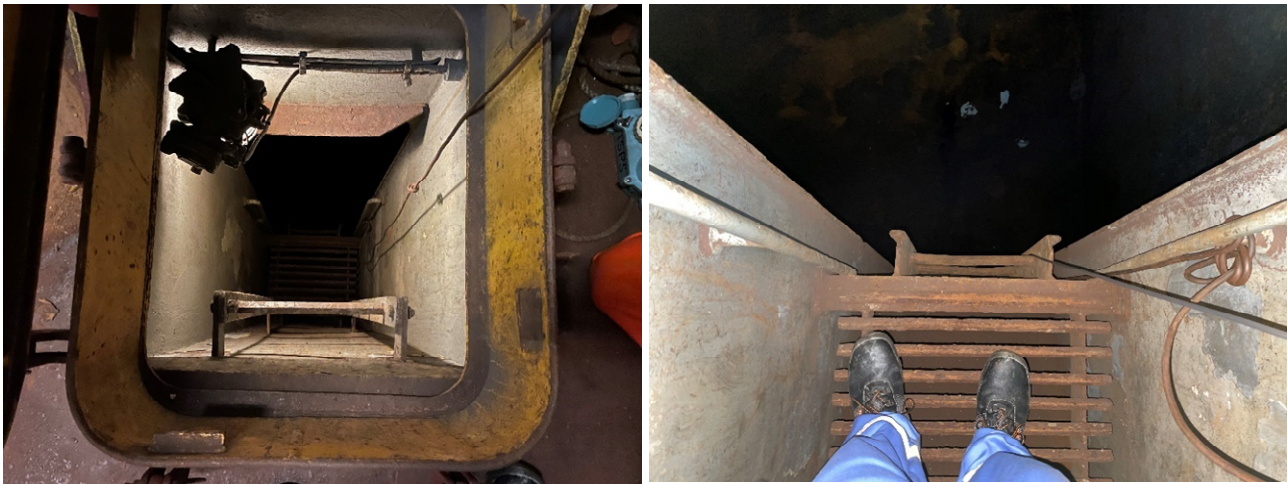
Other than a single light at the booby hatch, the holds were not fitted with any means of lighting – insufficient lighting was recognised as a risk by the chief officer and he included the need for headtorches in his pre-task briefing. However, to facilitate the hose testing, progress of the hose was followed with a torch. When working alone, the need to hold a torch and operate a radio meant that the bosun did not have a free hand to secure his position or brace himself against any unexpected movement.

Access to hold 7, looking down from cross-deck tunnel and ladder platform, hatches closed
