STATE MARINE ACCIDENT
INVESTIGATION COMMISSION

FINAL REPORT

024/22

**Drowning of 3 yacht crew members on the Gulf of
Gdańsk on 8 April 2022.**

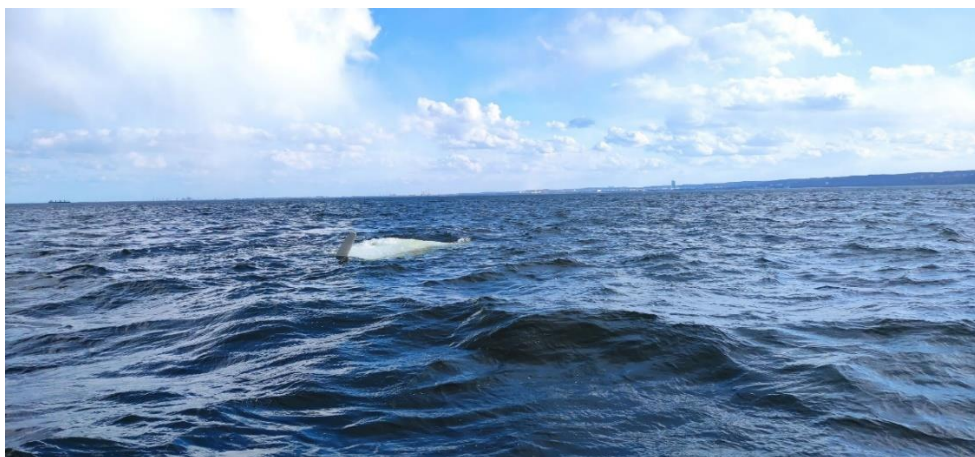
Photo 2 – Hull of the yacht when found by the rescue helicopter.

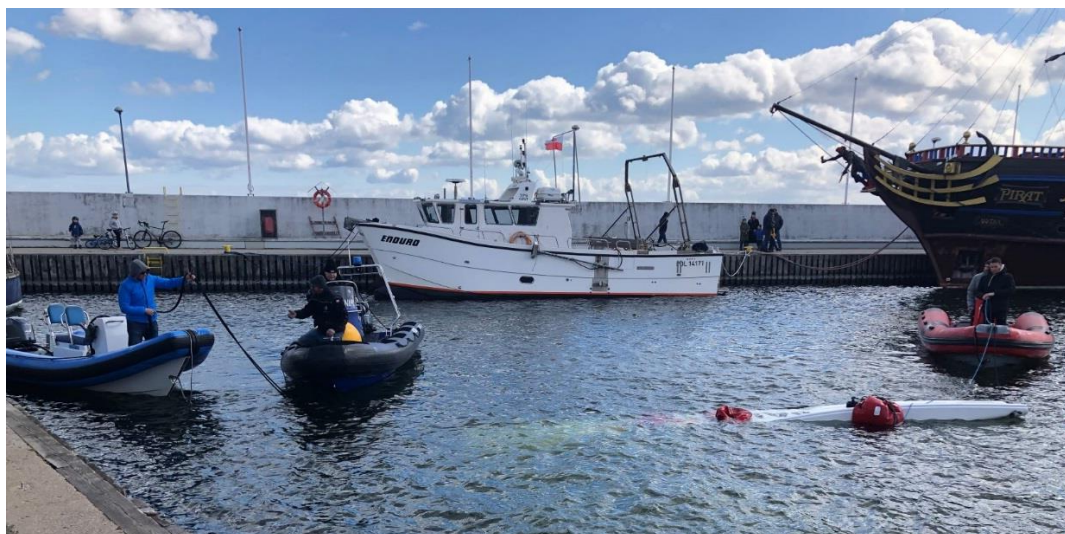
Photo 3 – The sunken yacht hull during preparation for lifting to the quay

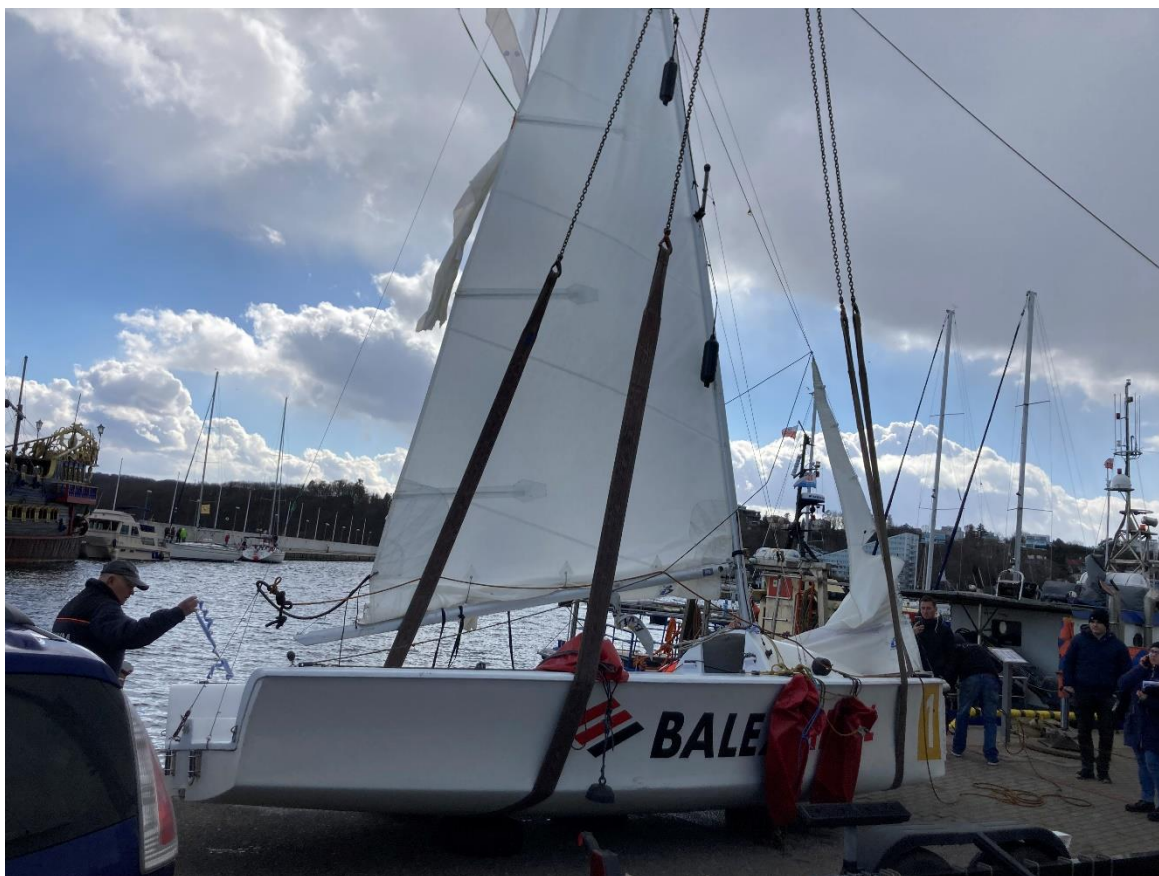
Photo 4 – The yacht when lifted from water

It is important to note that the yacht should not be allowed to operate due to technical deficiencies and repairs made that were not compliant with the class requirements. Part B of the "Delphia 24 One Design Class Rules" - Measurement Rules, contains a provision stating that *"maintenance and repair of the hull, deck, centreboard ballast, mast, boom, gennakerboom or fixed fitting may be carried out, but without violating these (class) rules. If a fixed fitting is damaged, it shall be replaced by another fitting complying with the Rules. The fitting or the item replacing it shall be of the same type as the original and shall be mounted in a place complying with the Rules"*.

Lack of proper maintenance and repeatedly allowing the yacht to operate in conditions that placed undue stress on her structure caused damage and constructional degradation during operation¹⁴.

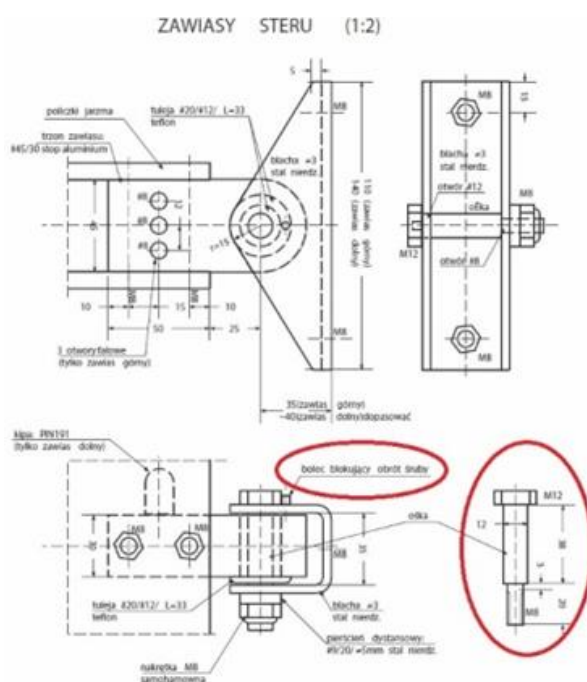
- missed rudder yoke pin in its lower fitting on the transom. 5 twin yachts were visually inspected on the water for correct installation of the rudder yoke to the transom and it was found that the installation method was incorrect and not compliant with the documentation. Instead of a Ø12 pin coved to an M8 nut, a M10 full thread bolt was used.

Fig. 2 – Drawing showing the correct fixing and securing of the pin to prevent it from falling out

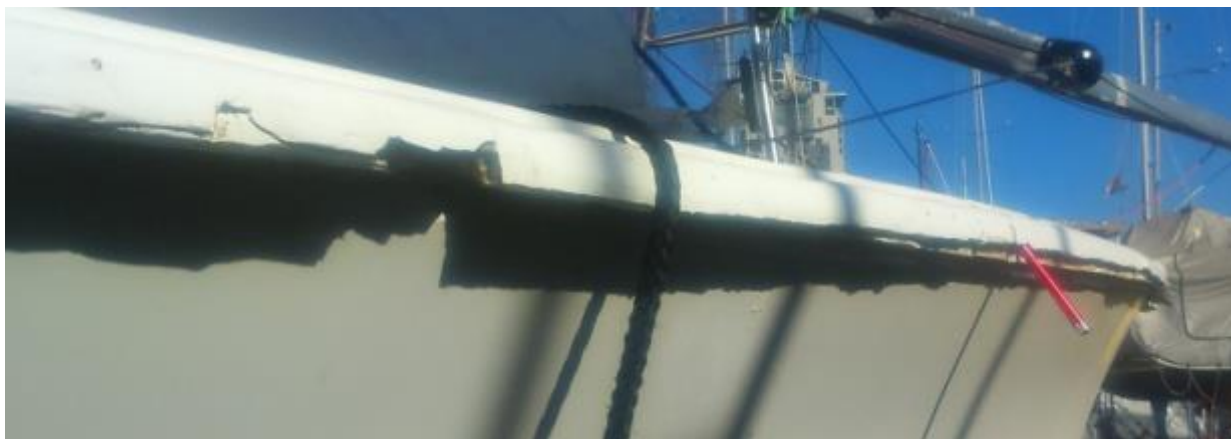
2. complete cracking, disintegration of the deck-board joint (port side) from the stern at a length of about 2.2m and numerous damages. Visible signs of several repairs by various means. It is possible that the damage was enlarged during the rescue operation and during the lifting of the water-filled yacht.

Photo 5 – damage to the deck-board junction

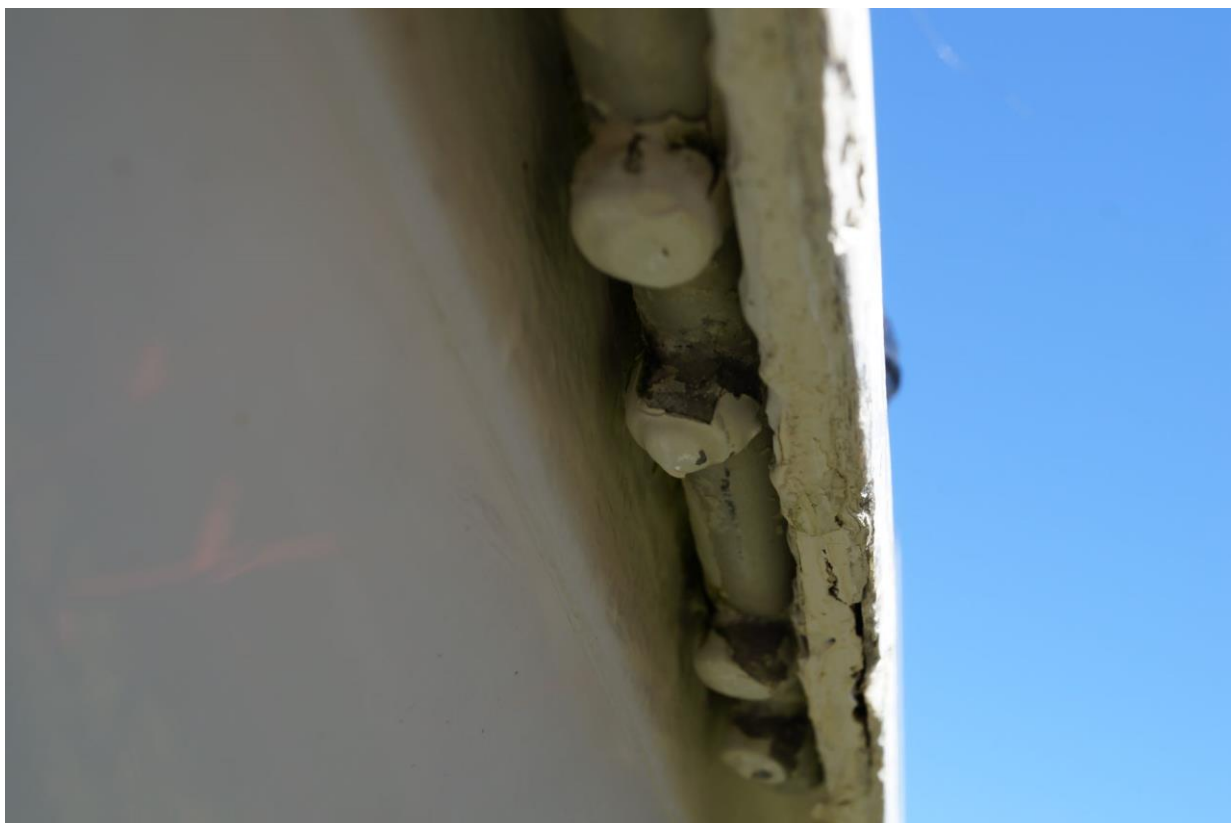
Photo 6 – damages to the shroud futtock

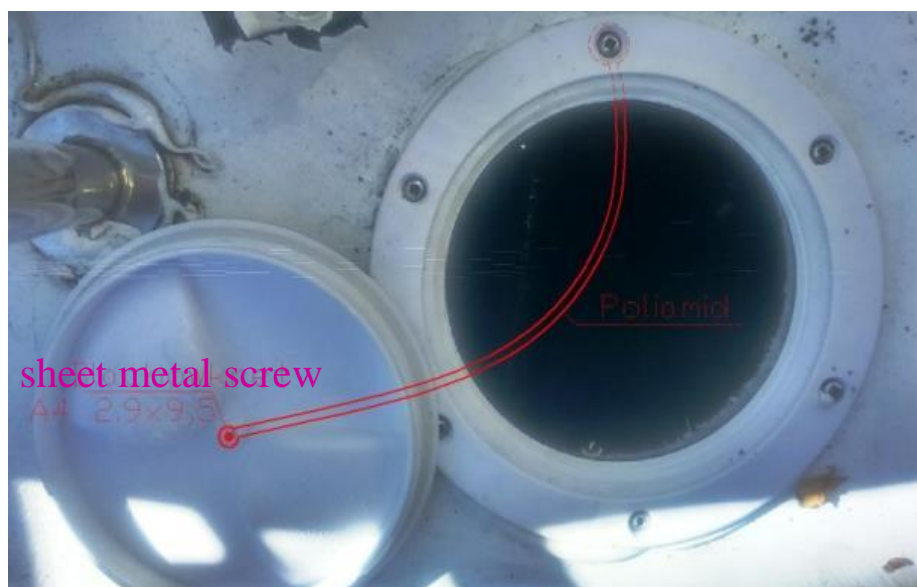
3. cracked plastic caps of control hatches Ø117/150 in the transom and the cockpit, lack of protection against losing the caps. Damaged control hatch caps should be replaced and should have overboard protection (the manufacturer provides them in the package).

Photo 7- no protection against falling out

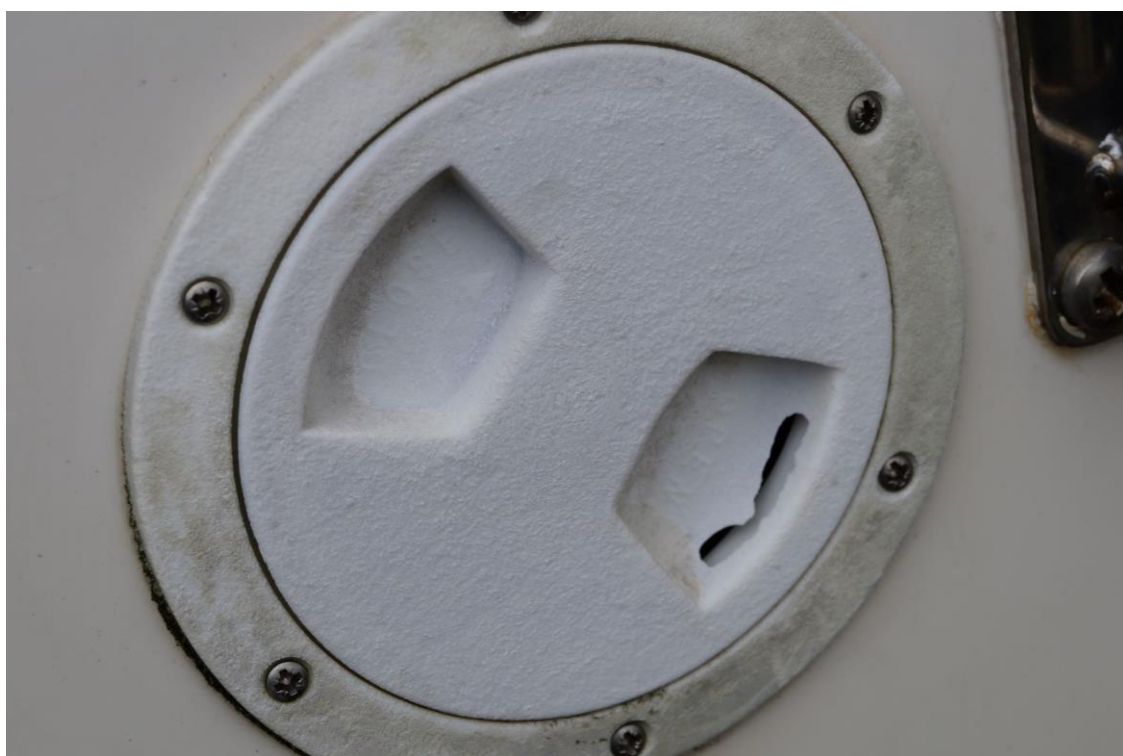
Photo 8 – damaged cap of the control hatch

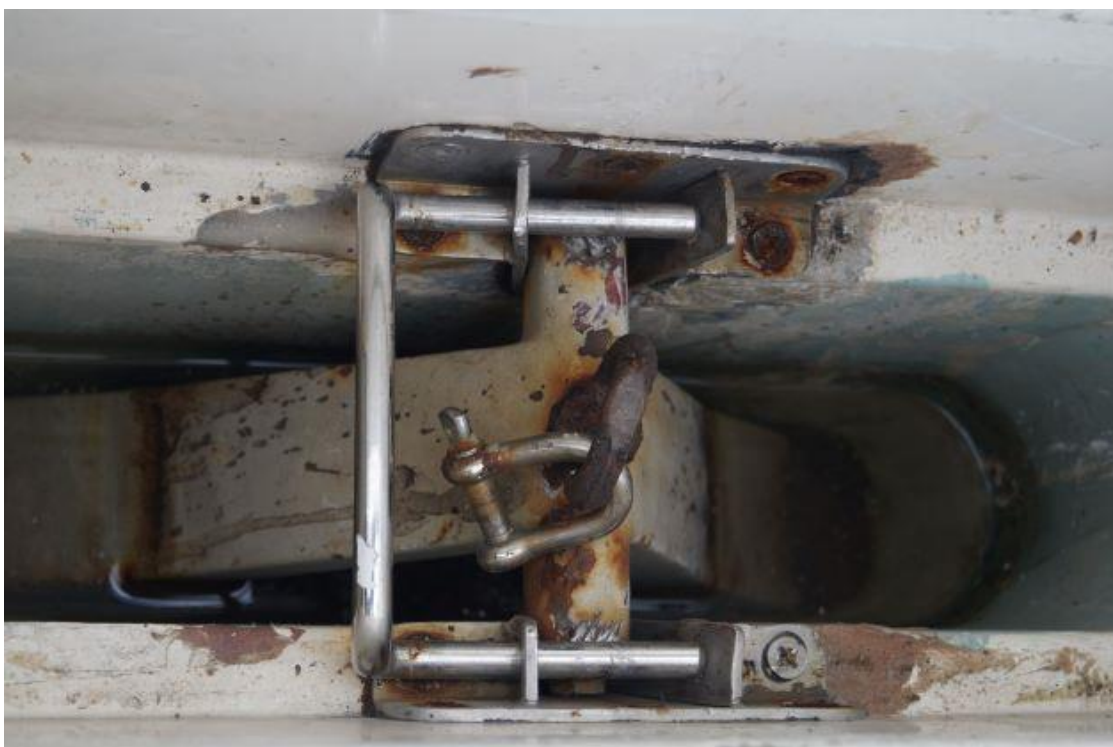
4. absence of a centreboard and absence of a cotter pin to prevent it from falling out. The lack of proper protection (full insertion of the cotter pin into all holes of the centerboard locking slot) was the direct cause of the loss, slipping out of the centerboard from the centerboard case. The visual inspection carried out on the twin yachts on the water to determine potential causes of the loss of the centerboard showed that on two of the

yachts the cotter pin was not inserted (retracted) into all the holes of the ballast locking sockets due to their non-linear alignment (bending). Several of the screws securing the ballast sockets were not stainless and deviated from the standard required to secure it. In the next two units, the cotter pins were unmovable with hammering signs.

Photo 9 – the holes in the centreboard locking seat are not aligned and do not allow the ballast fin to be properly secured.

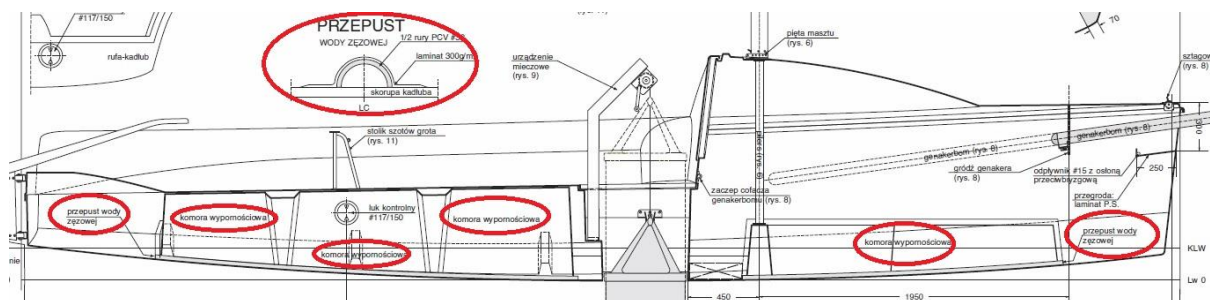
5. the bow buoyancy chamber was found to be completely flooded to the height of the unselected water from the yacht. This indicated that the chamber was not watertight. It is likely that the bilge water conduit through the chamber was delaminated.

Fig. 3 – location of buoyancy chambers and bilge water conduits

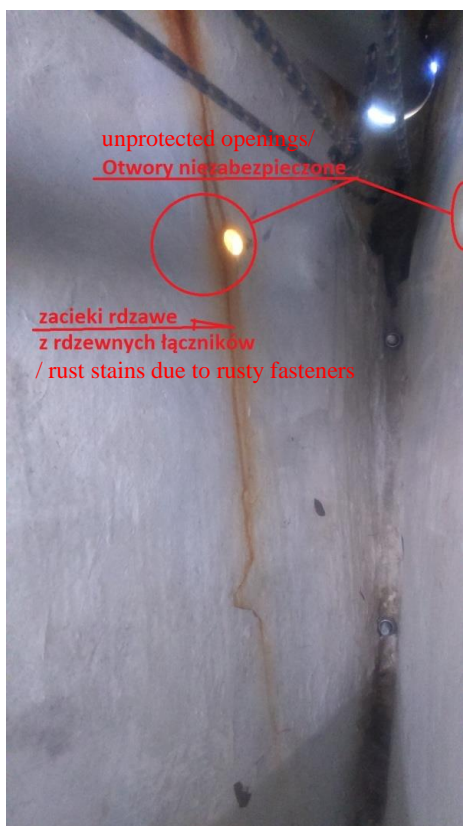
6. lack of a bow drain, which prevents water from entering the yacht through structural leaks in the passage of the gennakerboom pipe through the bow end.

Photo 10 – bow construction not compliant with the documentation

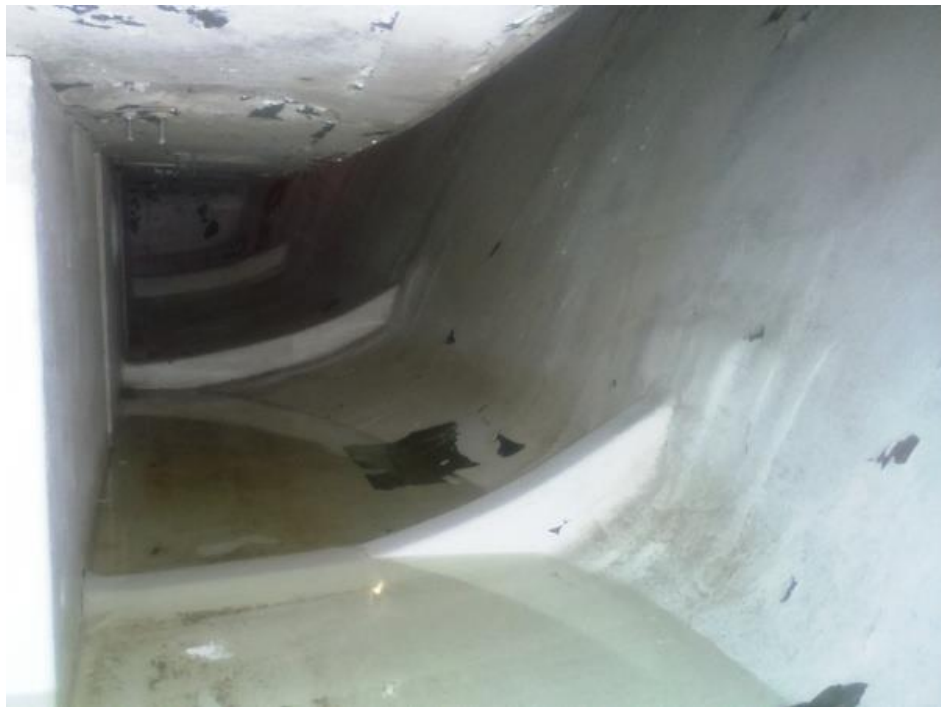
7. Neglected yacht interior with rust stains.

Photo 11 – condition of the yacht interior

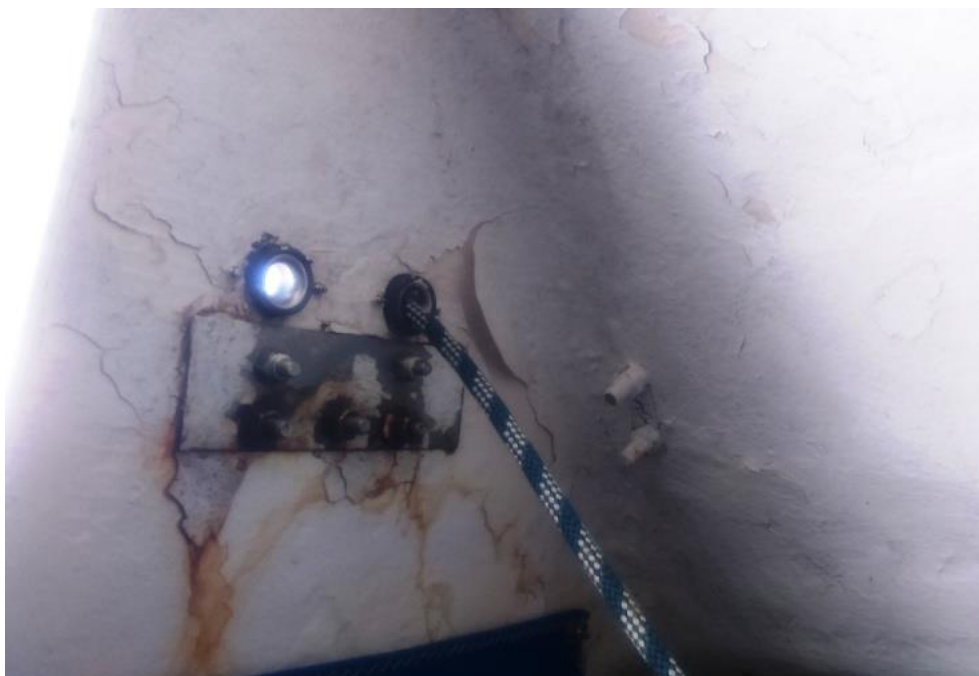
Photo 12 – rust stains due to the use of inappropriate materials

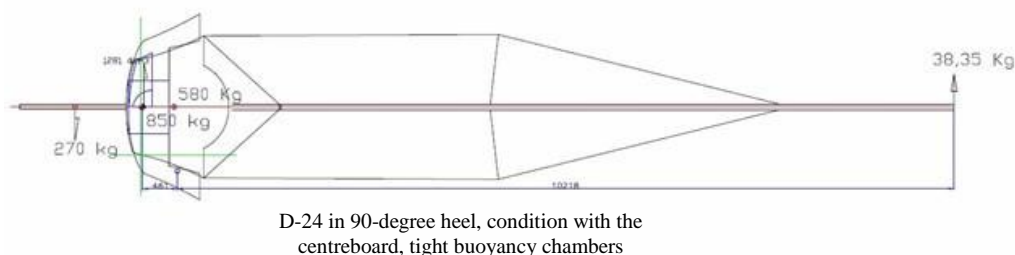
Fig. 5 – static stability in an undamaged condition

The yacht has good static stability.

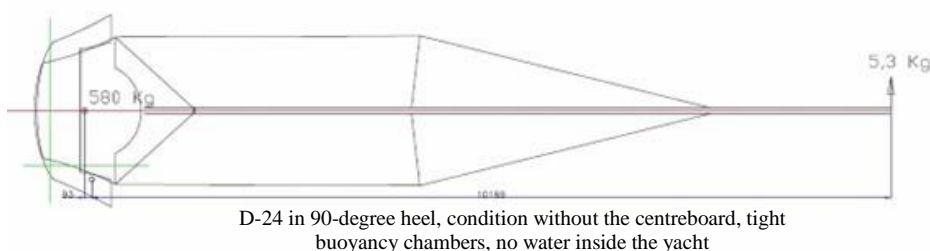
Fig. 6 – static stability in an undamaged condition

Static stability on the limit of turning the yacht upside down.

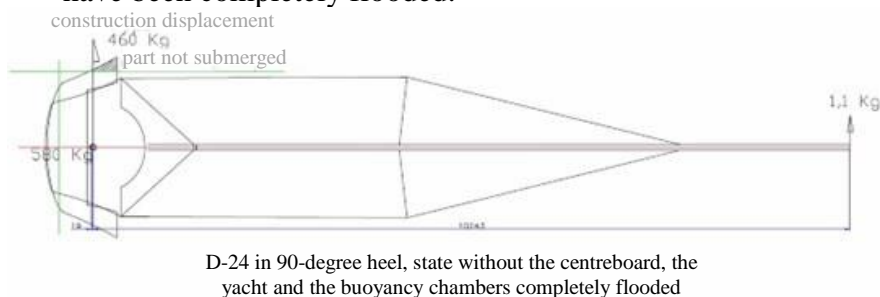
Fig. 7 – the yacht when completely flooded
