Marine Safety Investigation Report

into a man overboard from Star Peace on
23 October 2021

Date of Issue: 30 June 2023
Bahamas Maritime Authority
120 Old Broad Street
LONDON
EC2N 1AR
United Kingdom

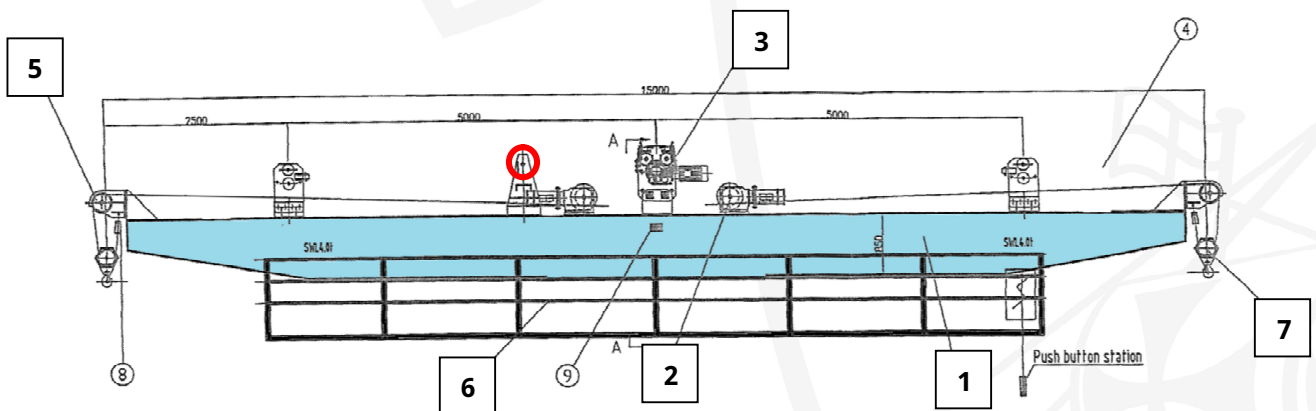
Schematic drawing of the provision crane, securing point ringed

The crane was constructed as a girder (1) with hoisting machinery (2) running a single wire fall through an upper block (5) to a travelling block (7) at either end of the girder. It was suspended from the ship's structure by a single I-beam fitted with a rack on the underside. The crane's travel machinery (3) drove a gear that engaged with the rack to move it athwartships. Underneath the girder was a service platform (6) to facilitate access.

The crane was operated using a hard-wired remote-control box, designed so that the operator could control the crane whilst stood on deck. When not in use the provision crane was secured by a locking pin that passed through a lug (ringed) and into the suspension beam. Additionally, the hooks were secured with wire strops to pad eyes welded on deck.

The provision crane had been secured for sea on departure from Rio Grande but the crane’s securing arrangements were not effective – the securing pin had no locking mechanism to prevent unintentional removal and the hoisting machinery were not designed to be used as securing devices.

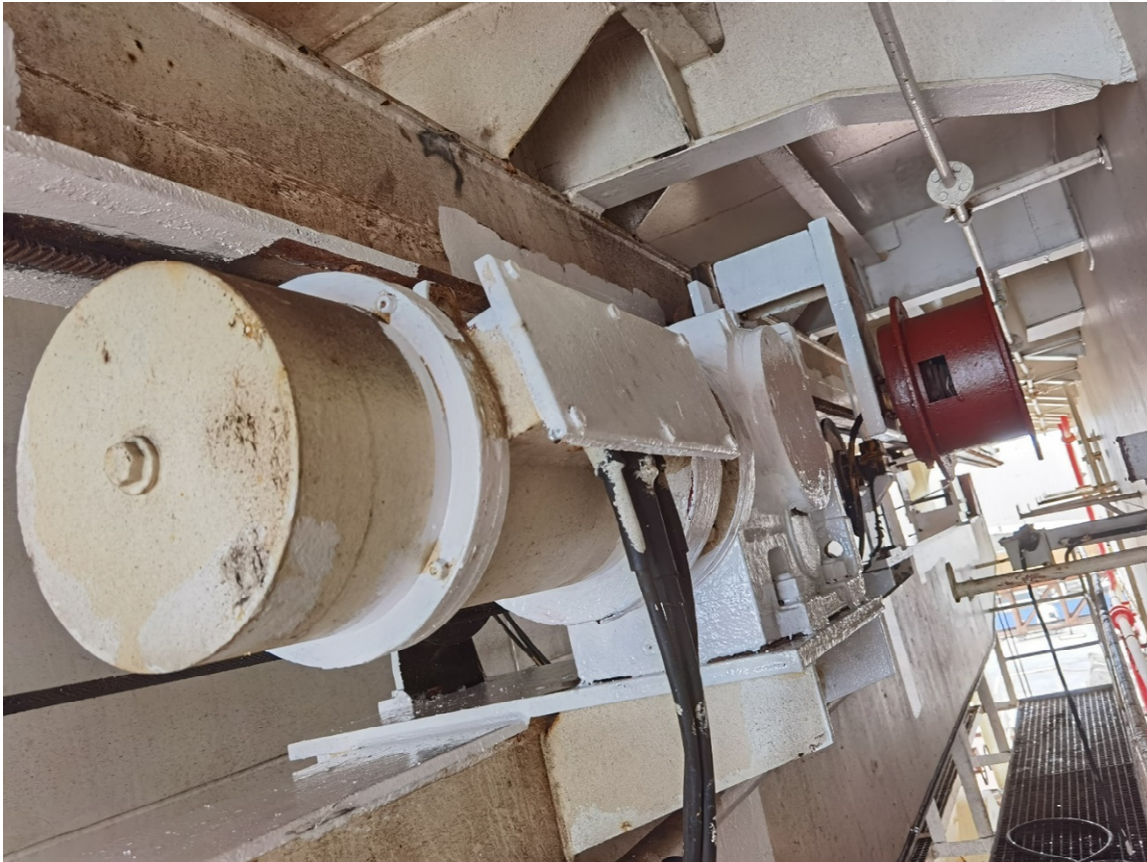
Provision crane machinery and suspension beam, taken from the service platform (forward side, pre-casualty)

The suspension beam was fitted with limit switches to stop the crane's travel machinery before overreach and end stops to prevent travel beyond operational limits.

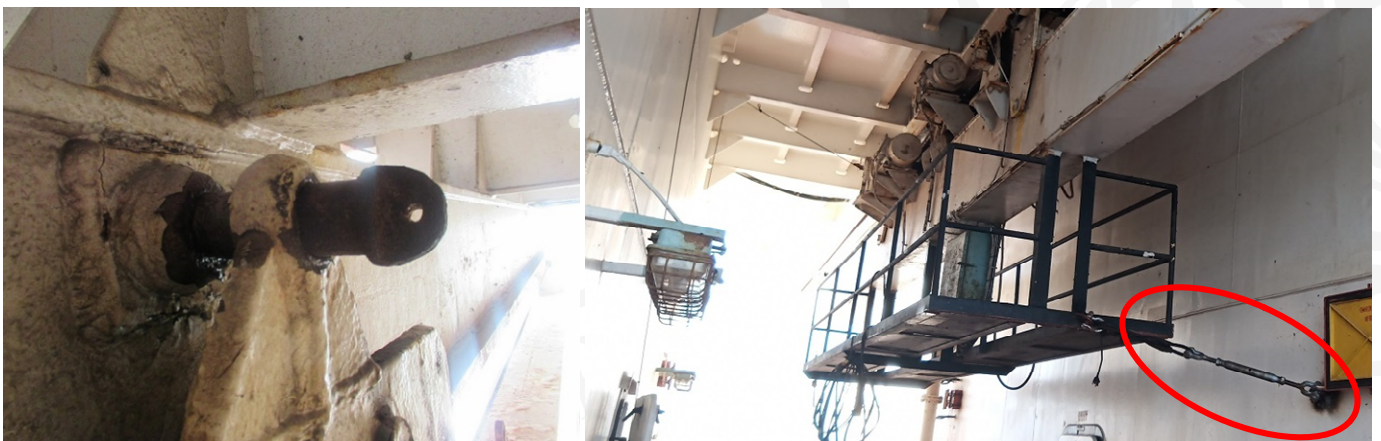
These limitations had been identified on a sistership and additional securing arrangements had been retrofitted. It is unclear whether there was a similar plan to add the same securing arrangement to Star Peace.

Sistership arrangement: securing pin (original design) and retrofitted securing arrangements (ringed)

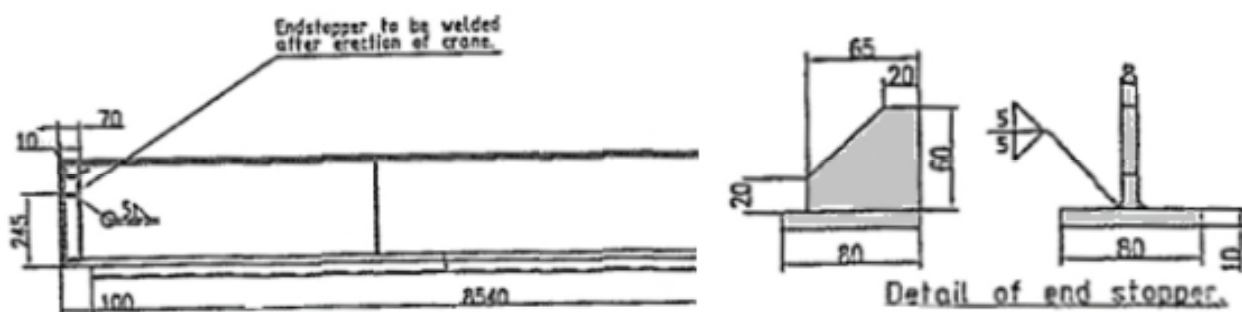
The end stops on Star Peace were constructed as 80mm x 80mm steel squares of 10mm thick steel, welded on the forward and aft faces, 70mm from the extreme end of the I-beam. The end stops did not incorporate any form of buffer to absorb energy of impact.

End stop design (text reads: “Endstopper to be welded after of erection of crane”)

Whilst the design of the stoppers do not appear to conform with rules requirements and (empirically) they were insufficiently strong to arrest the movement of the crane with significant momentum, the end stop on the aft face of the suspension beam was not as designed and had suffered a deflection (origin not confirmed). The end stop on forward face was found to be undamaged - indicating it did not engage with the crane when it passed its travel limit.

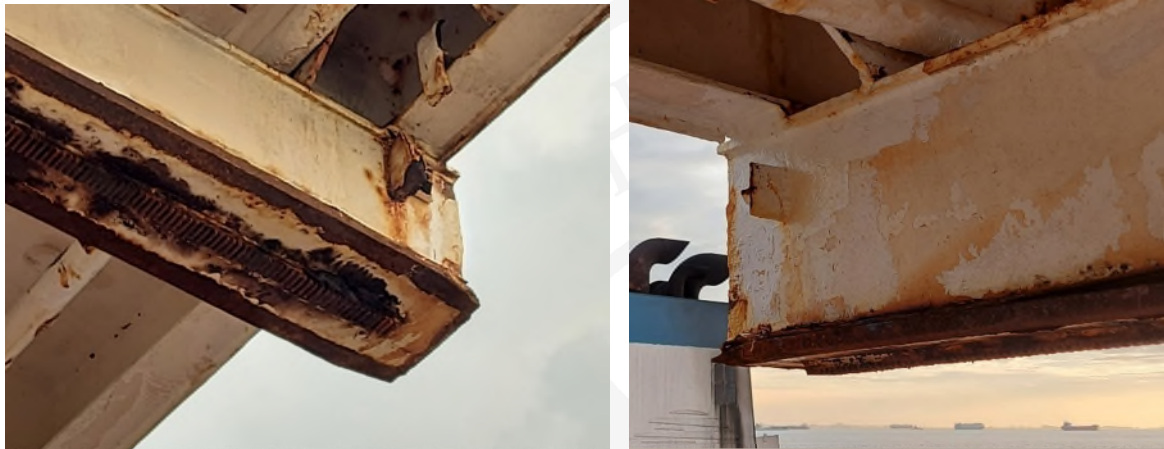
End stops - aft and forward sides, post-casualty

- The monorail end stops did not restrict the movement of the crane. Notwithstanding the limitations of their design, they did not effectively engage with the crane when it passed its travel limit.

- Adapted its classification rules, to clarify the requirement for weight-testing track-mounted cranes throughout their working range (i.e., to the end stops).
-
