STATE MARINE ACCIDENT
INVESTIGATION COMMISSION

FINAL REPORT

M/V Stena Nordica

Allision of the ferry 'Stena Nordica' with the chemical/oil products tanker 'Bull Kangean' at the Gdańsk Shiprepair Yard on 9 March 2023.

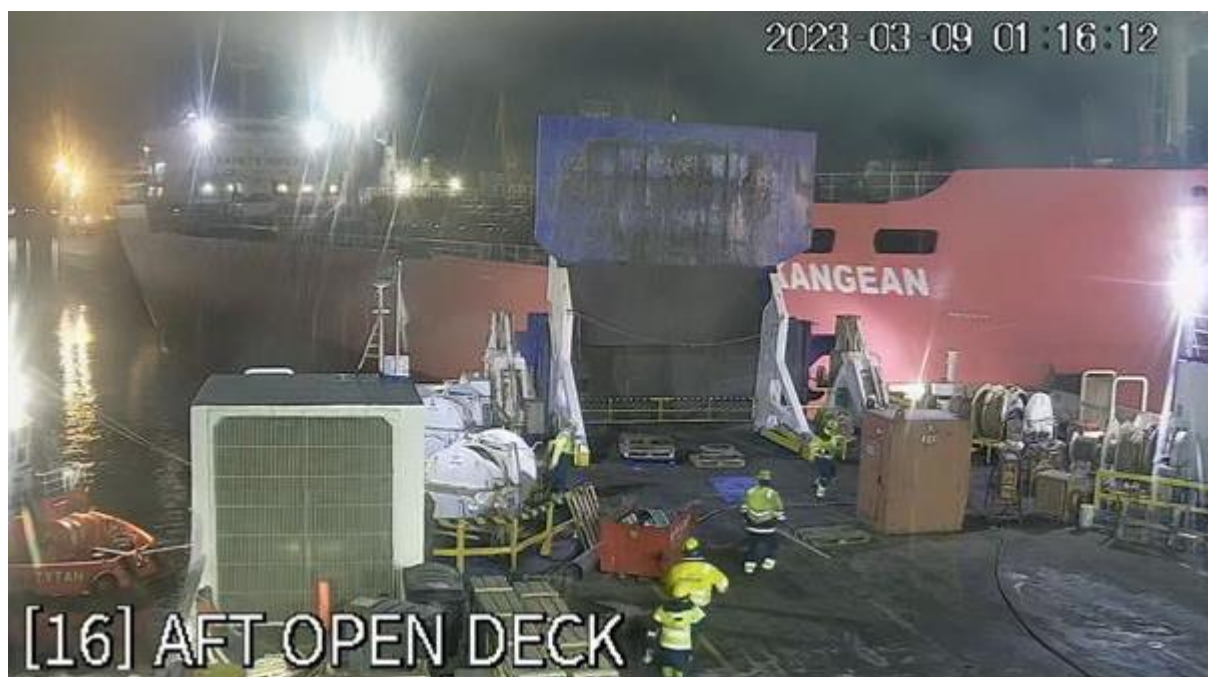
the starboard side. The aft corner of the ferry 'Stena Nordica' was reinforced so the damage to her plating was minor. As the collision occurred at a significant angular velocity the damage sustained by m/v 'Bull Kangean' included damage to the hull plating and damage to the hull reinforcements in two places:

- fwd tank (Fore Peak) about 8 m above the waterline under the starboard anchor and towards the stern from the stbd anchor⁸,
- ballast tank No. 15 approximately 1.5 m above the waterline⁹.

Photo 3 – Moment when the 'Stena Nordica' is hitting m/v 'Bull Kangean' based on the ferry's CCTV (the time on the camera does not reflect the time of the collision, tug 'Titan' is working hard on the starboard side)

⁸ Size of damaged shell plating 5m x 5m, according to captain's information.

⁹ Size of damaged shell plating 4m x 4m, according to captain's information.

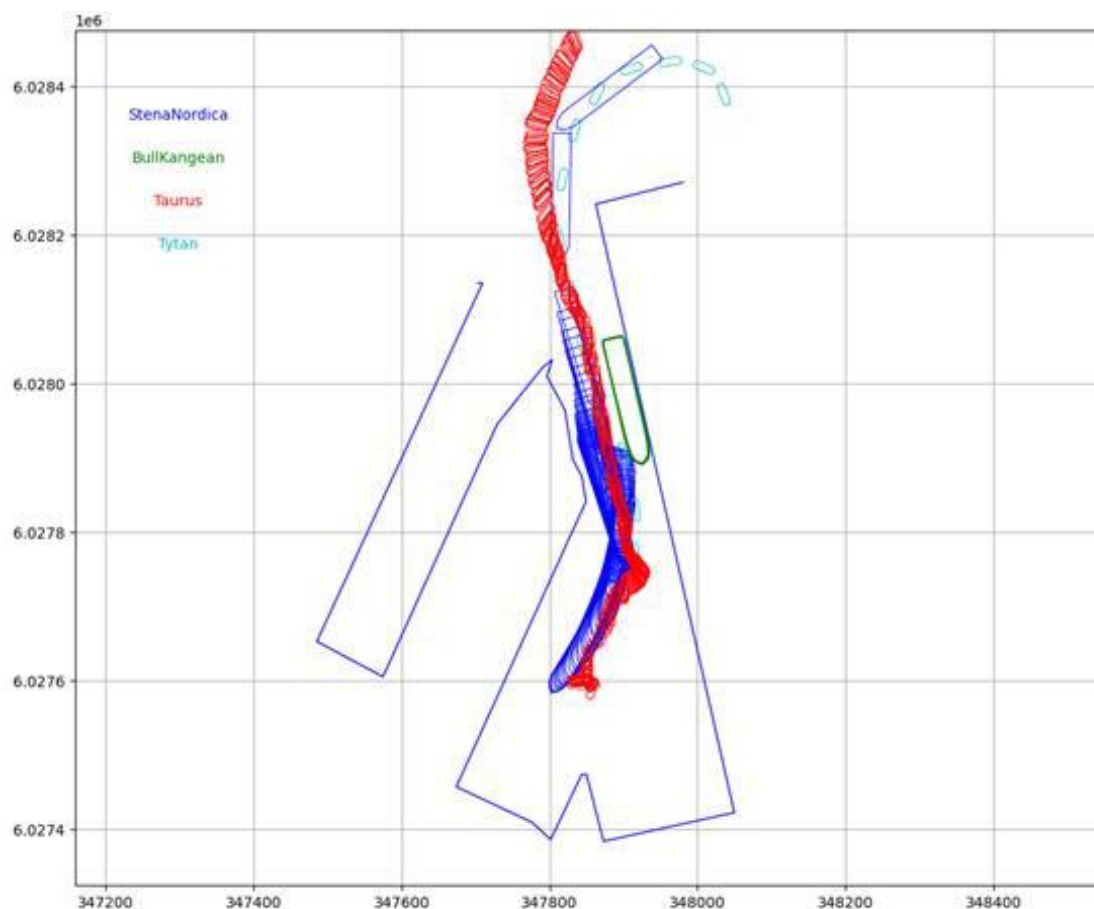
Figure 2 – Reconstruction of the SN towing set passage using combined AIS and VDR information of SN movement from 1:24:30 to 1:32:00 LT/SN (UTM system, grid every 200m).

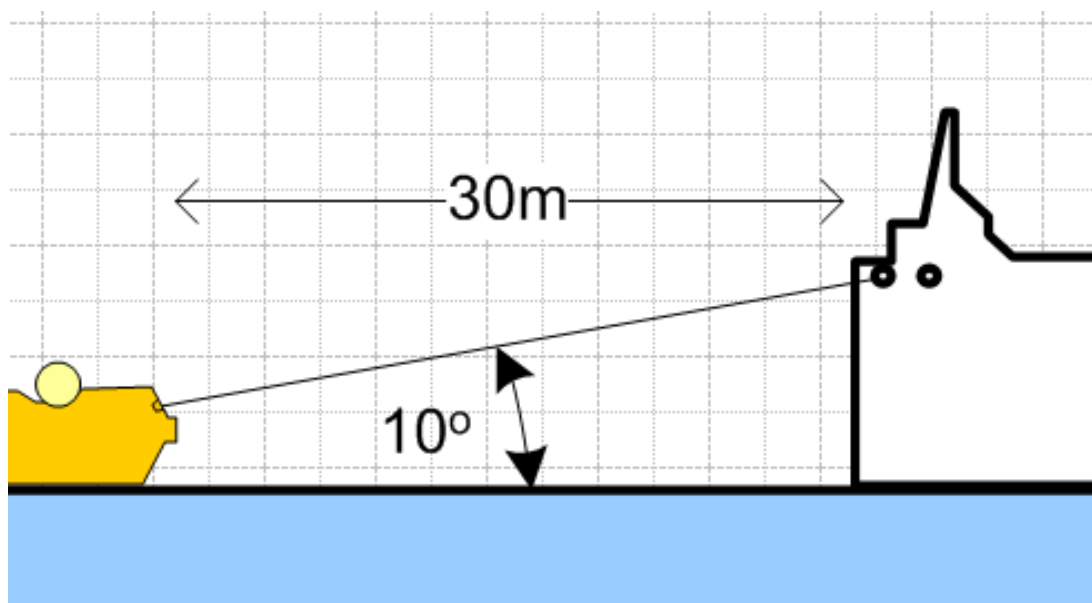
By analysing the vertical angles of the 'Titan' towing ropes and the length of the towing rope as determined by the AIS of approximately 30 m and knowing the heights of the fairleads above the waterline (SN approximately 10 m, Titan approximately 3 m), it is possible to determine the angle of view of the line (Figure 8). This was approximately 10 degrees which is an acceptable value. With the length of the towing rope shortened to a minimum, as the 'Taurus' had (<20m), the angle is still not great and is >15 degrees (Figure 4).

A big angle causes a distribution of unfavourable towing forces. In extreme cases, where the angle is very large (>30 degrees), due to the lifting force of the towing rope and the weight of the tug, the load on the line can increase significantly and the rope or ship bollard can exceed the load limits.

Figure 11 – Determination of towing rope angle for the 'Titan'.

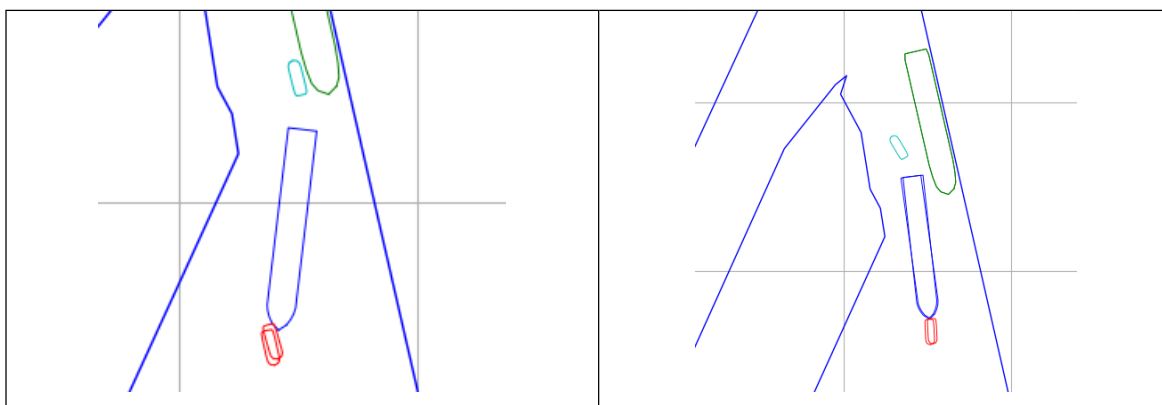
Based on AIS and VDR data, the length of the towing ropes was determined at 2 critical moments: 1) the collision, and 2) the strong drift towards the Hydrobudowa quay. These amounted to $L1 = 30$ m and $L2 = 29$ m (as projected onto the water surface) respectively. With the help of the CCTV camera, just before the moments of collision, the 'Titan' can be seen working at very high angles to the ship's direction of motion. However, assessing the length of the towing rope based only on the camera image may be illusory. For further analysis, it was assumed that the 'Titan' had a length of the towing rope of $L = 30$ m (as projected onto the water surface). The 'Taurus', on the other hand, based on the AIS, appears to be on a very short towing rope, i.e., shorter even than 20m (as projected onto the water surface). The waterline of the 'Taurus' practically touching the waterline of the 'Stena Nordica'.

*Figure 13 – Analysis of the towing ropes' lengths and the tugs' positions.
 On the left before the collision time 01:26:20 – 01:26:30.
 On the right from approximately 20 s to 35 s after the collision (waterline every 5 s.)*

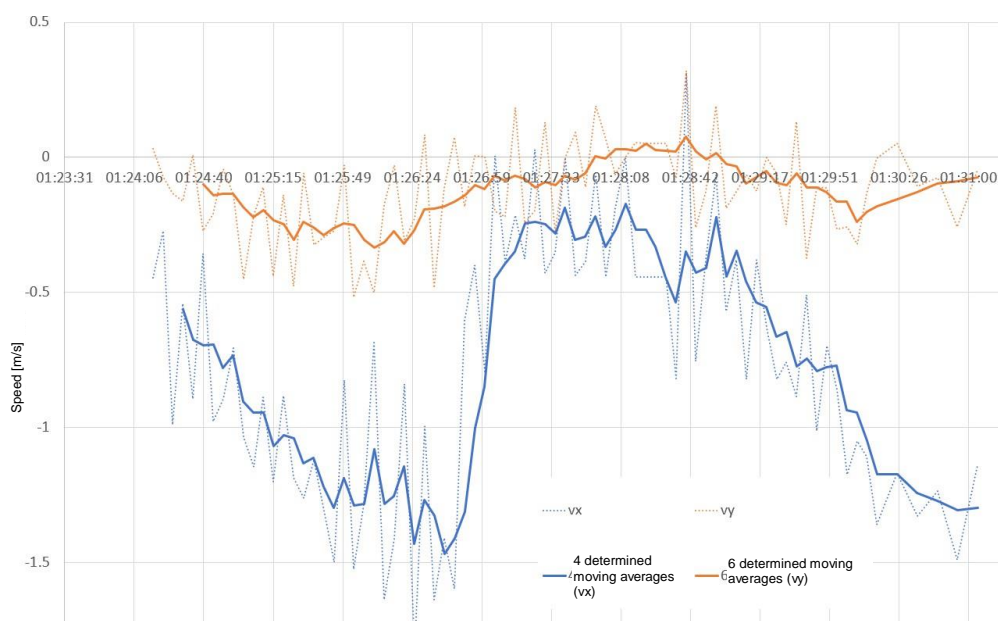
Figure 15 shows the longitudinal and transverse velocities of the ferry calculated from position differences (every 5 sec) determined with the VDR (DGPS ship position sequences were used). Moving averages were also determined to smooth the data. It can be seen that the ferry had a speed of about 3 knots at the critical moment, just before the accident.

Figure 15 – Longitudinal and transverse speed of the ferry over the bottom [m/s] based on VDR (LT time)

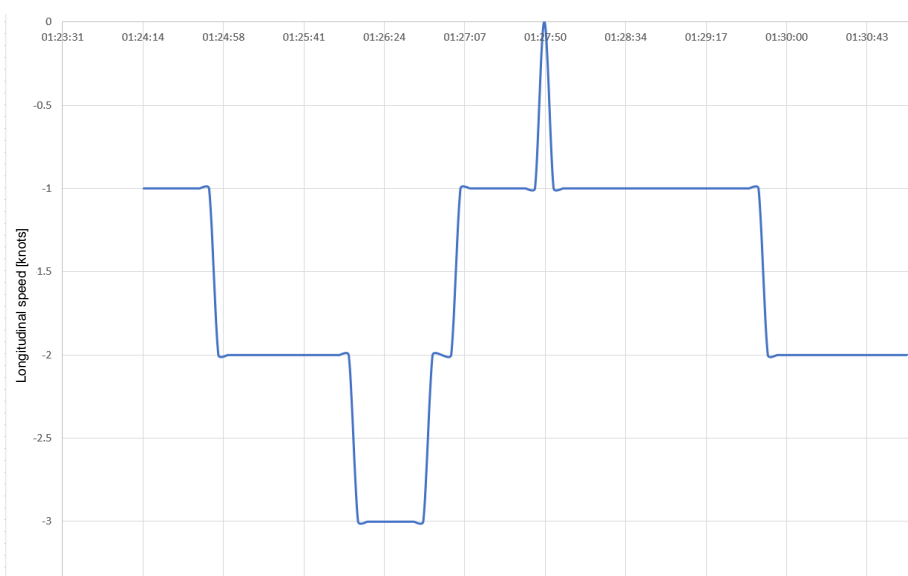
By analysing the ship's log record (it is not clear whether the speed indicated by the VDR is from the log – over water or from the GNSS – over the bottom) from the VDR, the ship's speeds over time were determined. It can be seen that they increase up to 3 knots and rapidly decrease after collision.

Figure 16 – Ferry longitudinal speed in knots based on log record from VDR (GMT time).

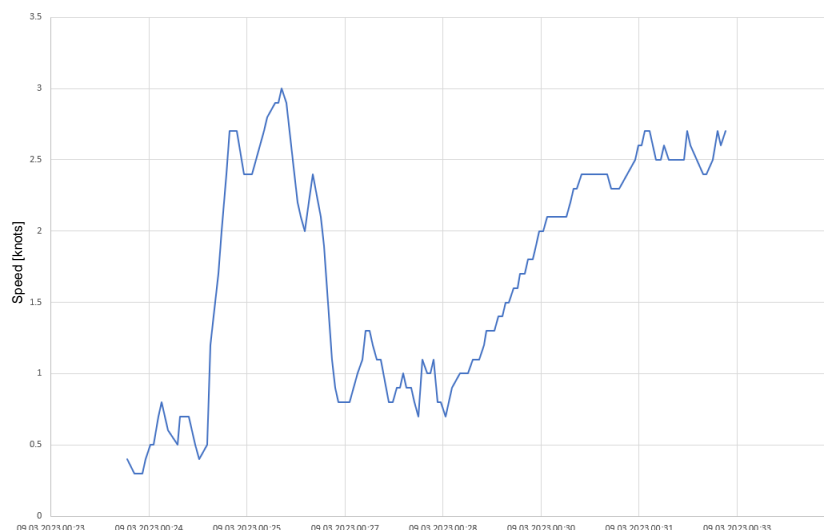
The speed of the 'Taurus' over the bottom as recorded by AIS-PL is shown on Figure 17. It was exactly 3 knots before collision.

Figure 17 – Speed over water of the tug 'Taurus' – AIS (GMT time)

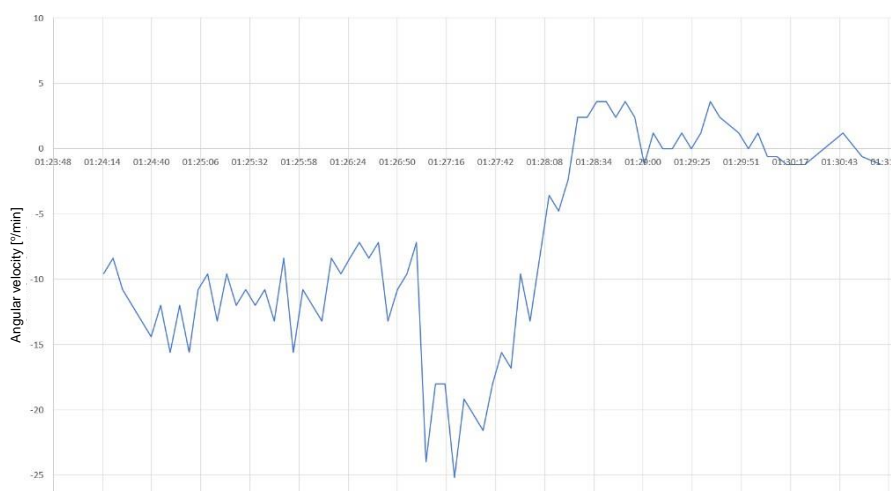
The changes in angular velocity based on the ship's gyro compass readings from the VDR are shown on Figure 18. The post-collision velocity increases rapidly due to the operation of the tug 'Titan'.

Figure 18 – Changes in angular velocity of the 'Stena Nordica' over time based on the readings from the gyrocompass.

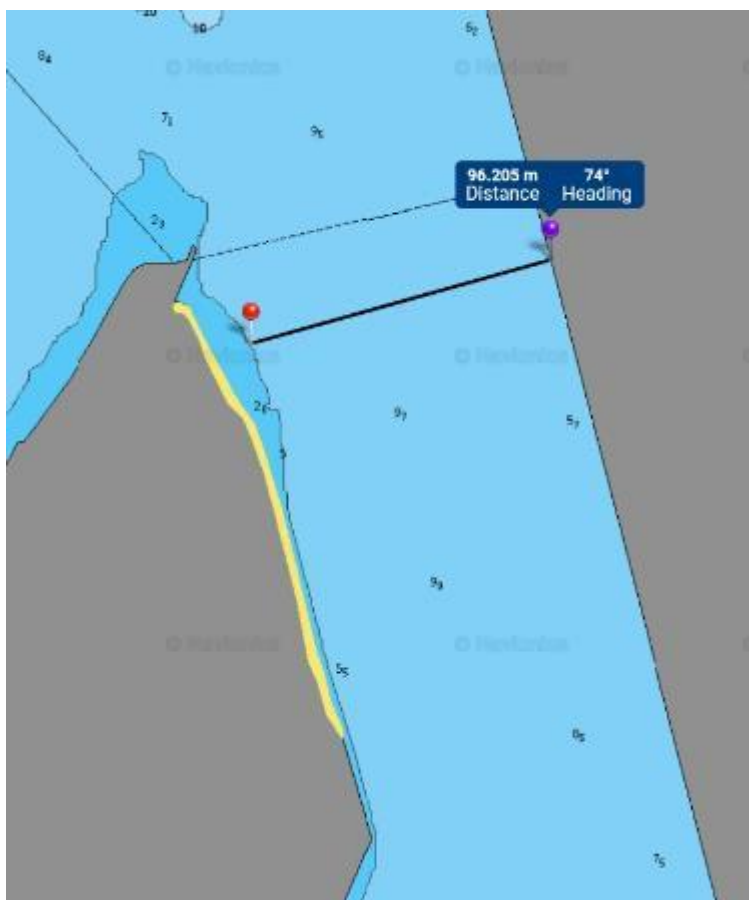
1. there may be stones on the seabed in the area of the whole Hydrobudowa quay for shore protection,
2. remaining of the quay slabs in the middle area of the Hydrobudowa quay, partially submerged, fall into the water,
3. in the water, on satellite images (www.geoportal.pl), the remains of the quay walls can be seen below surface.

Figure 20 – Bathymetric situation of the accident area, marked isobath $H=5$ m (Navionix/Garmin chart)(Navionics/Garmin navigation chart accessed via www.navionics.com on 14.09.2023)

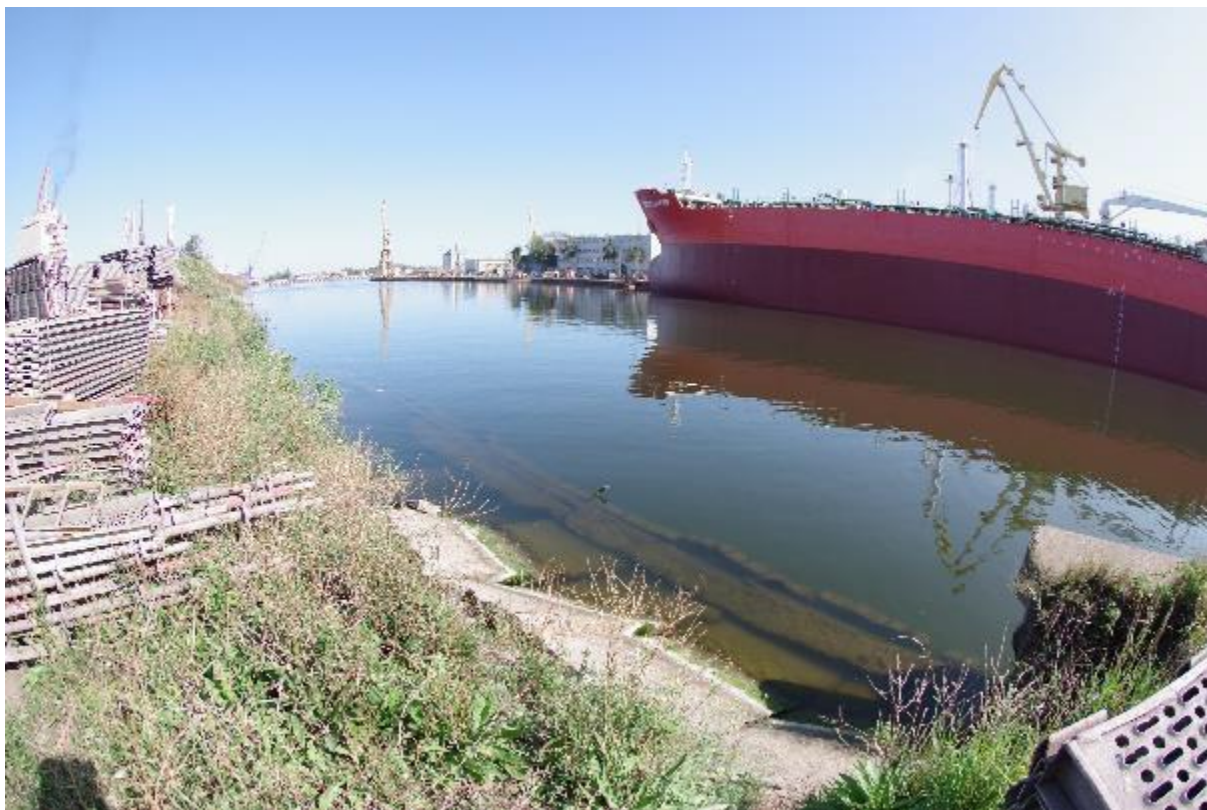
The Hydrobudowa quay is not used for mooring ships at it and is in a state of advanced and progressive destruction. It is endangering navigation by uncontrolled sliding of its elements into the Ostrawica I channel. The stones used for temporary protection of the quay endanger the propulsion systems of tugboats and the hulls of ships.

Photo 9 – View of the Hydrobudowa quay showing elements of uncontrolled sliding of concrete elements into the channel current.

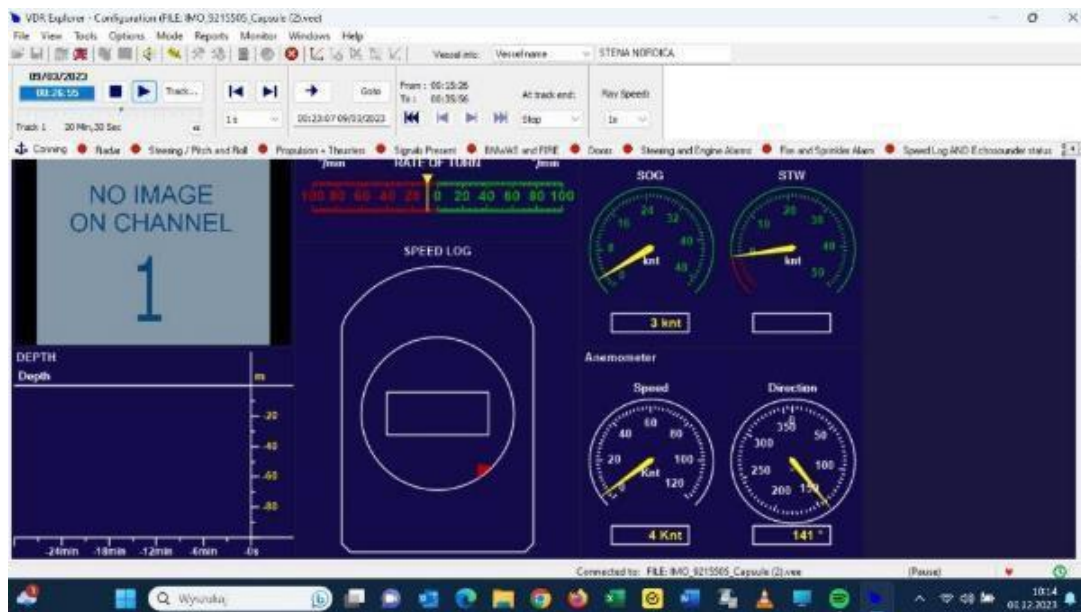
1. Failure to control the speed of the towing set and increasing its speed up to 3 knots.

Photo 10 – Speed of the ship 'Stena Nordica' as read from the VDR recording at the time of collision.
