## SAFETY INVESTIGATION REPORT

REPORT NO.: 13/2024

### **MV *Drawsko*** **Fatality of a crew member on deck** **while rigging a portable cargo hold light** **at Iskenderun, Türkiye,** **on 08 September 2023**

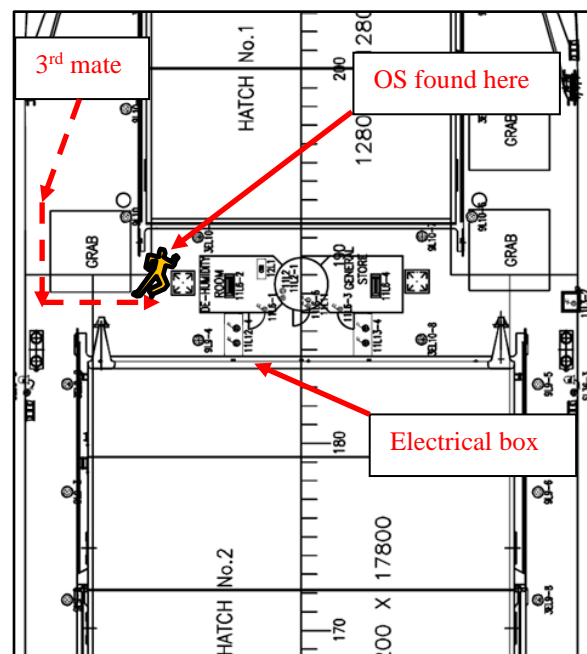
**Figure 1: Plan view of accident site**

At about 2215, the third officer walked back towards the accommodation ladder, to find out why the portable lights had not yet been rigged. When abreast of the cross deck between cargo holds nos. 1 and 2 (**Figures 1 and 2**), he noticed the OS collapsed on deck, with the steel frame of a portable light clutched in his hands. He observed that the portable light was not illuminated.

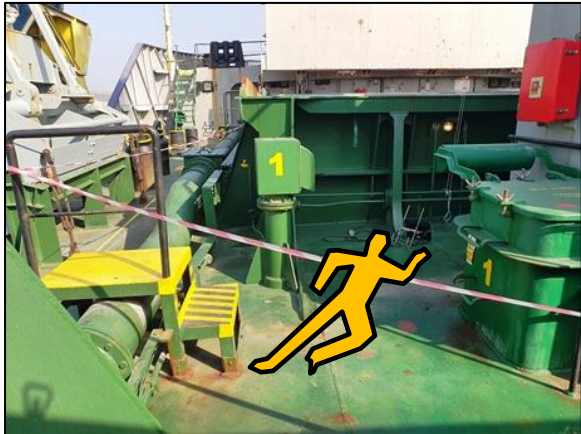
**Figure 2: Location of the OS, when discovered**  
(indicated position is for illustration purposes only)

The third officer immediately called the bosun for assistance, on the portable radio, and disconnected the portable light's plug from the socket. The master, who was awake, overheard this conversation and alerted the chief and second officers to proceed to the accident site.

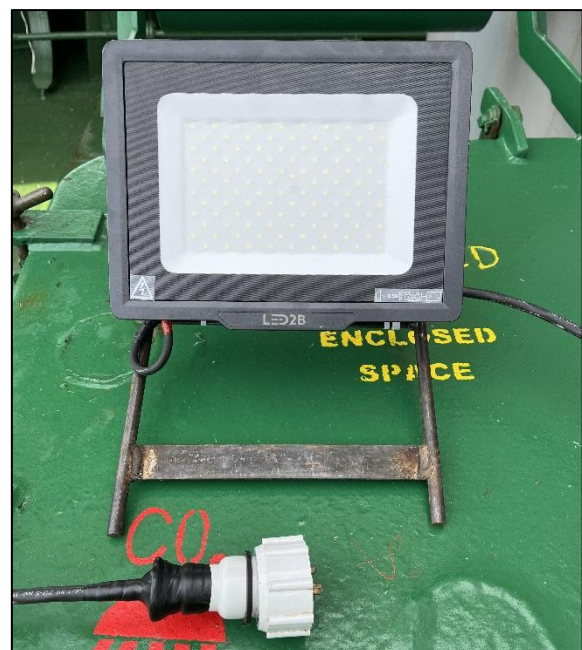
**Figure 3: A portable cargo hold light used on board**

The vessel was using several other lights, of the same make and model (**Figure 3**).

Each portable light was secured to a metal frame so that it could be easily hooked on a cargo hatch coaming. They were LED lights, rated at 100 W and operated on 230 V. Each portable light could produce 8500 LM and had an ingress protection (IP) rating of 65<sup>4</sup>.

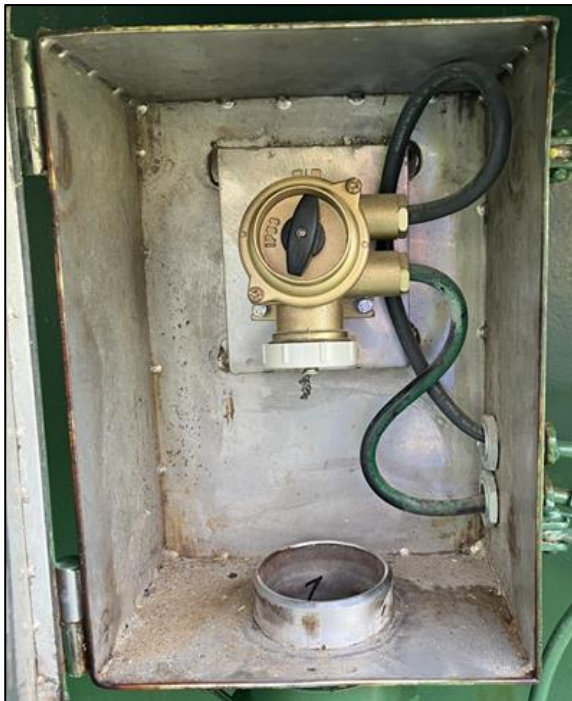
**Figure 4: Electrical box containing the socket**

The plug was inserted in a socket that was rated at IP56 and protected from the elements by a weathertight casing fitted on the cargo hatch coaming (**Figure 4**). The switch had two on / off positions, which meant it could be turned either side to either switch on or off.

The Company informed the safety investigation that the vessel had inspected the socket to which the plug was connected and could not find any fault in the connections. The circuits for the light sockets were not fitted with a residual current circuit breaker (RCCB) but had a main circuit breaker (MCB) which, according to the information provided by the crew members, had not tripped. Furthermore, the vessel's earth system had not alarmed when the accident took place.

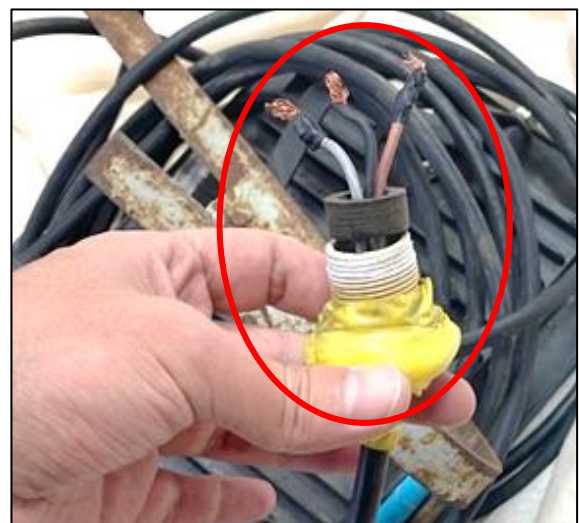
**Figure 5: The dismantled plug and wires**

Following confirmation by the relevant authorities of the coastal State that the cable was wired incorrectly, the safety investigation spent significant time analysing the matter. The colours of the wires inside the sheathed cable were brown, black, and grey (**Figure 5**).

It was reported that the portable light's earth terminal was connected to a live wire rather than grounded. However, the possible explanation for that to happen was less clear and perhaps more intricate. Although the safety investigation did not have information from where the cable had been procured (and when), the matter was considered in detail.

It was not excluded that the use of this cable with wire insulation coloured brown, black and grey may have directly contributed to the incorrect wiring of the live wire into the earth terminal<sup>9</sup>.

Although the hypotheses of opening the plug for whatever reason has been mentioned in the previous section of this safety investigation report, and **Figure 5** showed black insulation tape on the three wires, it was not possible for the MSIU to determine when the insulation tape had been applied, and by whom. Moreover, there was no information to indicate whether any other tools had been found on site<sup>10</sup>.

- Training on commitment to safety, work planning, risk assessment and scope of duties has been offered on board;
- The operation and conditions of the cable and casing, insulation and earthing have been incorporated in the planned maintenance system on all vessels within the fleet;
- All Company vessels have been directed to check the condition of all the portable floodlights' condition and tightness of the cable connections. Vessels were also instructed to withdraw from service any floodlights which were not satisfactory and to discuss the outcome at the first safety meeting on board;
- An electrical installation inspection was carried out by the ETO (no malfunction detected);
- The Company's SMS manuals have been updated to include the maintenance of the portable floodlights;
- A Company Safety Flash has been prepared and distributed among the Company's fleet.
