Investigation report / Relatório de investigação

Mv EF Ava, IMO 9389306 REGISTRY - GAMA 2019-012

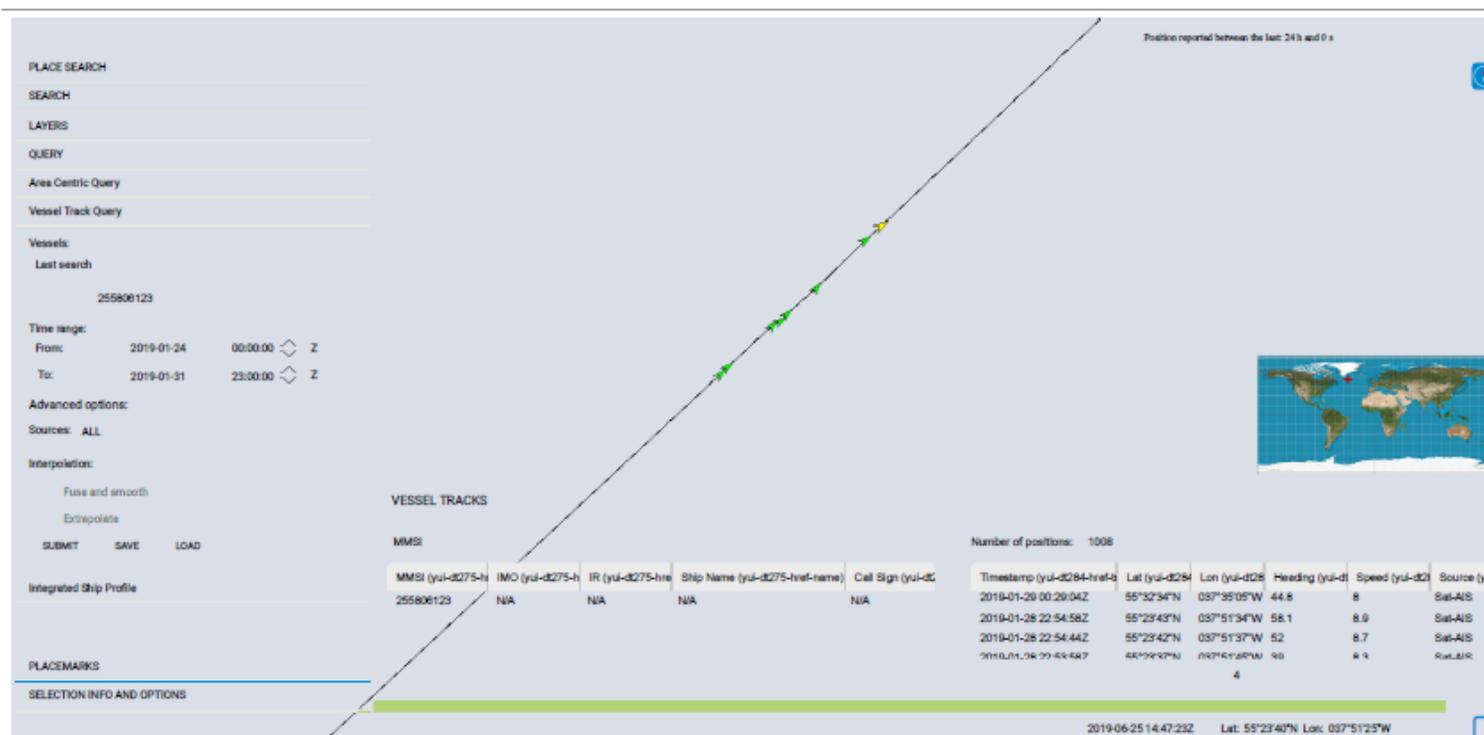
Figure 4 – Detail of the voyage record from the time of the accident

The accident occurred at 23:00 hours, the AB was standing by the steering wheel holding the safety grab rails when the ship rolled heavily, about 30° and seemingly fell into resonance – there were a series of

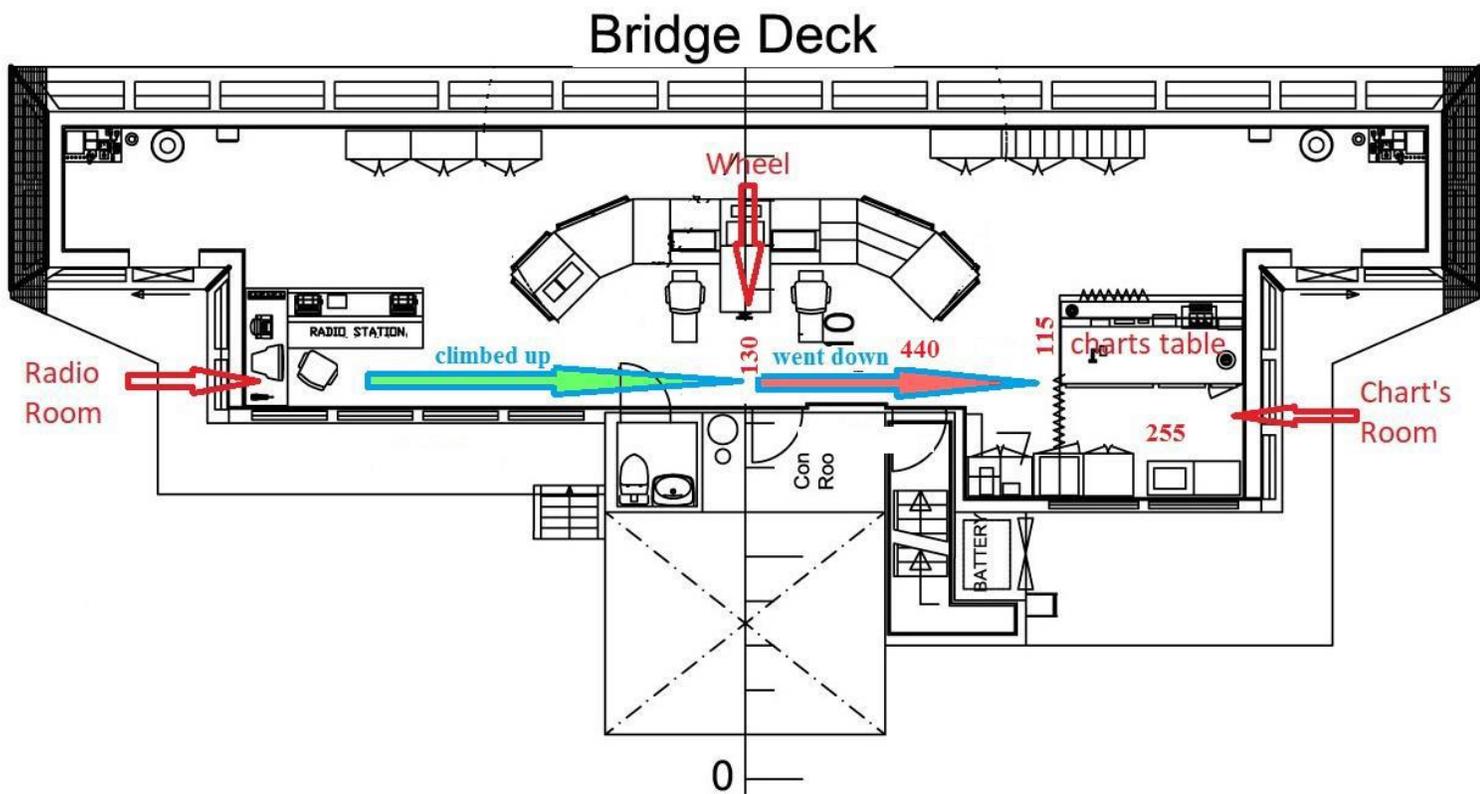
Figure 5 – Mv EF Ava bridge layout

The layout of the bridge is an important part in the sequence of events leading up to the accident. There are no safety grab rails on the bulkhead behind the centre console (figure below) but there are safety grab rails on the steering console.

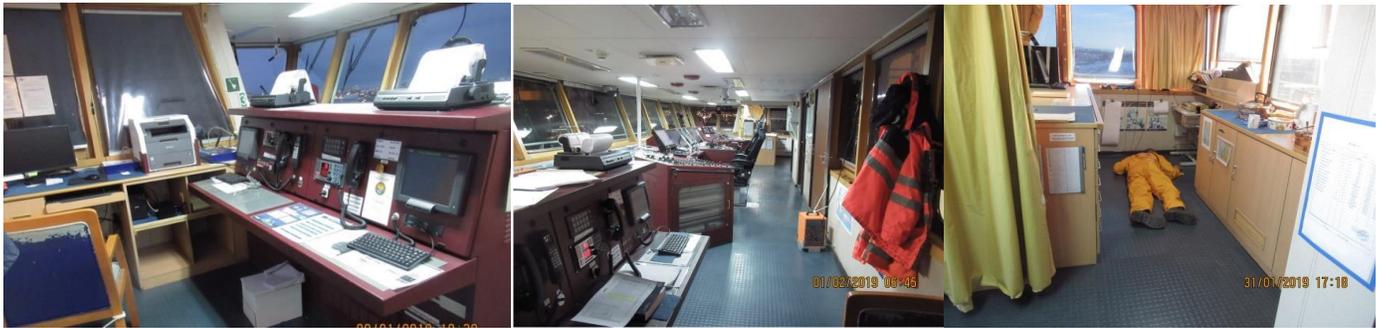
Figure 6 – Radio room, view to the chart room and simulated position of the Master in the chartroom

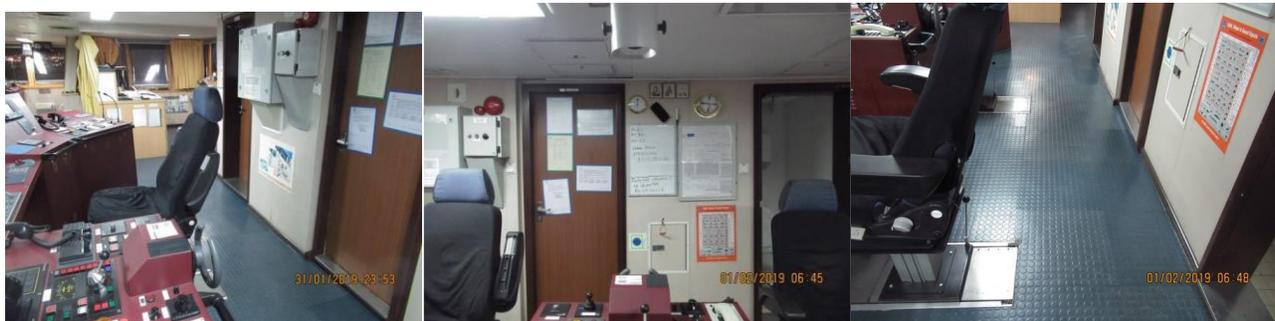
The Master was holding a cup of coffee in his right hand. He could only use the safety grab rails on his left side, and he could also grab the chair.

Figure 7 – Middle of the bridge, where the Master most probably lost his balance (No obstructions on the deck)

Following this accident, the Company issued a Circular to all vessels to be reminded of the dangers associated with synchronous and parametric rolling and decided to review and update the Working on Deck in heavy Weather Company bulletin in order to include general safety information in heavy weather.

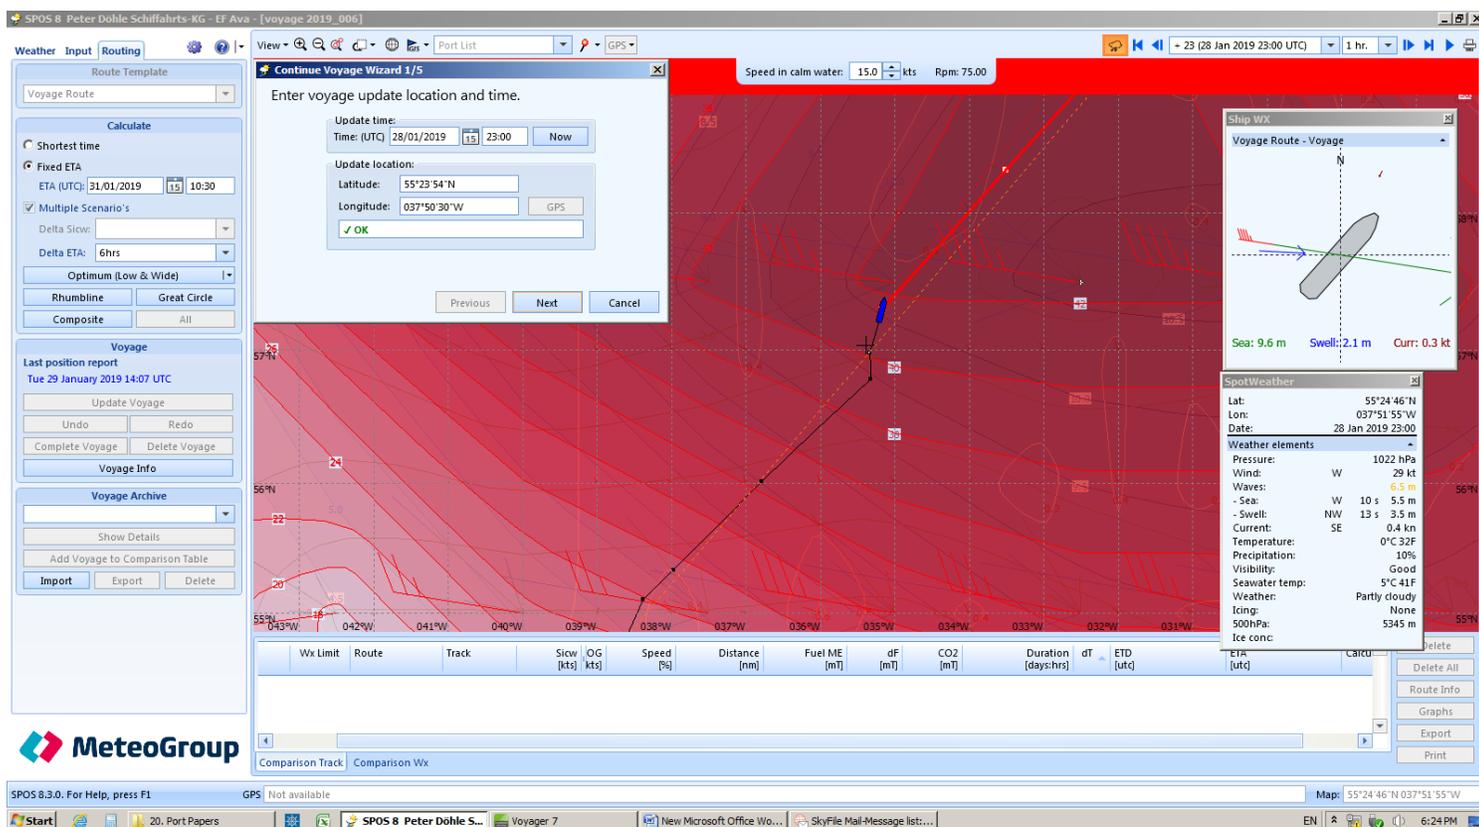
Figure 8 – Passage detail

The vessel was under heavy sea and swell, running with strong wind. The wave heights were estimated to be between six and seven meters, running just abaft the beam, causing the ship to roll heavily. At the time of the occurrence the ship was experiencing synchronous rolling, which may occur when the natural rolling period of a ship coincides with the encounter of the wave period. The solution to avoid synchronous rolling is to alter either the ship's course or speed to change the encounter wave period.

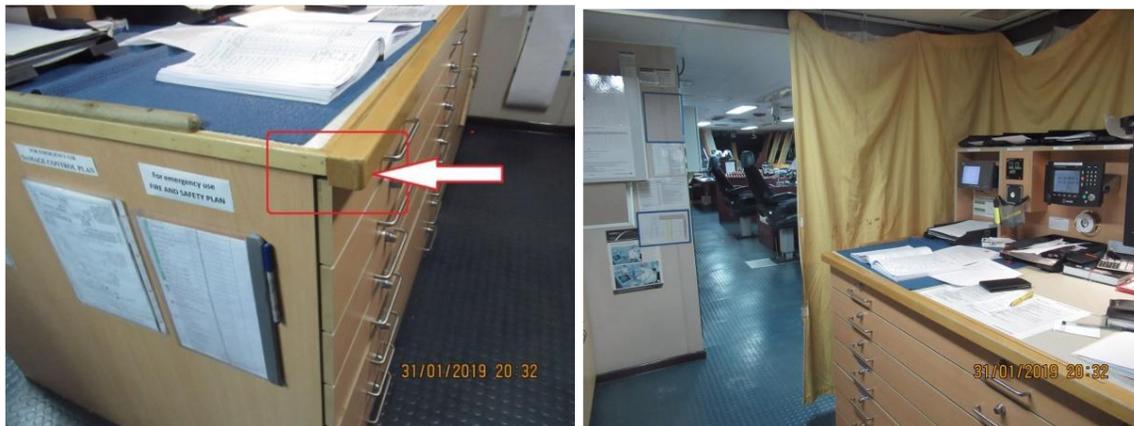
Considering the vessel was experiencing synchronous rolling, the most probably reason why the Master stood up from his chair in the radio room was that he intended to alter the ship's course.

Figure 9 – Place where the Mater sustained the head injury

The fact that the Master had to stand up from the Radio Room chair to, probably, perform a course change instead of requesting to the AB who was already at the centre console holding the safety rail is identified as a contributing factor.

Standing up - after being seated for a period, holding a cup of coffee in his right hand- under severe rolling without consider the possibility of losing balance was identified as a contributing factor.
