STATE MARINE ACCIDENT
INVESTIGATION COMMISSION

SIMPLIFIED REPORT

Tugboat VIRTUS Vessel BOMAR VICTORY

collision of a tugboat with a vessel
in the fairway to DTC in Gdańsk
on 24 June 2015.

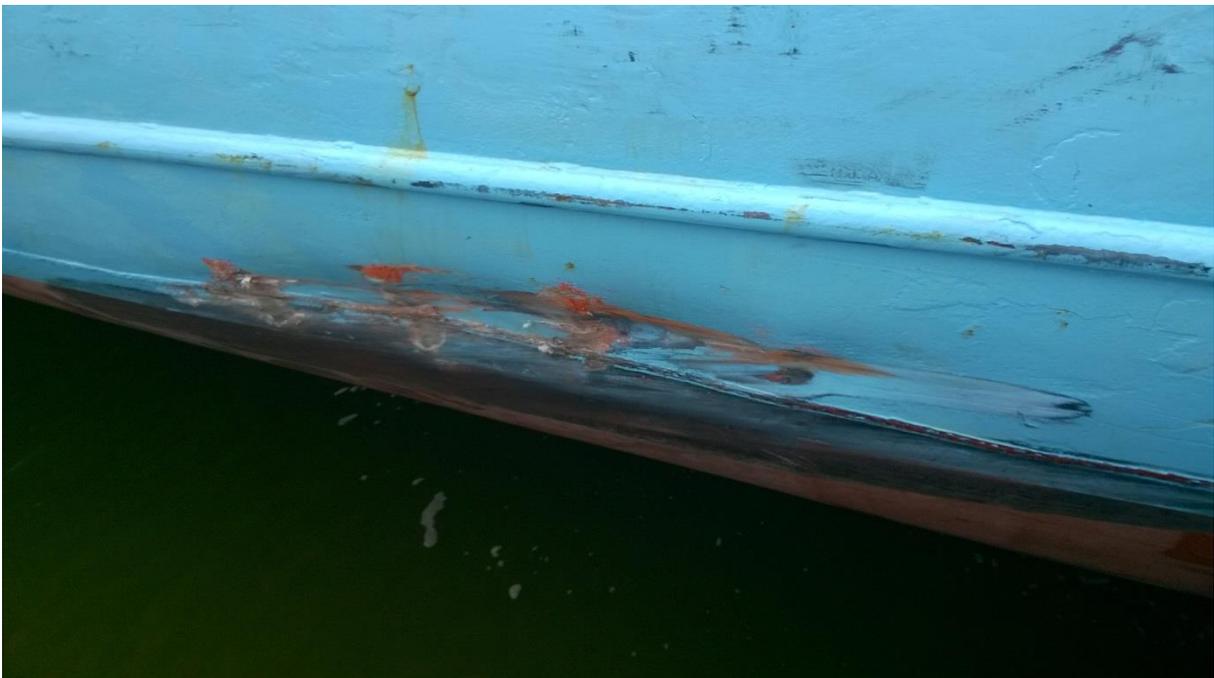
At 08:56 the stern of the tugboat came into contact with the starboard side of the vessel. The impact caused the indentation of the plating of *Bomar Victory* at the place where the bilge plate of the stern starts.

Photograph 3: Indentation of the plating of 'Bomar Victory' in the place of contact with 'Virtus'

At 08:56:33 the stern of the tugboat made a contact with the starboard side of the vessel (Annex 2b). As a result, the plating of the vessel’s side became indented at the point where the bilge plate of the stern starts.

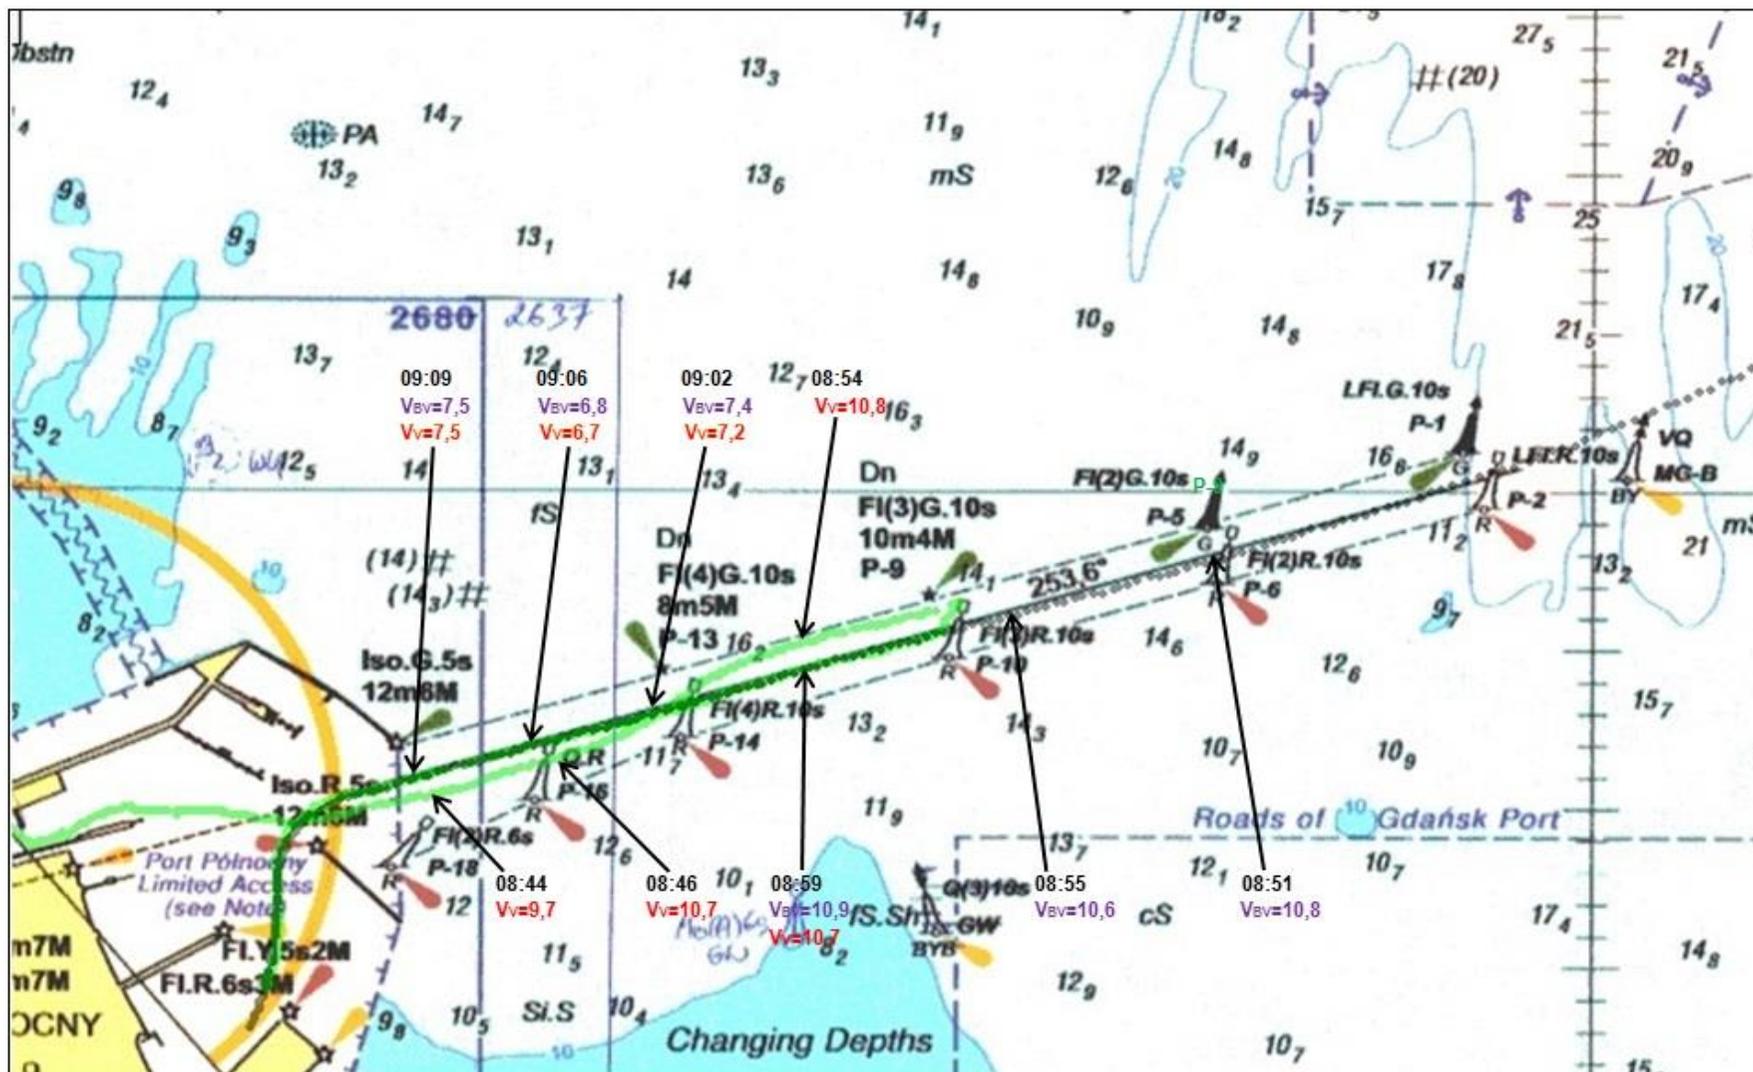
Figure 1: The track of movement of the vessel and the tugboat with time and speed markers

The *Bomar Victory* with the pilot on board had passed the first pair of buoys (“P1” and “P2”) in the DCT fairway at a speed of 14 knots¹. After reducing the speed to about 10.5 knots, she passed with this speed two next pairs of buoys “P5” and “P6” and “P9” and “P10”. At the time when the tugboat *Virtus* was approaching the vessel, she was navigating at a speed of 10.4 knots staying at the COG of 254.8°, about one degree more than the course indicated by the leading marks.

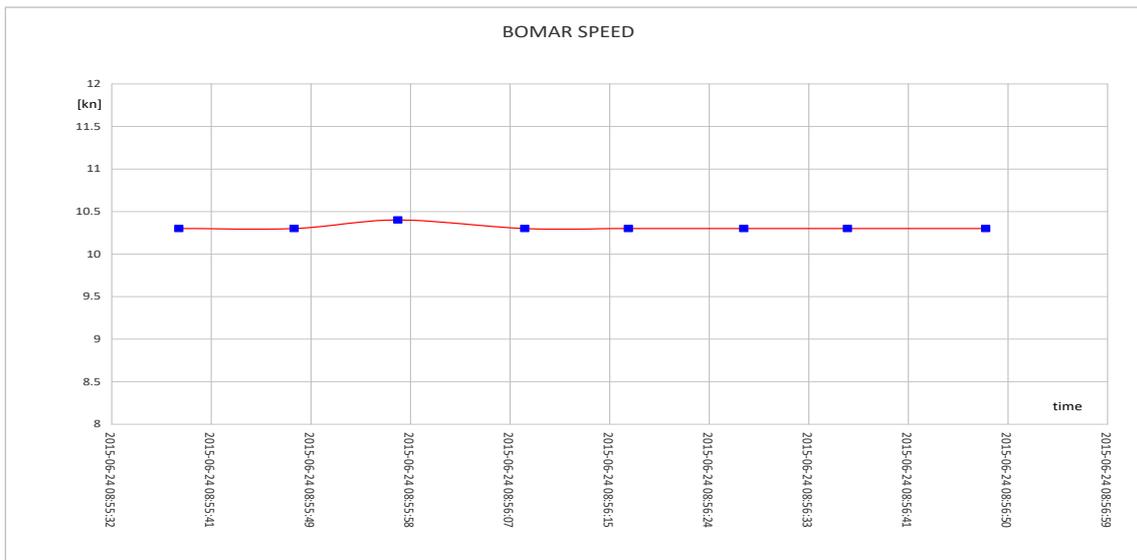
Figure 2: The speed diagram of ‘Bomar Victory’

¹ *Bomar Victory* exceeded twice the speed permissible in that place, which at the roadstead of the Port of Gdańsk is 7 knots (Par. 101, subparagraph 1, point 1 of the Order No. 5 of the Director of the Maritime Office in Gdynia of 20 February 2013 Port Regulations (Official Journal of the District of Pomerania, item 1314).

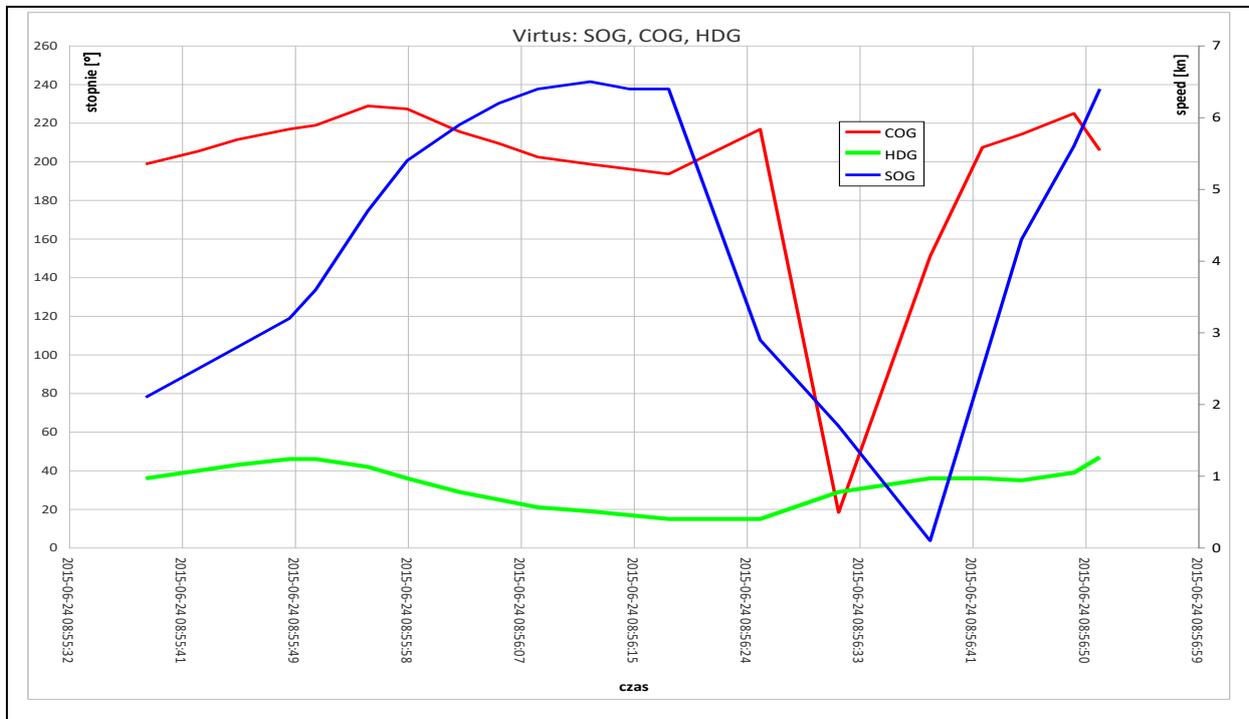
Another parameter of the decoded AIS recording – the course over ground (COG – red line), followed by the tugboat⁴ shows that after hitting the hull of the vessel there was a rapid change of the direction of movement of the tugboat – from 220° to 020°.

Figure 4: Global diagram of SOG, HDG and COG of Virtus

Such a rapid change was the result of “bouncing back” of the tugboat off the hull of *Bomar Victory*. The lack of obvious change in the heading (HDG – green line) indicated by the tugboat’s gyrocompass confirms that she has remained on the previously taken approach and only for a moment – just after bouncing back off the vessel – it was found on the counter-course (when losing speed) and then continued entering into the wake of the vessel which passed by.

It results from the analysis of the global diagram of SOG, HDG and COG of the tugboat (Figure 5), that the changes in the parameters of its movement (speed and course) were the result of the forces resulting from the operation of the tugboat (maneuvers performed by the tugboat skipper) and the contact with the hull of the vessel. Significant change of navigation parameters occurred almost at the same time (the difference of 8 seconds).

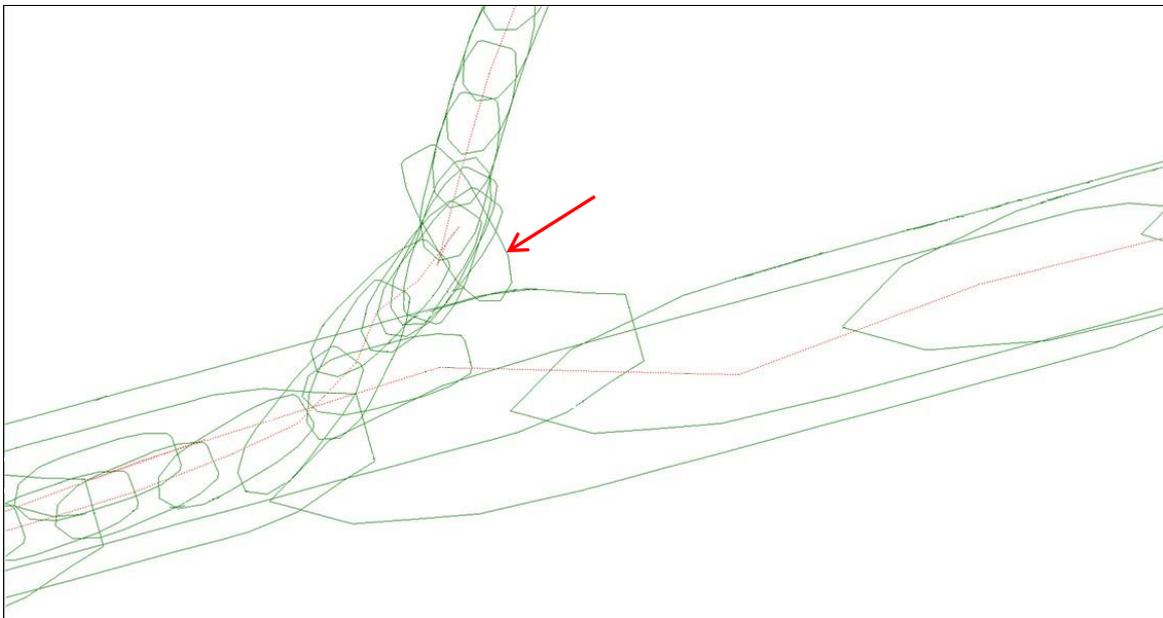
The tugboat approaching the midship by the converging or almost parallel course with the intention of being overtaken by the vessel to stay behind it, is subjected to the vessel's attracting forces and at the moment of passing from the reduced pressure area along the side to the increased pressure area in the vicinity of the vessel's stern, additionally to the torque in such a way that initially the bow of the tugboat (or its stern, if it approaches with the stern) may suddenly turn towards the vessel⁹.

Figure 7: Visualization of the AIS recording of 'Virtus' immediately before the impact against 'Bomar Victory'

⁹ The analysis of Figure 8 of the VTS image shows that the vector of movement direction of *Virtus* just before the collision tilted towards the vessel. On one hand this could indicate the hydrodynamic effect, but on the other hand it cannot be ruled out that it was the result of the action of the tugboat skipper.

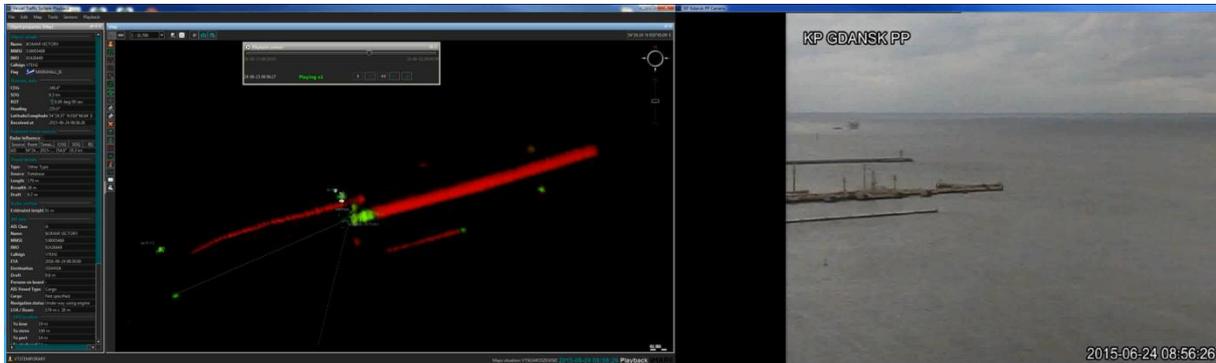
08:56:26: *Virtus* is coming up the side of *Bomar Victory*

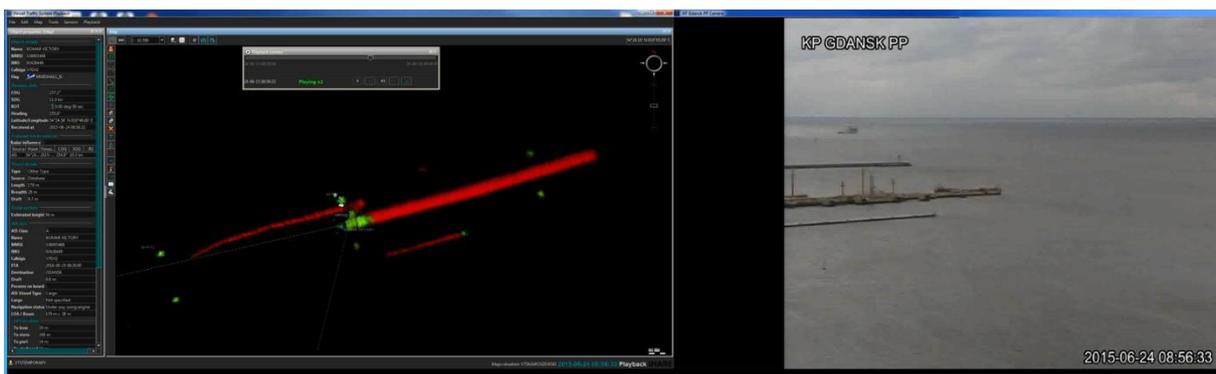
08:56:33: the moment of impact of *Virtus* against the side of *Bomar Victory*
