SMAIC
STATE MARINE ACCIDENT
INVESTIGATION COMMISSION

INTERIM REPORT

**SAILING YACHT
PRODIGY 2**

Loss of the yacht due to breaking off the ballast fin in the
North Sea on the day of 13 October 2017

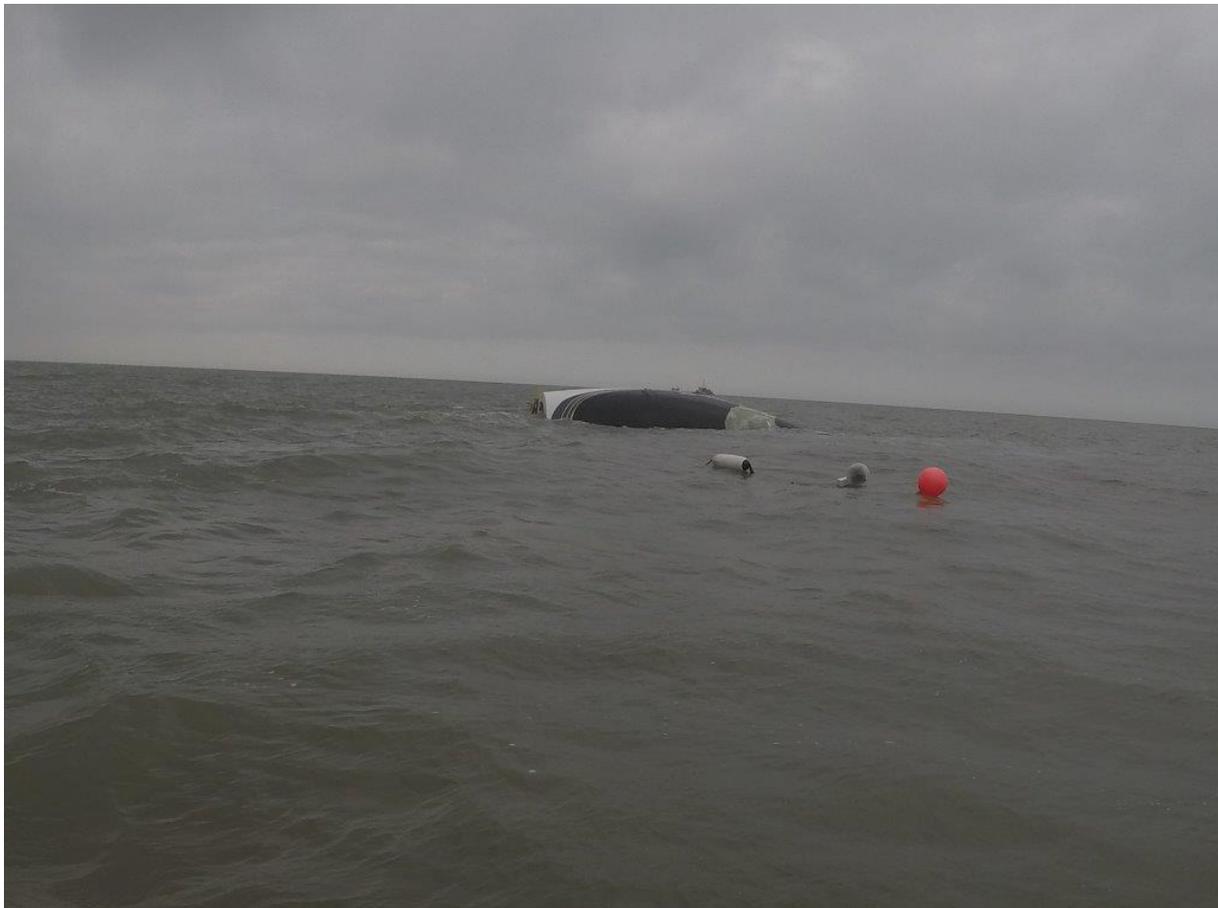
Photograph 2: The wreck of Prodigy 2 drifting after the accident

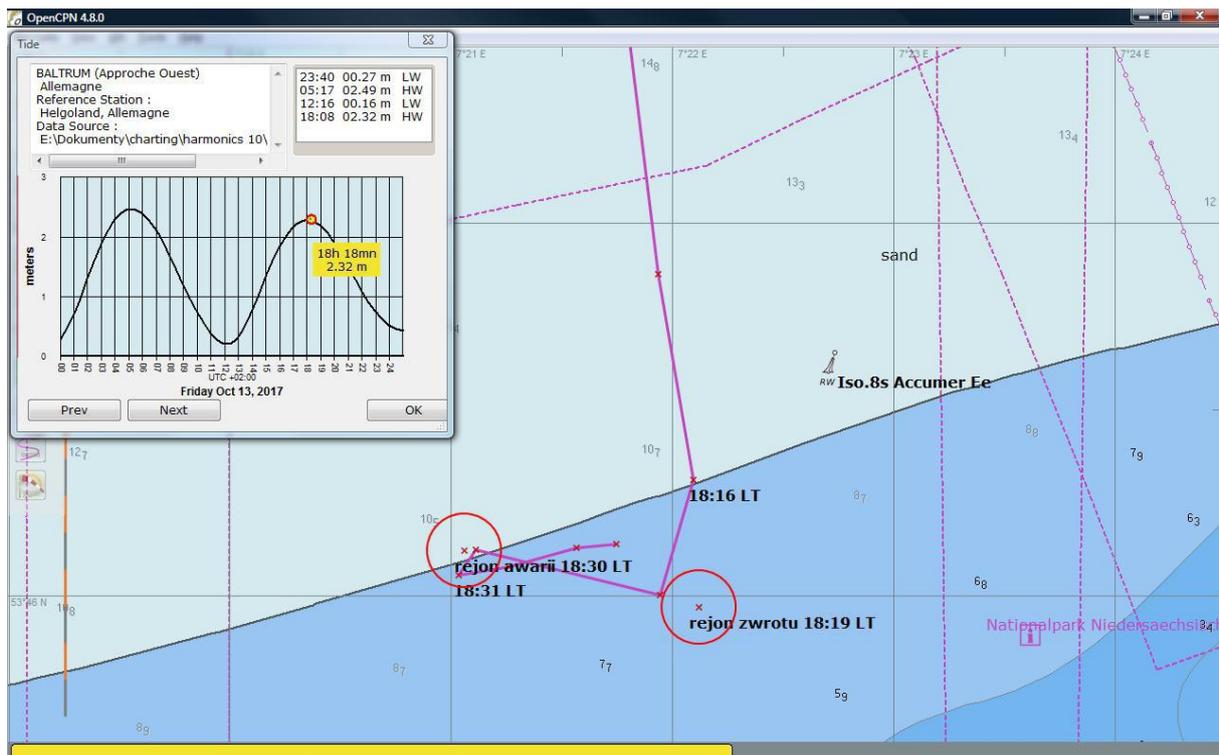
At 18:19 approaching by the southern course the coast of the Baltrum Island, the yacht turned to the left tack at the position $\phi = 53^{\circ} 45.9675' N$ $\lambda = 007^{\circ} 22.1200' E$. Before the turn, the yacht was sailing with a partially reefed mainsail and genoa at the speed of 6 – 7 k, heeling to ca. 12° (according to the master's assessment). The watch was performed by the boatswain, and he made the turn in the assistance of the master who went to the cockpit for that purpose. After the turn the yacht gained speed and within a few minutes accelerated to over 6 k, continuing its voyage towards $KD = 284^{\circ}$.

Figure 2: A detailed record of the route in the area where the break-down took place²

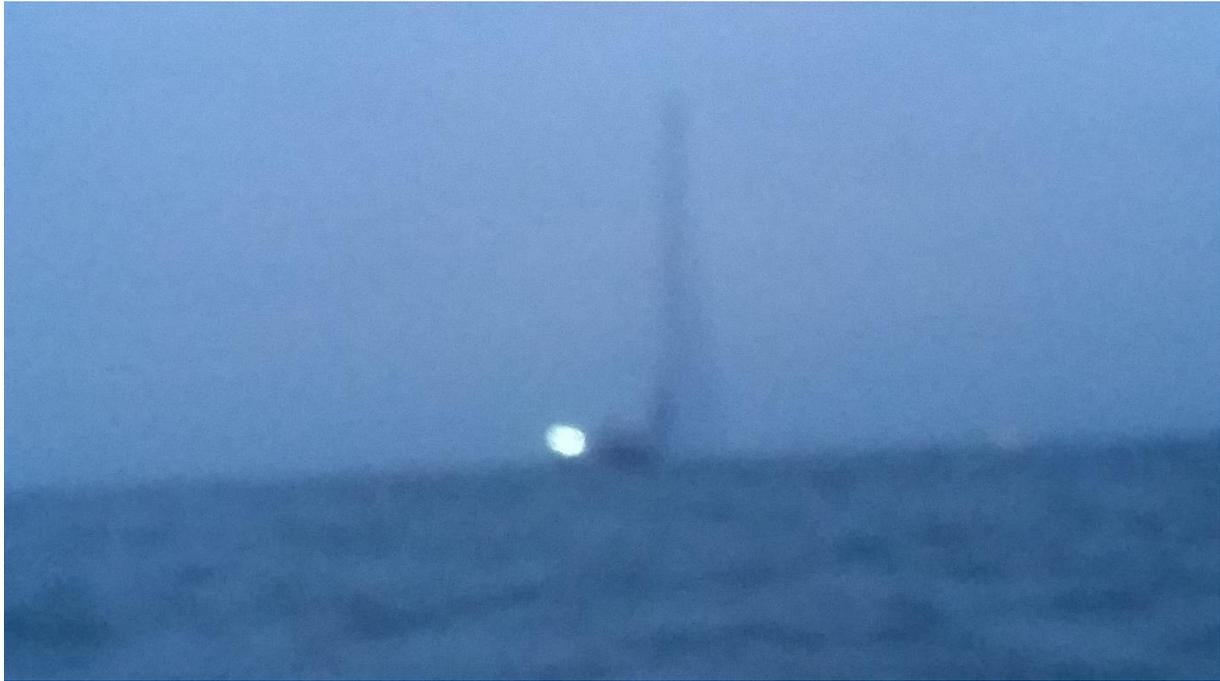
The painter was cut off and the crew could observe for a short time the sinking yacht, filming it and taking pictures with a mobile phone. In the last photograph taken at 18:52, despite it being blurred, one can see the yacht without heel, still emitting stern light.

Photograph 3: Prodigy 2 with no crew on board (source: Marcin Ciszewski)

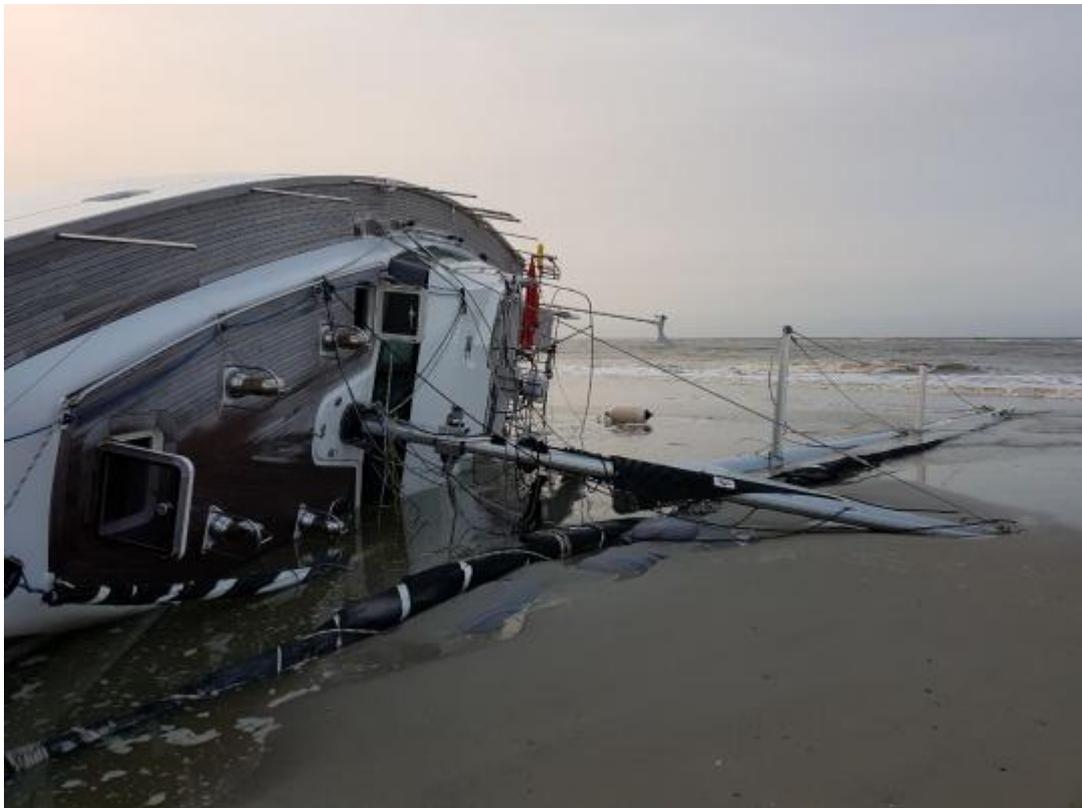
Photograph 4: Stranded wreck of the yacht on Langeoog

The wreck of the yacht was drifting on the surface further east, finally on 16 October settling on the shore of Langeoog near the position $\varphi = 53^{\circ} 45,73$ 'N $\lambda = 007^{\circ} 34,58$ ' E, ca 8 miles from the scene of the accident. The action of waves led to the total destruction of the yacht.
