FINAL REPORT

Marine casualty

M/V City of Rome

Damage to the fender frame of the eastern breakwater while exiting the port of Gdańsk on the day of 29 January 2018

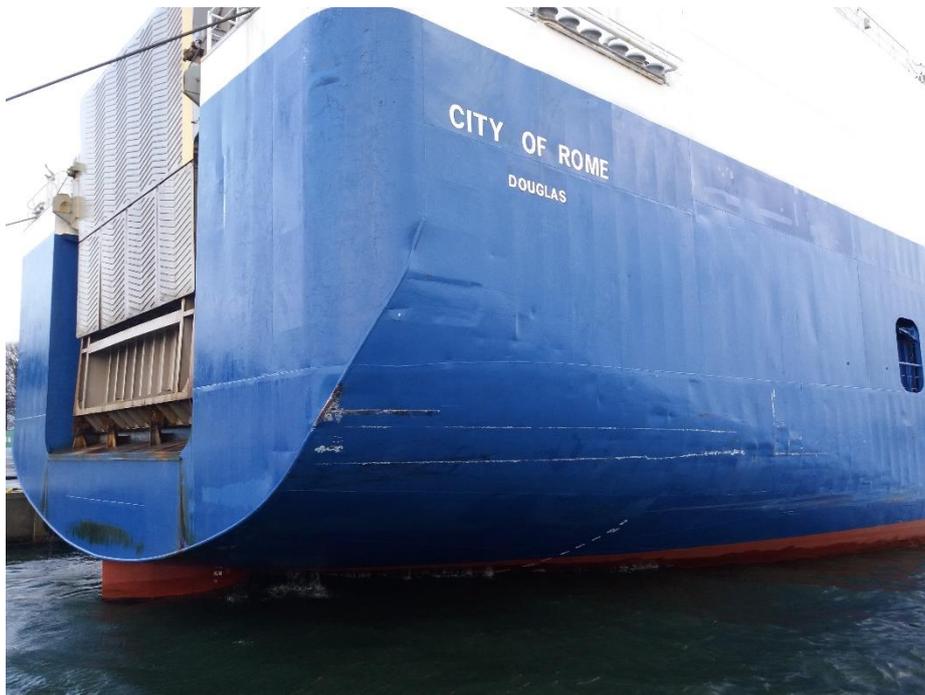
Operational status of the vessel during the event: under ballast
Consequences of the accident to people: no consequences for people
Consequences of the accident to the vessel: small damage to the sheathing of the starboard side over the waterline
Consequences of the accident to the infrastructure: damaged construction of the fender frame, bent back the cantilevers of the breakwater lead-in pier, broken fenders, damaged 7 signalling lights, damaged signalling railing, no lighting of the breakwater lead-in pier

Photograph 2: Traces of abrasion on the slant frame of the stern

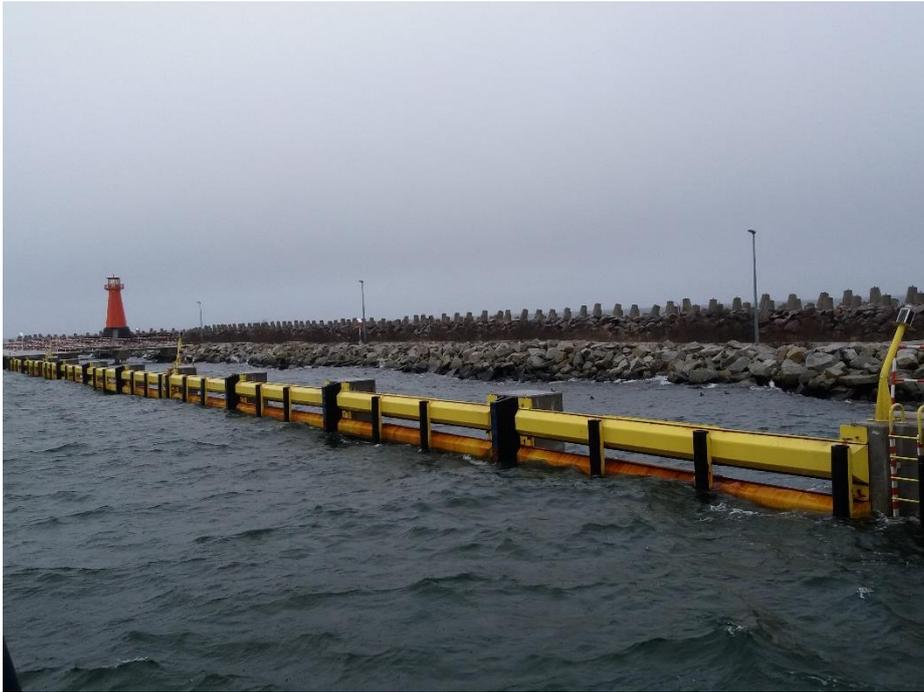
Photograph 1: Damaged fender frame of the breakwater lead-in pier

The dynamic contact of the vessel's hull with the fender frame contributed to the deflection of the support of the lead-in pier of the breakwater, damage to the safety railing and signalling lights (7 pieces). The result of the damage was the lack of lighting of the eastern lead-in pier and cracked fenders.

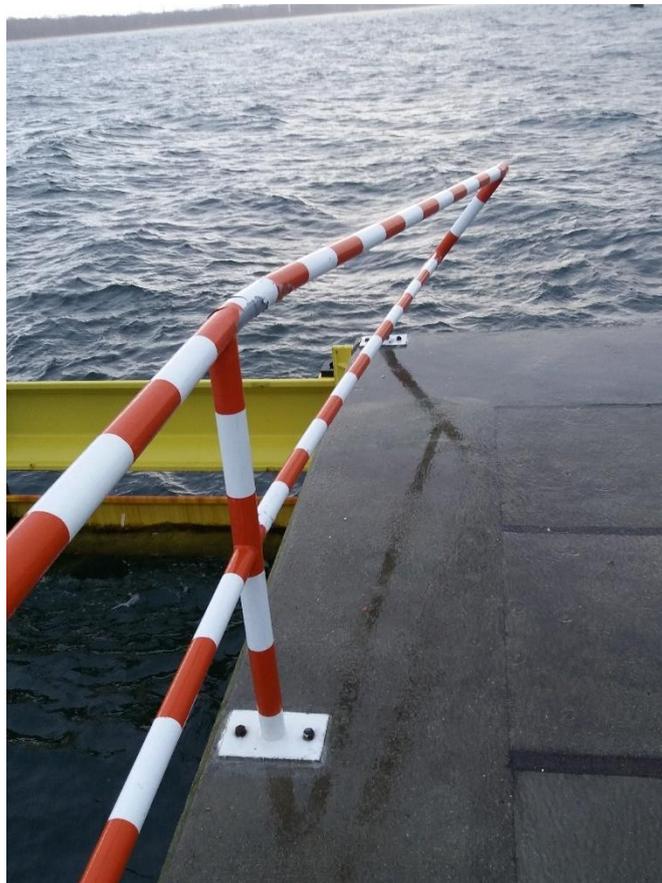
Photograph 2: Damaged security railing

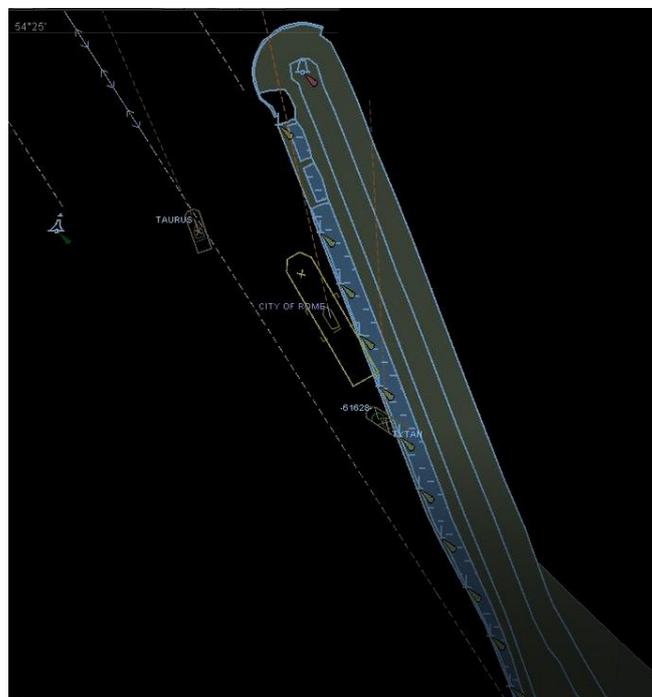
Figure 1: Screenshot of the VTS radar image (20:46:00)

In spite of manoeuvres with the thruster and helm and the assistance of the tugboat at the stern, the drifting of the vessel towards the eastern breakwater could not be stopped and at ca. 20:46 the first contact of the vessel with the fender of the breakwater occurred. Moving at the speed of about 4.3 knots the vessel brushed its stern against the fender beam damaging the dolphins, and then it began to move forward, rubbing against its steel spans.

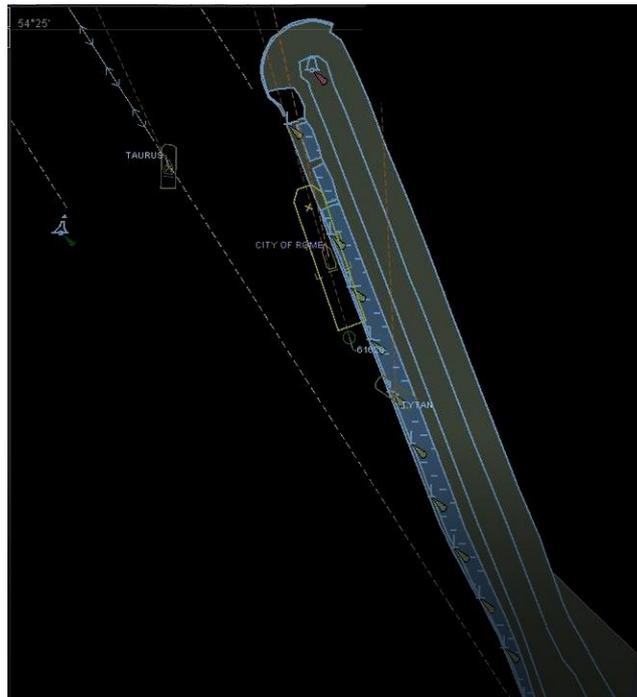
Figure 2: Screenshot of the VTS radar image (20:46:18)

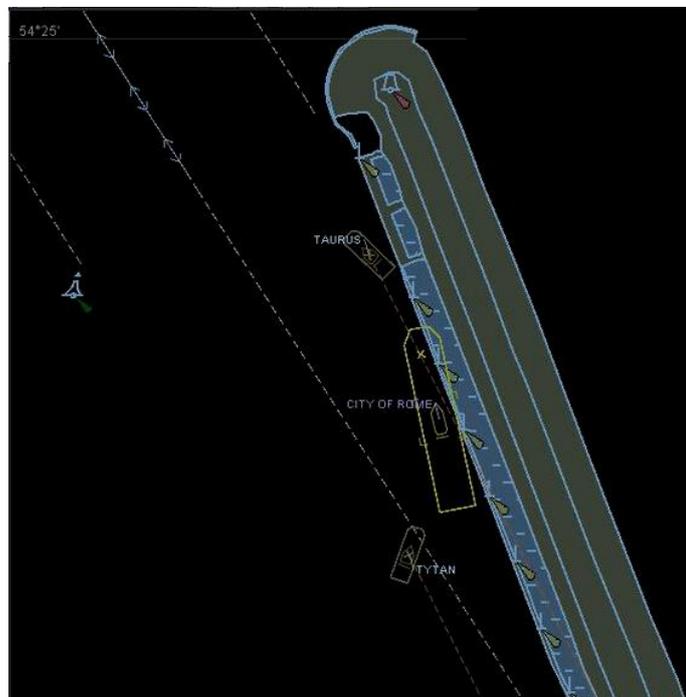
Figure 3: Screenshot of the VTS radar image (20:49:12).

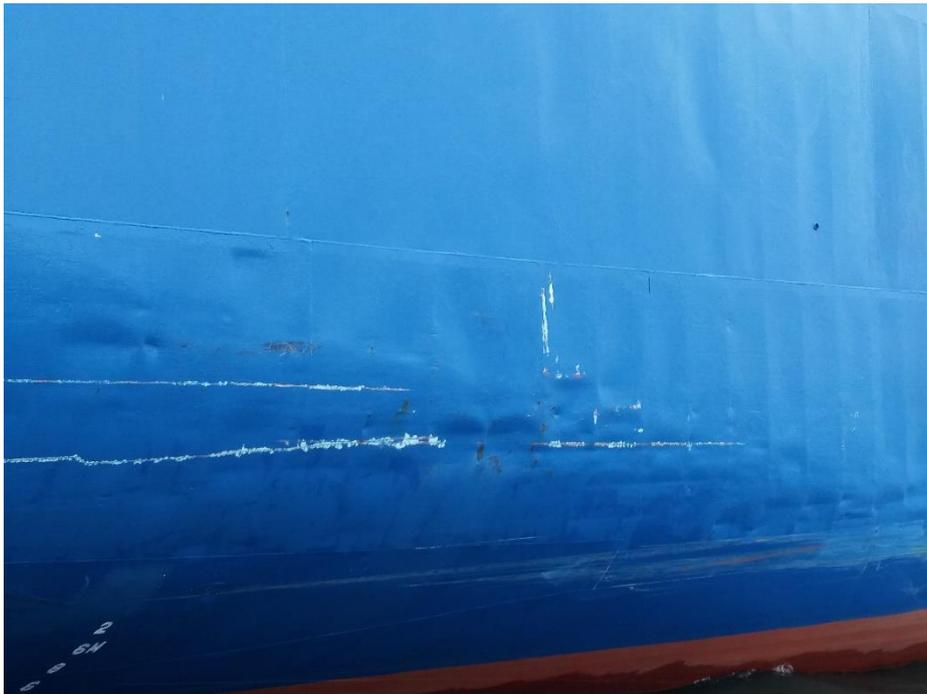
Photograph 6: Abrasions of the aft part of the hull – starboard.

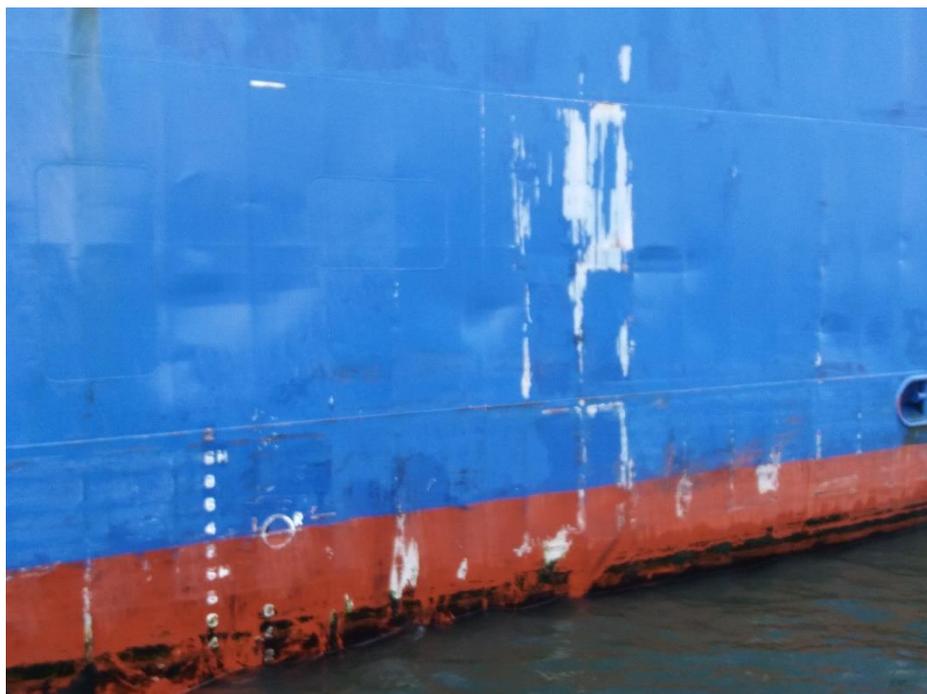
Photograph 3: Abrasions of the midship – starboard.
