**SMAIC**  
STATE MARINE ACCIDENT  
INVESTIGATION COMMISSION

# FINAL REPORT

# 21/17

**SAILING YACHT *DUNLIN***

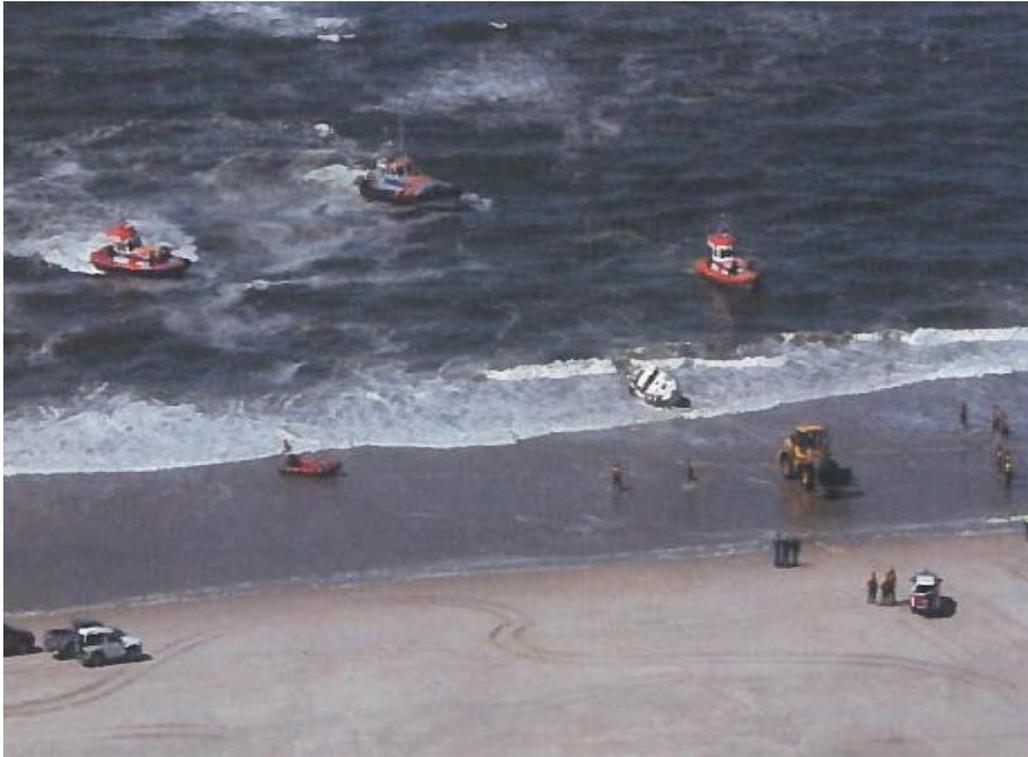
*Photograph 2: The wreck of the yacht after it had been towed to the beach (source: Maritime Politie)*

The yacht towed to the beach was inspected, documenting the damage and condition of the equipment. The hull which was cracked and extensively damaged in many places, was partly delaminated.

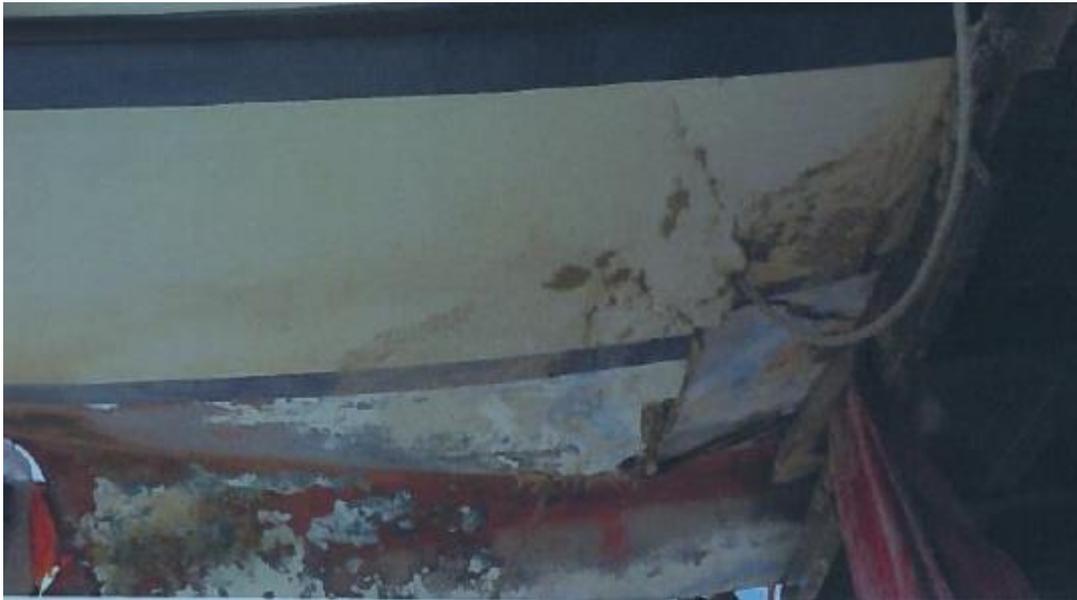
*Photograph 3: Visible delamination of the hull*

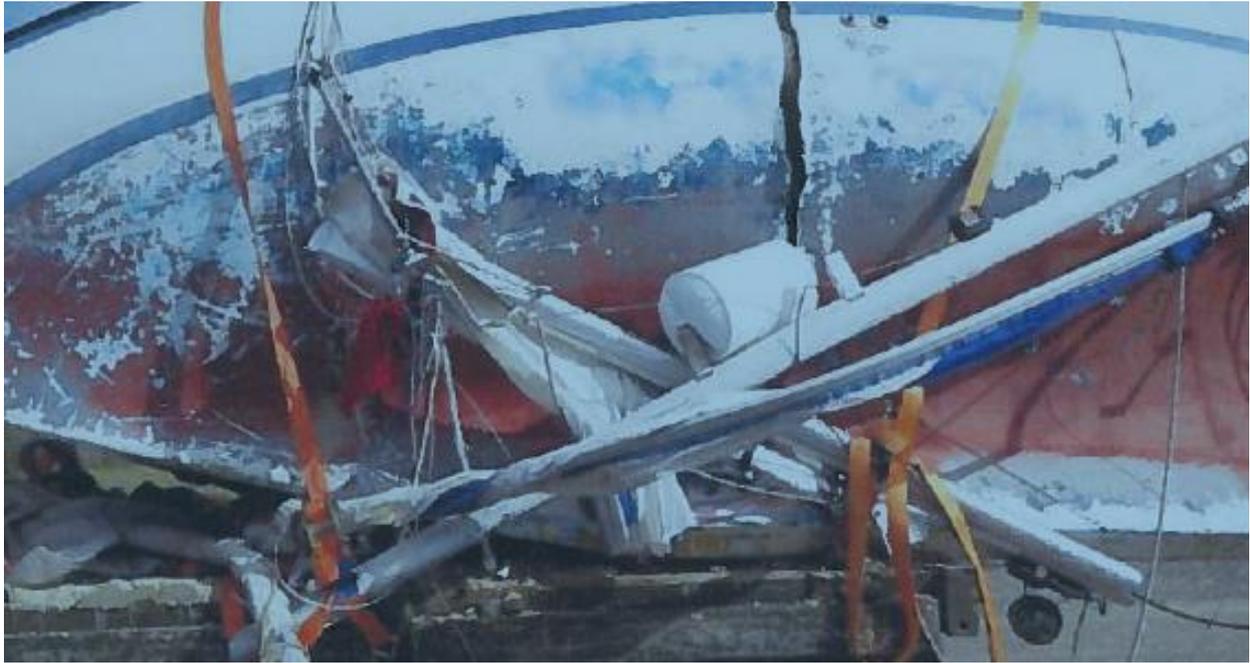
The mast, broken in several places, was hanging on damaged fixed rigging. The foresail was completely rolled up on the roller, and the mainsail was trimmed and temporarily attached to the boom.

*Photograph 4: Fixed rigging after the yacht had been taken ashore*

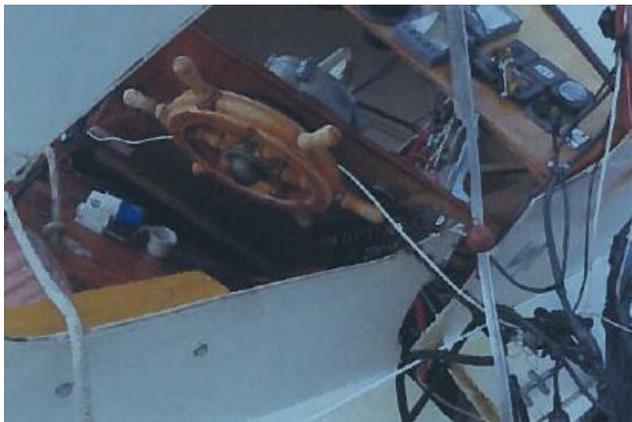
The rudder blade was broken just under the hull and disappeared. Steering devices – the tiller (broken) and the steering wheel in the interior console (torn out together with the bulkhead) - despite the damage indicated that the rudder was in working order until the grounding.

*Photograph 5: Steering wheel torn out with the bulkhead*

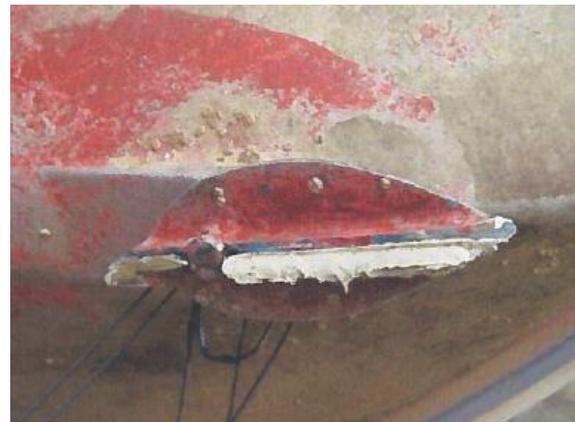
*Photograph 6: Visible trace of the broken rudder blade*

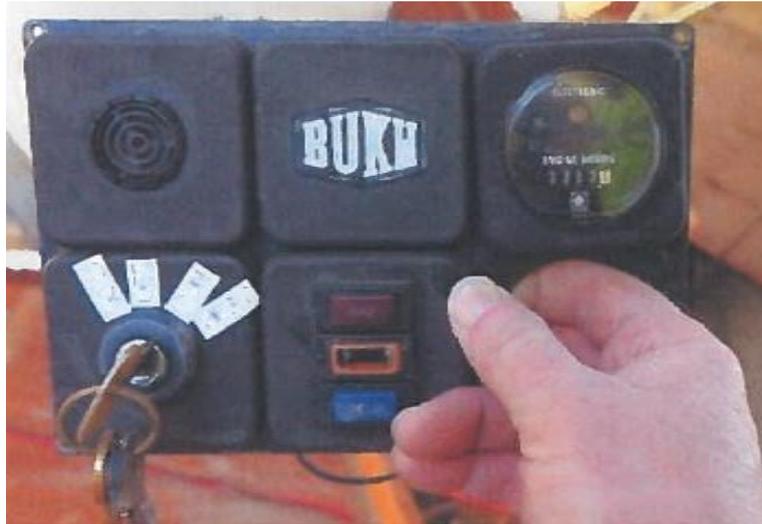
The key in the engine control panel was in the „Run” position.

*Photograph 7: The engine control with the key in the „Run” position*

The pull rod of the engine control lever was broken, so the position of the ignition lever did not allow to determine whether the engine was on revolutions when it was stopped. The V-belt was stretched correctly. The level of fuel in the tank could not be determined because the tank was torn out of the fasteners and separated from the yacht. The filter with the water separator, installed in the engine power line, was heavily contaminated with oily sediment, but there was no water in the engine.

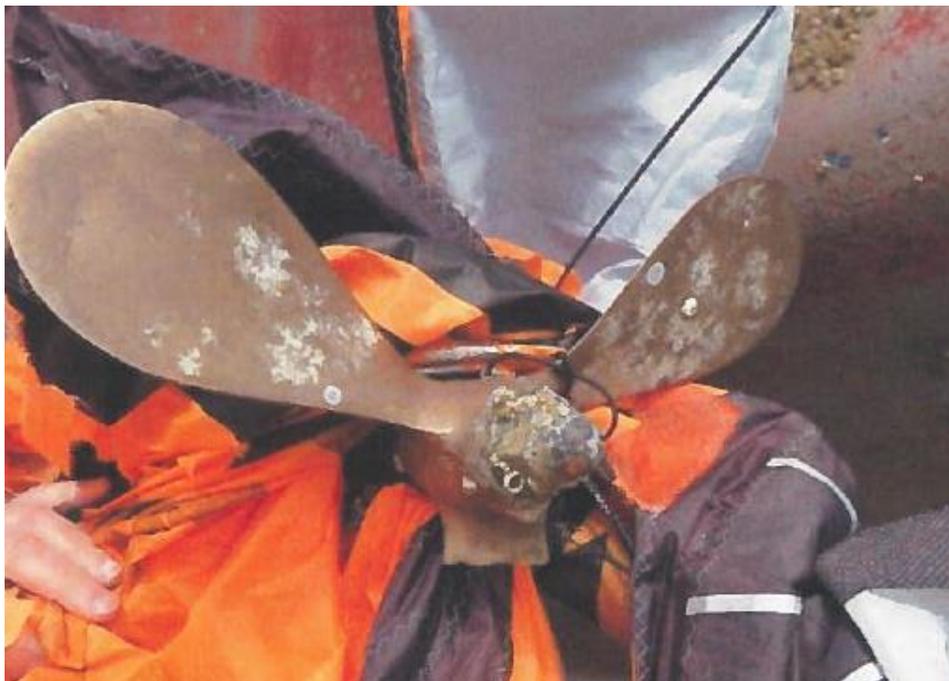
One of the three propeller blades was broken and missing.

*Photograph 8: The screw propeller with visibly broken down one of the three blades*
