STATE MARINE ACCIDENT  
INVESTIGATION COMMISSION

# FINAL REPORT

# 39/15

## **M/V GREEN EBERSUND**

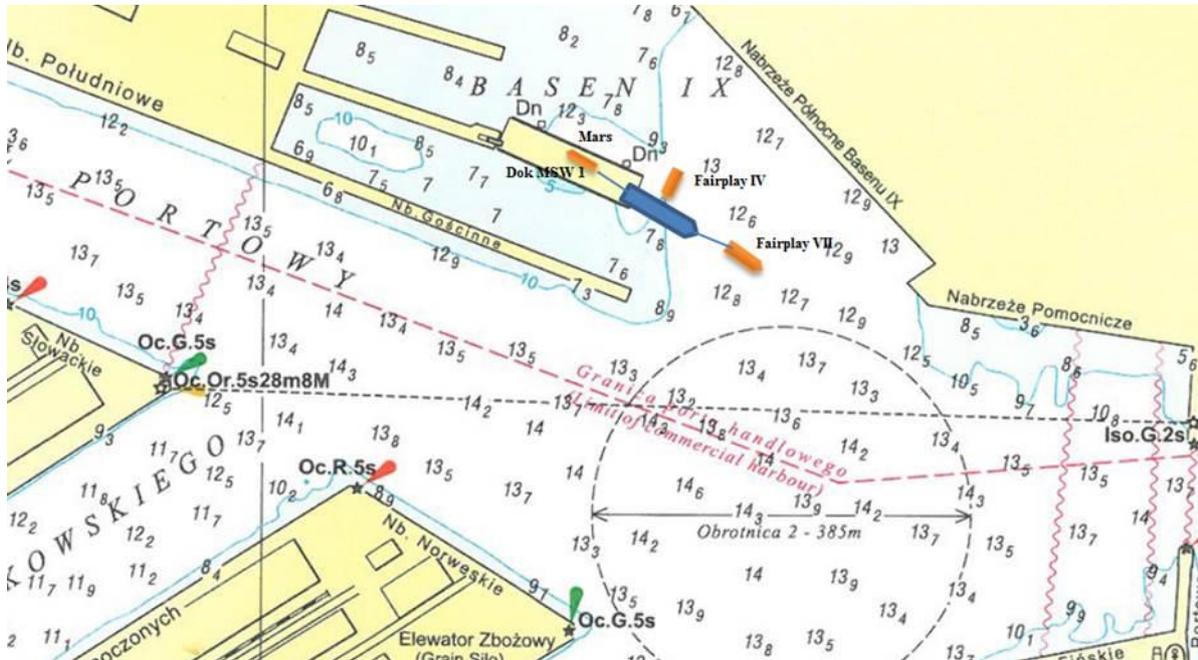
Figure 2: A situational sketch of the manoeuvres of „Green Egersund” entering the dock with “Fairplay IV”, “Fairplay VII”, and “Mars” tugboats

Displacement of the stern of *Green Egersund* while docking towards the right side wall of the dock and hitting the hull against the foundation of the mooring roll resulted from the pilot's errors in tugboat manoeuvres.

Moreover, the Commission has noted that the commands given to *Fairplay VII* by the pilot to pull the bow southwards, especially in the final phase when the stern of the vessel was already in the dock, just before the impact, intensified the impact forces.

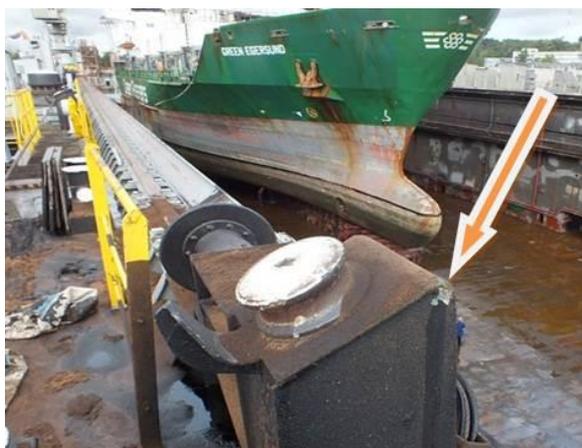
Despite the departure manoeuvre, at 17:14:10 the vessel bumped its curved part of the stern at starboard against a foundation of the mooring roll on the front (Photograph 11) of the southern side wall and damaged the plating of the hull (Photograph 12).

*Photograph 11: Traces of paint from the hull of the vessel at the edge of the foundation of the mooring roll*

However, the Commission has considered that the post-accident protection (rubber cover – Photograph 34) of the foundations of rolls guiding the lines on each side wall were insufficient.

- 1) to make changes to the “Docking Instructions for the Floating Dock 8000T””, which would specify in greater detail the way of docking the vessels in the “SMW-1” dock, taking into account the need to stop the vessel before reaching the front of the dock and to pass additional lines from the dock to stabilize the lateral movement of the stern (bow) of the vessel until the mooring lines are passed from the dock and secured;
- 2) to secure properly all protruding elements of the dock, such as the foundations of the mooring rolls on both side walls so that the vessel would not be exposed to damage:

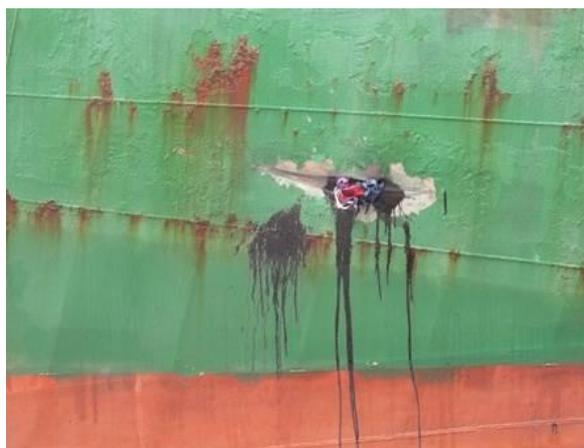
*Photograph 12: Damaged (pierced) plating of „Green Egersund” hull plating*

The chief engineer of *Green Egersund* informed the master that the leakage from the damaged hull plating came from the heavy fuel service tank No. 15. With no possibility of pumping fuel into another tank, the chief engineer discarded some of the fuel to the engine bilge and to the oil waste tank.

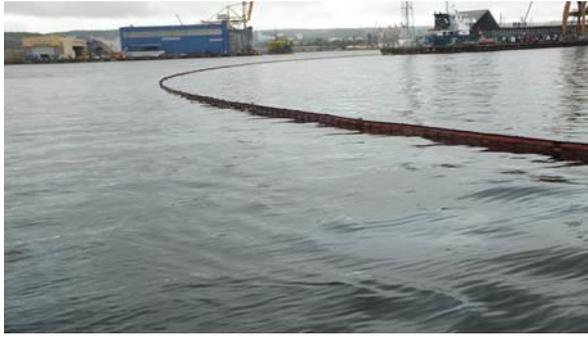
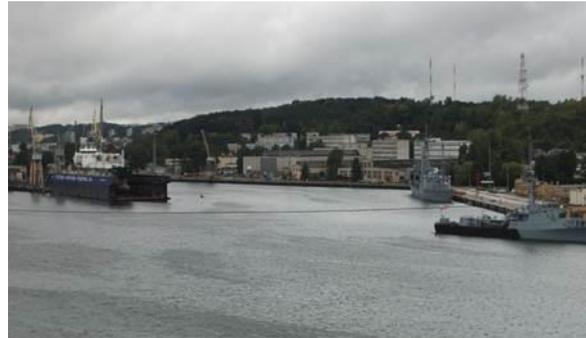
*Photograph 14: Basin IX separated from the rest of the port by an oil spill containment boom*

With regard to the actions carried out by various entities immediately after the leakage of fuel overboard, the Commission has considered that the deployment of the oil spill containment boom near the “SMW-1” dock was delayed and caused the spilled fuel to flow out of the shipyard waters, polluting water and wharfs of the inner port in Gdynia. The shipyard’s Rescue Service neither had the oil boom at their disposal nor had they means and abilities to set it. The actions of the Shipyard’s Rescue Service activities were limited to neutralizing and gathering spilled fuel at the dock itself<sup>18</sup>.

To equip the Shipyard Rescue Service with necessary floating equipment for immediate deployment of oil spill containment booms in case of the leakage of fuel from vessels coming in or out of the floating dock or being repaired in the shipyard and to train of their personnel in the deployment of the booms unaided.

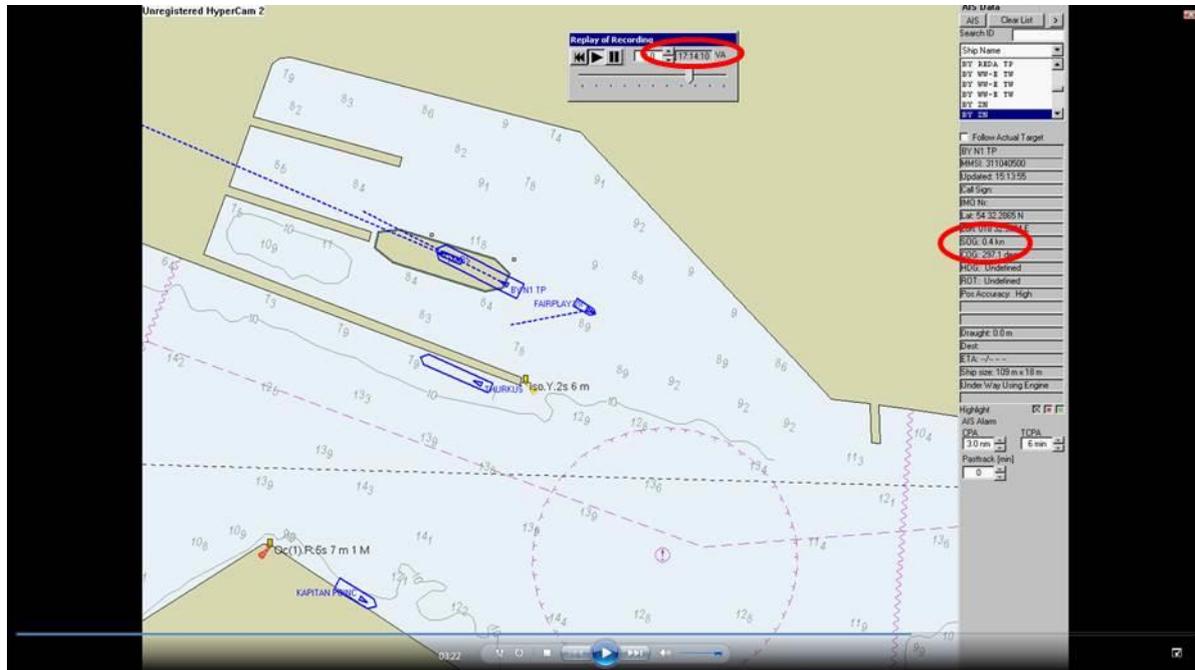
in the south-westerly direction, as instructed by the pilot. *Green Egersund* was navigating at the course over ground (COG) 297° at the speed of 0.4 kn<sup>9</sup>.

Figure 3: Position of vessels at the moment when the vessel hit the side wall of the dock; source: materials of the Maritime Office in Gdynia, application SAAB „Adveto - Aecdis 2000 400 v3.49”

<sup>9</sup> It should be noted that the vessel's silhouette shown in Figure 3 does not reflect its actual position. The vessel was moving stern to, not the bow in. The lack of actual heading (HDG) and thus the correct position of the envelope of the vessel is due to the lack of data from the vessel's VDR on its course. In addition, the Commission has noted that the figure is missing the silhouette and AIS data of the third tugboat taking part in towing the vessel. The AIS device of the *Fairplay IV* was switched off or out of order.

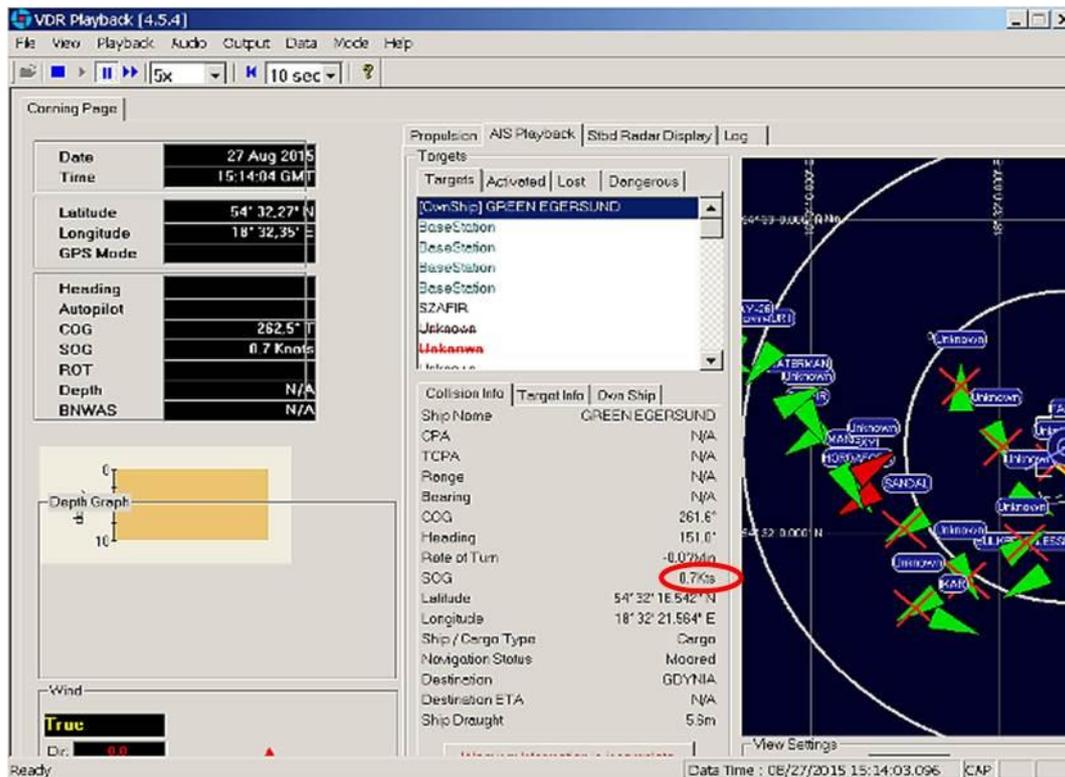
The speed with which *Green Egersund* was entering the “SMW-1” dock just before the collision was 0.7 kn (Photograph 20).

The speed of *Green Egersund* at the entrance to the dock was 0.7 kn (Photograph 20). The Commission has recognized that such speed was safe and appropriate to pass heaving lines and take over the towlines provided that the vessel was moving in the axis of symmetry of the dock.

Photograph 20: The parameters of “Green Egersund” when its stern went into the dock from the S-VDR device

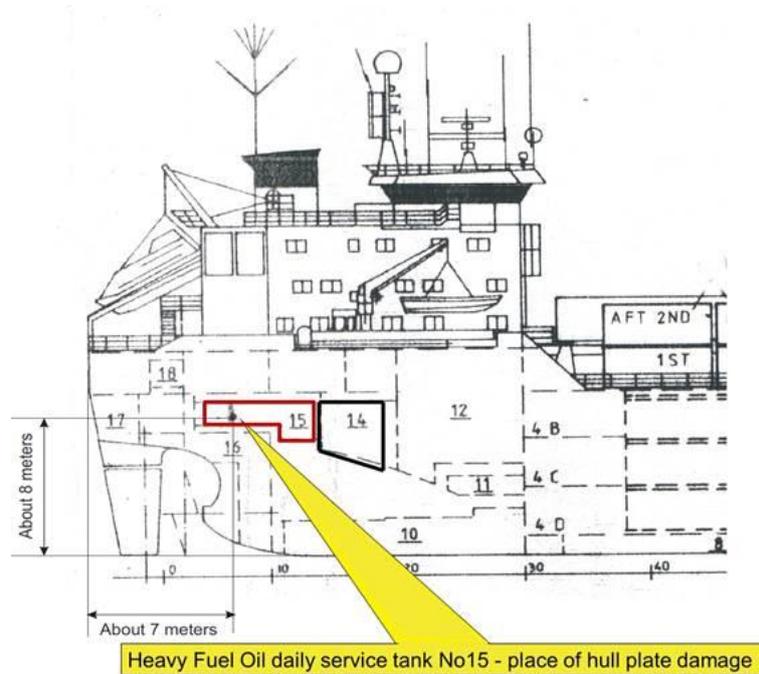
The impact of *Green Egersund*'s stern at starboard against an uncovered edge of the foundation of the mooring roll of the right side wall of the “SMW-1” dock caused a 2.2 mm x 100 mm cut in the aft part of the vessel at about 8 m from the baseline and 7 m from the stern (Figure 4).

At this place of the hull there is a heavy fuel service tank No. 15 and the cut was made about 70 cm above its bottom.

*Figure 4:* A place where the hull plating was damaged and positioning of heavy fuel tanks – starboard stern (catch tank No. 14 and service tank No. 15)

Consequently, about 9 m<sup>3</sup> of heavy fuel flowed out of the tank contaminating the shipyard's basin, a part of port basins, 13 wharfs and a part of the main detached breakwater under the management of the Port of Gdynia Authority SA. The degree of contamination of individual basins and wharves was different and it depended mainly on the wind direction during the first hours after the accident. The "SMW-1" dock itself, mainly its southern side wall, and the sides of *Green Egersund* (Photographs 22-25) were also contaminated with heavy fuel.

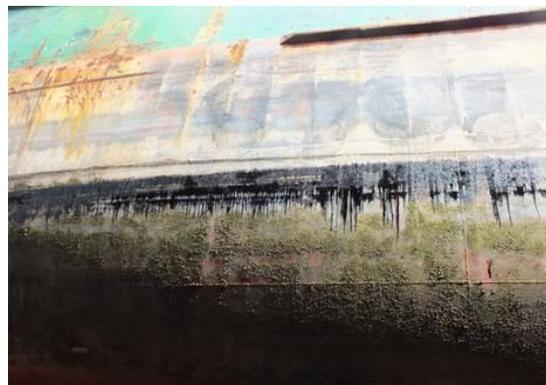
*Photograph 23:* The hull of "Green Egersund" soiled with fuel

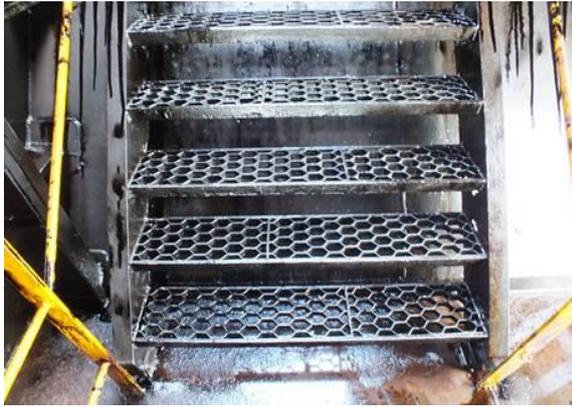
*Photograph 24* Stairs on the right sidewall of the “SMW-1” dock soiled with fuel

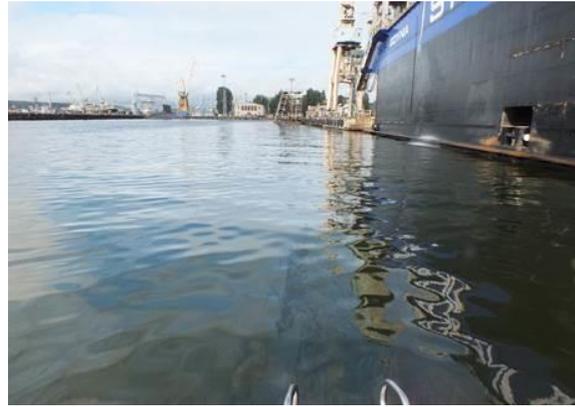
*Photograph 25:* Oil film in the Basin IX between the Gościnnie Wharf and the dock

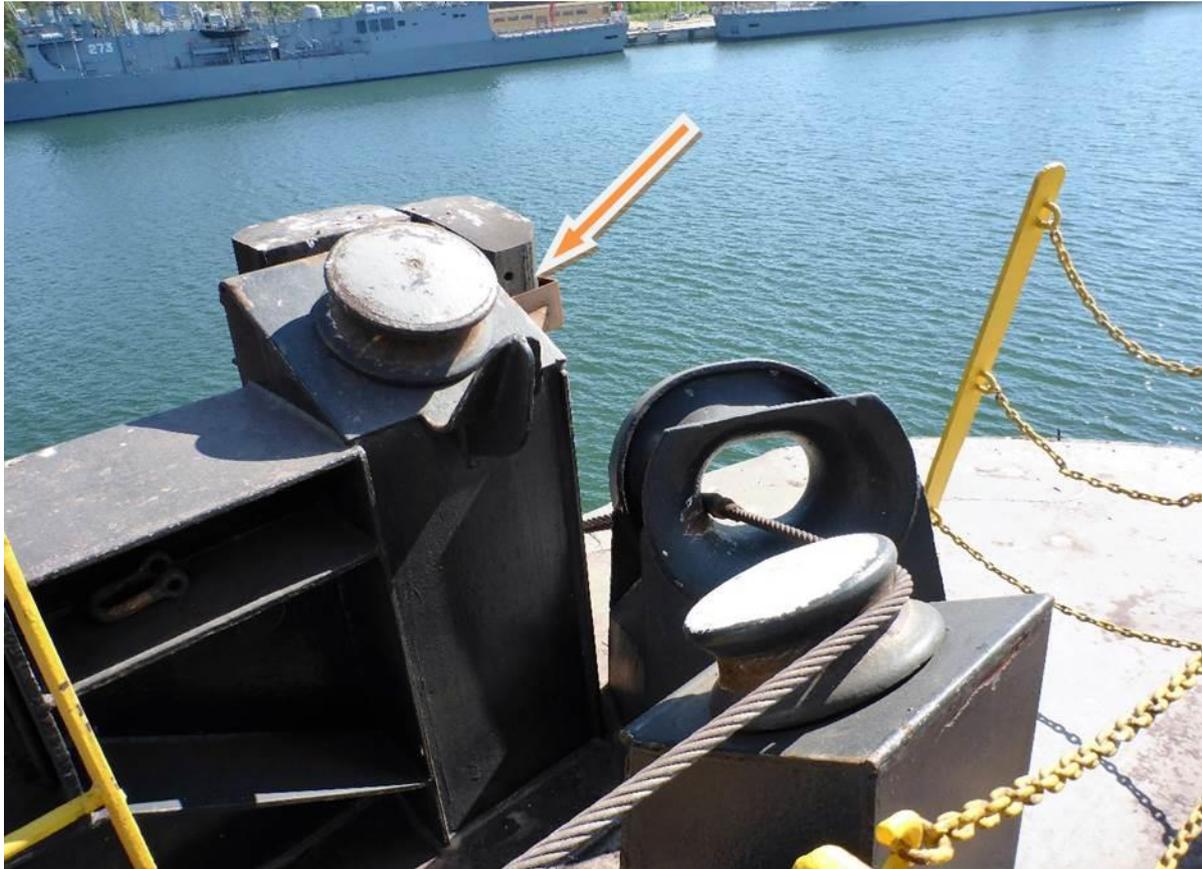
Photograph 34: The cover on the foundation of the direction roll in the “SMW-1” dock
