**SMAIC**  
STATE MARINE ACCIDENT  
INVESTIGATION COMMISSION

# FINAL REPORT

**m/v Kamelia**

Loss of control and bumping against the Nabrzeże Cementowe wharf in the Port of Szczecin on 23 August 2017

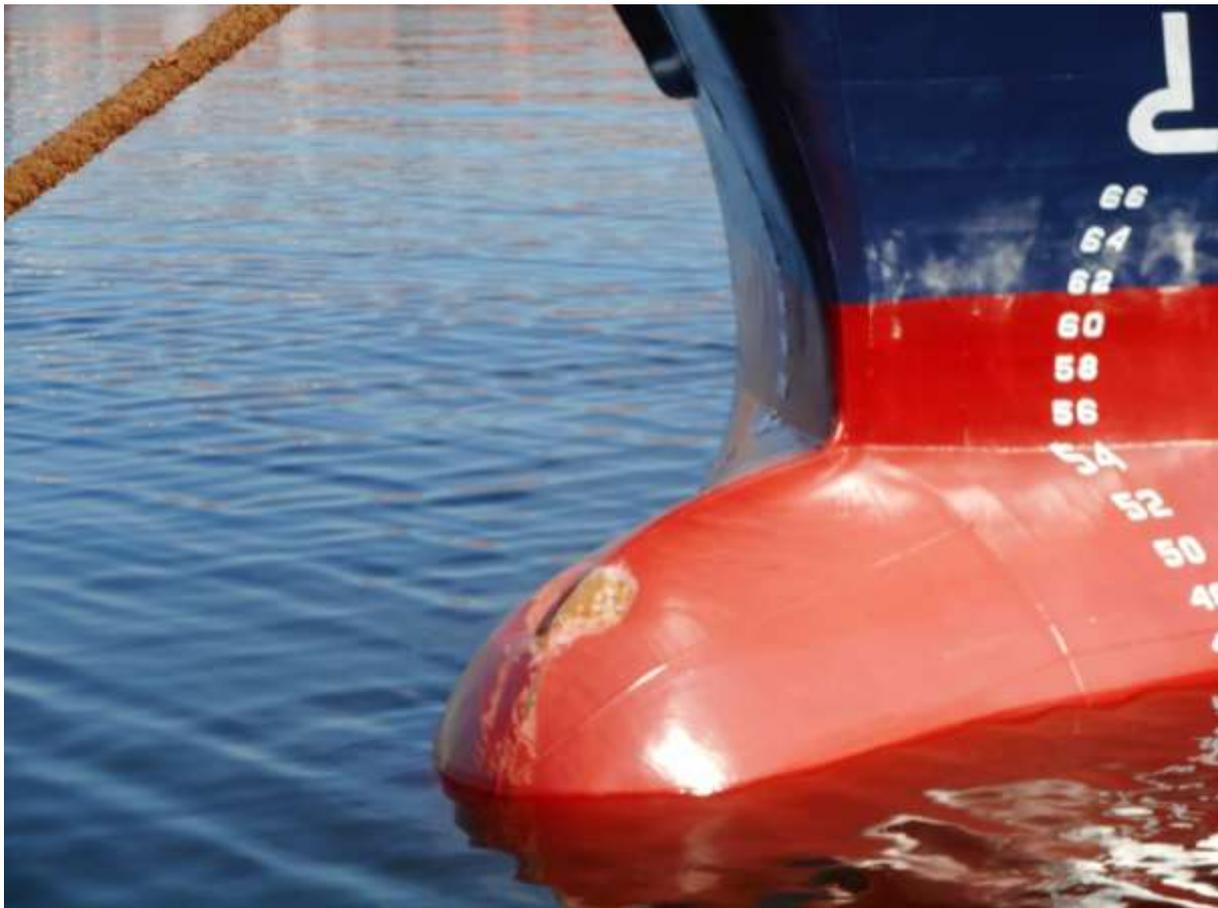
Weather during the event:	Wind WNW 1-2° B, sea state 1, air temp. 23° C, water temp. 17° C
Operational status of the vessel during the event:	Loaded vessel
Place of the accident on board:	Bulbous bow
Consequences of the accident to the vessel:	Indentation of the bulbous bow at starboard of the following dimensions: 300 x 300 mm and the depth of 80 mm, and at portside of the following dimensions: 300 x 150 mm and depth 50 mm
Consequences of the accident for the port infrastructure:	Damage of the edge of the underside of the wharf of the following dimensions: 3.5 m x 0.35 m x 1.0 m – the concrete crumbled and reinforcement was damaged; and the steel sheet piling was exposed; damage to the sheeting at a length of 2.8 m and a depth of about 3.0 m from the bottom of the sheet, 7 pieces of Larssen segments of sheet piling were flattened and bent about 80 cm (deflection arrow)

*Photograph 2: Damage of the bulbous bow visible on the exterior*

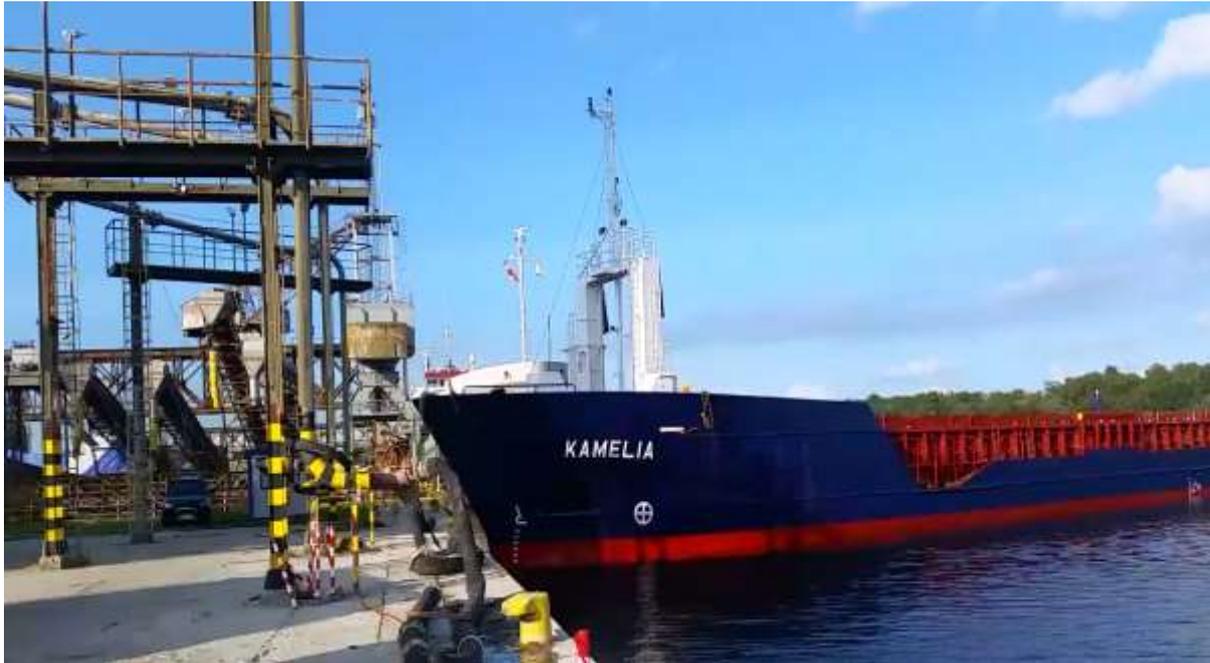
In order to return to the fairway at the 198° course, the vessel went full astern while the bow thruster was set at its maximum position to starboard. After setting the vessel on its course, the journey was resumed, reaching the speed of about 7.5 knots. The chief officer was steering the vessel at that time. At about 5:55 pm, on the traverse of the beacon no 58, the attempt was made to use the autopilot for steering the vessel. Once the master switched the main rudder to the autopilot mode, it automatically turned to starboard by 20° - 25°. The vessel started turning to starboard approaching the Nabrzeże Cementowe wharf and the Alfa wharf where a vessel m/v *Doggersbank* was moored. In order to stop further turn to starboard, first the thruster was laid hard to port. Then, to stop the vessel and additionally to prevent it from making the turn at 17:59 the right anchor was cast, no less than one and a half shackle, into the water. Turning of the vessel ceased at the course perpendicular to the wharf but the propeller could not be steered full astern. At 18:00, m/v *Kamelia* at a speed of about 0.8 knots bumped perpendicularly to the edge of the wharf its bulbous bow against the underwater part of the Nabrzeże Cementowe wharf. After the collision m/v *Kamelia* completely lost its speed. The bow of the vessel during the contact with the wharf immersed by ca 15-20 cm, and the bulbous bow slipped under the edge of the wharf to the point where the stem stopped at a distance of about 10 cm from the upper edge of the wharf. A moment later, the bulbous bow and the whole vessel bounced back from the underwater part of the wharf. As a result of the bounce the bow of the vessel emerged from water and the vessel moved back by ca 7-10 m and stopped in the drift.

*Photograph 3: M/v Kamelia in contact with the Nabrzeże Cementowe wharf*

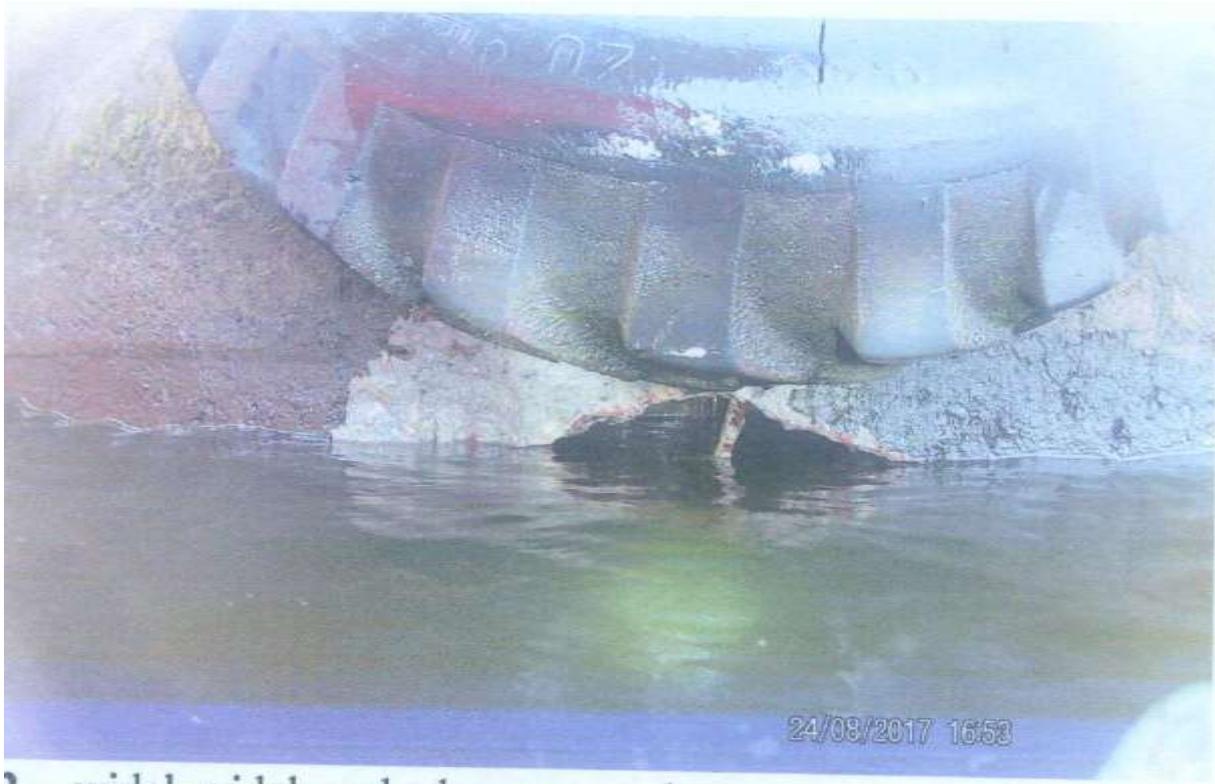
After anchoring the vessel at its port side at 20:10 at the Nabrzeże Węgierskie wharf both tugboats were released. The police arrived on board and carried out an alcohol test of the pilot and crew members. The result of the test was negative. Because the accident damaged the hull of the ship, *Kamelia* lost its class certificate and was inspected by the PSC and the classification society. At the same time, the underwater part of the Nabrzeże Cementowe wharf was inspected at the site of the incident and the waterfront structure was found to be damaged.

*Photograph 4: Underwater photograph of the construction of the Nabrzeże Cementowe wharf after m/v Kamelia had bumped against the wharf*
