STATE MARINE ACCIDENT
INVESTIGATION COMMISSION

FINAL REPORT

Peak Bergen

**Grounding of the ship in the Port of Świnoujście
on 20 September 2018**

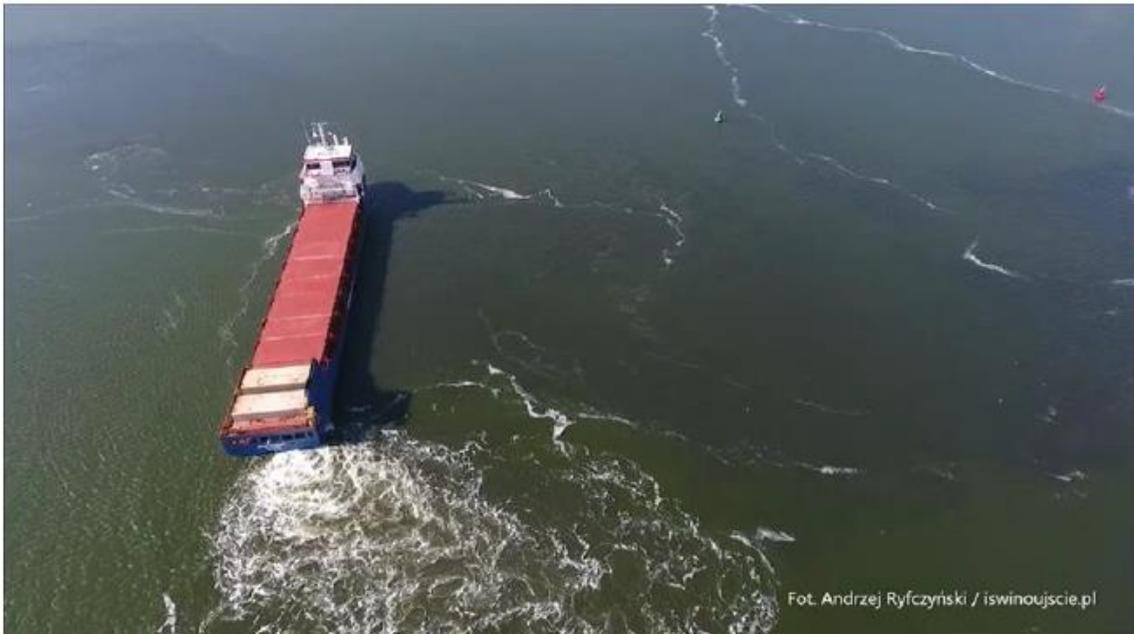
The accident resulted in the need to use a tug to pull the ship off the shoal and employ divers to carry out the underwater part of the hull survey. This survey showed that the hull, rudder and propeller were not damaged.

Photograph 2 Peak Bergen aground in the Atlantic Basin in the Port of Świnoujście

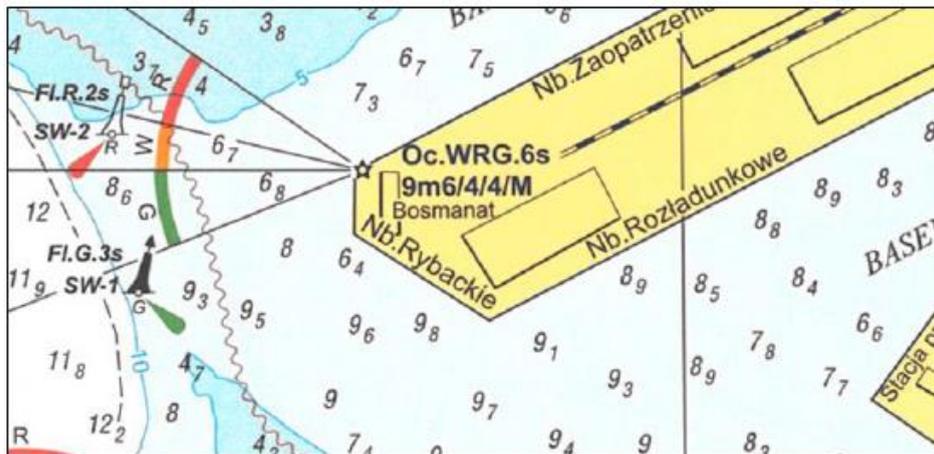
Figure 1 Fragment of map BA 2676, Plan C. Buoys SW-1, SW2.

Referring to the first regulation, the ship's route should take into account the recommended navigation routes. SW-1 and SW-2 buoys indicate a safe approach and exit from the Rozładunkowe Quay in the Port of Świnoujście (Figure 1).

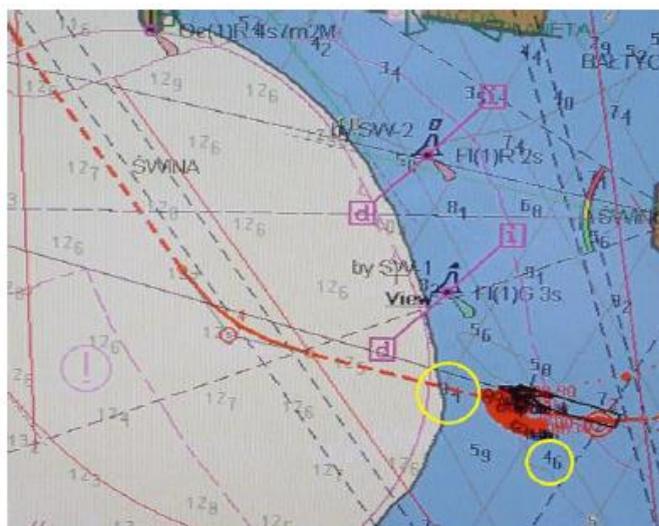
Figure 2 Screenshot of the ECDIS on Peak Bergen with the planned voyage route with an indication of the current depths of the water.

According to the provisions of the second regulation, which the navigation officer also did not comply with, the planned route should ensure sufficient sea room for safe passage. While preparing the voyage plan, the navigation officer did not take into account the current draught of the ship and the depth of the water in which the manoeuvres took place. The voyage plan was prepared without taking into account the depths marked on the map (Figure 2).

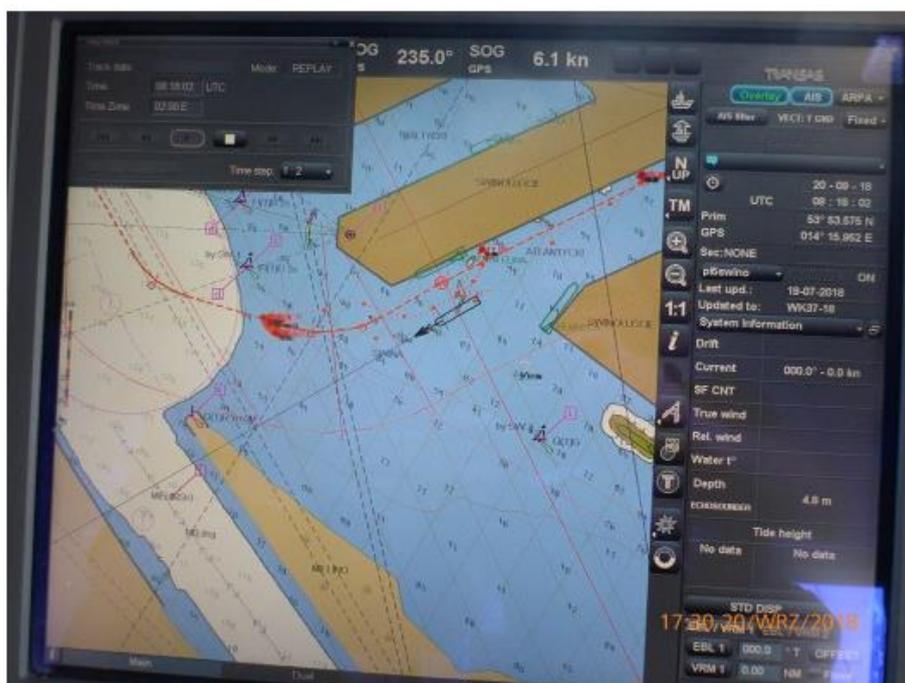
Analysis of the route planned by the navigation officer on the ECDIS chart (Photograph 3) showed that the ship's route was plotted outside these buoys.

Figure 3 Radar screenshot of the ECDIS on Peak Bergen

Plotting the course leading from the quay almost directly to the fairway and bypassing the recommended route exposed the ship to the danger of grounding and the possibility of damage to the ship's plating.

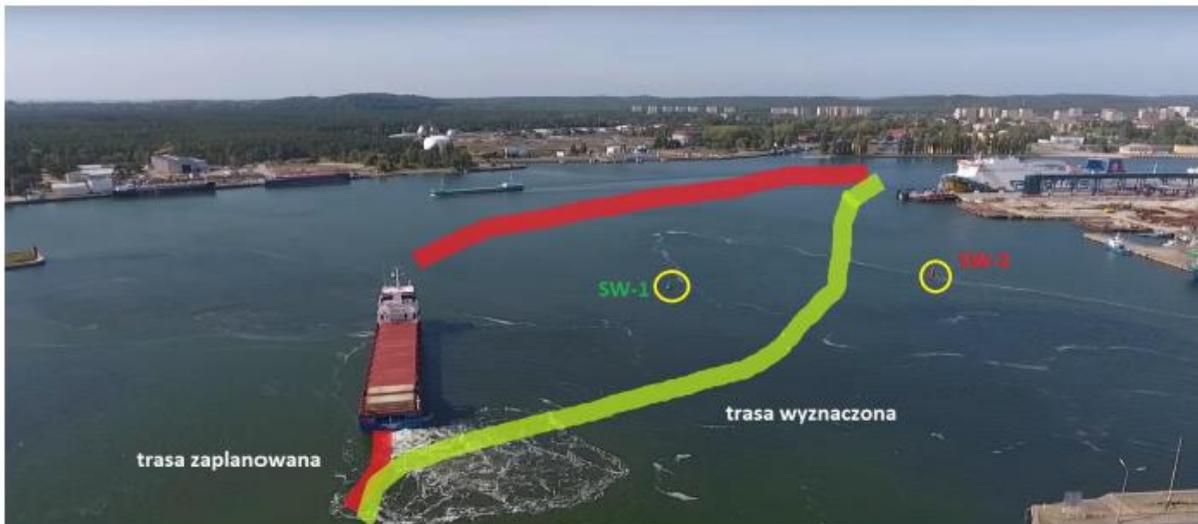
Figure 4 Peak Bergen in the Port of Świnoujście. Own drawing based on a photo received from the iswinoujście.pl website
