SMAIC
STATE MARINE ACCIDENT
INVESTIGATION COMMISSION

ANNUAL ANALYSIS

2017

MARINE CASUALTIES AND INCIDENTS

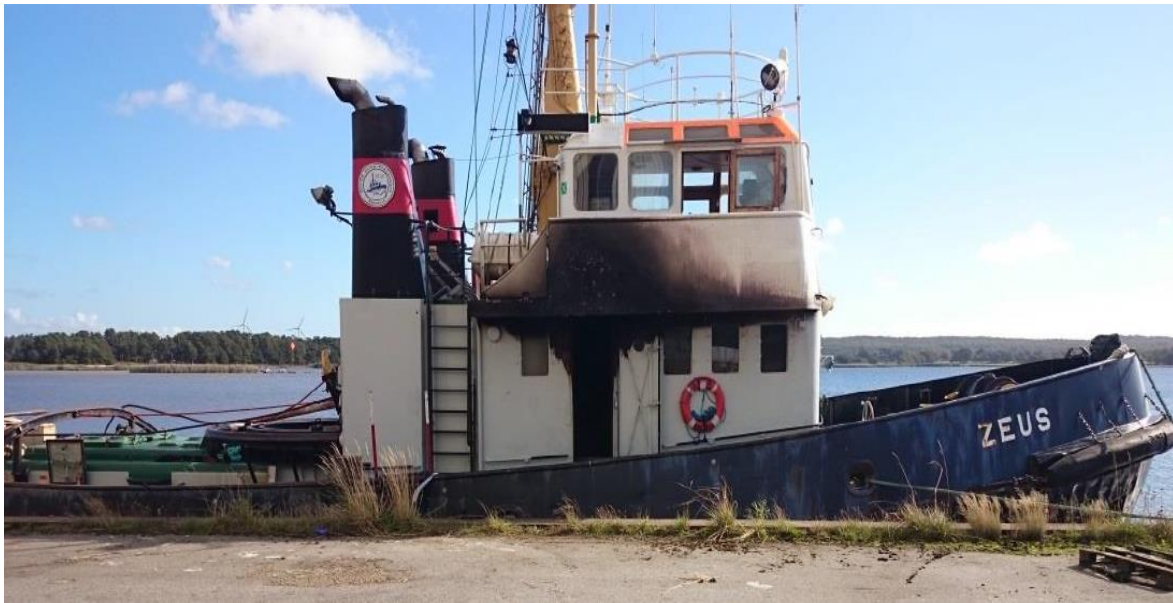
Photograph 1: Fire on a tugboat, “Zeus” (WIM 46/15)

In connection with corrective actions undertaken by the operator of the tug, *Zeus* in the period between the casualty and the day of publishing the report, which fulfil the recommendations prepared by the Commission during the investigation related to the fire-fighting equipment on the tug and the alcohol policy in place, the Commission concluded that there was no need to formulate recommendations in that regard.

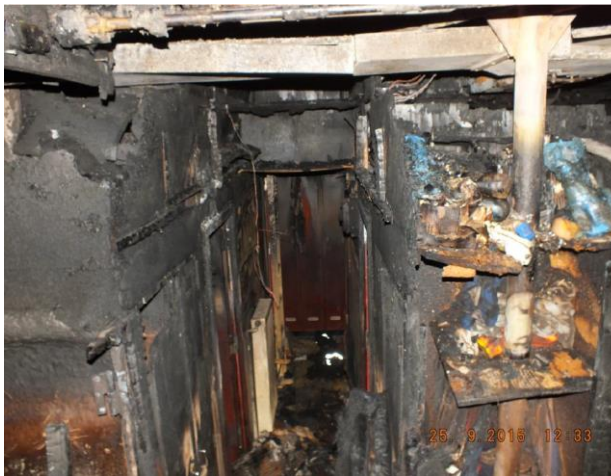
Photograph 2: Fire on the tug, “Zeus” (WIM 46/15)

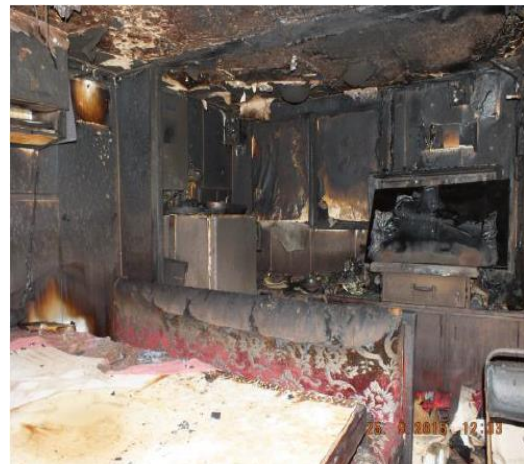
Photograph 3: Fire on the tug, “Zeus” (WIM 46/15)

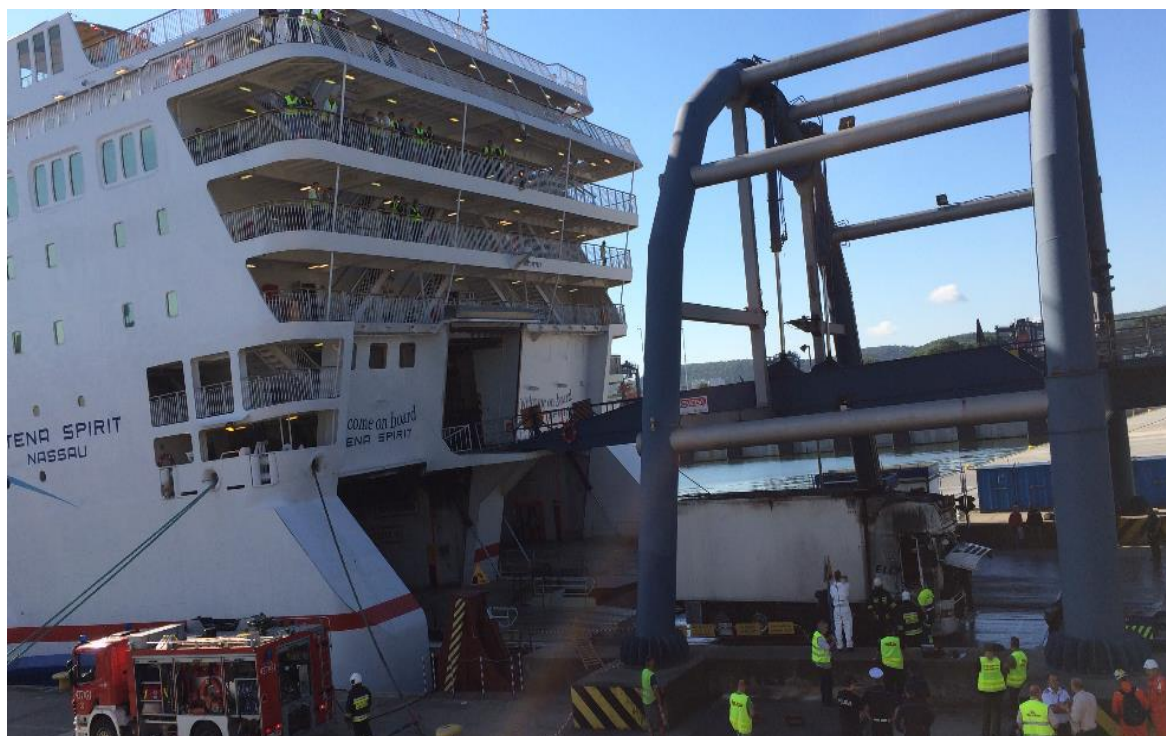
Photograph 4: Fire on the car and passenger ferry, "Stena Spirit" (WIM 60/16)

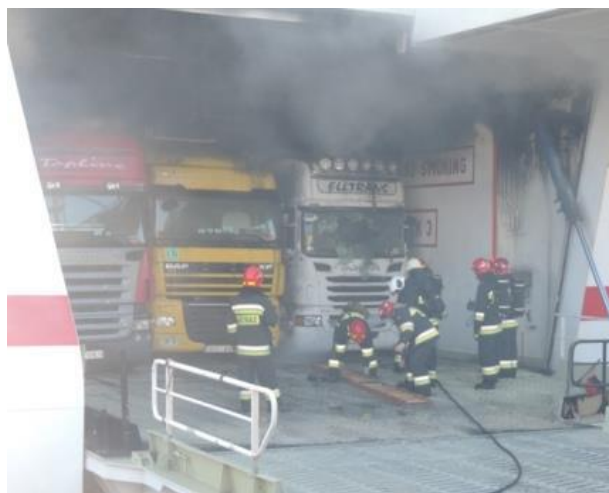
Photograph 5: Firefighting action of the shore unit on the car and passenger ferry, „Stena Spirit” (WIM 60/16)

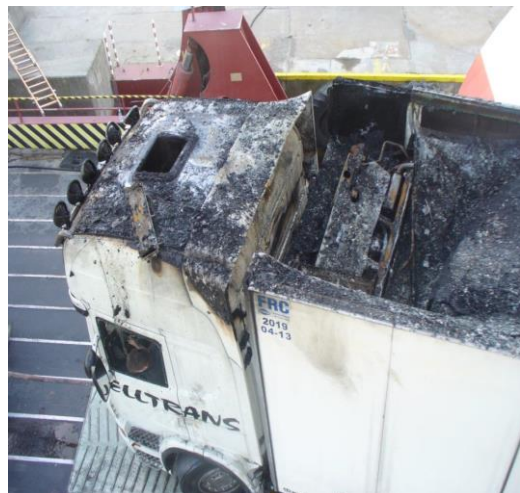
Photograph 6: The car, whose cooling unit was the source of fire on „Stena Spirit” (WIM 60/16)

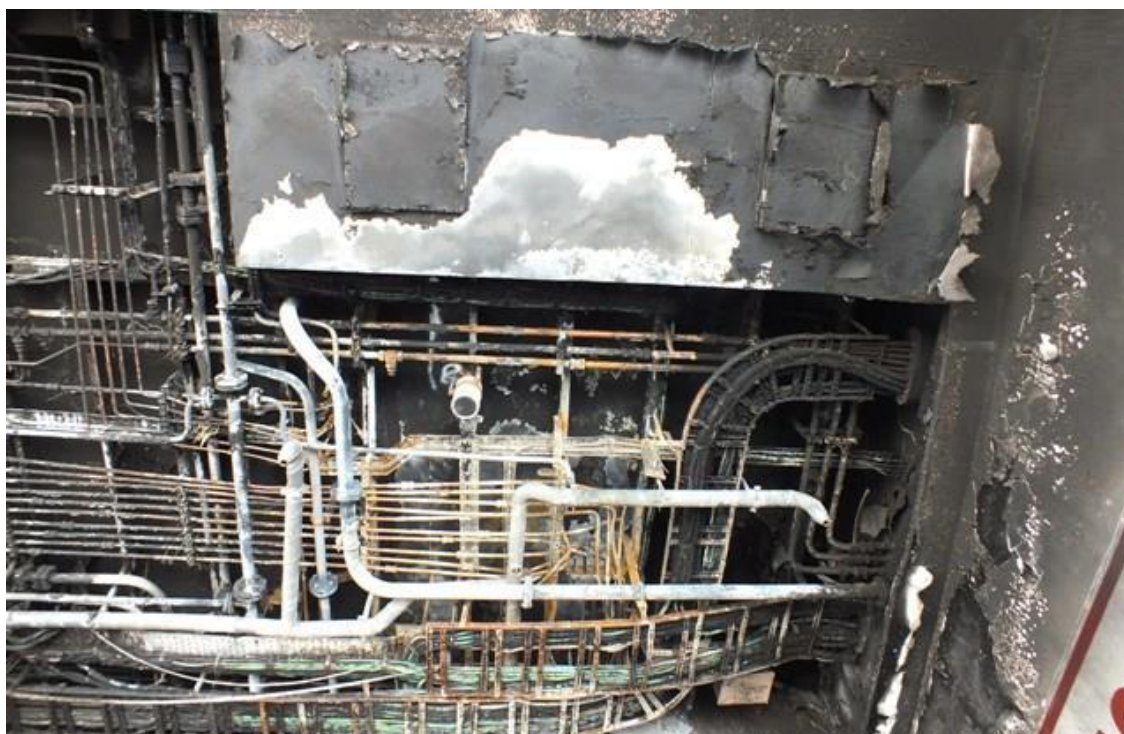
Photograph 7: Hydraulic installation damaged during fire on „Stena Spirit” (WIM 60/16)

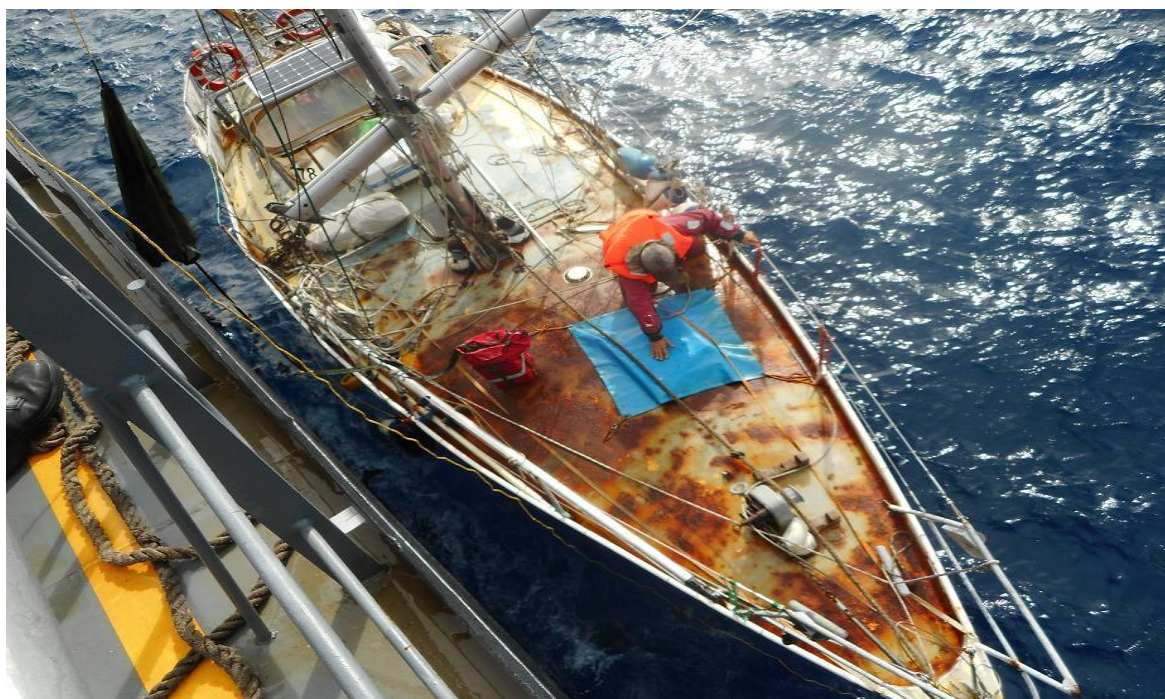
Photograph 8: The yacht, „Regina R” during final evacuation (WIM 20/17) [Source: m/v „Key Opus”]

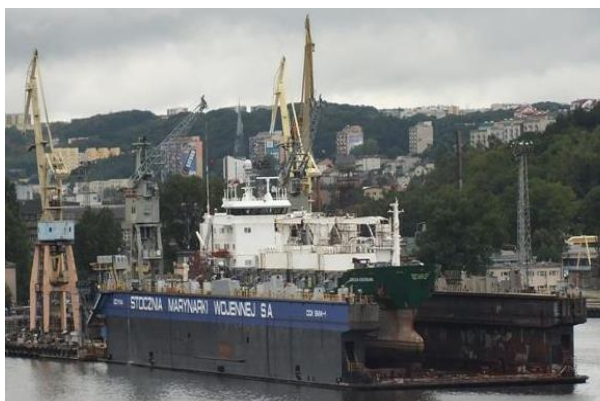
Photograph 9: The dock "SMW-1" (WIM 39/15)

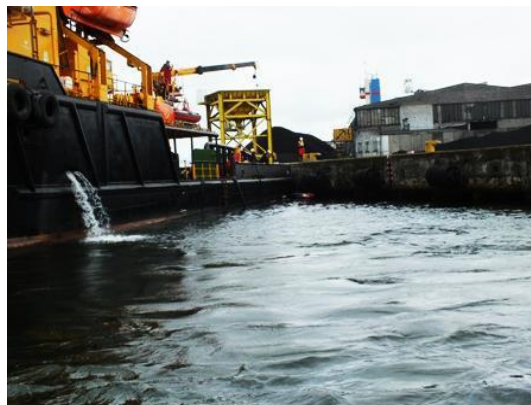
Photograph 10: Removing the spill by the SAR "Kapitan Poinc" (WIM 39/15)

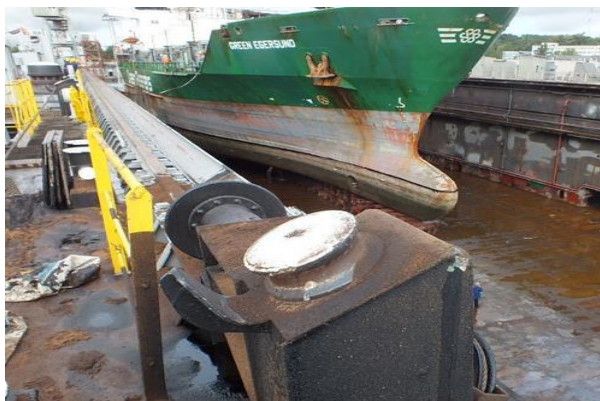
Photograph 11: Traces of paint from the hull of the vessel on the edge of substructure of a mooring roll (WIM 39/15)

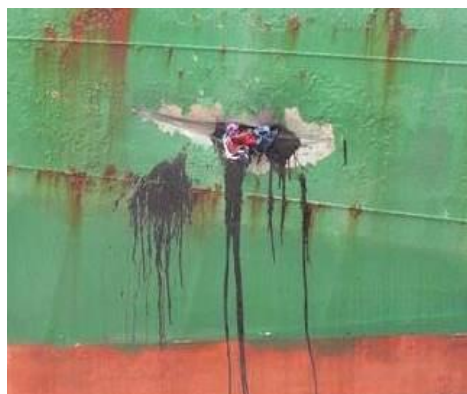
Photograph 12: Damaged (pierced) sheathing of the hull of "Green Egersund" (WIM 39/15)

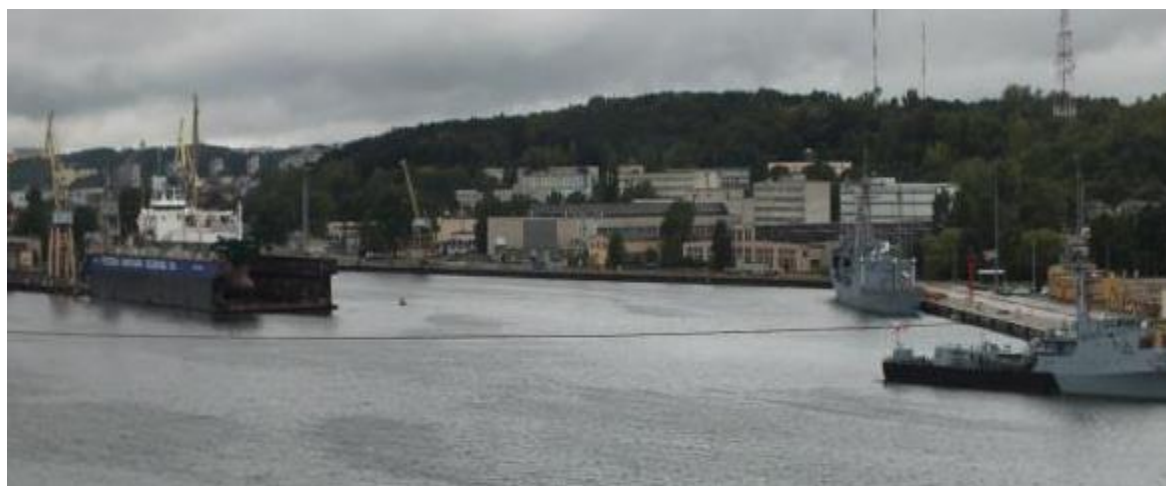
Photograph 13: Dock IX separated by an oil spill boom from the port (WIM 39/15)*

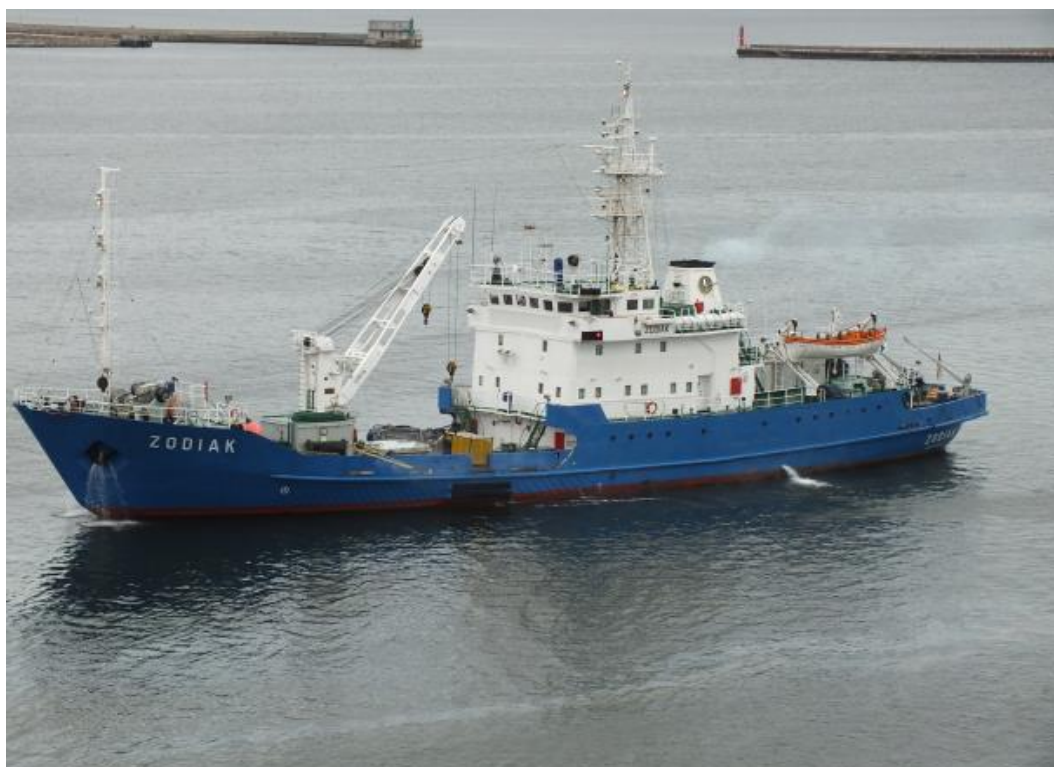
Photograph 14: The hydrographic vessel, „Zodiak” neutralizing the spill of oil in the roadstead (WIM 39/15)
