# **STATE COMMISSION ON MARITIME ACCIDENT INVESTIGATION**

## **FINAL REPORT 41/13**

**Collision of Annemieke and Tao Hua Hai  
during exit manoeuvres from the port of Świnoujście  
on 19 December 2013**

**February 2015**

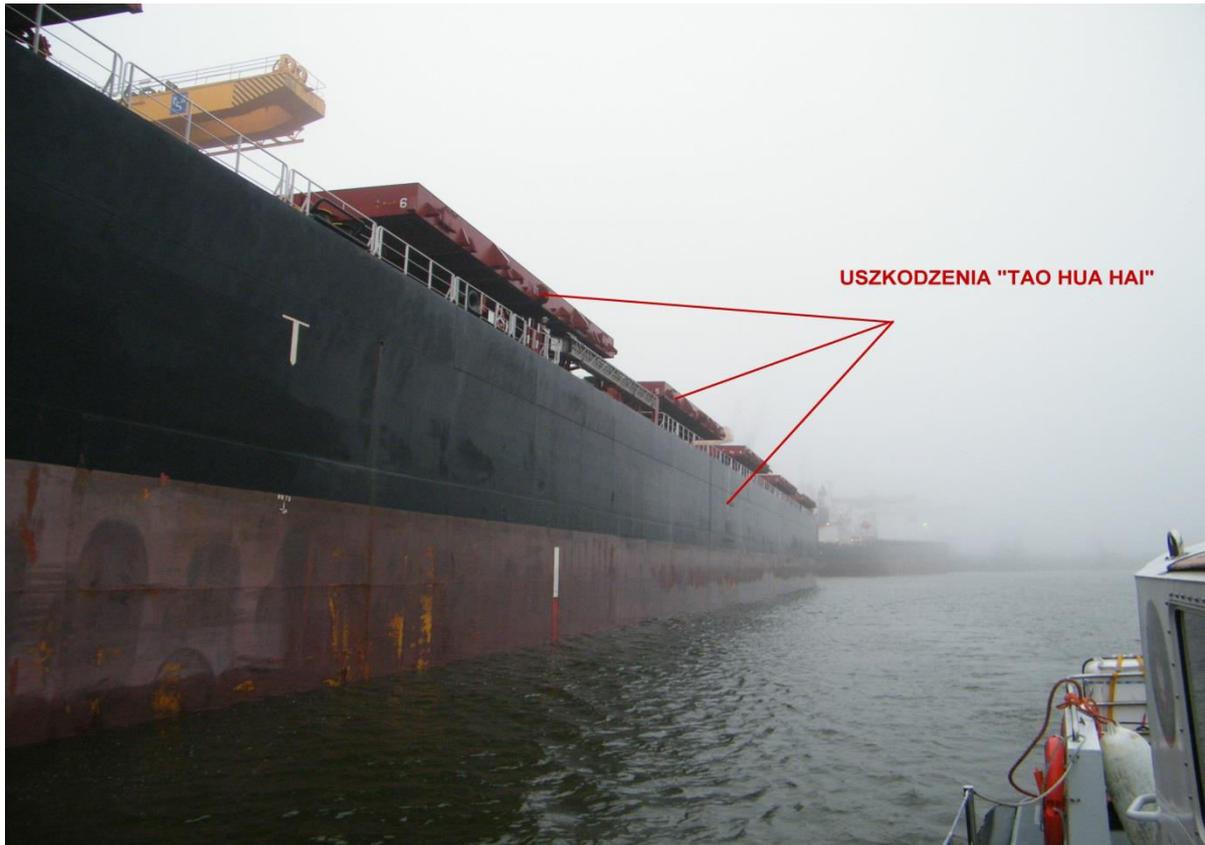
Just before 22:17 Annemieke moving at the speed of 10.2 knots rubbed with her starboard side against the vessel Tao Hua Hai laying at the Chemików Wharf. As a result of the impact the ship's side and the elements of two hatches of the hold of Tao Hua Hai were damaged. At Annemieke the cantilever of the crane no 3 at the stern was damaged as well as starboard side fenders.

Photograph 4: Damages of Tao Hua Hai

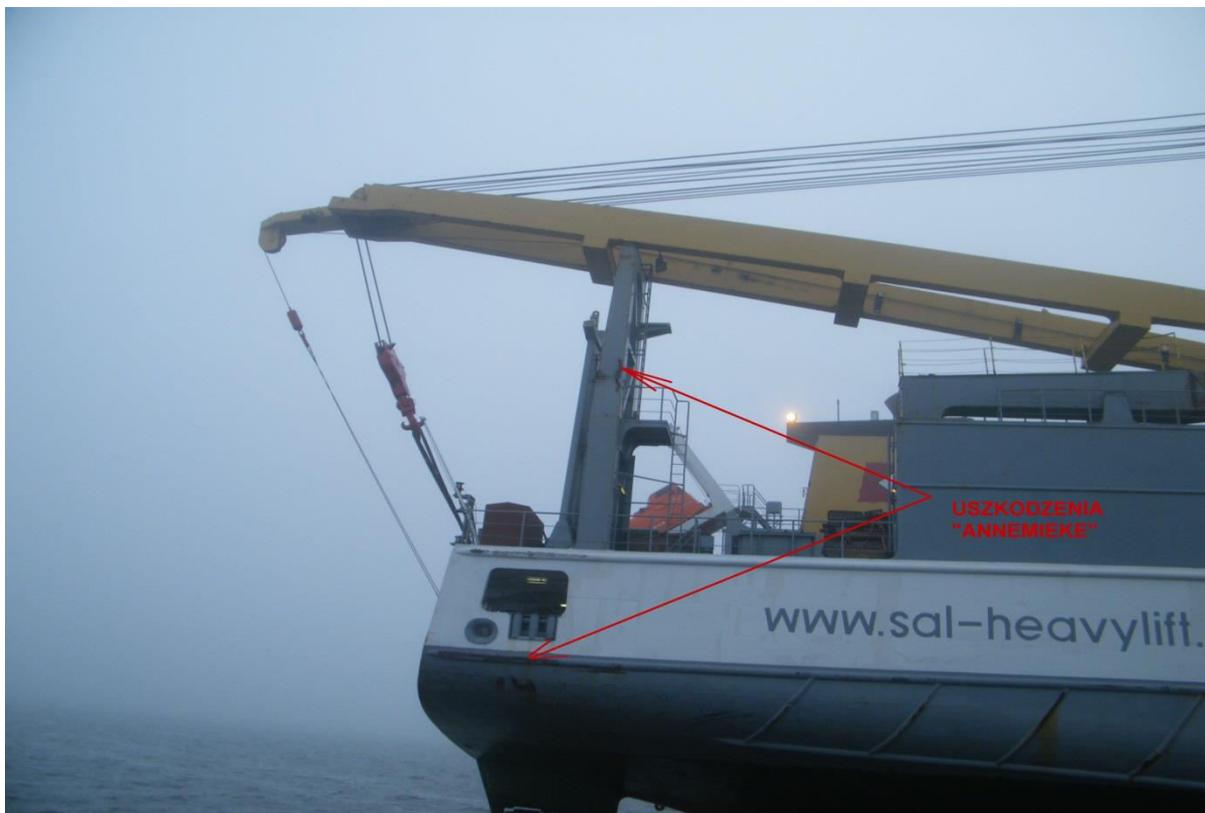
Photograph 5: Damages of Annemieke

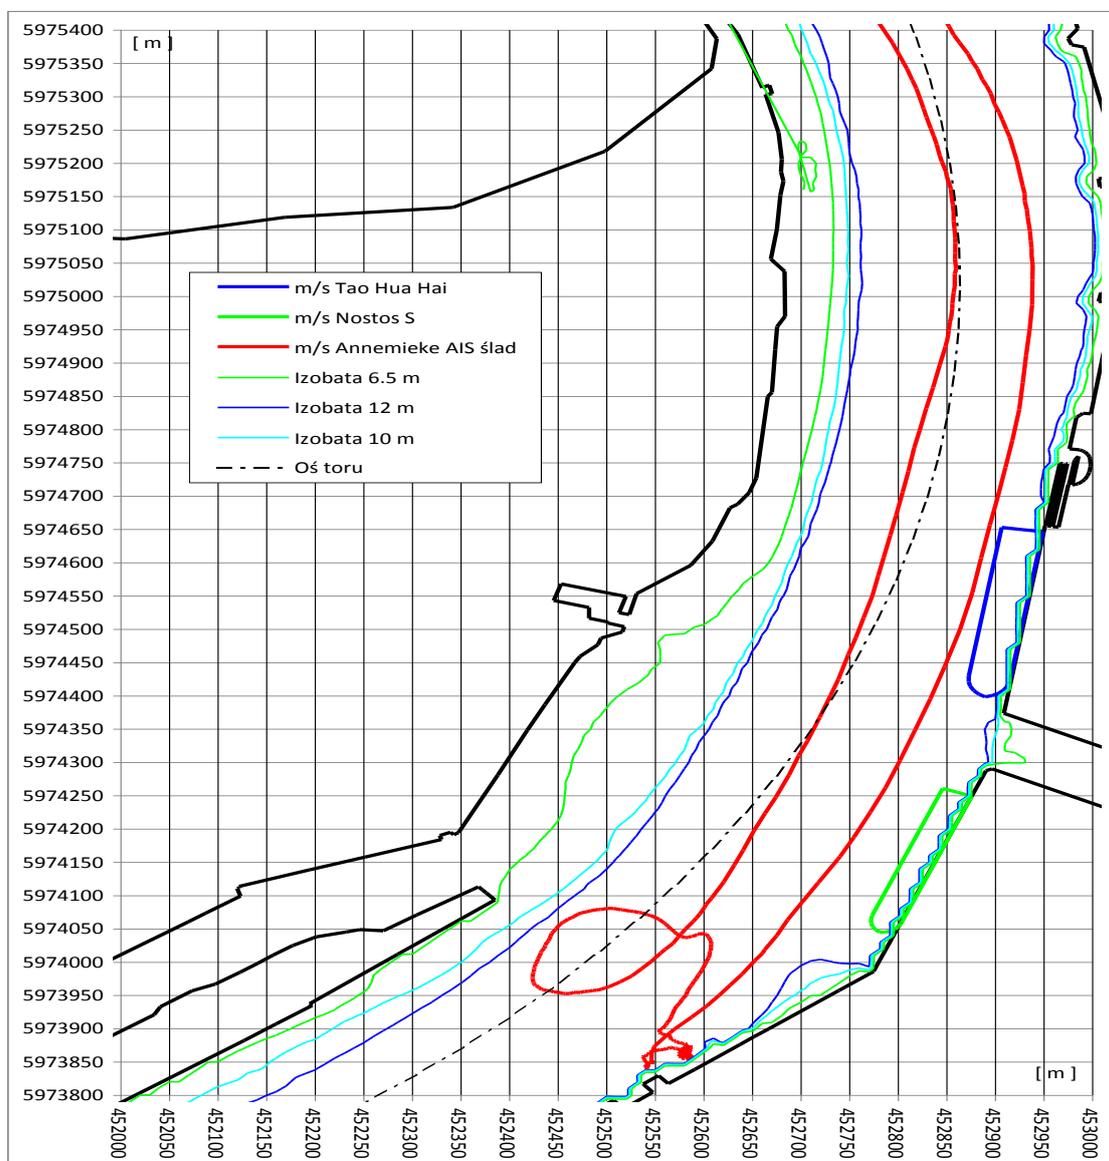
Figure 1: Trajectory of movement of Annemieke while calling at the port of Świnoujście

To examine the way in which Annemieke was manoeuvring at the port, the Commission read out AIS data stream coming from the receiver installed on the vessel at the time of entering and leaving the port of Świnoujście on 19 December 2013.

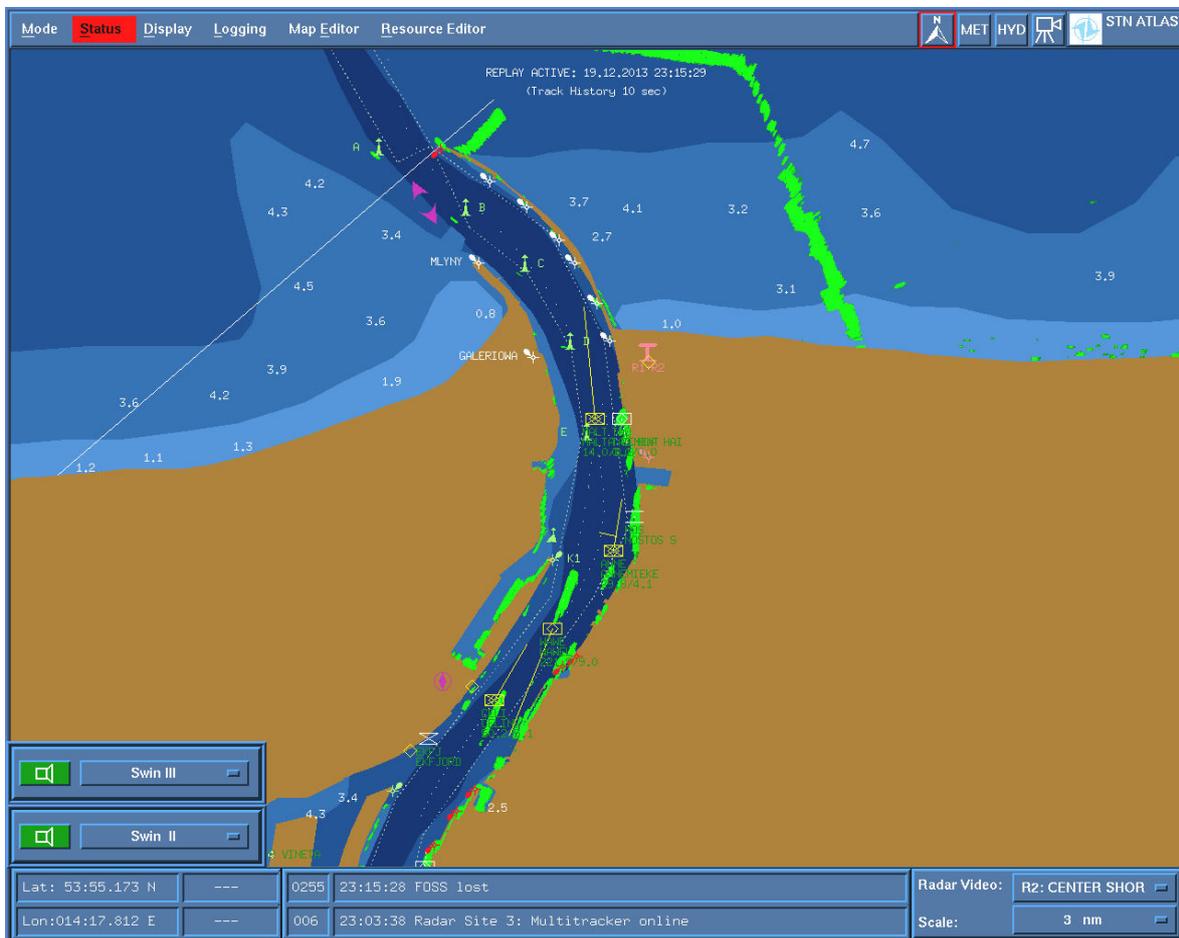
Figure 3: VTS image of 23:15:29

Fig. 3 presents the VTS image of 23:15:29 showing the navigational situation at the time when Annemieke was approaching the Hutników Wharf at which the ship Nostos S was moored. The ferry Wawel had already passed the stern of Annemieke going in the opposite

direction at a safe distance on her (western) side of the fairway. At the port entrance there were no other vessels. Annemieke was moving at a course of 023° at the speed of ca 8 knots<sup>1</sup> and the main rudder in the midship position.

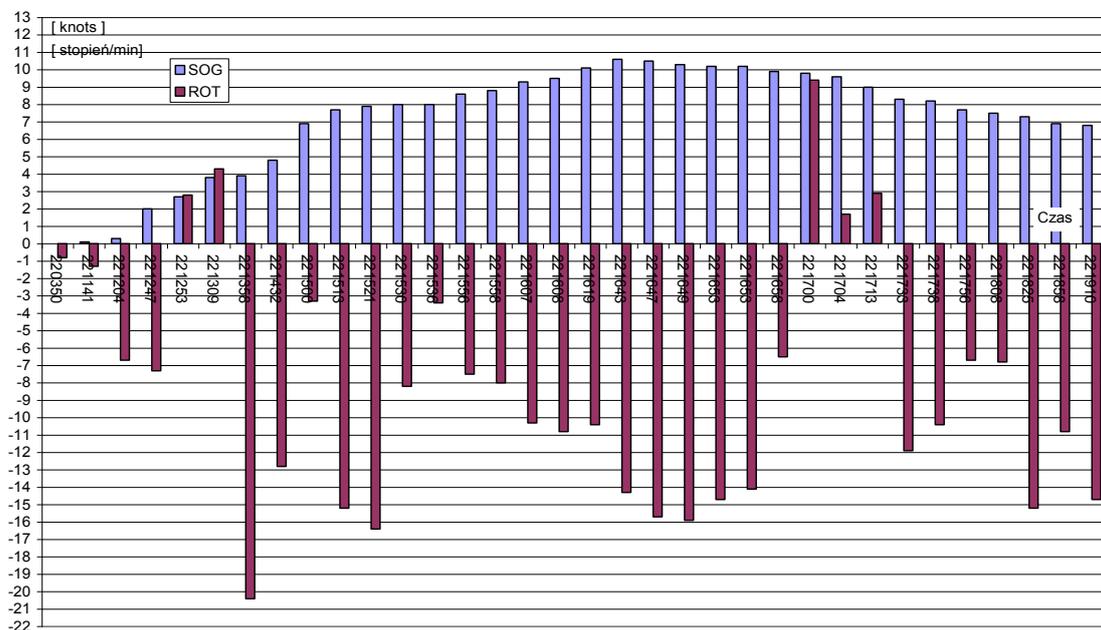
Figure 4: Diagrams of the speed over ground (SOG) and angular velocity (ROT) of Annemieke as a function of the manoeuvre duration

Fig. 4 shows a histogram representing speed over ground and the angular velocity of the vessel as a function of time for several minutes critical for Annemieke’s manoeuvres.

The analysis of angular velocity shows that when the vessel was setting off from her parking space near the Górników Wharf, she had a minimum angular velocity to port. That speed increased considerably by the use of the bow thruster at 23:11:41. If the tendency to rotate to port ( $7^{\circ}/\text{min.}$ ) was maintained it would allow the vessel to slowly enter the fairway however the rudder command *Starboard 20* given at 23:12:47 caused that the vessel lost her angular velocity to port and started rotating in the opposite direction. The analysis of VDR shows that at that time the ferry Wawel was approaching the bow of the vessel. Probably it was the reason why the pilot “aligned” the course of the vessel parallel to the fairway.

Then, the subsequent manoeuvres of the rudder (*Port 20, Midships, Port 10*) restored angular velocity to port. Nevertheless it was too low (at 23:15:21 the pilot ordered again to turn the rudder *Starboard 10*, which once again significantly reduced the angular velocity to port) in combination with increasing longitudinal speed to move the vessel closer to the axis of the fairway and let her safely sail past the vessel mooring at the Chemików Wharf.

The analysis of the histogram presented above makes it possible to determine precisely the time of the collision. The impact occurred at 23:16:58. Then there was a sudden change of the direction of the angular velocity from port to starboard, due to the rebound of the Annemieke’s stern from the ship’s side of Tao Hua Hai. The impact must have been significant, because the angular velocity amplitude was as high as  $16^{\circ}/\text{min.}$

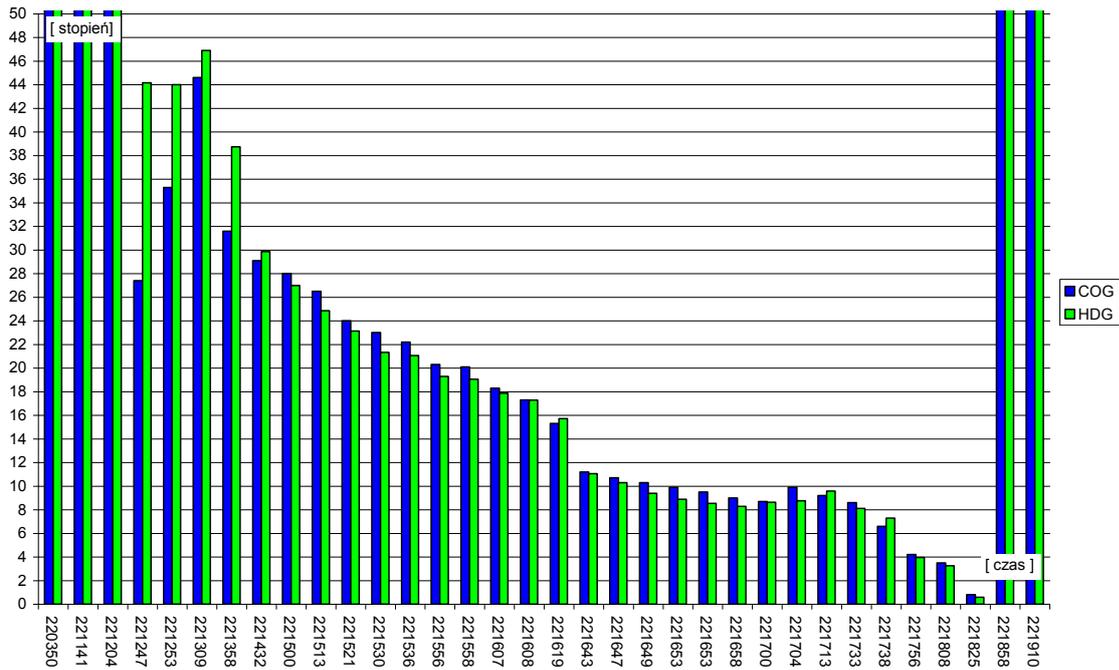
Figure 5: Diagrams of the course over ground (COG) and heading (HDG) of Annemieke as a function of duration of a manoeuvre

Fig. 5 shows a histogram representing the values of the vessel’s heading and the course over ground in the function of manoeuvres’ duration. The analysis shows that from 23:12:47, that is since the vessel was set on the course of  $027^{\circ}$  towards the exit from the port of Świnoujście, until 23:18:25 i.e. when the heading of the vessel stabilized after the collision, the heading did not differ much from the course over ground which indicates that the influence of hydro-meteorological conditions on manoeuvring of the vessel was small and they did not have to be counteracted.

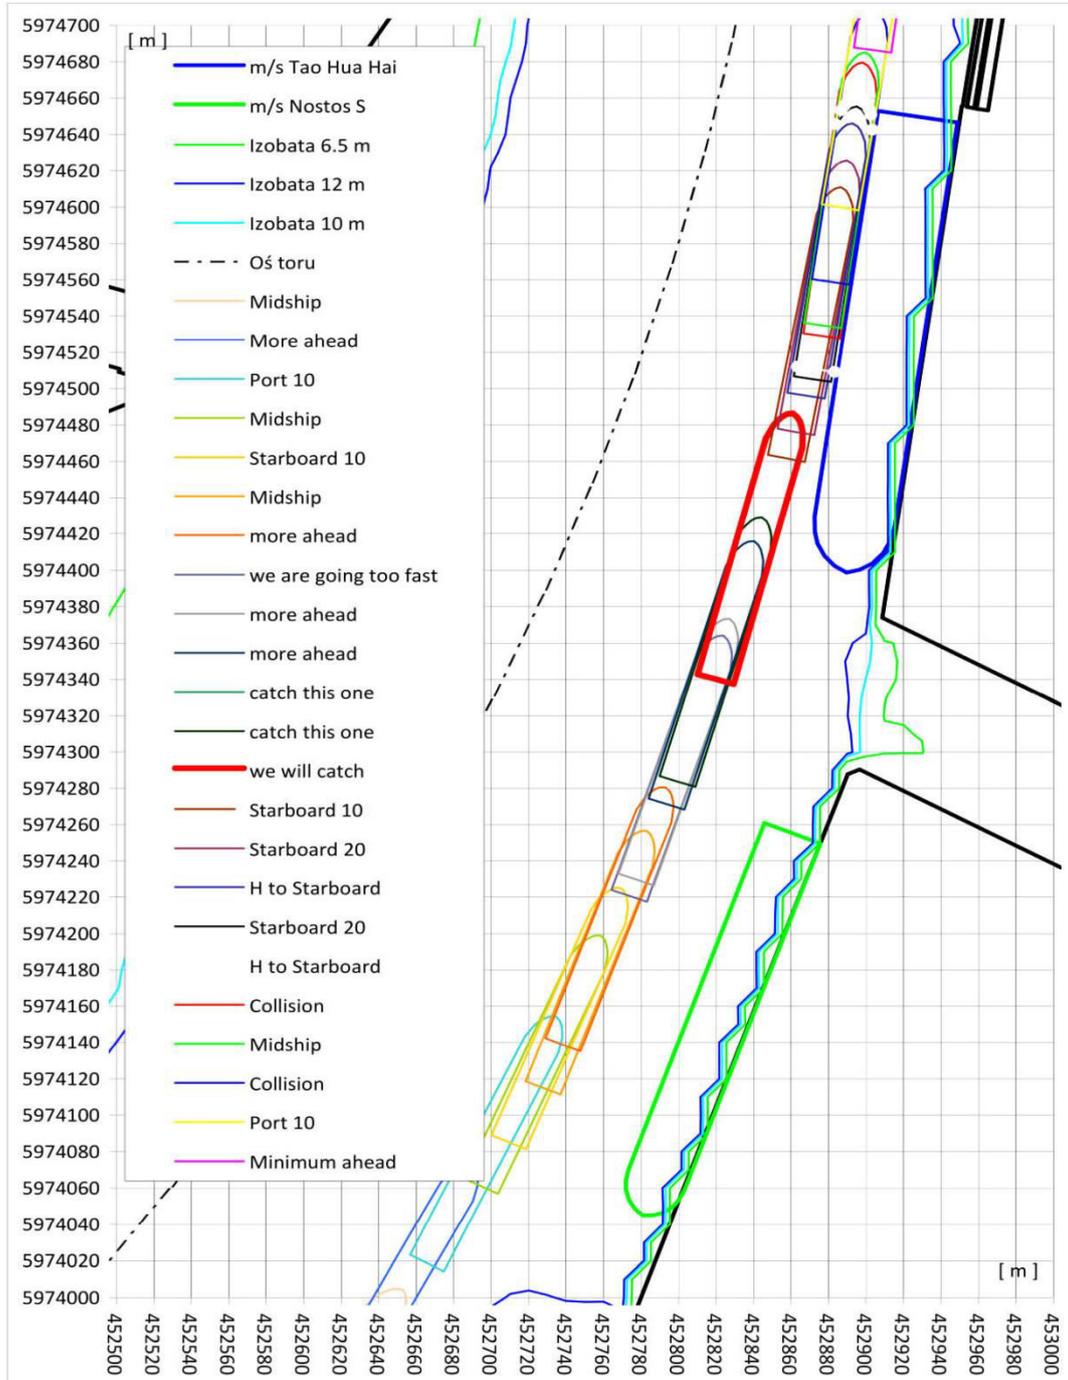
Figure 6: Annemieke's watelines when passing by Nostos S and the collision with Tao Hua Hai

Fig. 6 shows the positions of the Annemieke’s outlines (which are maximum waterlines) in the ship’s manoeuvring water region of the northern part of the fairway at the port of Świnoujście and a table of commands (the left side of the figure) given by the pilot or description of events that took place during the corresponding positions of each outline, in the chronological order, starting from 22:14:32 (blue waterline at the bottom of the figure and the corresponding pilot’s command *More ahead* in the table).

A reference point for further analysis is a red (bold) waterline of the vessel, which refers to 23:16:29 hrs. corresponding to the position of the vessel in which the captain was already convinced that the collision was unavoidable (correlated in the table on the left with what the captain said: *We will catch this one*). All actions taken by the vessel after that time were the evasive ones aiming only to minimize the effects of the collision.

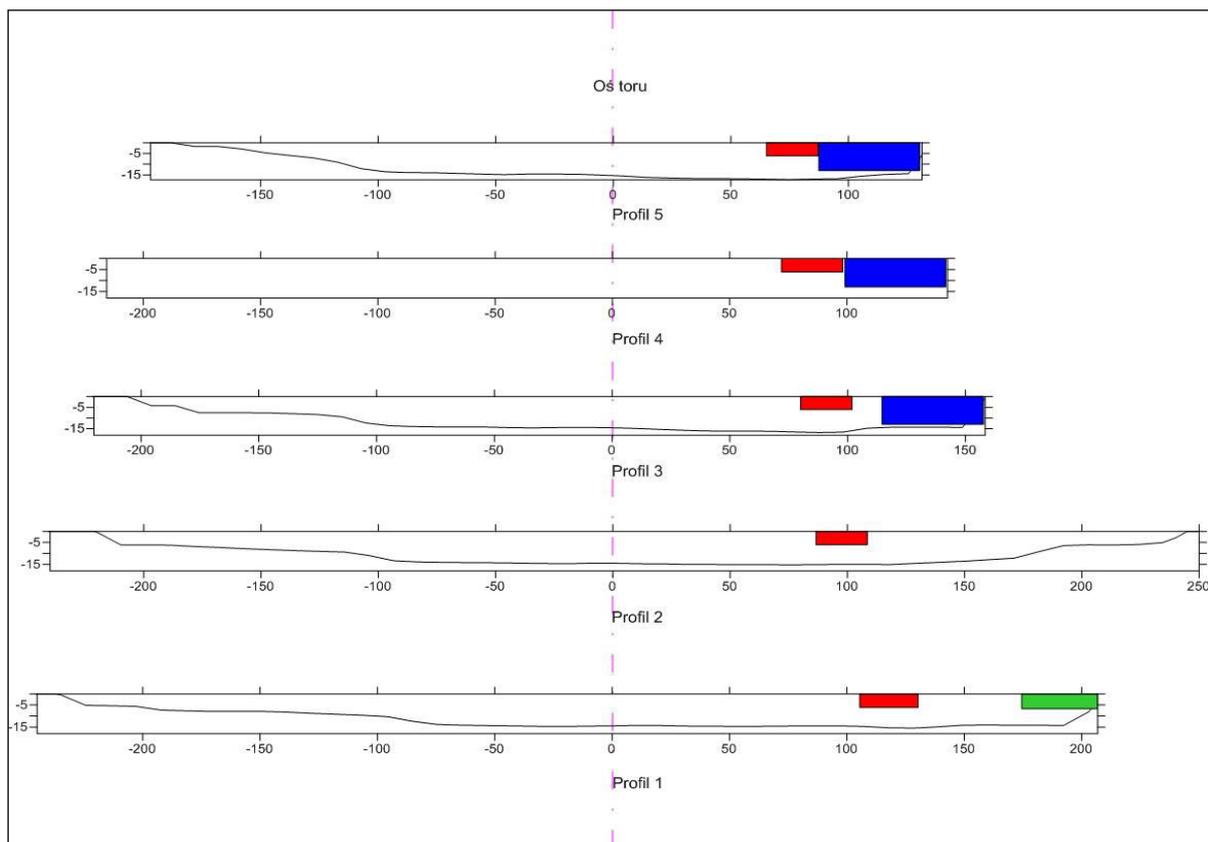
Figure 7: Profiles of the ground of the port channel with outlines of vessels: *Nostos S* (green), *Tao Hua Hai* (blue), and *Annemieke* (red)

The port of Świnoujście is located over the Świna Strait, which joins the sea in its northern part. The curvature of the fairway and configuration of wharves causes that the currents there have different directions and strength. On the outer edge, closer to the shore, the values of currents can be increased whereas on the inner edge they can be decreased. Furthermore, in relation to the vessels navigating down the strait there occurs a phenomenon of a channel effect with variable intensity, as well as the effect of interaction of passing ships. Both phenomena may impair the steering ability of the vessel because of the asymmetrical flow of water along the hull. Due to a difference in the profiles of the flow of water along the sides of the vessel, the flow rate of a water jet is greater on the side of a shore or the hull of another ship. Therefore, in the vicinity of the stern, where the flow of water is greatly increased by the sucking action of the screw, there appears a great force attracting the stern towards a nearer shore or ship.

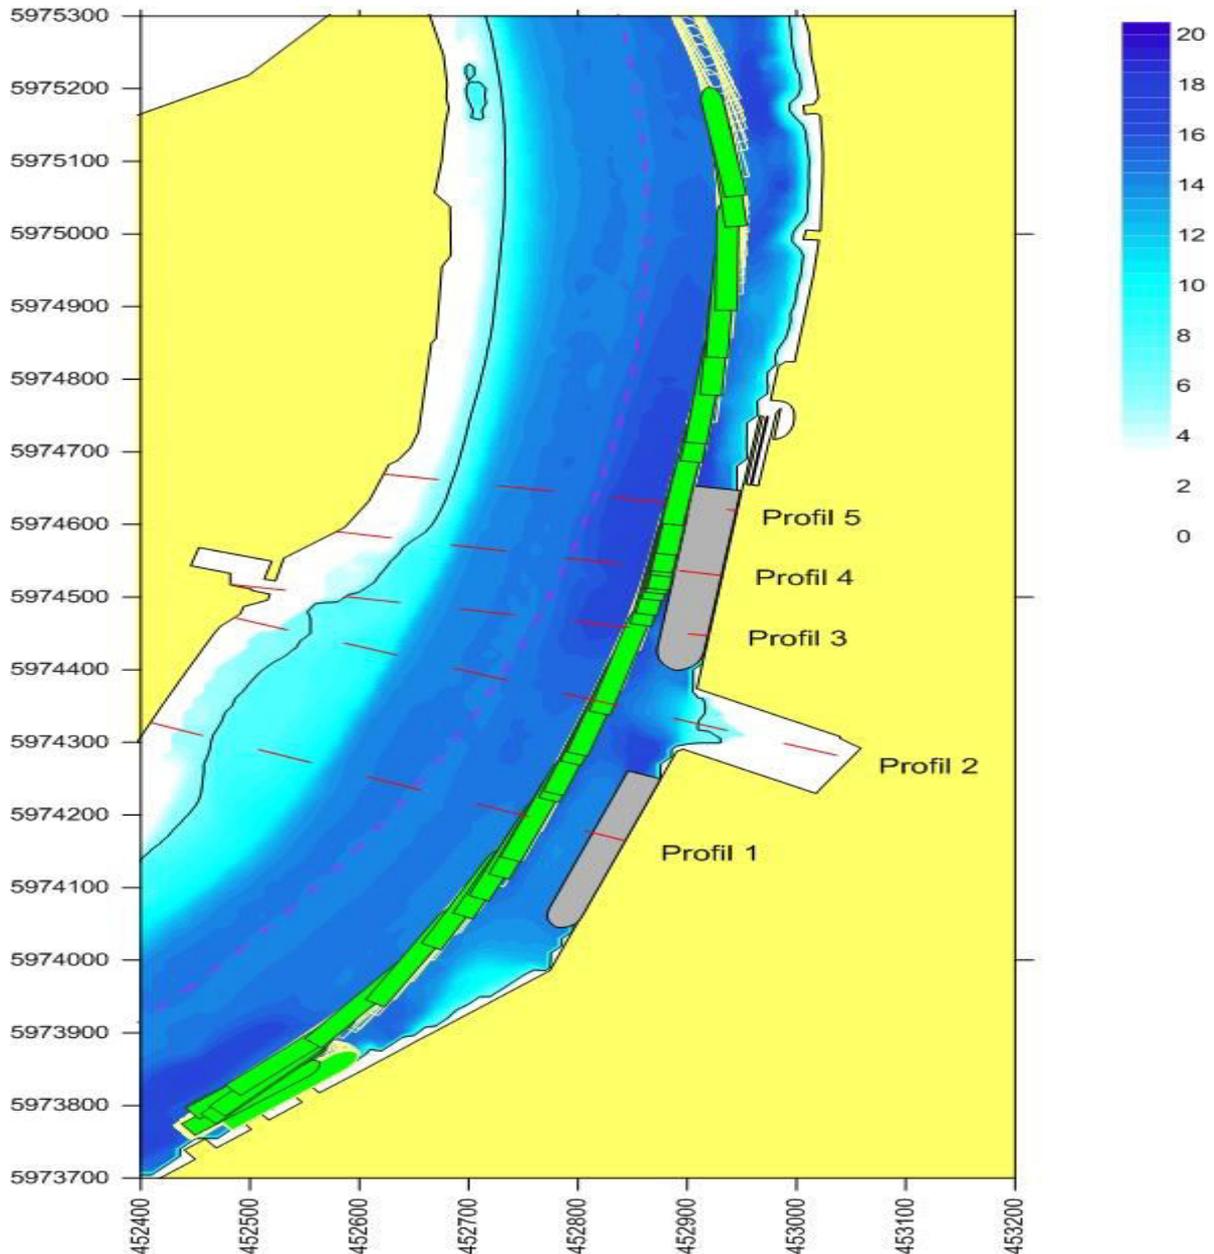
Figure 8: Trajectory of movement of Annemieke and indicated bottom profiles

The basic principle in preventing the channel effect, that is attracting the stern of the ship to the shore, is to navigate at the greatest possible distance from it, which in case of the port of Świnoujście means navigating in the middle of the fairway. As one can see from the presented figures No. 7 and No. 8 Annemieke was navigating away from the axis of the fairway.

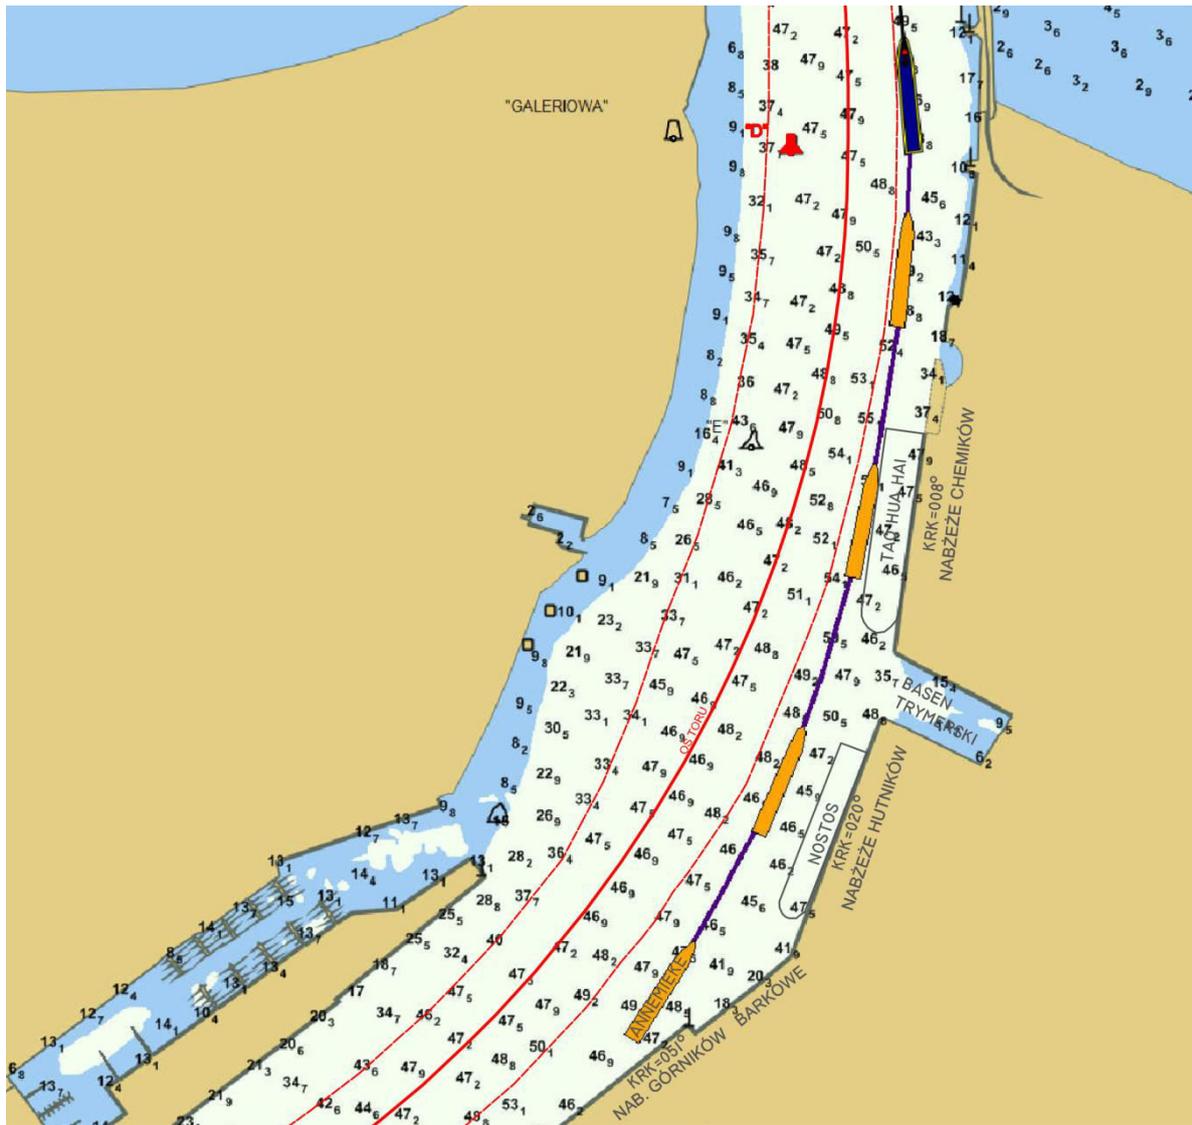
Photograph 6: Trajectory of movement of Annemieke in relation to the shape of the fairway and mooring vessels

Photograph No. 6 shows an image of the electronic chart with outlined northern part of the fairway in the port of Świnoujście and the trajectory of movement of Annemieke, set with the help of the program NavCruiser PRO based on data read from the VDR recorder, covering the period just after the vessel started moving from the drift at the Górnice Wharf (23:13:28) until she appeared at the level of the base of the central breakwater (23:19:04) after the collision with Tao Hua Hai.

The map in the photograph No. 6, clearly shows that Annemieke was being led all the time outside the fairway, even after the collision and after passing Tao Hua Hai.
