STATE COMMISSION ON MARITIME ACCIDENT INVESTIGATION

FINAL REPORT 29/13

M/T HORIZON APHRODITE

Bumping against a concrete cap of the head and damaging the fender frame
of the eastern breakwater at the exit from the port of Gdańsk on 22 September 2013

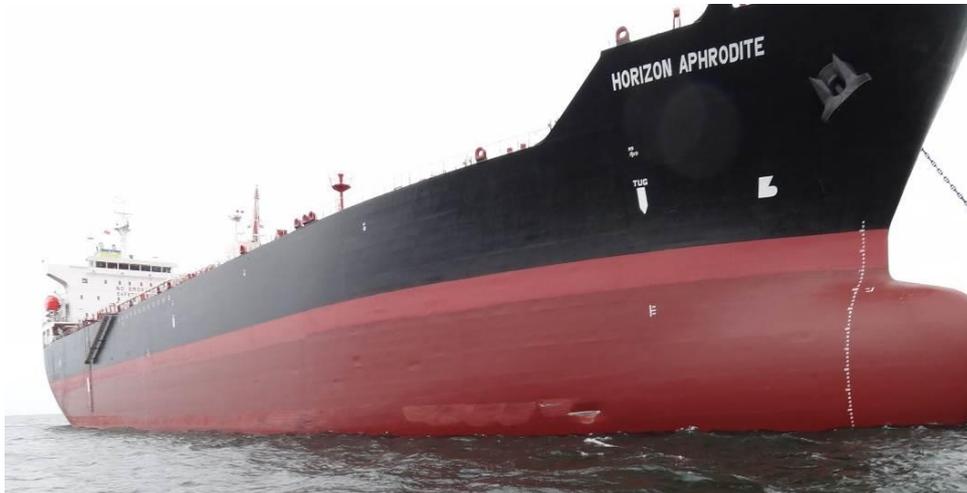
Because of the contact of the vessel with the cap of the eastern breakwater head, the outer shell was damaged on the starboard side in the bow section of the vessel. After a short stop at anchor, Horizon Aphrodite was led back into the Ship Repair Yard to be repaired.

Photograph 2. Damaged hull at the level of alternating draught line

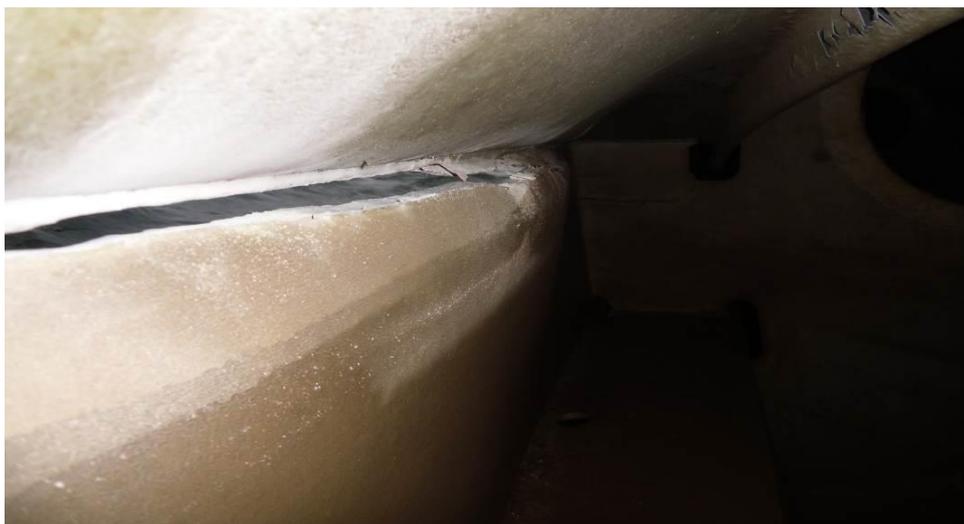
Photograph 3. Torn hull plating - view from the inside of the vessel

After inspecting the tanks at the bow, the crew stated that the plating of the hull in one of the dents had been punctured, and one of the longitudinal frames deformed.

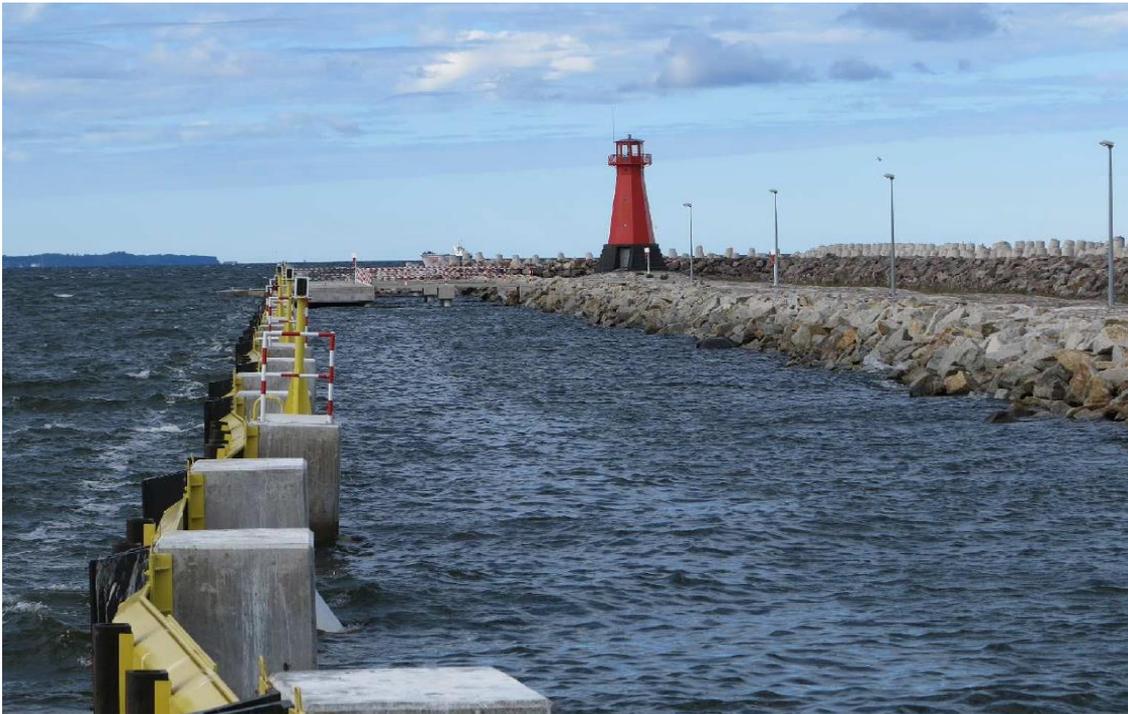
damage to the fender frame construction of the eastern breakwater: above water - damage to more than a dozen steel bays (slides) between dolphins at a distance of ca. 100 m; under water - deviation of 7 dolphins from the vertical position.

Photograph 4. Damaged bays and supports (dolphins) of the fender frame of the breakwater

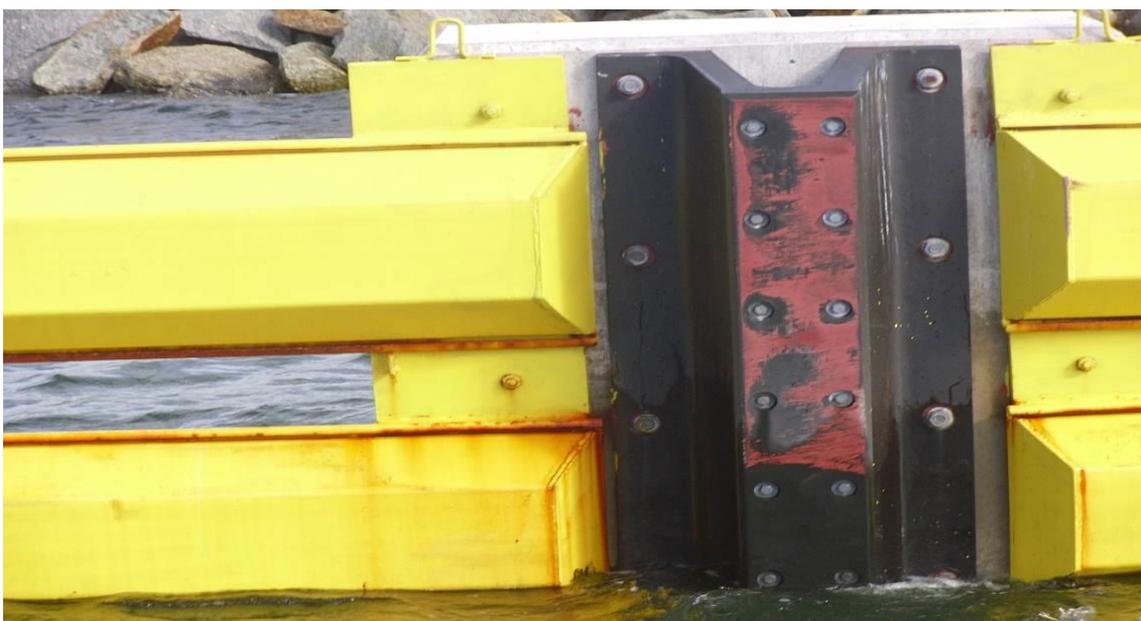
Photograph 5. Fender on a dolphin with traces of red paint stripped off the vessel's hull

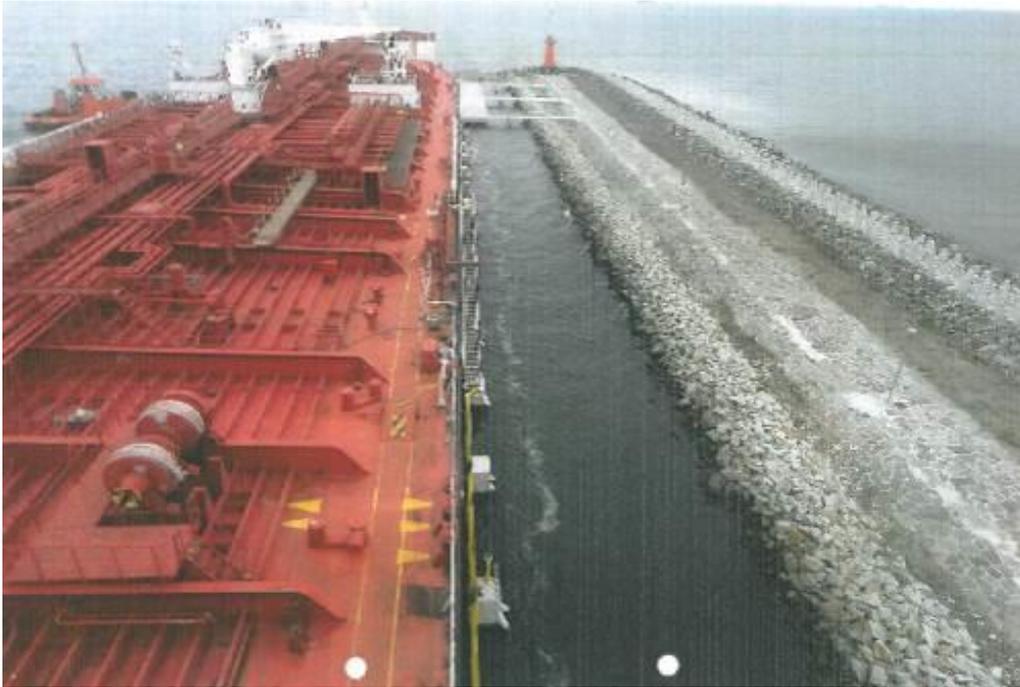
At ca. 15:58 moving at the speed of 3.7 knots the vessel first rubbed with the stern against steel bays between main dolphins no. 7 and 8 (equipped with warning lights and ladders), damaging three dolphins, and then began to move forward along the fender frame of the breakwater rubbing its steel bays. Subsequent manoeuvres with the rudder: *Left 10, Hard a Port, Midships*, did not push the vessel away from the fender frame.

Photograph 7. The vessel leaning starboard side against the fender frame protecting the breakwater

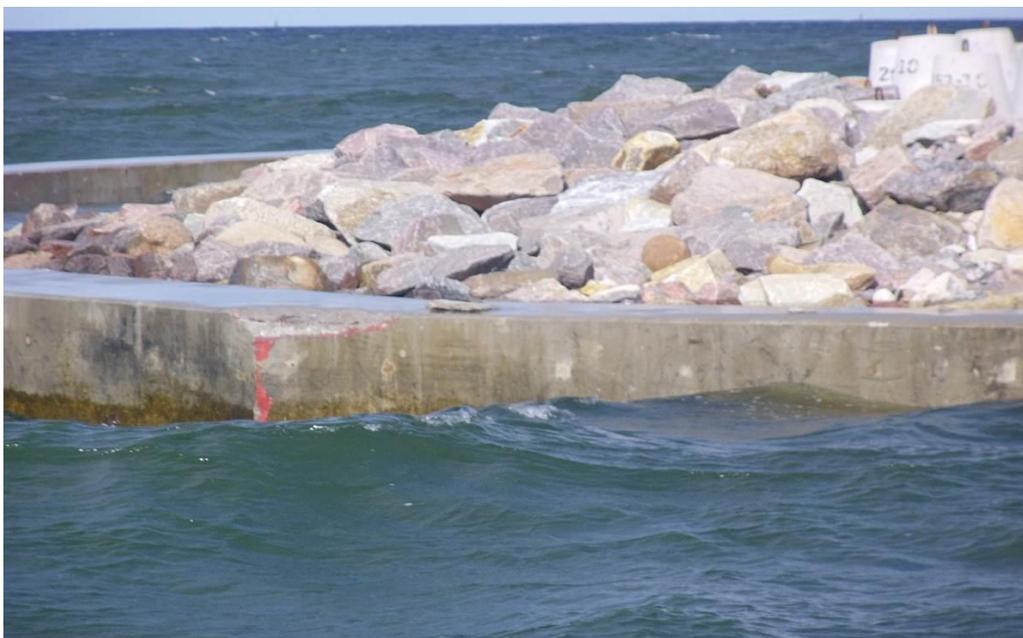
At ca. 15:59 the pilot stopped the engine, called the tugboat Taurus and ordered to give tow-line at the bow. Then he commanded *Slow Astern*. At ca. 16:00 the vessel got caught at the bow part of the starboard side in the concrete cap of the eastern breakwater head and stopped.

Photograph 8. The cap of the breakwater head with a visible point of contact with the vessel's hull

Hitting on the concrete cap of the breakwater head, which caused damage to the vessel in her bow part, could have been prevented if the captain or the pilot used full power of the main engine (the vessel was capable of almost 11 thousand HP). The applied manoeuvre *Slow Astern* proved to be ineffective and the vessel stopped just after hitting the cap of the head.

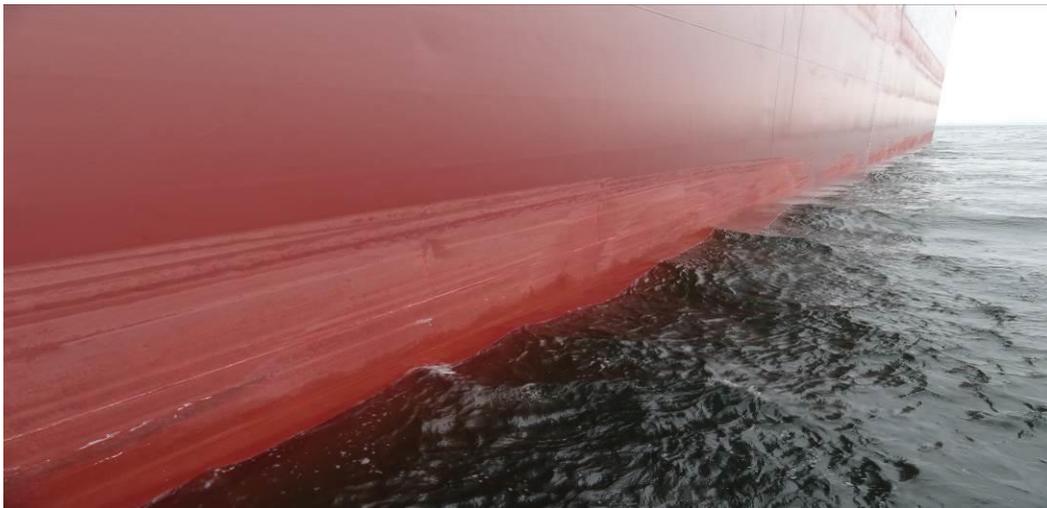
After half an hour the vessel arrived to the anchorage No. 3 at the roadstead and at 16:50 dropped anchor at position $\varphi = 54^\circ 27,67'N$, $\lambda = 018^\circ 42,46'E$. The pilot and the captain of the vessel took the pilot boat and made visual inspection of the hull from the outside. There were noticed abrasions on the starboard almost along the entire length of the vessel and two dents in the bow section near the bulbous bow.

Photograph 9. Abrasions of the hull on the starboard side

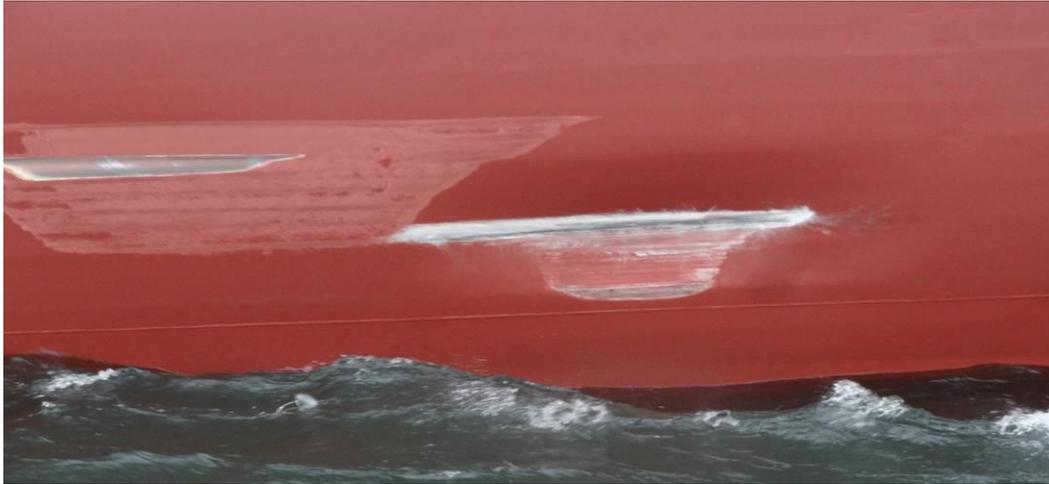
Photograph 10. Dents on the hull on the starboard side

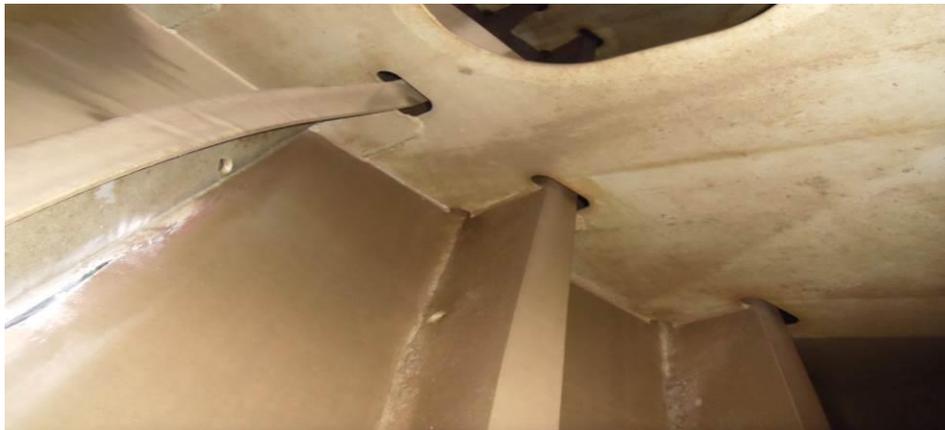
Photograph 11. The deformed longitudinal frame in the ballast tank

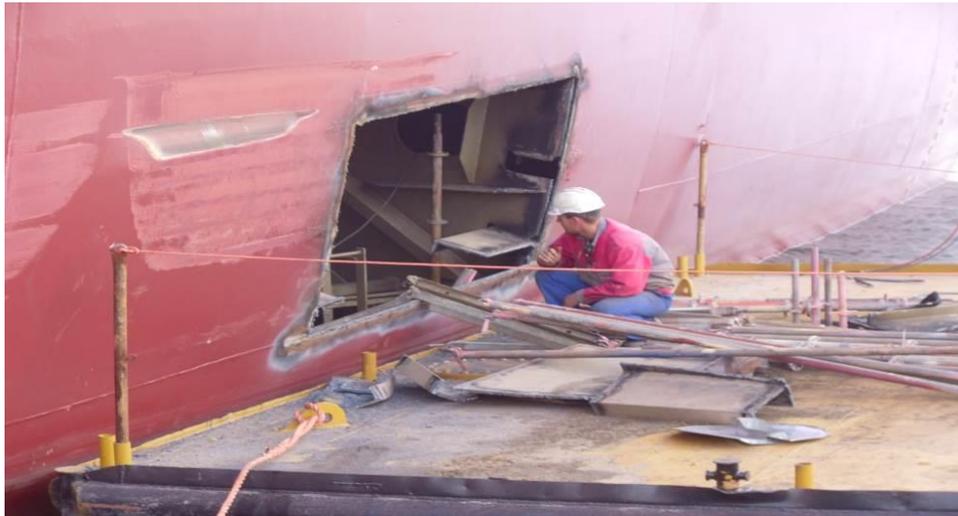
Photograph 12. The cut out part of the hull's metal plating in the place of tear

Later, the same day after leaving the anchorage the vessel returned to the Gdańsk Ship Repair Yard to have the plating repaired.

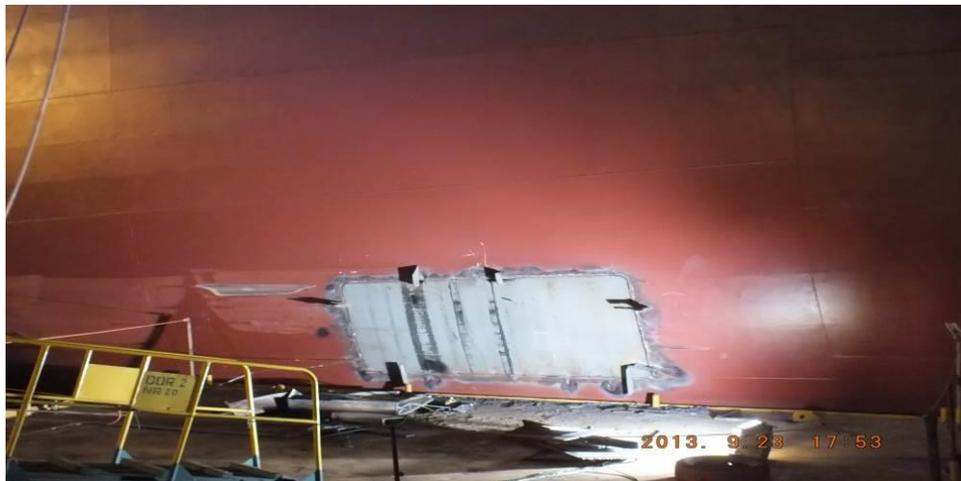
Photograph 13. Inserted new metal plate in the plating of the hull

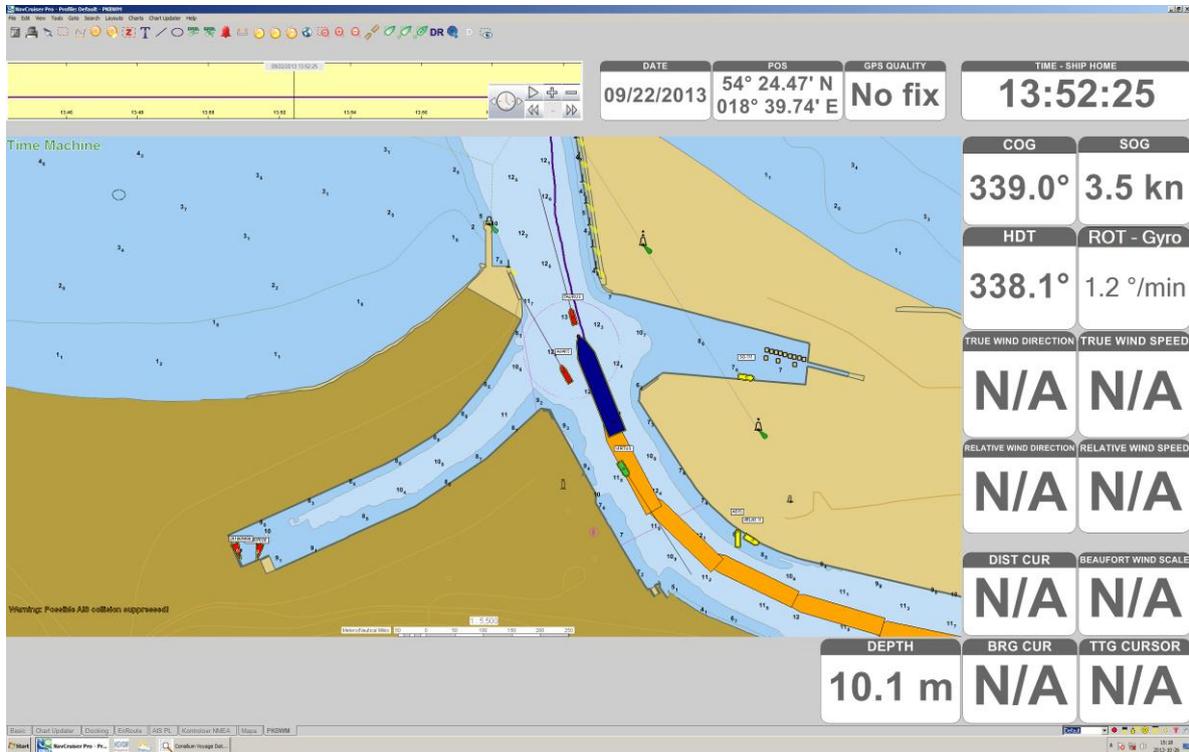
In the opinion of the Commission, the pilot leading the vessel out of the Port of Gdańsk made a mistake by dropping the tugboat at the bow too early.

Figure 1. Location of the vessel at the time the command was given to drop the towline at the bow (13:52:25 LT)

The pilot should have foreseen that at such a large windage area of an empty and not fully ballasted vessel, and with a strong wind blowing almost perpendicularly to the ship's side, the vessel would be exposed to its effect, especially after passing the quays and port buildings, which accounted for some protection from the wind. Using a tugboat at the bow after the vessel had passed the western breakwater, holding the vessel on the towline from the port or pushing the bow from the starboard, would prevent drifting and causing damages.

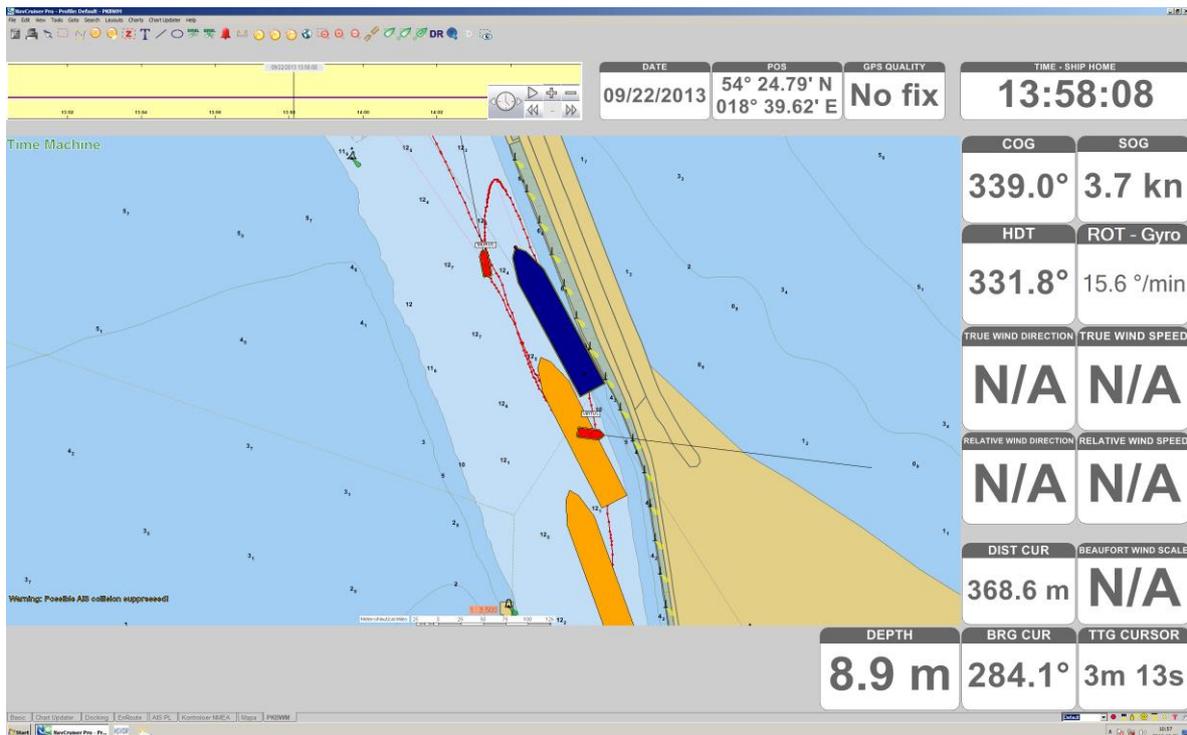
Figure 3. Position of the vessel at the time of bumping with the stern into the fender frame (15:58:08 LT)

Drift of the vessel had started before it reached the western breakwater and continued - despite the use of a tugboat at the stern - until the vessel rested on the fender frame.

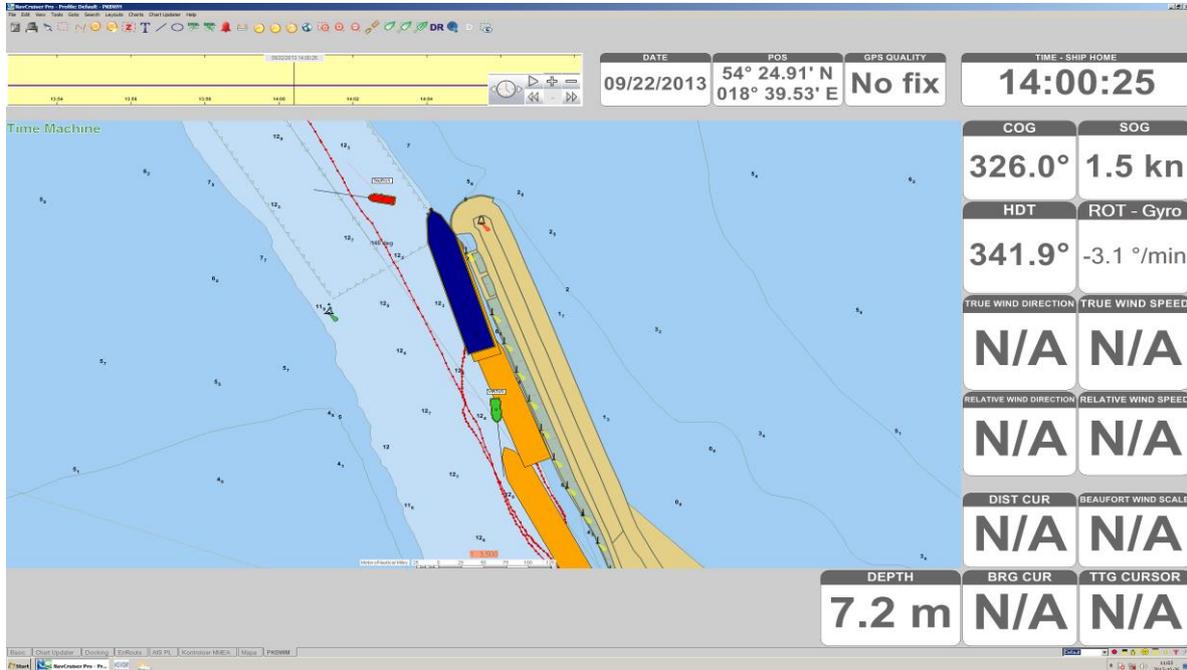
Figure 4. Position of the vessel at the time of hitting on the cap of the breakwater head (16:00:25 LT)

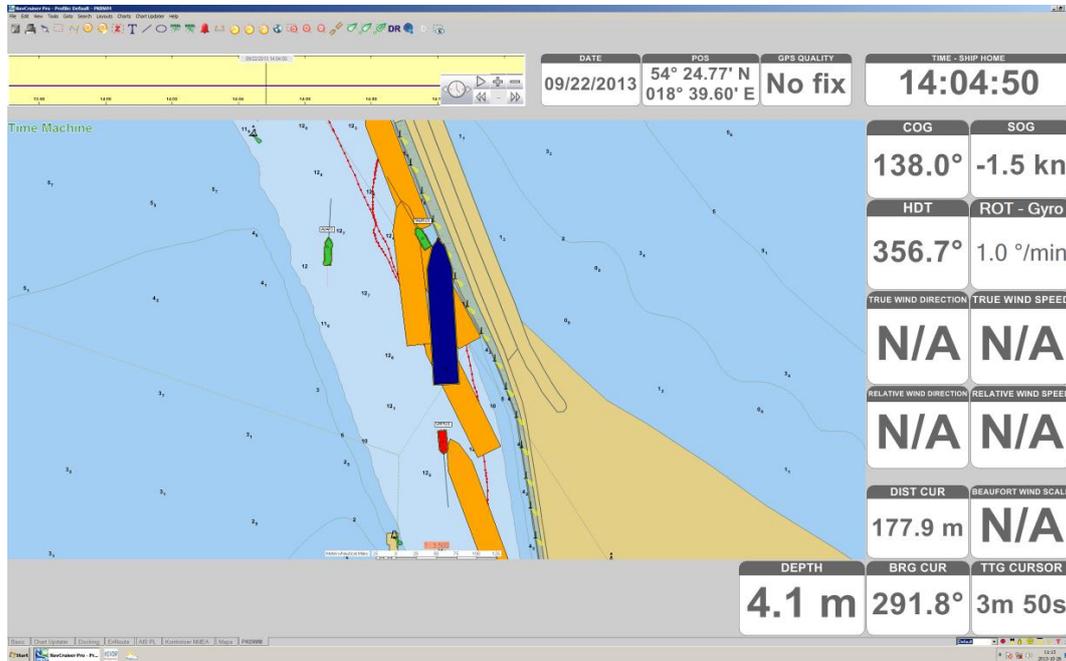
After the vessel moved away from the head and the fender frame of the breakwater due to a strong drift and prolonged time of giving the towline at the bow, there was another blow at the fender frame (with the bow). There passed almost 6 minutes from the time the pilot ordered to give the towline until it was fixed. The towline was fixed 10 seconds before the blow.

Figure 6. Position of the vessel at the time the bow leaned against the fender frame (16:04:50 LT)

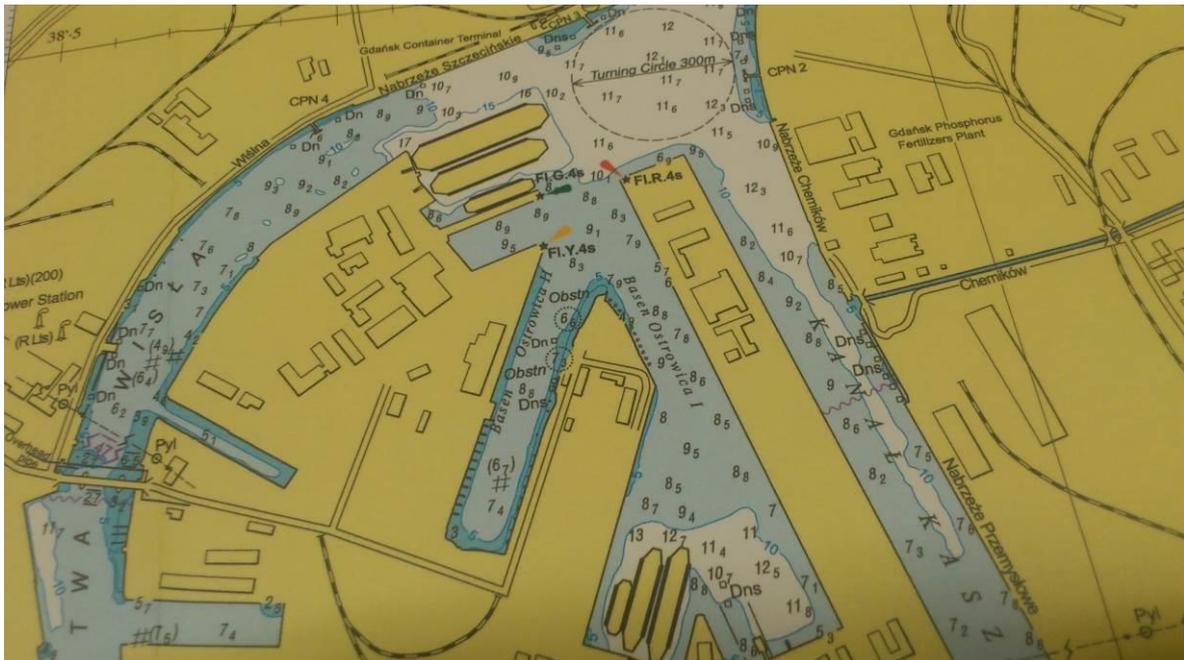
An organizational factor that could have had some effect on the occurrence of the accident was the lack of berth or a waiting area in the GSR yard where Horizon Aphrodite could have been ballasted to reach the draught at which the vessel would have a smaller windage area and the propeller and the rudder completely immersed in water.

Photograph 14. The chart BA 2680. Depths in the Ostrowica I Basin.

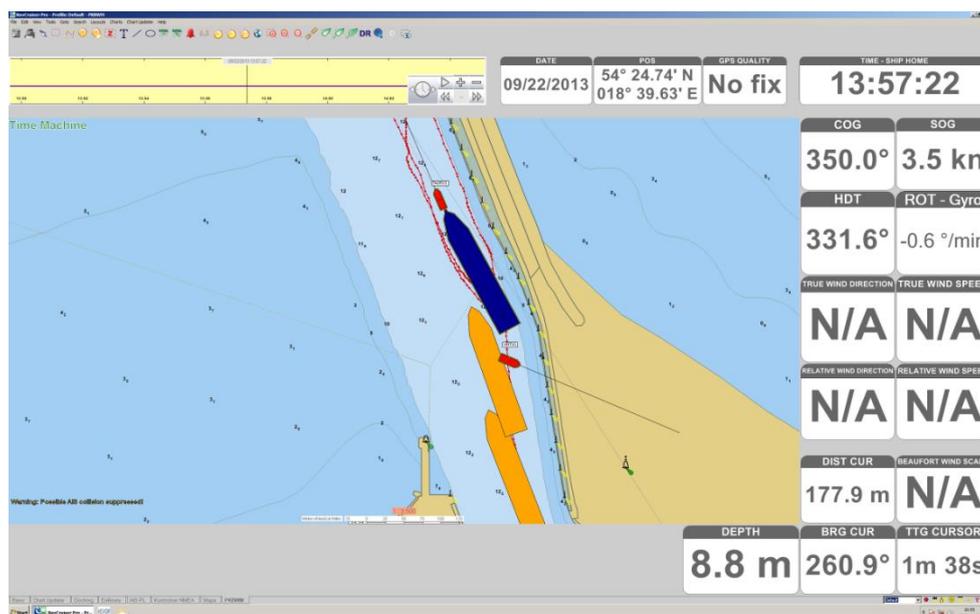
The decision to increase the engine speed to *Half Ahead* was delayed and this manoeuvre did not prevent the vessel from drifting and leaning the stern against the fender frame of the breakwater.

Figure 8. Position of the vessel at the time of the Half Ahead command (15:57:22 LT)
