STATE COMMISSION ON MARITIME ACCIDENT INVESTIGATION

FINAL REPORT 06/13

M/V JU DA

fall of the cargo inspector from the ladder in the ladder way to the hold of the vessel
in the Port of Gdynia on 15 May 2013

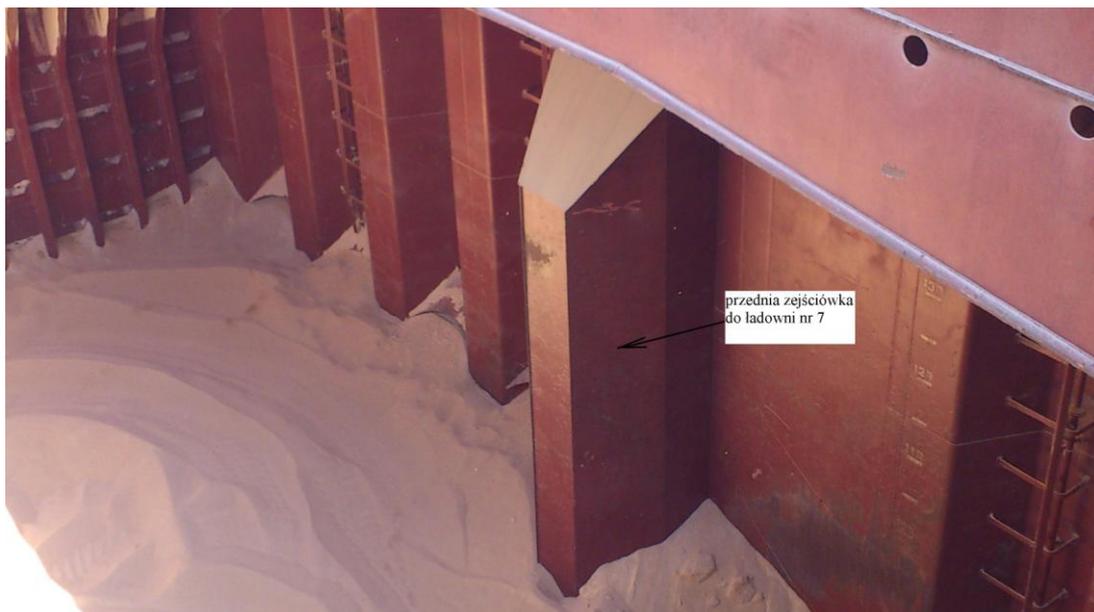
Photograph 3. Soya bean meal in the hold of the vessel

Soya bean meal are a sensitive cargo and when transported in bulk in the vessel's holds in result of damp or moisture it undergoes intensive microbiological (development of various

types of microorganisms) and biochemical processes. These processes become the most intense when the relative humidity exceeds 17% of the meal.

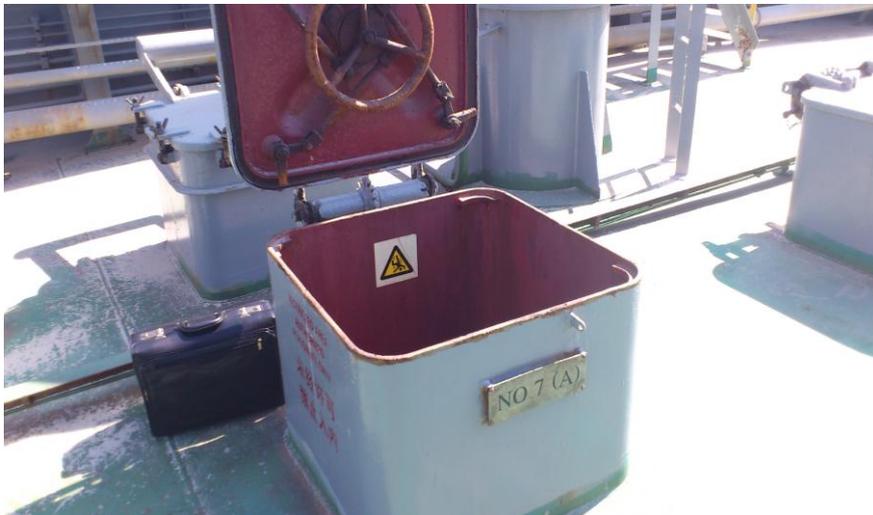
At ca 16:10 the inspector collecting samples went through front deck hatch to the hold no 7 which had been opened by the crew.

Photograph 4. Entrance to the ladder way to the hold no 7

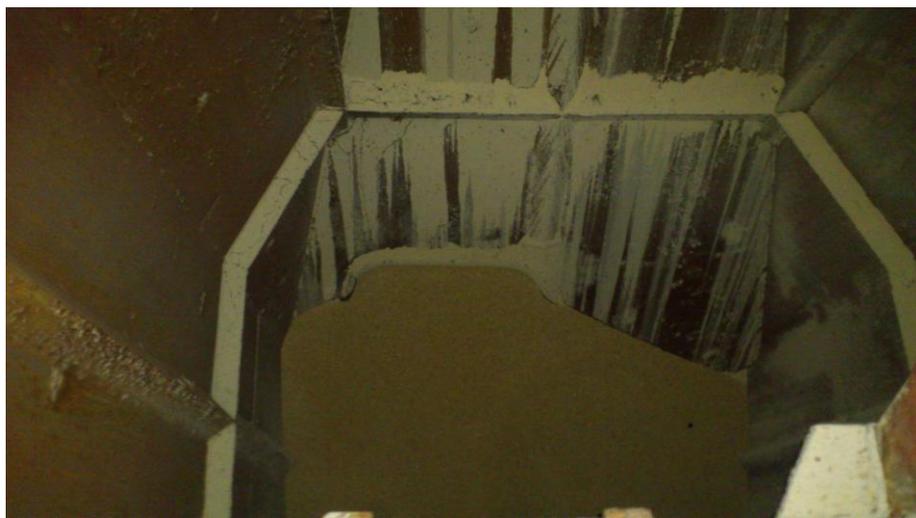
Photograph 5. Entrance to the hold no 7 covered with cargo - view from the inside of the ladder way

Since he could not get into the hold because of the entrance covered with the cargo, he collected part of the cargo sample from the heap in the ladder way and went back upstairs to the exit aboard. While ascending the stairs he fainted and fell 1.5 m down to the landing (*Australian ladder*).

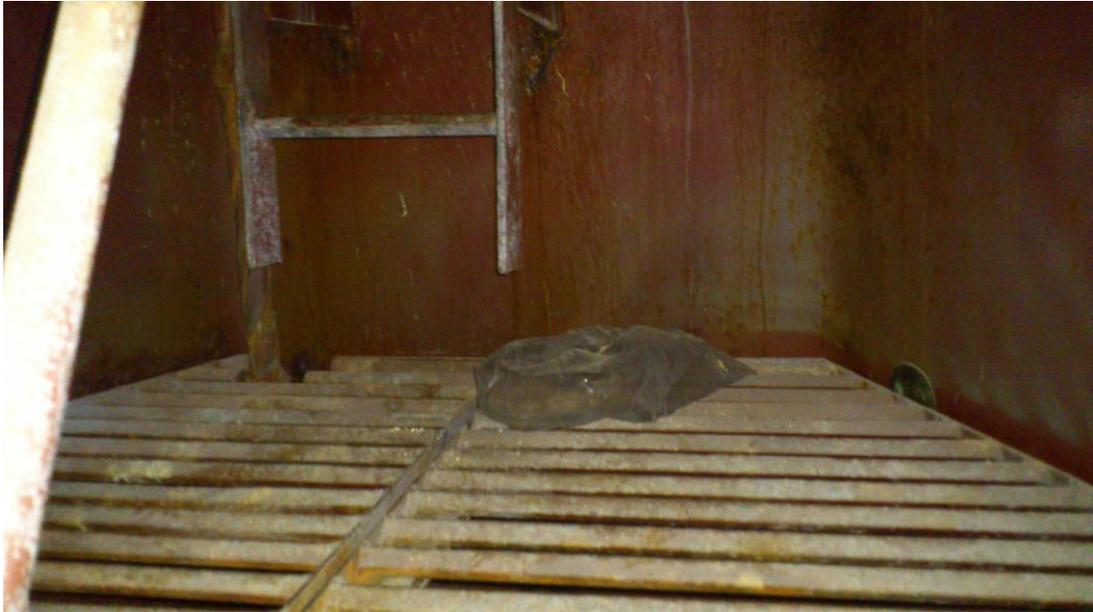
Photograph 6. Second platform of the ladder way to the hold no 7

At ca 16:15 the other clerk, waiting on board, being concerned over the prolonging absence of his colleague, who went down to the hold, after unsuccessful calling for him, went into the ladder way and found him unconscious, lying on the platform. He ran out of the ladder way and alerted the encountered crew members about the accident. Together they pulled the unconscious man up the ladder way to the main deck.

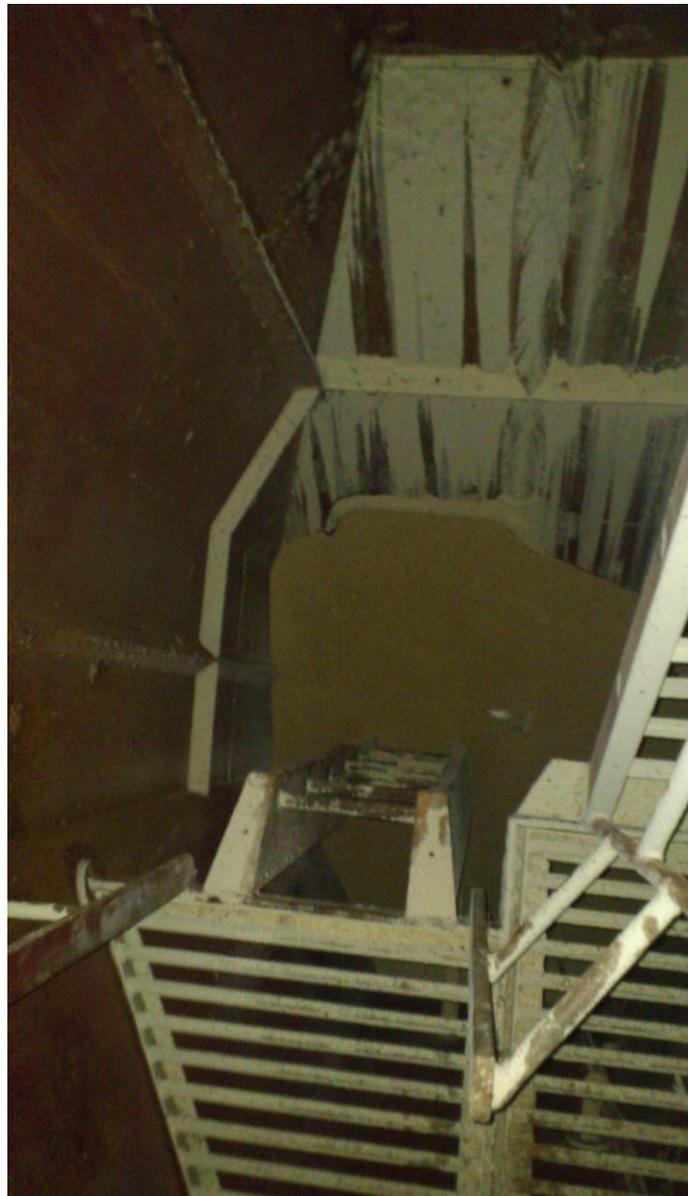
The bottom of the Australian ladder shielded with a steel casing was covered with cargo from the side of the hold.

Photograph 7. View of the ladder way in its lower part at the entrance to the hold no 7

This has resulted in the creation of a small enclosed space, covered from the top by the hatch of the ladder way, completely separated from the rest of the hold. In such a place the condensation (which is most intensive during the journey from warmer to colder climates) may proceed without interference and cause dampness of the meal, and consequently the intense growth of microorganisms, including aerobic bacteria that consume significant amounts of oxygen.

Neither the inspectors nor the crew of the vessel had made the necessary measurements of gas concentration in the holds of the vessel prior to sampling. It was assumed that the mere opening of the holds was sufficient to ventilate them. It has not been taken into consideration that the ladder way to the hold no 7 closed tightly with the hatch for the sea voyage would not be ventilated because there was no gap between the hold and the ladder way due to a heap of cargo mounting above the entrance to the ladder way. Opening of the hatch to the ladder way by the crew shortly before the inspector entered it for sampling had not allowed for full exchange of air thus securing safety for people in lower part of the ladder way.

² The concentration of oxygen in the air in the amount of ca 21% is regarded as a normal level. According to the investigation of the Commission based on the hearing of witnesses of the incident, the concentration of oxygen in the ladder way to the hold no 7 could be at a level of ca 0-12%. This was confirmed by the symptoms manifested by the injured.

To some extent, the vessel's crew could have prevented the incident, which took place in the Port of Gdynia, if during the voyage, and specially in its last phase, they had been opening regularly in good weather the hatches of ladder ways, to ventilate the cargo which appeared there from the hold of the vessel. This would result in a longer exchange of air and would ensure adequate oxygen concentration in the ladder way.
