STATE COMMISSION ON MARITIME ACCIDENT INVESTIGATION

FINAL REPORT 30/14

M/V LANGBALLIG

Contact of the stern with underwater part of the central breakwater embankment
on the fairway in Świnoujście on 9 August 2014

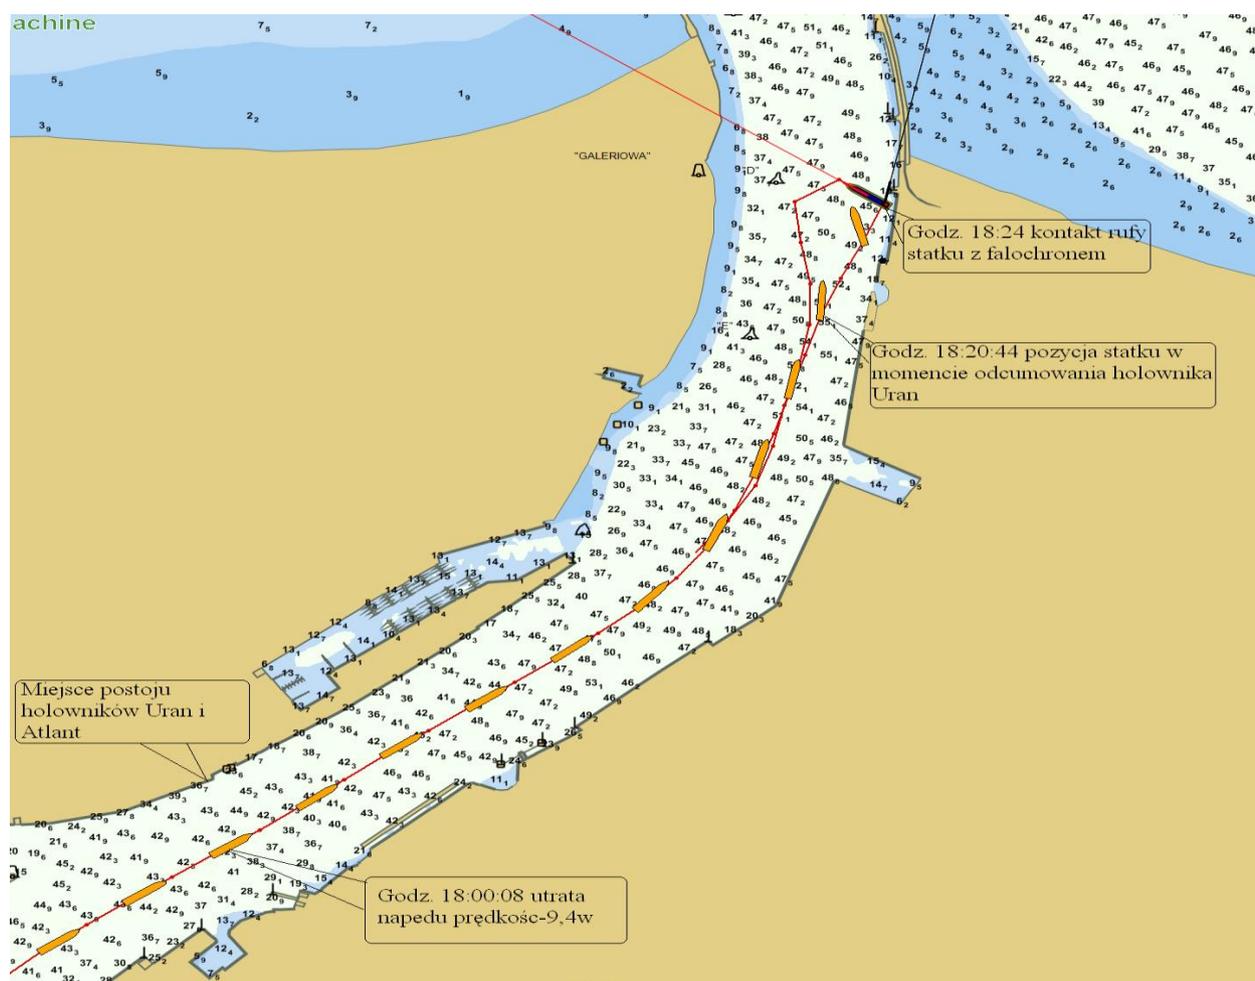
Photograph 2: Trajectory of movement of "Langballig" from the S-VDR recorder

At 18:21:16 the pilot asked a skipper of the pilot boat for assistance in pushing the vessel away from the breakwater to avoid contact. The pilot boat was too weak for that operation and at 18:24 "Langballig" touched the underwater part of the embankment of the central breakwater with the stern and the rudder, about 10 meters south from the sixth groyne.

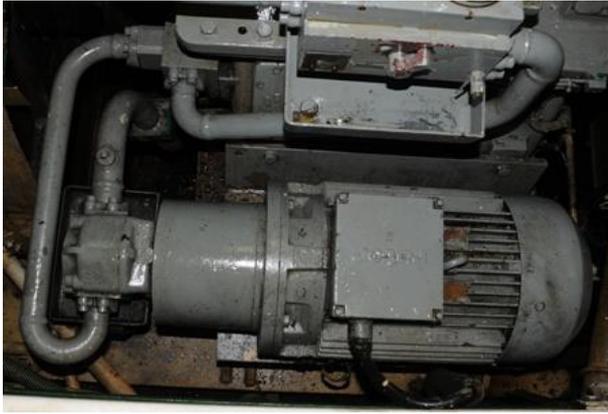
Photograph 2: Auxiliary pump of the hydraulic oil driven by an electric motor

Among the mechanical factors that contributed to the accident the Commission included contactors in the on/off system of the electric motor of the auxiliary hydraulic pump which were partly burned by electric arc and a very poor state of insulation of the damaged DC electric motor of the propeller hub oil pressure pump. These defects and malfunctions were found after the accident of the vessel during her stay in the repair yard.

system of the electric motor of the auxiliary hydraulic oil pump there was used a new contactor which had too small maximum nominal current range in relation to the power of the electric motor. This led to the damage of the working contacts.

The repair of the propulsion system after the break-down required the replacement of the contactor of the electric motor in the electric power supply system of the auxiliary hydraulic oil pump and check of the value of pressure at which the pump is switched on when there is a pressure drop in the system. The electric motor of the propeller hub oil pressure pump was repaired and the work of the pump was tested. The test showed that the pump was not running in an automatic mode. Switching the pump on and off could be done only manually. That malfunction was specified in the inspection report made by the classifier.

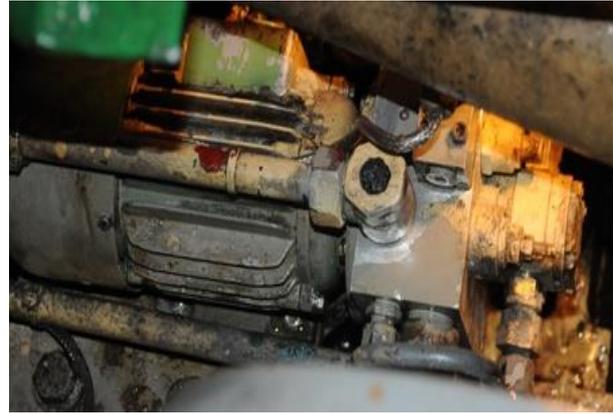
Photograph 3: Oil pressure pump of the adjustable propeller hub driven by means of an electric motor

The Commission found out that the failure which caused the main engine to stop was due to a very poor state of insulation of the damaged electric motor that drives the propulsion hub oil pressure pump. Poor insulation condition caused interference in the working of the electronic control system, which caused instability and fluctuations in the hydraulic oil pressure in the gearbox lubrication system. The hydraulic oil pressure drop below the 16 bars activated the security system against lack of lubrication of the gear that stopped the main engine.

The oil pump of the hub pressure with an electric motor is mounted on the body of the propulsion gear, near the bilges of the engine room, in a place which is obscure and hard-to-reach for an engineer. The electric motor of the pump is exposed to dust, moisture and vibrations coming from the transmission gear and this can cause premature wear and sudden failure.

The State Commission on Maritime Accident Investigation has recommended that the shipowner should include in the system of planned overhaul and repair of “Langballig” the oil pump of the adjustable propeller hub, together with the electric motor and keep these devices in good technical condition as well as he should observe the timing of overhaul and repair of all propulsion elements and components to operate that system according to the manufacturer's instructions.

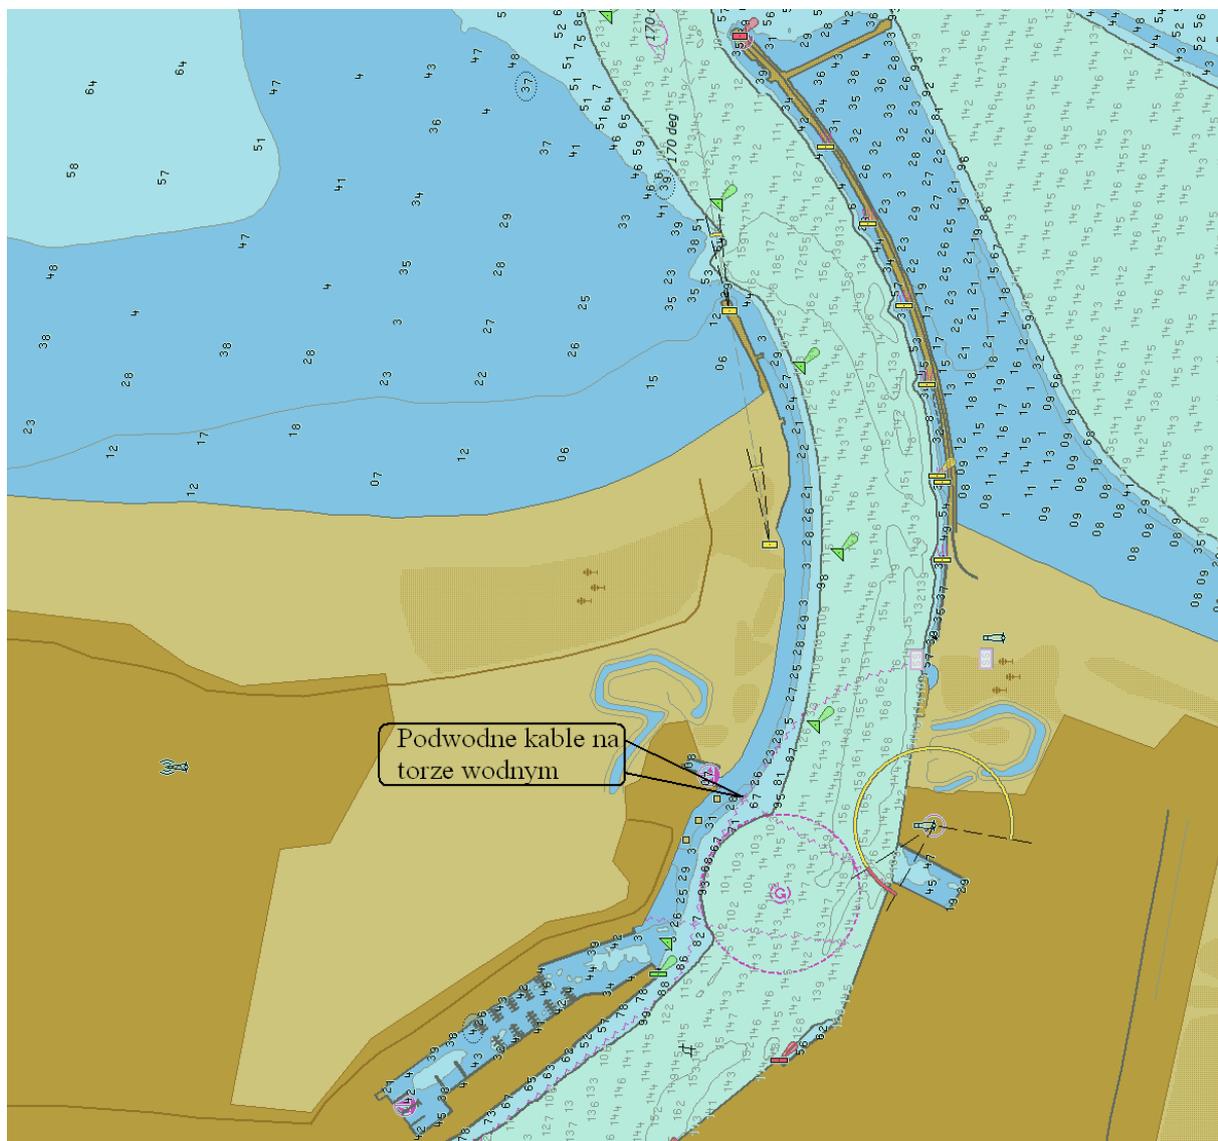
Photograph 4: Distribution of underwater cables on the fairway in Świnoujście

The Commission also found the presence of another type of external factor. The location of submarine cables on the way of the drifting vessel prevented the captain of the vessel to cast anchor safely and to stop the vessel at an appropriate distance from the breakwater.

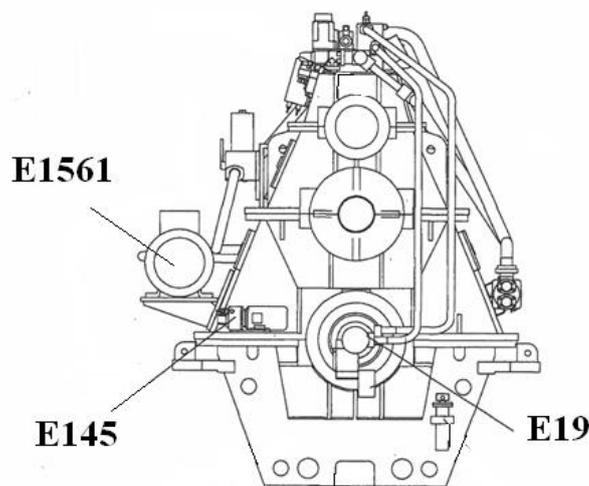
Figure 3: Transmission gear of the propulsion – view from the aft of the propulsion

While the ship had been in the repair yard before the accident, the owner did not provide a full survey of the technical state of the propulsion transmission gear and had not reviewed the oil pump of the propeller hub, together with the electric motor (Fig. 3 - abbreviations, as shown in Fig. 2).
