STATE COMMISSION ON MARITIME ACCIDENT INVESTIGATION

FINAL REPORT 34/13

M/V NEWA

The immobilization of the main propulsion system of the vessel and grounding
on the Szczecin - Świnoujście fairway on 4 November 2013

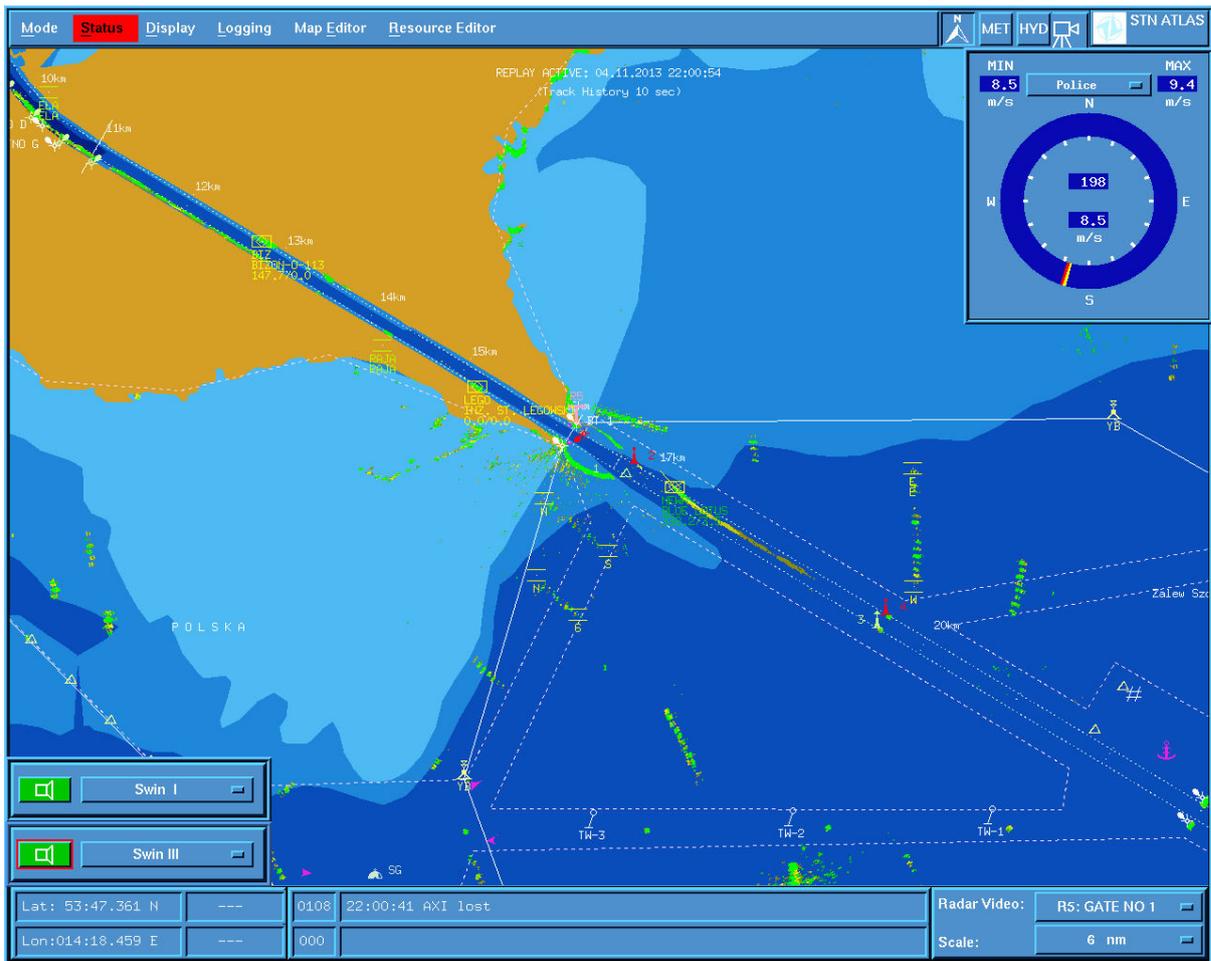
Photograph 2: VTS Image of Szczecin – Świnoujście. Newa at the approach to the 27th km of the fairway is leaving the fairway to drop anchor

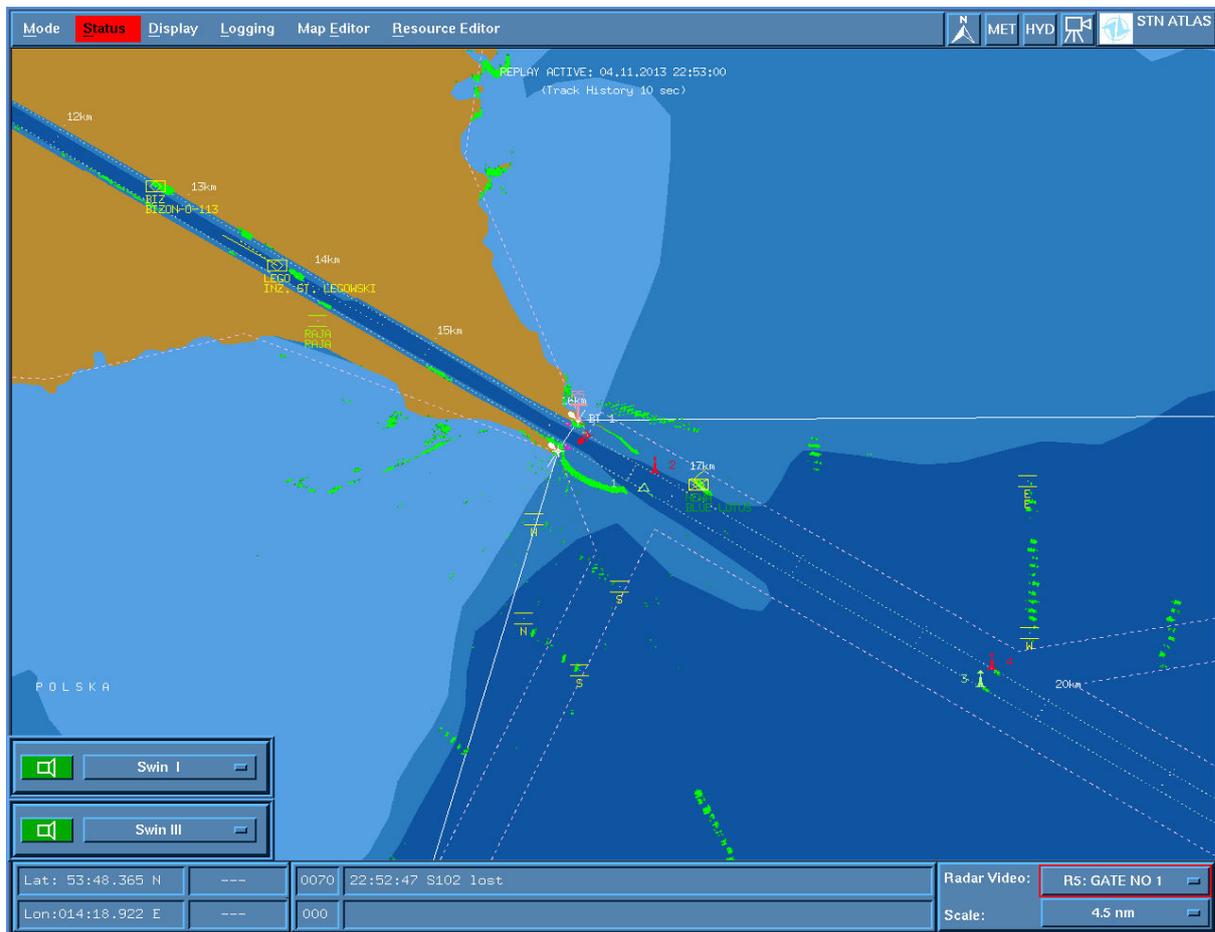
Photograph 3: Szczecin – Świnoujście VTS Image with marked position of Newa aground

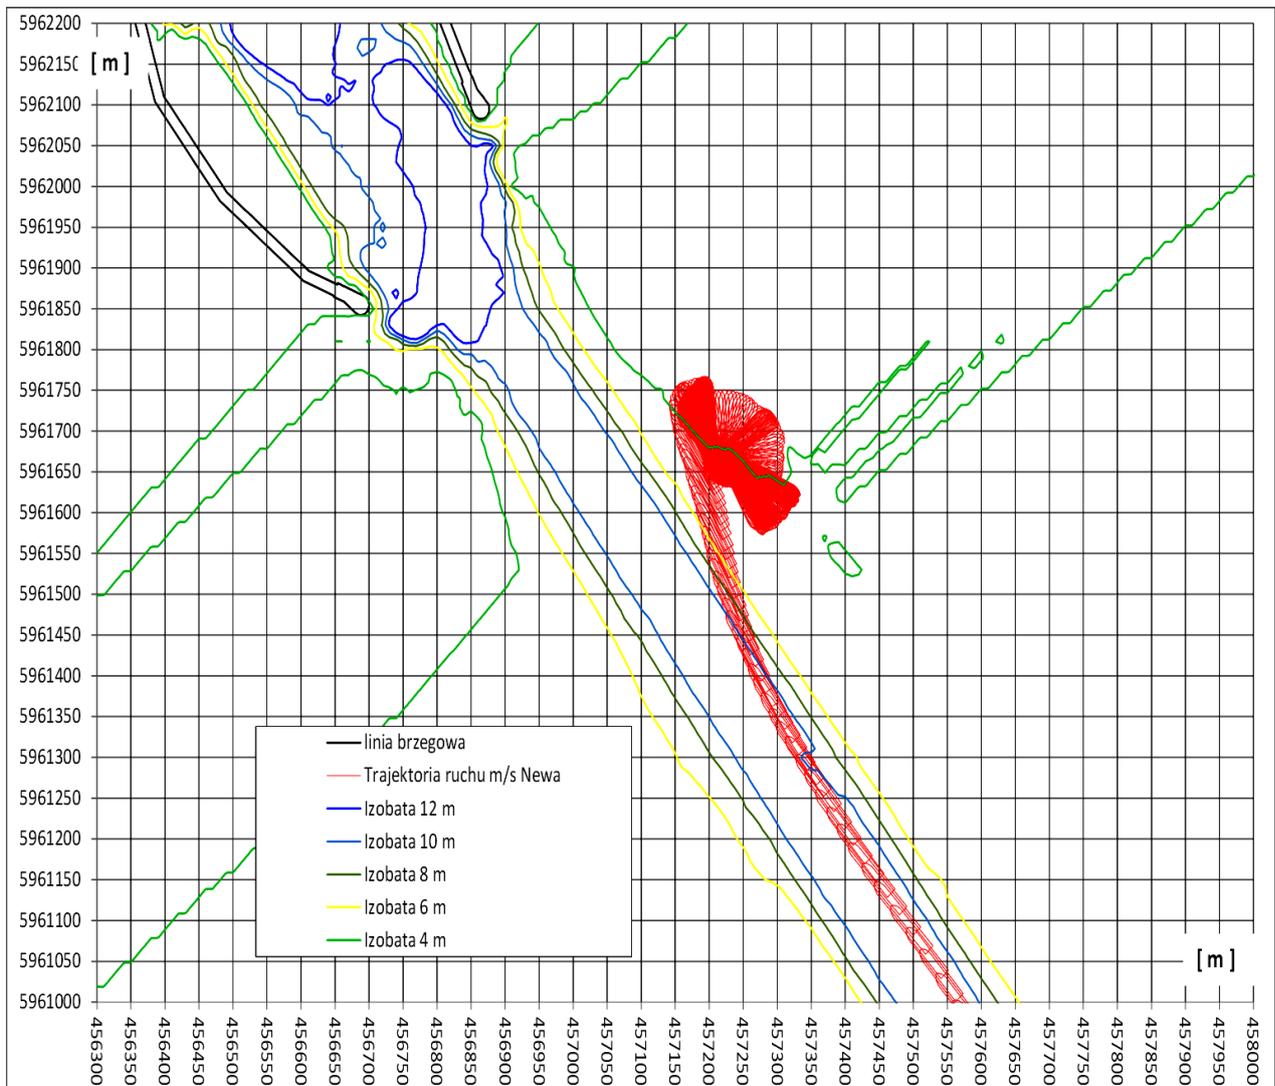
The main reason for which the vessel got off the fairway on the way from Szczecin to Świnoujście was the failure of the ME. The vessel, devoid of control over her movements, might have posed a threat to other units moving along the fairway. The pilot together with the captain took the decision to leave the fairway and drop anchor.

Figure 1: Movement trajectory of Newa marked on the numerical map of the water basin of the Szczecin-Świnoujście fairway until grounding in front of the breakwater in the Piastowski Channel; the area right before the accident, where the vessel was moving with a broken-down ME.

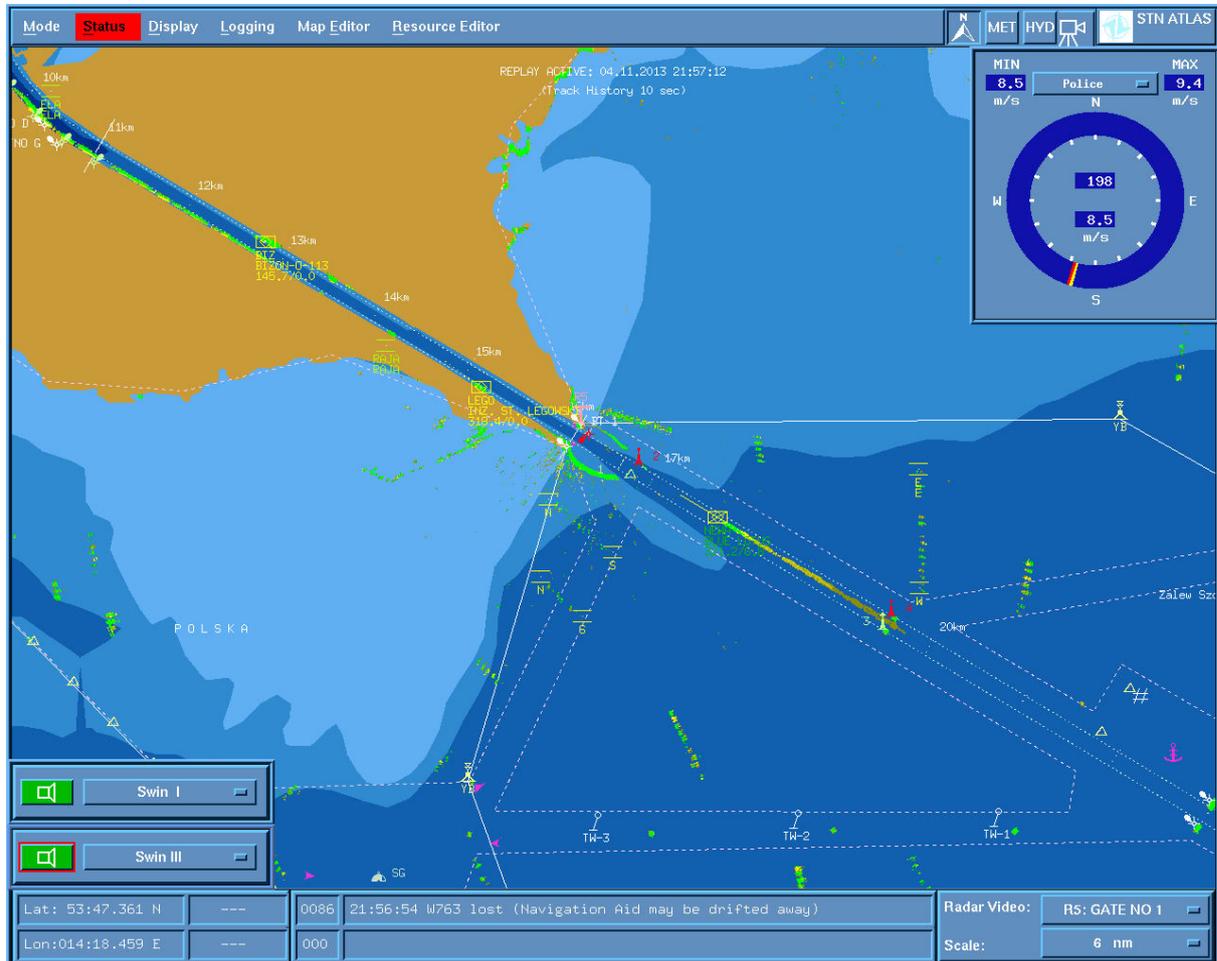
Photograph 4: Szczecin – Świnoujście VTS image. *Newa* during passage down the fairway between the Fairway Gate no 2 and the Piastowski Channel, after passing by buoys no 3 and no 4

After passing the pair of buoys no 3 and no 4 the vessel began to slow down. The photograph above shows the course of the vessel at 321.2° and the speed at 6.8 knots. The deceleration indicates that the failure of the ME had occurred slightly before and the vessels was moving only by the force of inertia.

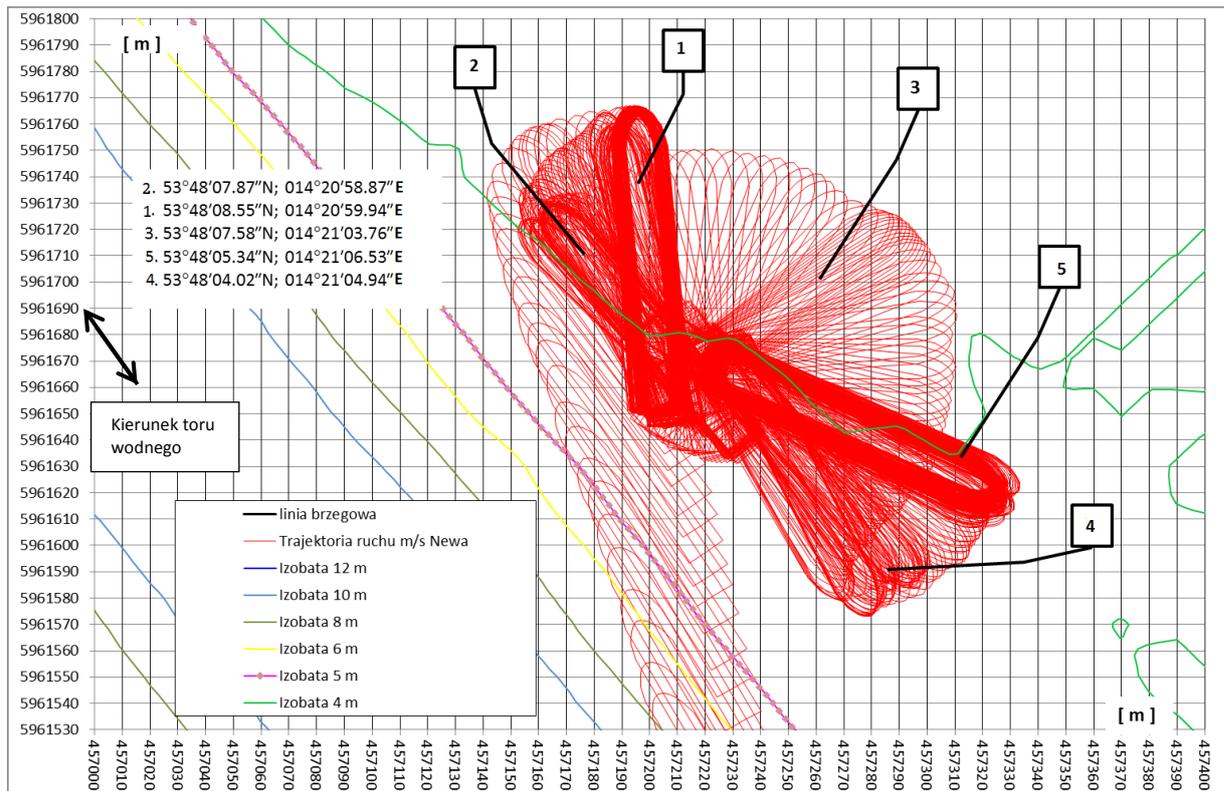
Figure 2: The trajectory of movement of Newa with marked area of performing the manoeuvre of turning after the ME was operational again marked on the numerical map of the water basin

In Figure 2 in the position 1 of the vessel after dropping anchor past 22:00, it is clear that the hull of the vessel was more than half of its length within the isobath of 4 m. The vessel was on the starboard anchor, 2 shackles in water, on the course of 355°, supported in her front part (in front of the superstructure) at the bottom. The draught at the bow of 3.20 m allowed the hull to move outside the isobath of 4 m. Since the aft draught exceeded 4 m, the vessel leaned her stern against the bottom.

Despite the fact that the stern section of the vessel grounded on the muddy bottom, the rotation of the vessel continued until 23:05, when it reached the course of 152° (position no 4 on Figure 2). In this position, the vessel was most vulnerable to the effects of side wind and current, which pushed her deeper and deeper to the shallows. The attempts to use inefficient engine (35% of the maximum load of the ME) failed. After a few minutes the captain and the pilot gave up attempting to continue to turn the vessel and working forward with the engine. The vessel returned again on the course of 137° (position no 5 in Figure 2) and remained in this position until the tug boats arrived.

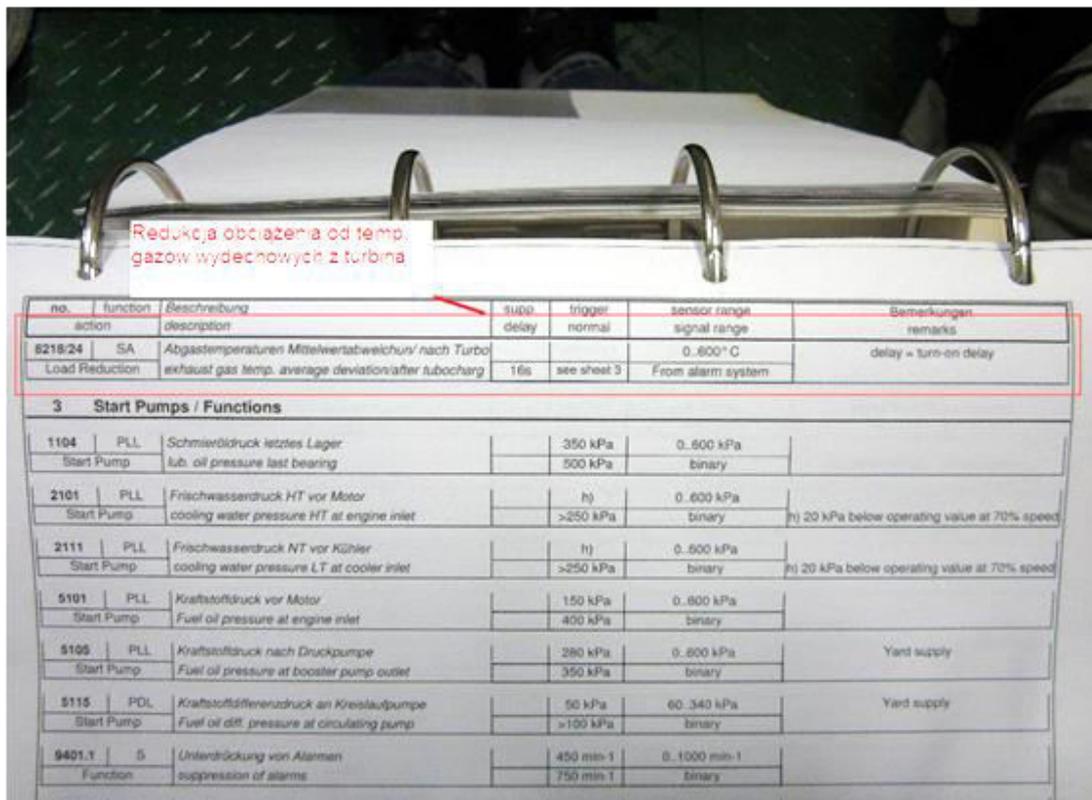
Another factor that indirectly influenced the accident because it limited the manoeuvrability of the vessel, was a failure of the ME causing inability to increase the speed of the vessel. This failure occurred as a result of the alarm “High temperature of the turbine exhaust gas”, according to the setting of the temperature detector in the ME control and security system, i.e. at the temperature exceeding 400°C. The alarm was activating 12 times since the vessel unberthed from MSR Gryfia to her return to the yard⁶ and was associated with exceeding the limit of the temperature of exhaust gas at the outlet of the turbine in the ME control and security system. According to the alarm specification in the ME manual the activated alarm caused the reduction of the ME load (by changing the pitch of the screw propeller, i.e. reducing the deflection of its blades). This alarm activated at every attempt to increase the speed of the vessel when the exhaust gas temperature exceeded the limit value of 400°C and caused the reduction of work-load of the ME to 35%.

Photograph 6: Draft from the list of the ME alarms on Newa. Alarm 8218/24 – reduction of the ME work-load due to exceeding the temperature of the turbine exhaust gas

⁶ Such alarm may be caused by a condition of the injection apparatus of the engine, condition of the turbine, quality of fuel or condition of the air cooler.

Failure to set a correct limit of the turbine exhaust gas temperature of the ME in the system of control and motor protection alarm panel, after replacing a damaged exhaust gas temperature sensor for the turbine, caused a decline in control of the vessel. After replacing in the yard a detector of temperature of the ME turbine exhaust gas, a correct value of the temperature for variable conditions of ME work-load that occur at manoeuvrability speed of the vessel had not been changed.
