STATE COMMISSION ON MARITIME ACCIDENT INVESTIGATION

FINAL REPORT 26/13

M/V POPRAD

Chief engineer's burn caused by electric arc
while repairing the control system of the G1 generator
on 9th September 2013 at the port of Rotterdam

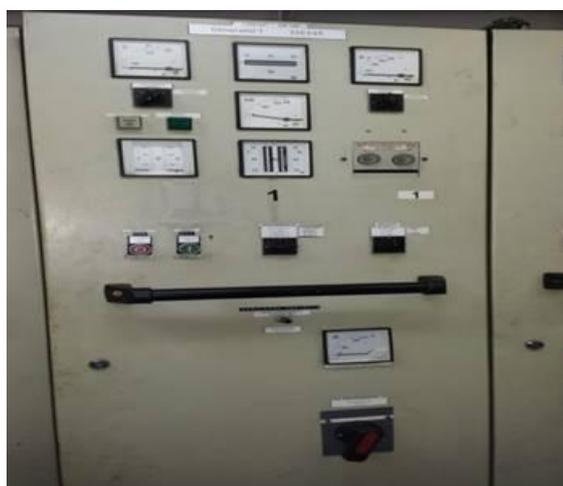
The control system of the G1 generator was repaired by replacing damaged “Start” and “Stop” buttons, among others. Next day the repair works were completed. The connection of the G1 generator into the network and its disconnection were tested once.

Photograph 2. Switchboard – G1, generator’s steering area

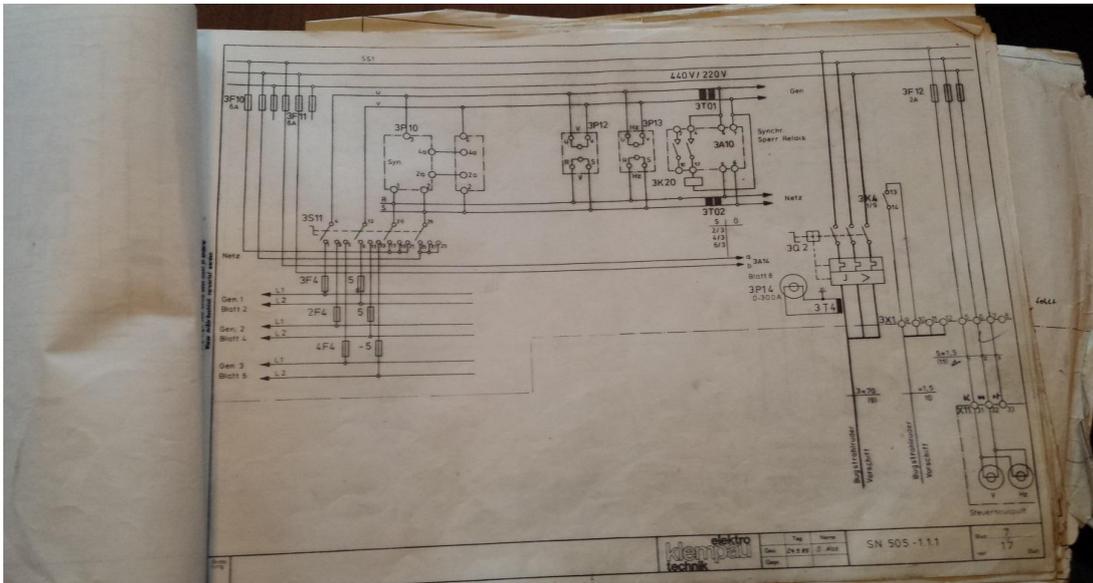
Photograph 3. Electric diagram depicting connections of the damaged 3F4-5 fuse separator

The chief engineer replaced the 3F4 fuse with a new one of the rated current of 6A. The blown 3F5 fuse was replaced with the fuse of the same rated current of 16A as the damaged fuse had¹. After replacing the second fuse and switching on the fuse separator an arc shorting occurred. The chief engineer was burnt by the electric arc. The equipment and electrical wires were damaged as well as wires in the G1 generator's area. Because of injuries, the chief engineer was taken to hospital in Rotterdam.

¹ According to the electric diagram, the 3F5 fuse should have the rated current of 6A.

According to the Commission, a mechanical factor that contributed to the incident was a damaged electrical device (fuse separator) 3F4-5, which caused problems with synchronization and switching on the G1 generator to the electric network of the vessel.

The inspection and repair of the control system of the G1 generator by a technician-electrician, the day before the accident had not removed all the defects of the system causing its failure. The investigation showed that neither the 3F4-5 fuse separator had been exchanged nor the inserted fuse-links checked for compliance of their rated current against the wiring diagram of the main switchboard.

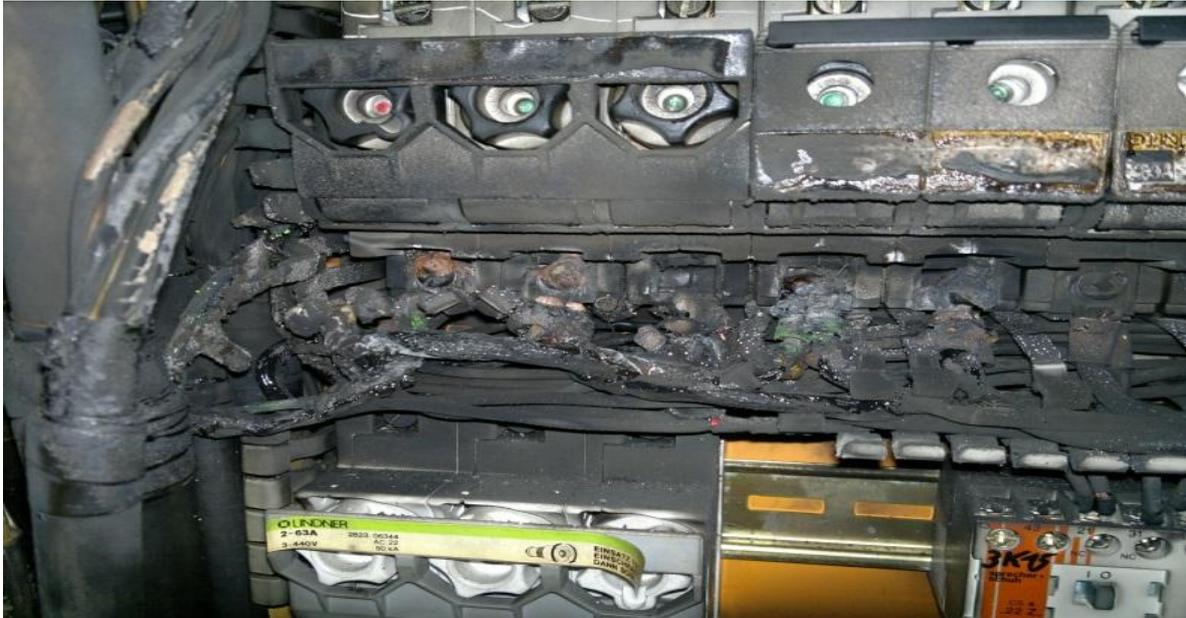
Photograph 4. Main switchboard – blown electric circuits in the G1 generator's area

As a result of the investigation, the Commission determined that the use of fuse with the nominal value of 16A instead of 6A and the replacement of fuses while the generator was induced caused the marine incident. Then, the damaged electrical device was switched on (the fuse separator). When switching on, the damaged electrical device (while working under voltage and electric load) initiated arc shorting at the contacts on the side of the power supply from the G1 generator. Working G1 generator was inducing the arc shorting until the conductive elements in the fuse separator burnt out and the electric arc self-extinguished.

- 1) developing a procedure and instructions regarding safety at work while repairing electric equipment and installations, in particular in the main switchboard, by the crew devoid of a qualified electrician, which should be published in the Safety Management Book, Chapter P-08 "Emergency and Breakdown Actions";
- 2) observing the P-03 procedure contained in the Safety Management Book ("Reporting, and Discrepancy Analysis of Accidents and Emergency Situations") regarding the appointment of a post-accident team to determine causes of the accident and to suggest preventive actions;

- 3) requiring from persons engaged in the technical service of the vessel (service technicians) to prepare and submit to the operator and the vessel detailed reports documenting commissioned and performed service works;
- 4) equipping the vessel with adequate and effective personal protective gear for work with electrical equipment, including face shields protecting from electric arc;
- 5) convincing the captain and chief engineer to make entries in the ship's and engineer's log books related to the incidents or cases of equipment malfunction having a significant impact on the safety and operating condition of the vessel.
