STATE COMMISSION ON MARITIME ACCIDENT INVESTIGATION

SIMPLIFIED REPORT 14/15

M/V FAST JEF

Collision of Fast Jef and Alora while passing by
in the fairway in Świnoujście on 14 May 2015

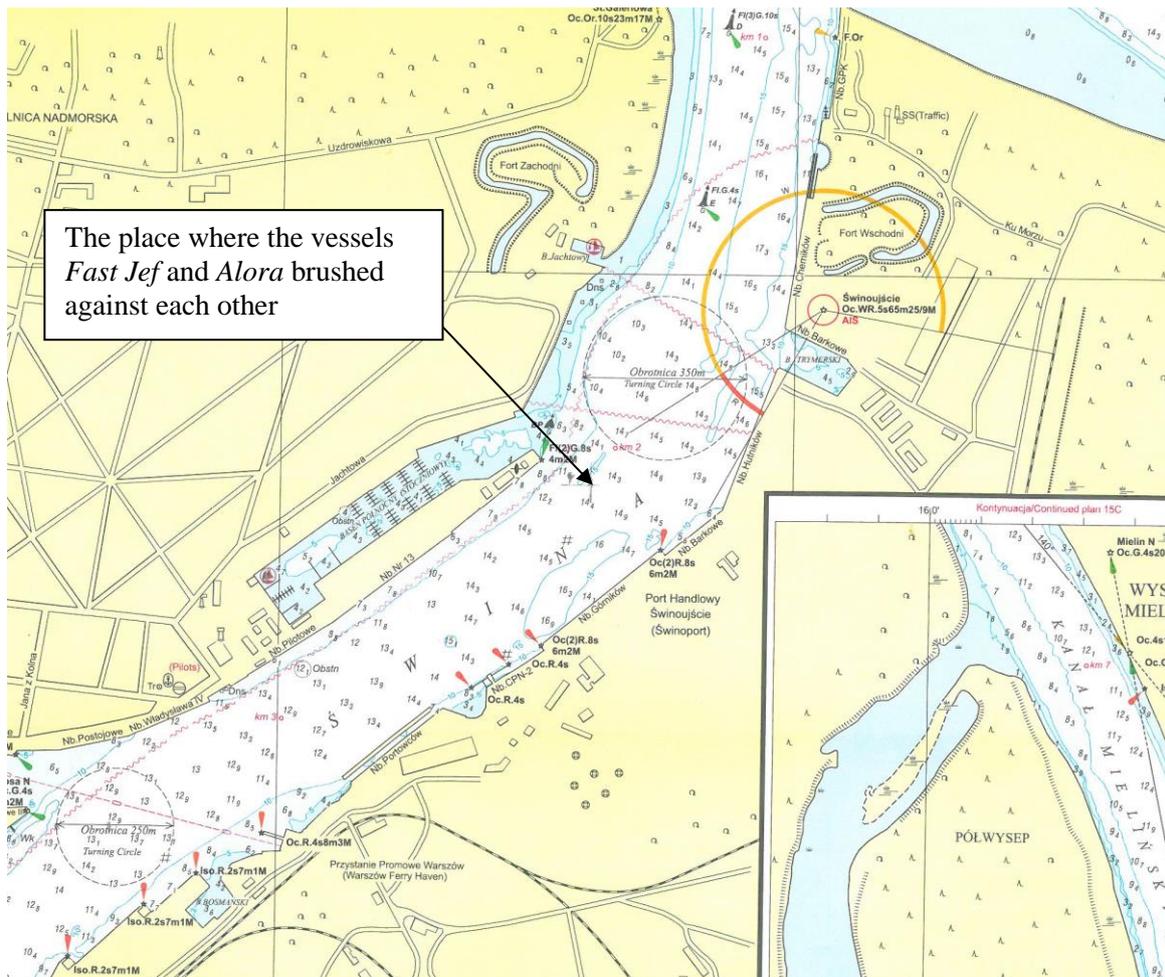
Photograph 1: A fragment of the BHMW chart No 15C (the plan of the port of Świnoujście) with a marked place of collision of Fast Jef and Alora

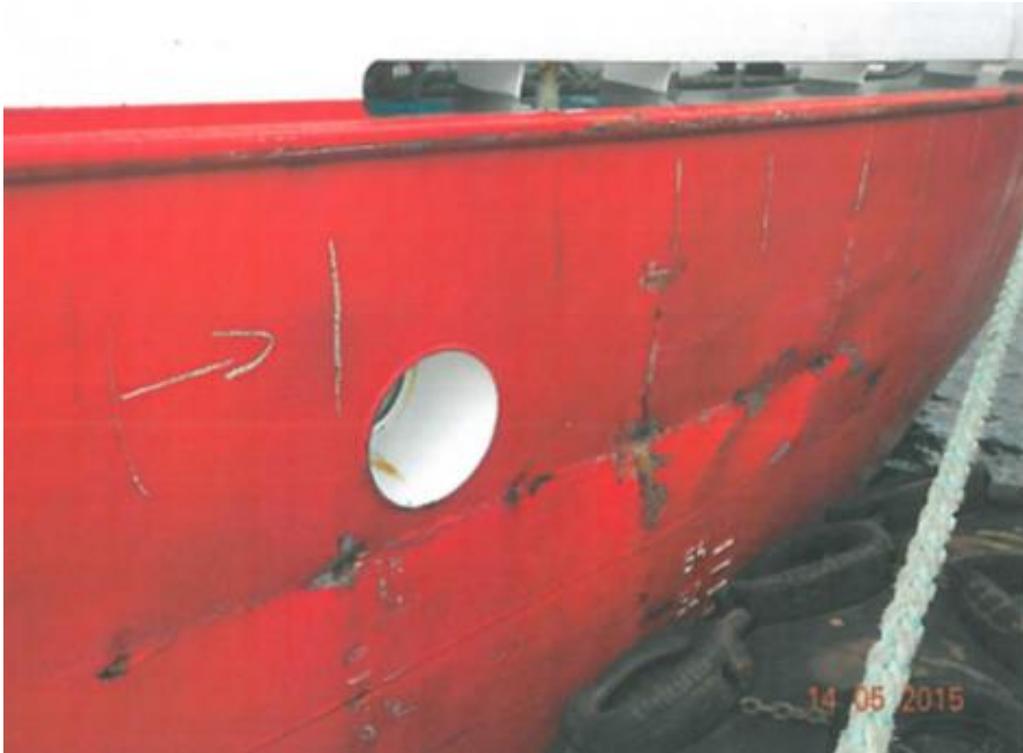
including the elements of the internal construction between frames 7-13

a transitory contact of hulls. “Fast Jef” brushed her run at port side against the port side of “Alora” at the level of the upper fender beam, right behind the entrance of the hull near the place designed for pushing the vessel by tug boats.

Photograph 4: Damage of Fast Jef

“Fast Jef” damages were more serious (Photograph 4). A detailed inspection conducted by the ship’s class (BV) showed damage to the hull between the frames No 7 - 13 at the port side stern, as well as frames (Photograph 6), brackets and a transverse bulkhead on the frame No 10, above the waterline. Also, among other things, a porthole was damaged in one of the dwelling cabins (Photograph 7).

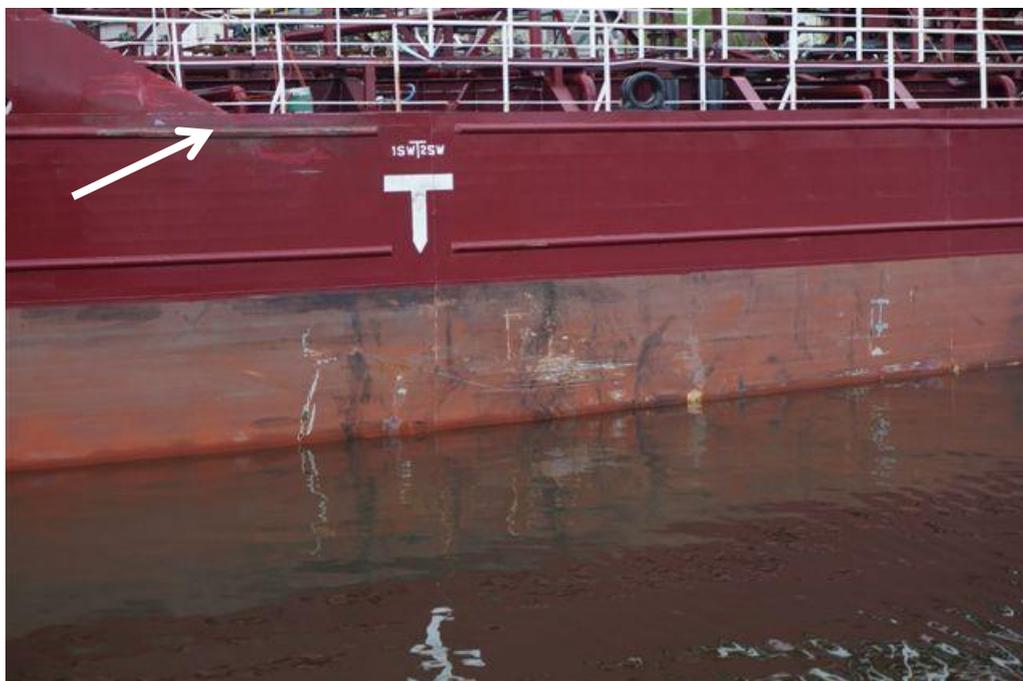
Effects of the accident on “Alora”:
Small indents of the hull’s plating at port side near the bow at a distance of 2.5 m and deformation of 4 adjacent frames

Photograph 5: Dents and scratches of the Alora's port side

As a result of the collision, apart from visible scratches of the paint in a place of contact “Alora” suffered a slight indentation in the hull in form of a strip ca. 2.5 meters long (Photograph 5). Four side frames in the belt were deformed – luckily, without cracks.

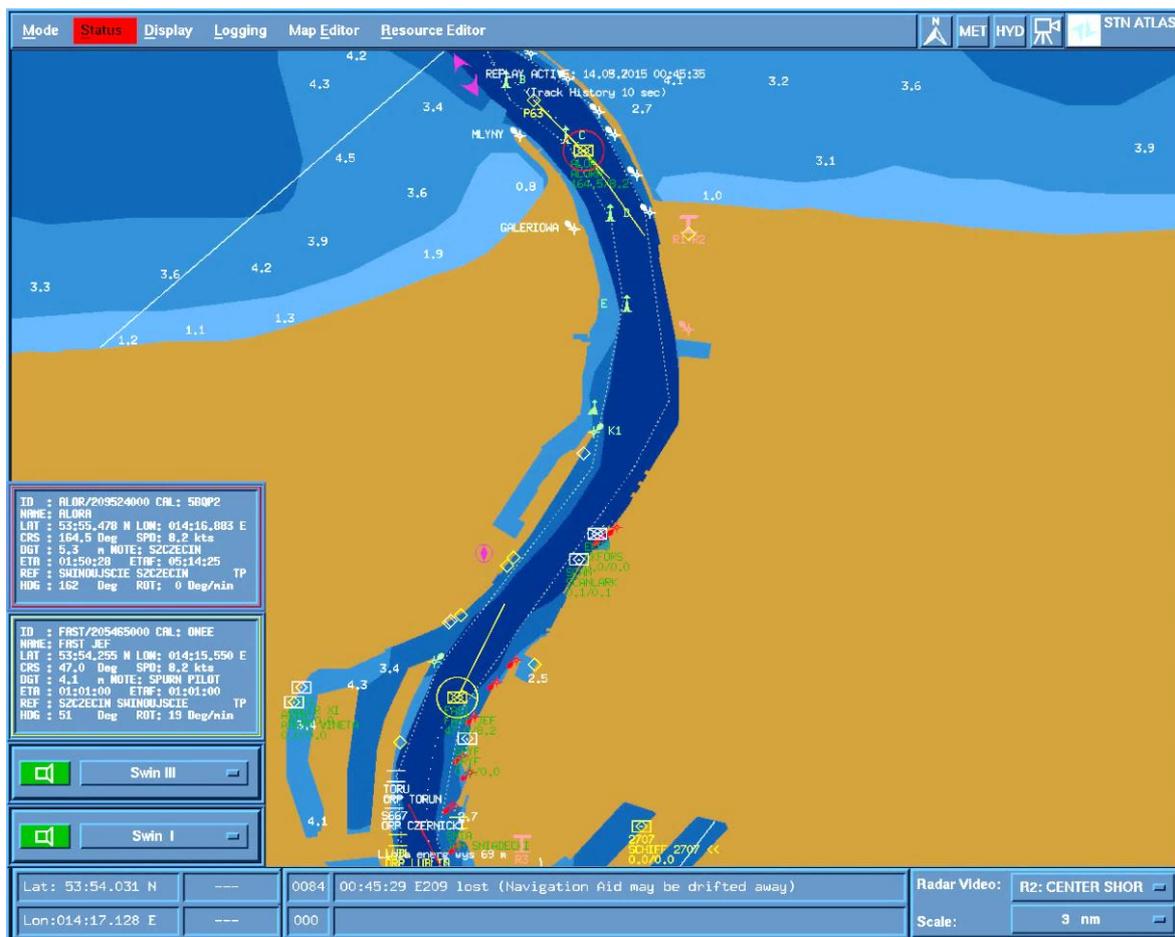
The screenshot from the VTS monitor shows in Figure 1 that about 7 minutes before the accident, both vessels had been moving properly on their respective sides of the fairway.

Figure 1: Radar image of Fast Jef and Alora at ca. 00:39

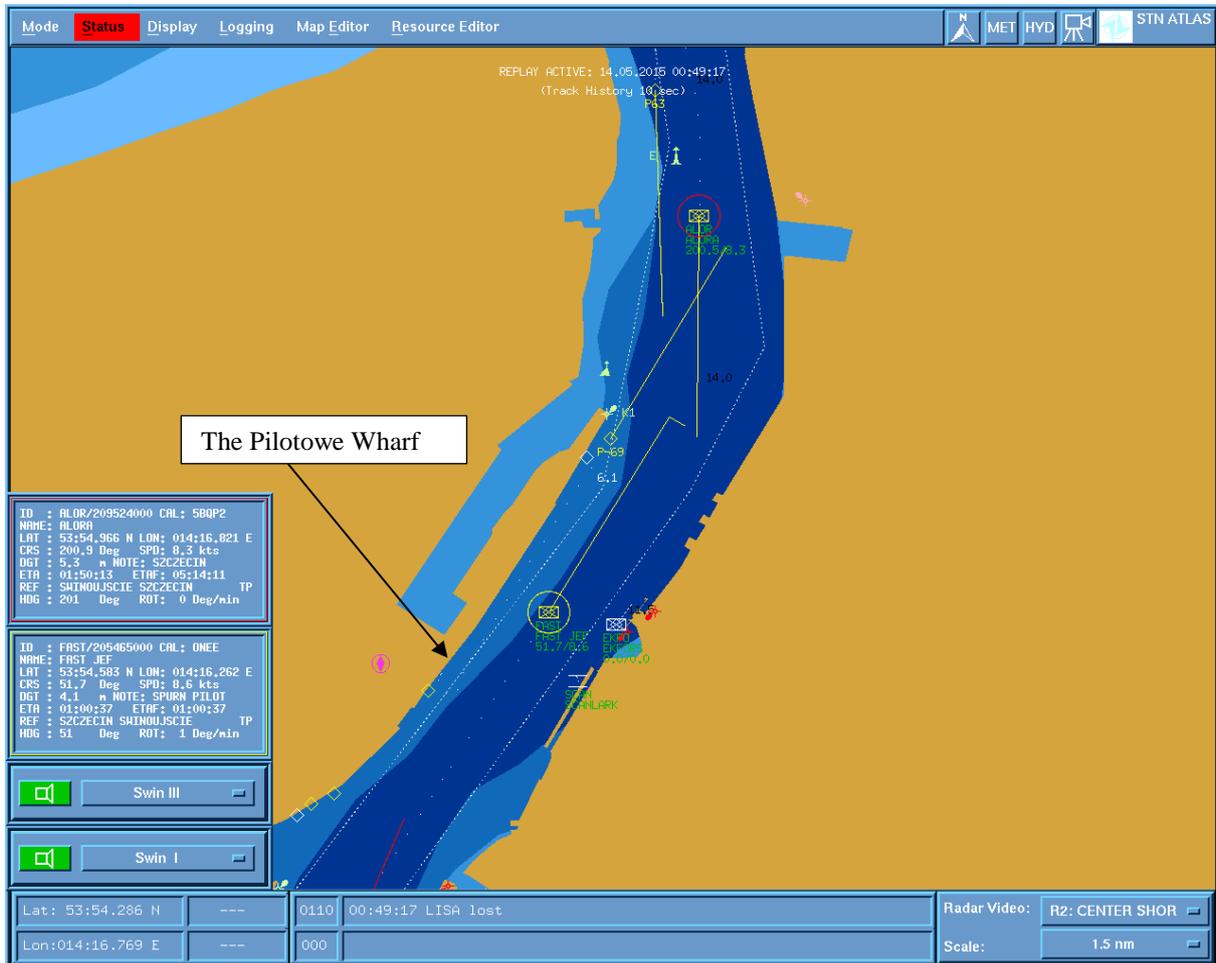
The analysis of subsequent imagery of the movement of both vessels shows that after passing the city ferries' harbour "Fast Jef" has gradually started to move to the left and after passing the Pilotowe Wharf it was already on the wrong, western side of the fairway (Fig. 2).

Figure 2: Radar image of Fast Jef and Alora at a distance of ca. 5 cables from each other

The pilot of "Fast Jef" noticed "Alora" coming from the opposite direction at 0:44, when the vessels were at a distance of about 5 cables from each other (Figure 2). He assessed the situation and decided to pass by "Alora" starboard-to-starboard. The chief officer switched the rudder over to manual steering and turned on the second pump of the rudder. The pilot called out "Alora" on VHF channel 12 and suggested the passing manoeuvre starboard to starboard.

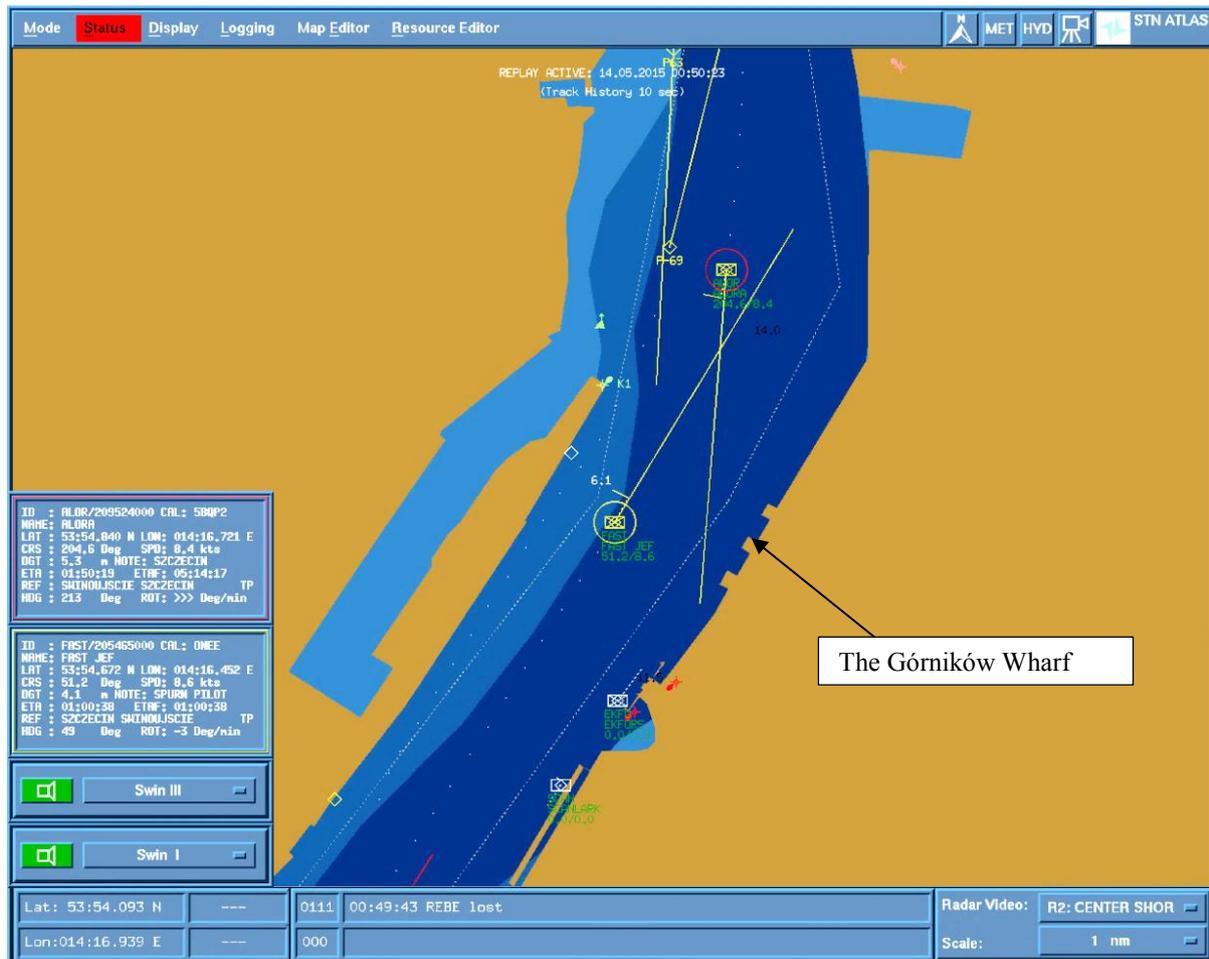
When "Fast Jef" was at the level of the Górników Wharf, and the distance between the vessels decreased to about 2 cables (Figure 3), the "Fast Jef's" pilot seeing that "Alora" was changing its course to starboard, he himself began turning the vessel to starboard.

Figure 3: Radar image of Fast Jef and Alora 45 seconds prior to collision; distance between the vessels ca. 2 cables

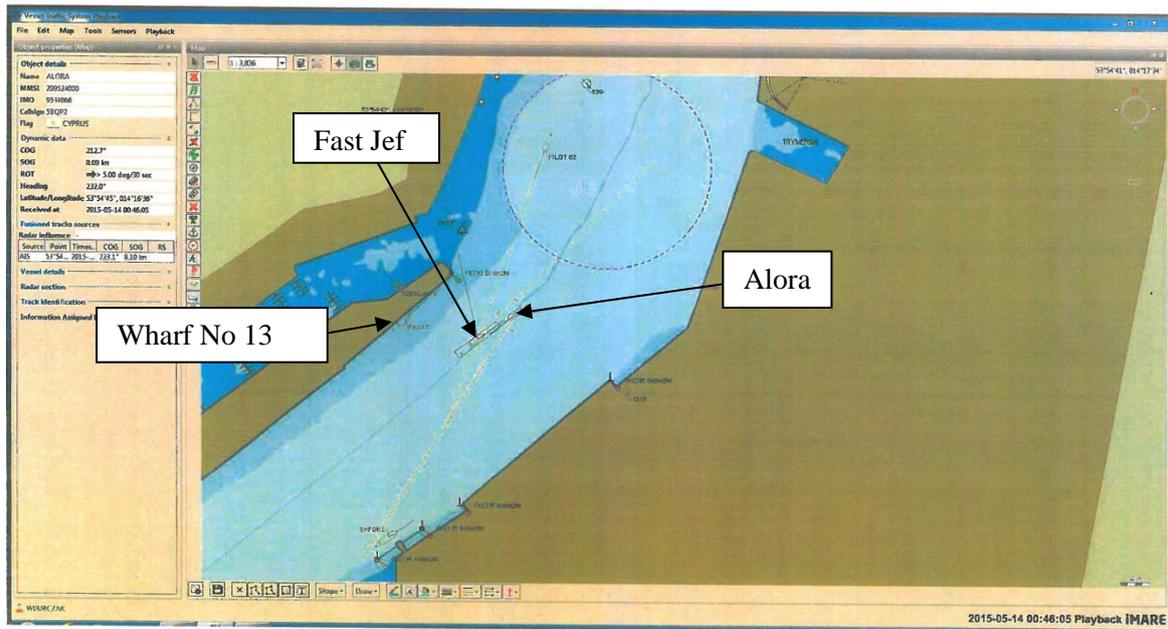
The alteration of the course made by the pilot allowed “Fast Jef” to pass in front of the bow of “Alora” and to start going the ships past each other port to port in accordance with the COLREGS¹ rules, however it has not prevented the stern of “Fast Jef” passing by “Alora” at a distance of a couple of metres from adhering by suction to the hull of “Alora” and from brushing the vessels against each other. The collision occurred at the level of the northern end of the Wharf 13 (SAR) (Figure 4).

Figure 4: Image of AIS signals registered by VTS indicating the position of AIS antennas of Fast Jef and Alora a few seconds before the collision

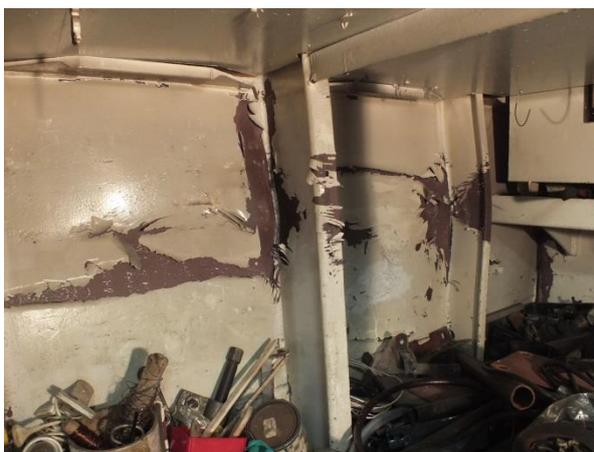
Photograph 6: Damage of frames and side in the stern locker of Fast Jef

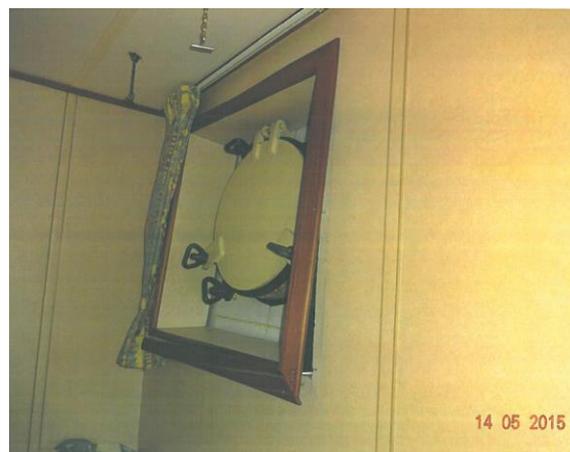
Photograph 7: Damage to a porthole in one of the dwelling cabins at Fast Jef

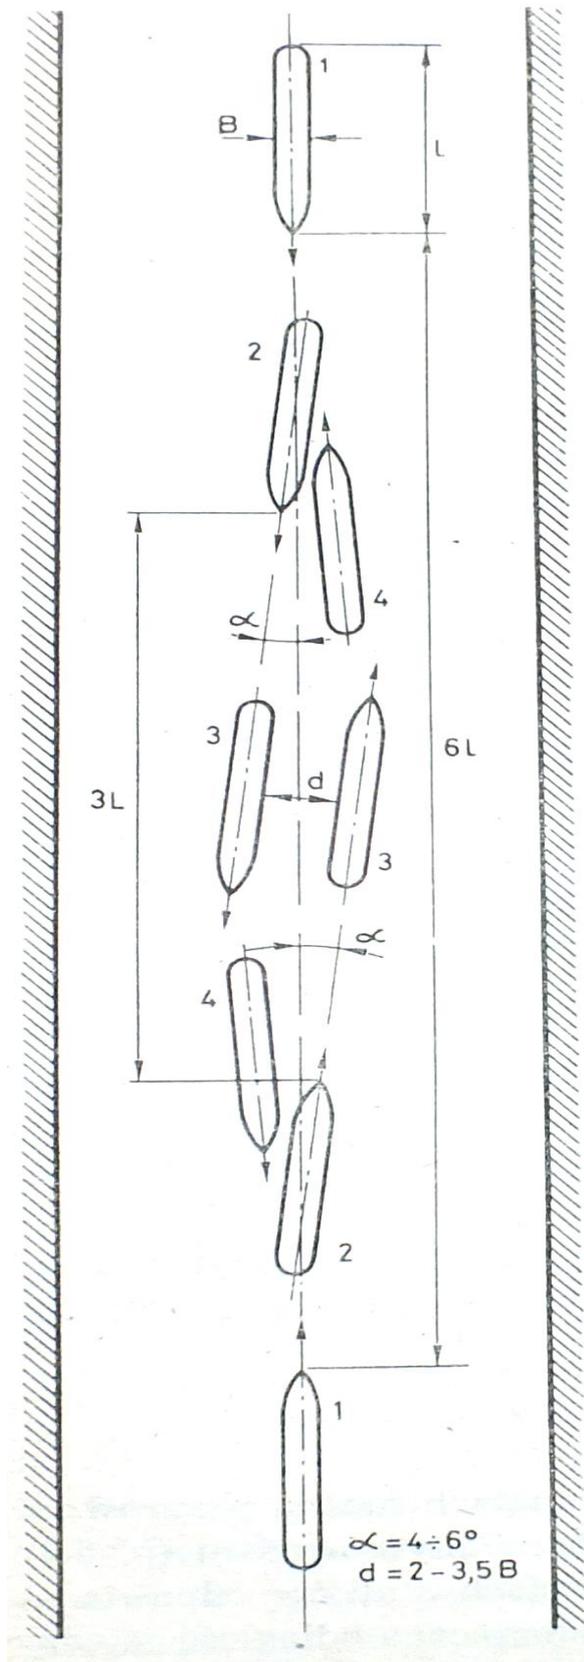
In the channels which are wider than $14B$ the passing time of vessels moving at manoeuvring speed equaling 8-9 knots on the average can be assessed for 15 to 20 seconds, and the manoeuvring instructions (depicted by the silhouettes of vessels in Figure 5) are as follows:

- before passing each other, both vessels should be moving down the central part of the channel;
- when their bows are at the distance of six lengths of a vessel, each one turns the course to starboard by 4 to 6° ;
- after this change the distance between the bows of the vessels equals just about three lengths of a vessel;
- new courses kept on both vessels cause that they pass by each other at a transverse distance between the sides of 2-3.5 B ;
- at the point where the bow of one vessel passes the stern of the other, the course must be changed to port leading to the centre of the channel.

If the manoeuvre is performed in the above mentioned way, the passing distance resulting from the course changes does not lead to excessive departing from the axis of the channel. Also, the distance from each of the banks is not less than four widths of a vessel*.

Figure 5: The passing manoeuvre in a wide channel
