# **STATE COMMISSION ON MARITIME ACCIDENT INVESTIGATION**

## **SIMPLIFIED REPORT 59/14**

**M/T JUTLANDIA SWAN**

Grounding in the fairway in Świnoujście  
on the day of 30 December 2014

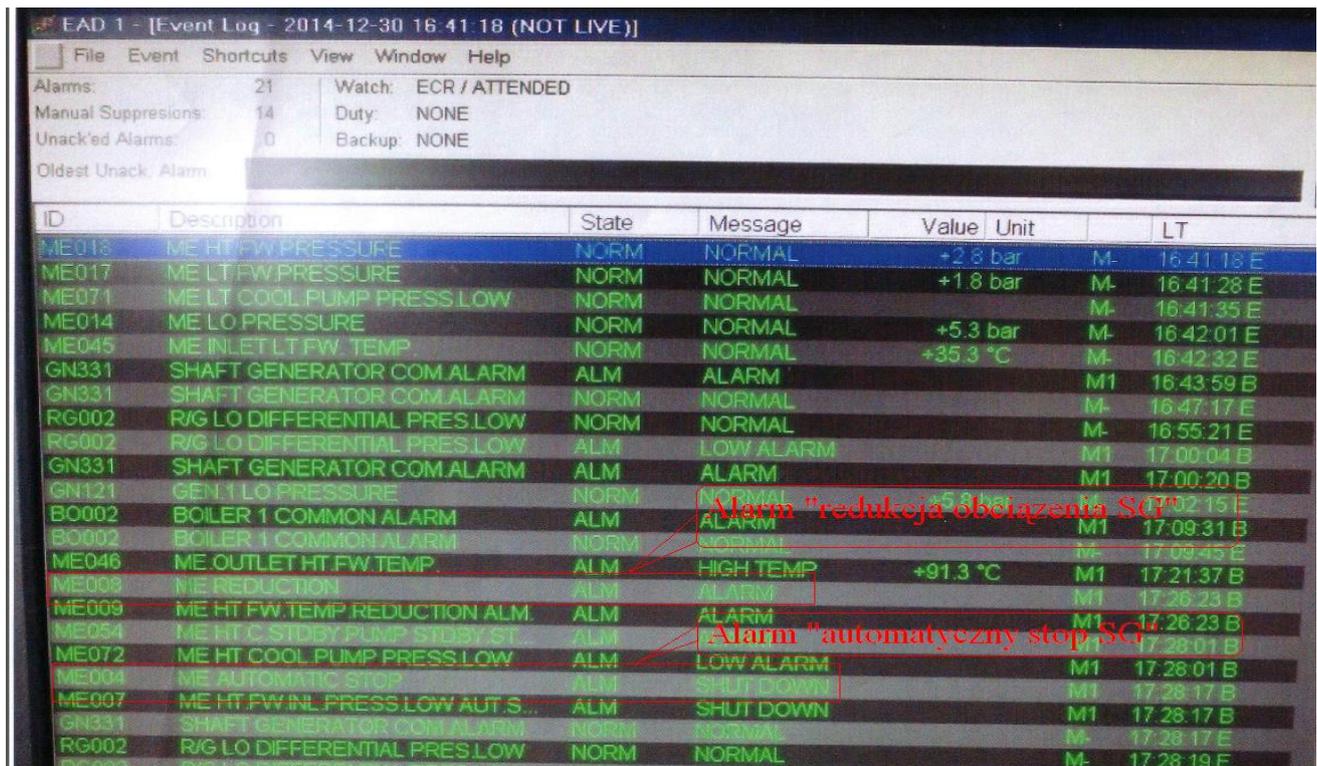
*Photograph 2: The alarm activated in the ME control system*

At 16:30:26 the security system in the ME remote control system automatically activated the “ME load reduction” alarm due to the high temperature of the cooling water (Photograph 2).

ID	Description	State	Message	Value	Unit	LT
ME018	ME HT FW PRESSURE	NORM	NORMAL	+2.8 bar	M-	16:41:18 E
ME017	ME LT FW PRESSURE	NORM	NORMAL	+1.8 bar	M-	16:41:28 E
ME071	ME LT COOL PUMP PRESS LOW	NORM	NORMAL		M-	16:41:35 E
ME014	ME LO PRESSURE	NORM	NORMAL	+5.3 bar	M-	16:42:01 E
ME045	ME INLET LT FW TEMP.	NORM	NORMAL	+35.3 °C	M-	16:42:32 E
GN331	SHAFT GENERATOR COM.ALARM	ALM	ALARM		M1	16:43:59 B
GN331	SHAFT GENERATOR COM.ALARM	NORM	NORMAL		M-	16:47:17 E
RG002	R/G LO DIFFERENTIAL PRES.LOW	NORM	NORMAL		M-	16:55:21 E
RG002	R/G LO DIFFERENTIAL PRES.LOW	ALM	LOW ALARM		M1	17:00:04 B
GN331	SHAFT GENERATOR COM.ALARM	ALM	ALARM		M1	17:00:20 B
GN121	GEN 1 LO PRESSURE	NORM	NORMAL	+5.9 bar	M-	17:02:15 E
BO002	BOILER 1 COMMON ALARM	ALM	ALARM		M1	17:09:31 B
BO002	BOILER 1 COMMON ALARM	NORM	NORMAL		M-	17:09:45 E
ME046	ME OUTLET HT.FW TEMP.	ALM	HIGH TEMP	+91.3 °C	M1	17:21:37 B
ME009	ME REDUCTION	ALM	ALARM		M1	17:26:23 B
ME009	ME HT FW TEMP REDUCTION ALM.	ALM	ALARM		M1	17:26:23 B

ME054	ME HT C STDBY PUMP STDBY ST.	ALM	ALARM		M1	17:28:01 B
ME072	ME HT COOL PUMP PRESS LOW	ALM	LOW ALARM		M1	17:28:01 B
ME004	ME AUTOMATIC STOP	ALM	SHUT DOWN		M1	17:28:17 B
ME007	ME HT FW INL PRESS LOW AUT S...	ALM	SHUT DOWN		M1	17:28:17 B
GN331	SHAFT GENERATOR COM.ALARM	NORM	NORMAL		M-	17:28:17 E
RG002	R/G LO DIFFERENTIAL PRES.LOW	NORM	NORMAL		M-	17:28:19 E

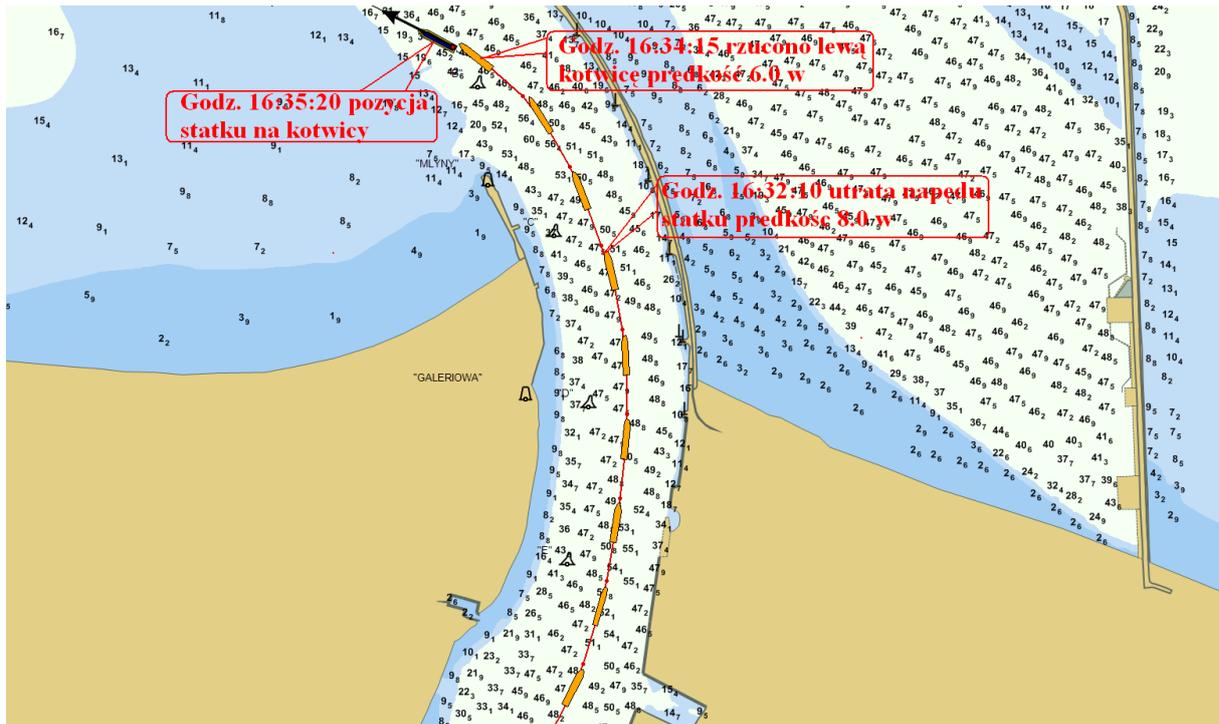
*Photograph 3: Trajectory of movement of Jutlandia Swan from the VDR recording*

At 16:34:15 port anchor was dropped on the western side of the fairway, 2 shackles in water. After dropping anchor, the ship lost her speed. At. 16:35:20 the ship’s pilot informed the VTS that the ship was at anchor between the heads on the western side of the fairway and that 2 tug boats were needed to refloat the ship.

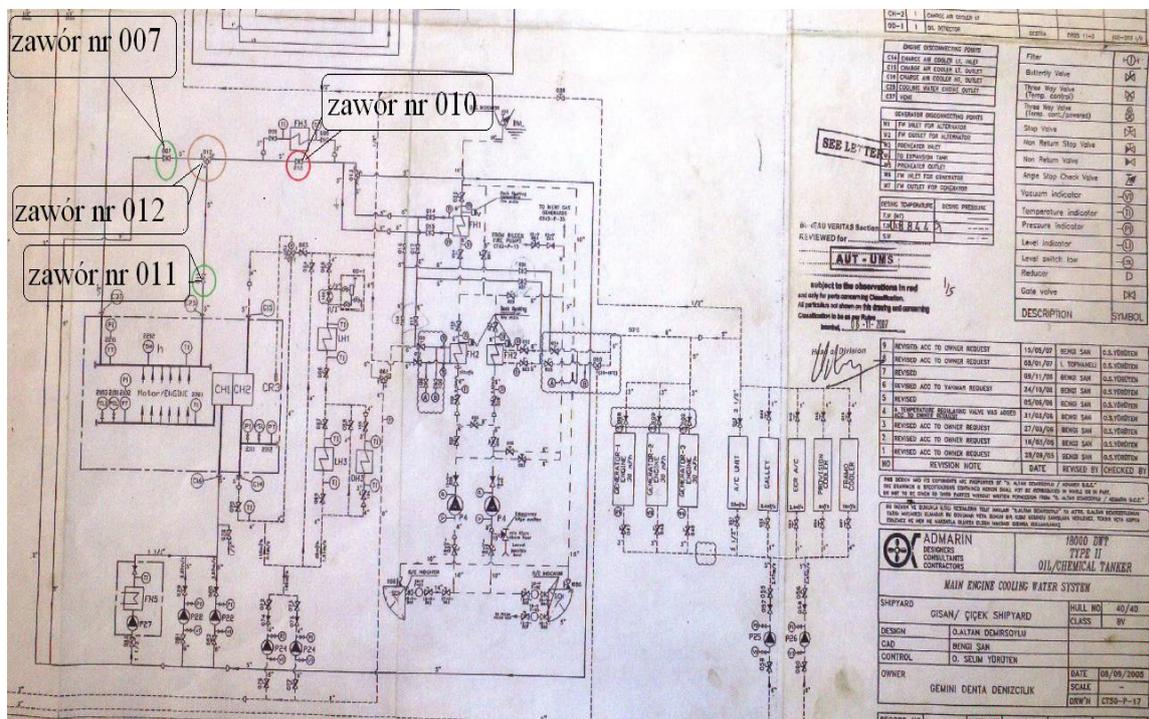
Figure 1: ME cooling system

On December 29, 2014 second engineer made a technical review of improperly functioning thermostatic 3-way valve No. 012 in the ME cooling system in the high-temperature circuit. For this purpose, the pump of high-temperature cooling circuit was turned off and the valves Nos. 007, 011 and 010 were closed (Figure 1). The pipeline was drained and after the review of the valve, the same valves according to the report of the second engineer were opened, and the system was prepared for normal operation. After starting the cooling water system all parameters of ME were found within normal working conditions.

A mechanical factor, which indirectly contributed to the accident, was a closed valve No. 010 of the ME cooling system, causing a lack of supplying the radiator with cooling water which caused the temperature of the coolant to rise above the limit value together with the reduction in ME load. Low pressure of cooling water due to opening of the valve No. 010 was a mechanical factor that caused immobilization of propulsion. The air collected in the pipeline between the valve No. 012 and the valve No. 010 reached the cooling water suction pump causing sudden drop of pressure and activating the "ME automatic stop" alarm. The restoration of the ME performance and the ship's propulsion required to eliminate the air from the pipeline and pumps of the cooling water system.

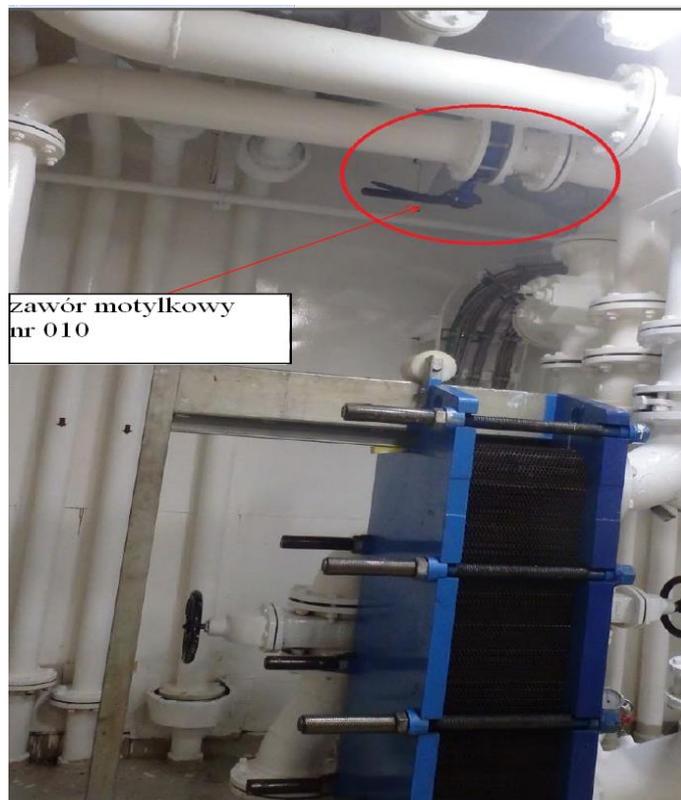
Photograph 4: Manual butterfly valve No. 010

According to the Commission, the valve No. 010 left in the closed position after the repair made it impossible to check the operation of the ME cooling water system properly. While the ship was in port and the ME was working at low load, the raise of the cooling water temperature above the permissible value was not observed because underheated cooling water at the ME outlet through a thermostatic 3-way valve circulated in the so called small cycle without the radiator.

The engineer on watch when preparing the engine room for work had not checked proper setting of valves in the system of cooling water of the high-temperature ME but he had limited himself to the observation of pressure and temperature on a computer monitor.

The Commission acknowledged that leaving the valve No. 010 closed in the cooling water system after inspecting the thermostatic three-way valve was an oversight that prevented proper venting of the system. During port exit manoeuvres engineers limited themselves to observing the ME operating parameters displayed on the monitor of the control system in the engine control room which proved to be insufficient.

The lack of procedures in the ship's Safety Management Manual regarding the use of the labeling system, information tags during inspections of devices and the preparation of the engine room for maritime or port traffic, contributed to leaving the valve No. 010 in the closed position. When inspecting and preparing the engine room for movement the engineers did not observe the principle of good seamanship and did not use the *tag in/out* system which is placed in the engine control room as the so called information board where information about the actual operational status of important systems, equipment and valves is displayed. Such a system allows the users to minimize the possibility of error.

Pending the development of this report, the owner of the vessel identified the causes and circumstances of the accident and made recommendations for the ships' crews and made changes in the ship's Safety Management Manual. He developed checklists for the preparation of the ship to leave or enter the port along with instructions for their observance by watch

There was introduced a *tag in/out* marking system that will help identify the operational status of devices and systems in the engine room, informing the watch engineer which devices are excluded from service and have "under repair" status.
