STATE MARINE ACCIDENT INVESTIGATION COMMISSION

FINAL REPORT 47/15

M/V NEFRYT

Poisoning of the ship crew after the fumigation of cargo in the port of Abidjan
on 25 and 26 September 2015

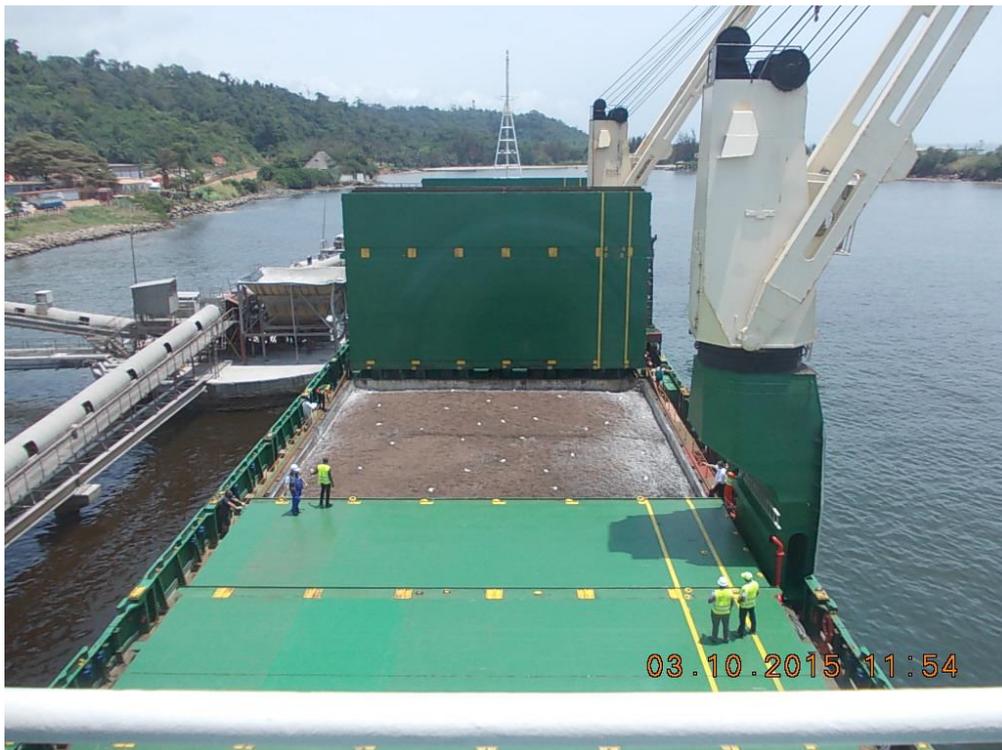
Photograph 2. Bags (white) with fumigant laid out in the cargo hold

A total of 120 bags with approximately 18,500 pellets of the fumigating agent were laid out. During the distribution of the preparation, the crew smelled an unidentified sharp odour. When the bags with fumigant were laid out, sections 3 and 4 of the cargo hold hatches were closed as ordered by the chief officer. The chief officer advised the crew to avoid inhaling the smelling substance when closing the hatches.

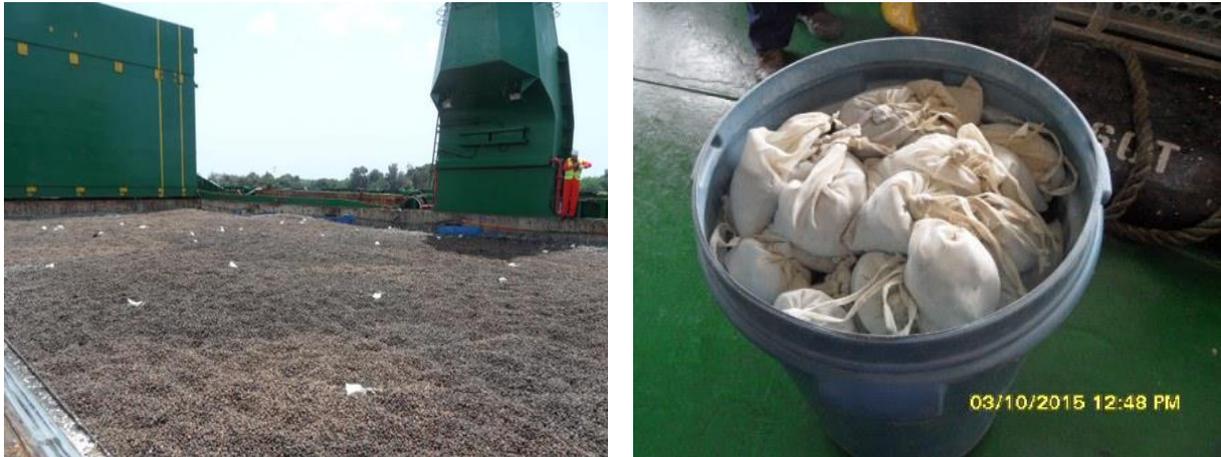
Photograph 4. Phosmium bags distributed on top of cargo and placed in a container after the accident, at San Pedro.

The Commission established that on board of Nefryt the quantity of fumigation preparation was calculated adequately to the volume of fumigated cargo in proportion of 3 g/m^3 . The expected effective time of the active substance was calculated at 72 hours.

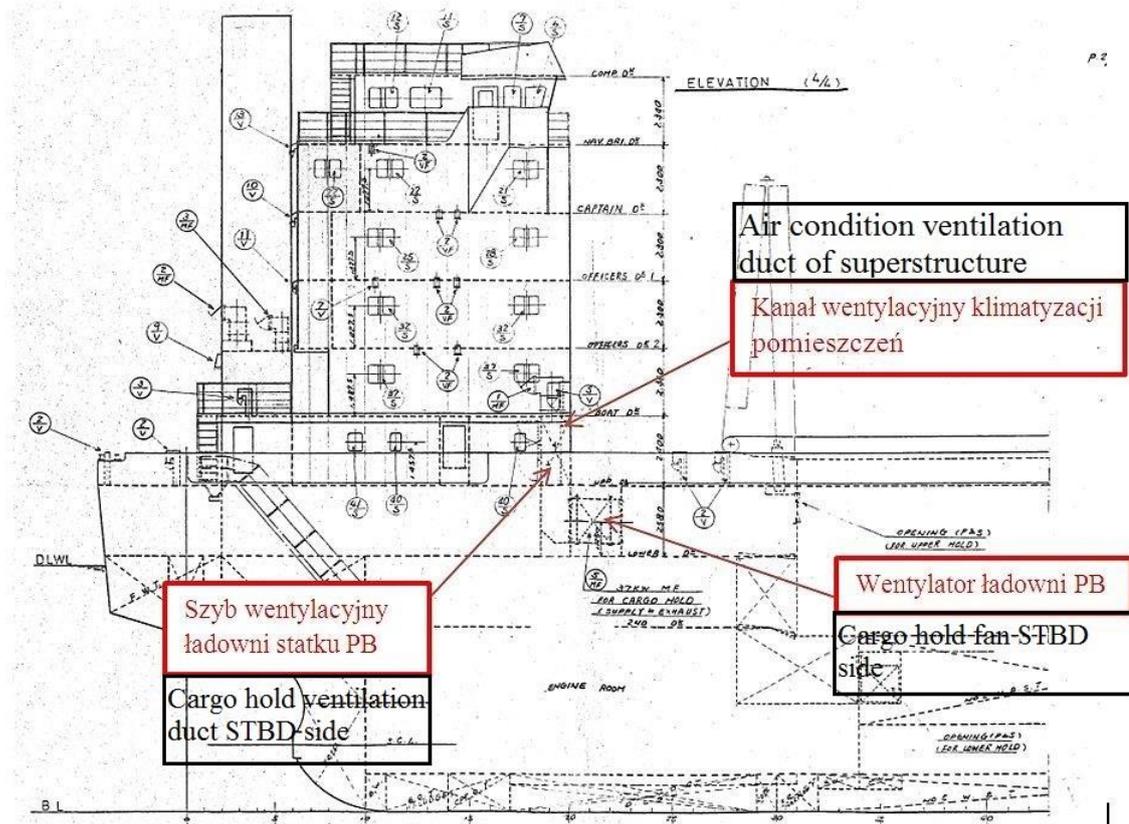
The mechanical factor that contributed to the incident were leaks in the ventilation trunk of the air conditioning system running inside the starboard side ventilation casing of cargo hold that supplies air to the air conditioning control room and further on to living quarters in ship superstructure (Figure 3).

Figure 3. Location of ventilation casing of cargo hold and air conditioning trunk in crew living quarters on ship starboard side.

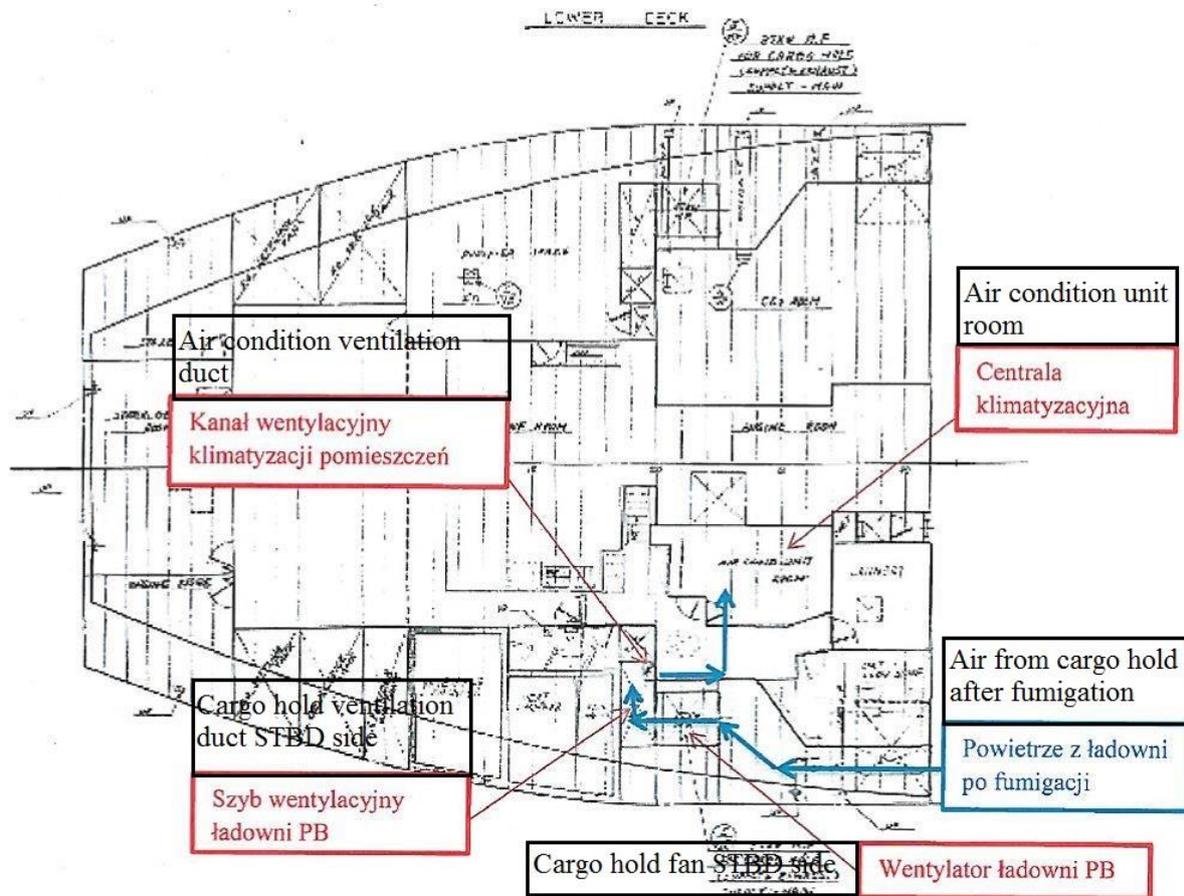
To enhance the air cooling effect, the air conditioning system in living quarters on Nefryt worked in recirculation mode: air inlet was on the corridor on the superstructure lower deck. Leaks in the upper part of the air conditioning ventilation trunk inside the cargo hold ventilation casing allowed poisonous gas from the fumigated cargo hold to get to the air conditioning control room by the ventilation trunk (Figure 4).

Figure 4. Location of the ventilation casing and trunk on lower deck of Nefryt superstructure.

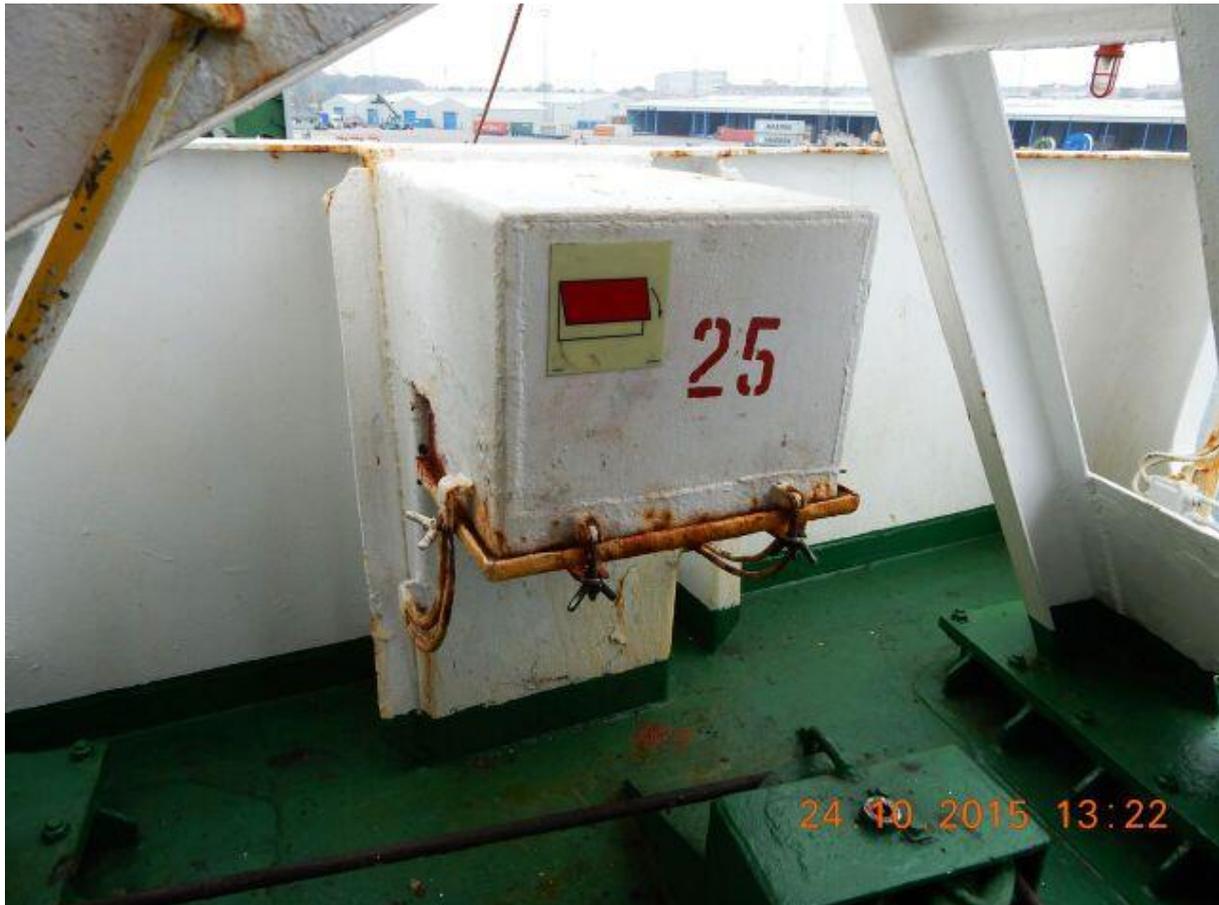
Photograph 5. Air conditioning inlet in ship superstructure on boat deck on starboard side.

Air conditioning inlet in ship superstructure on boat deck on starboard side (Photograph 5) has most probably not been closed after the ship left the port, but even if it was, it would not eliminate the threat of sucking in poisonous gas from the cargo hold generated during cargo fumigation.

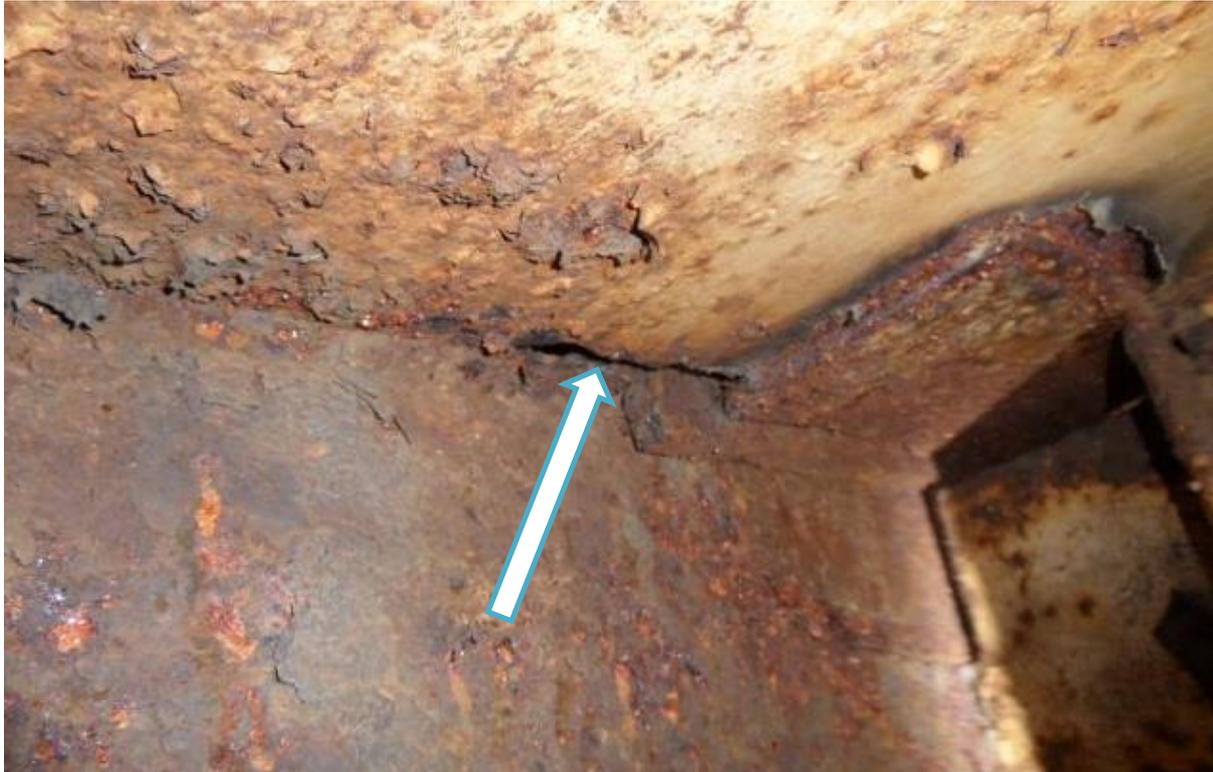
The ventilation trunk of superstructure air conditioning system running inside the stern cargo hold ventilation casing²² on starboard side was considerably corroded. There were pronounced cracks in the upper part of the trunk next to gussets along welded metal sheet joints of cargo hold ventilation trunk and the air conditioning trunk, there were visible cracks in the place of the previous repair at the meeting place of both ducts. One of these cracks is shown in photograph 6 taken at San Pedro port on 3 October 2015. Signs of the previous repair are visible in the lower wall of the air conditioning trunk.

Photograph 6. Cracks in the upper part of the air conditioning ventilation trunk on welded joints of metal sheets in the ventilation casing of ship starboard side cargo hold.

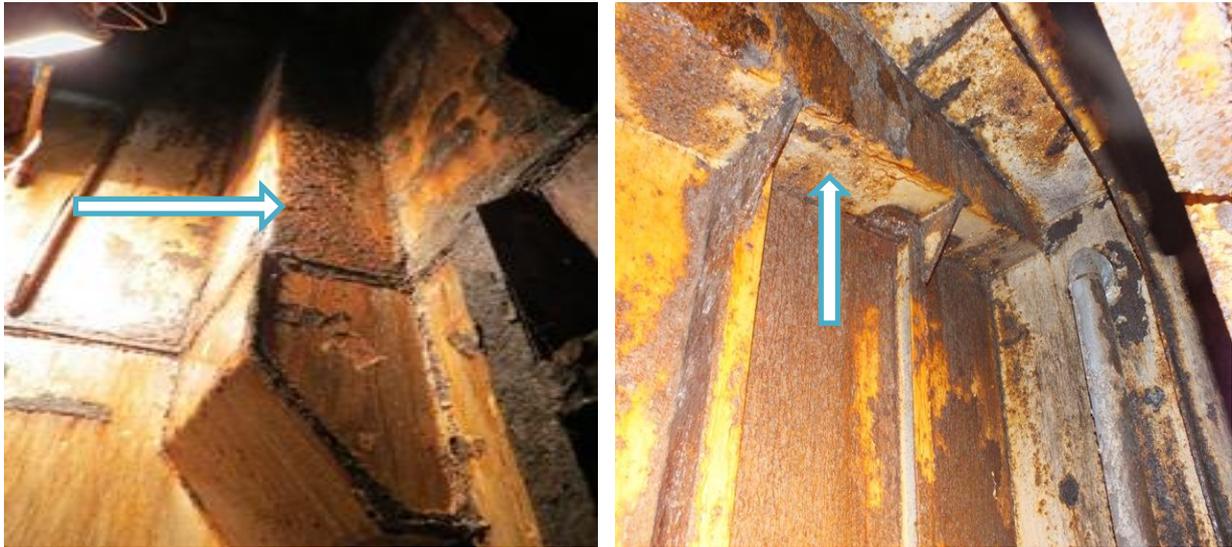
Only careful visual inspection and repair after the accident, i.e. crew poisoning with gas from the cargo hold in October 2015, have shown the actual technical condition of both ventilation trunks, extensive corrosion on trunk metal sheets and cracks at the welded joints.

Photograph 7. Air conditioning ventilation trunk before the repair.

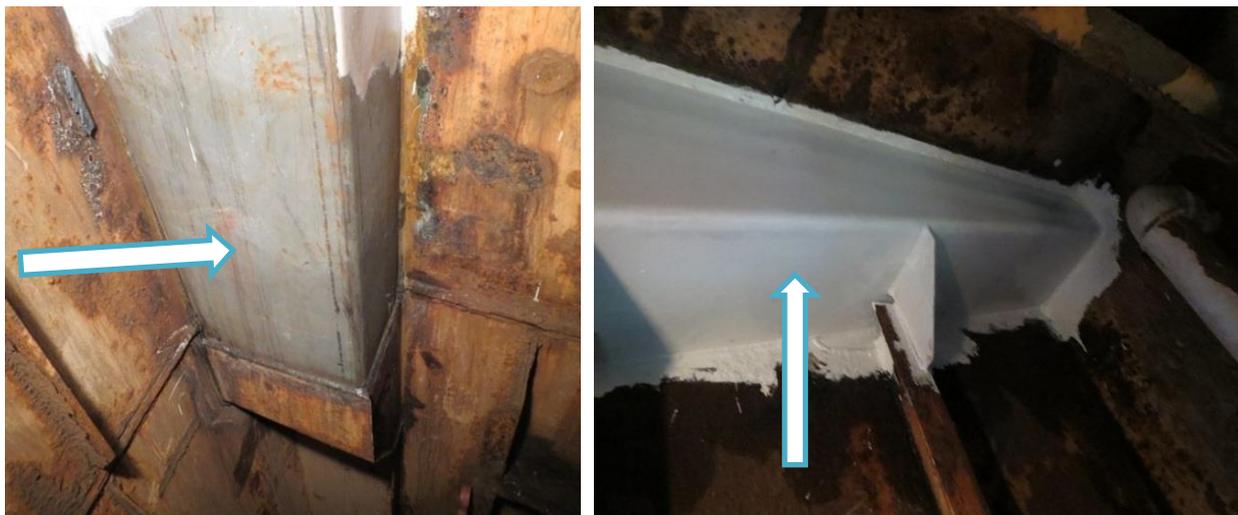
Photograph 8. Air conditioning ventilation trunk after the repair.

The Commission established that during the between voyage repair, when the ship was in Gdańsk in November 2014, the damaged front superstructure plate was repaired (during maintenance, two holes leading to cargo hold ventilation trunk were tapped out) on the starboard side at about 2 m over the main deck by cutting and welding in the plate two patches of steel plate with dimensions of 300 x 300 x 8 mm and 300 x 400 x 8 mm. The repair of the front superstructure wall which is at the same time the front wall of the ventilation casing of the cargo hold and the ventilation trunk of air conditioning, was done from the outside (from the deck side). After the repair no in-depth inspection of the condition of both ventilation trunks from the inside was carried out and the cracks were not detected (weld cavity) between the ventilation casing of the cargo hold and the ventilation trunk of air conditioning.

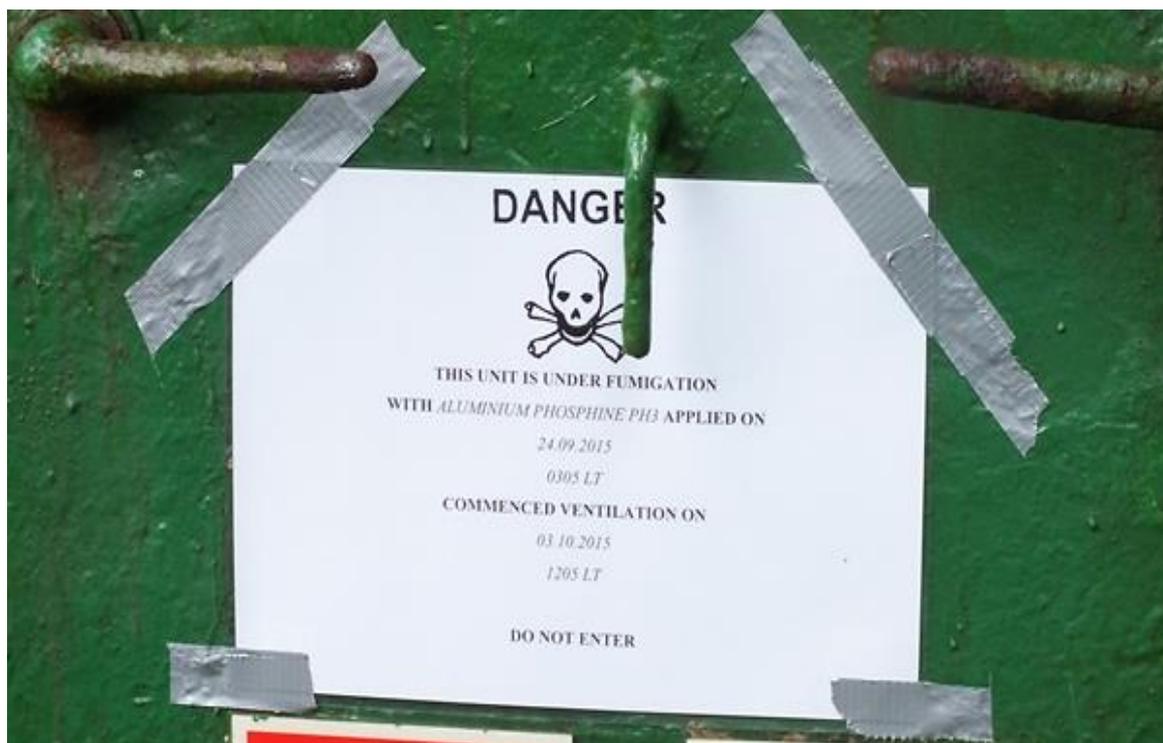
Photograph 9. Entry to the Nefryt cargo hold marked during ventilation with a sign warning of fumigation using PH₃.
