STATE MARINE ACCIDENT INVESTIGATION COMMISSION

FINAL REPORT 07/15

Very serious marine casualty

Collision of Transforza and Kugar
in the fairway in Świnoujście on 16 February 2015

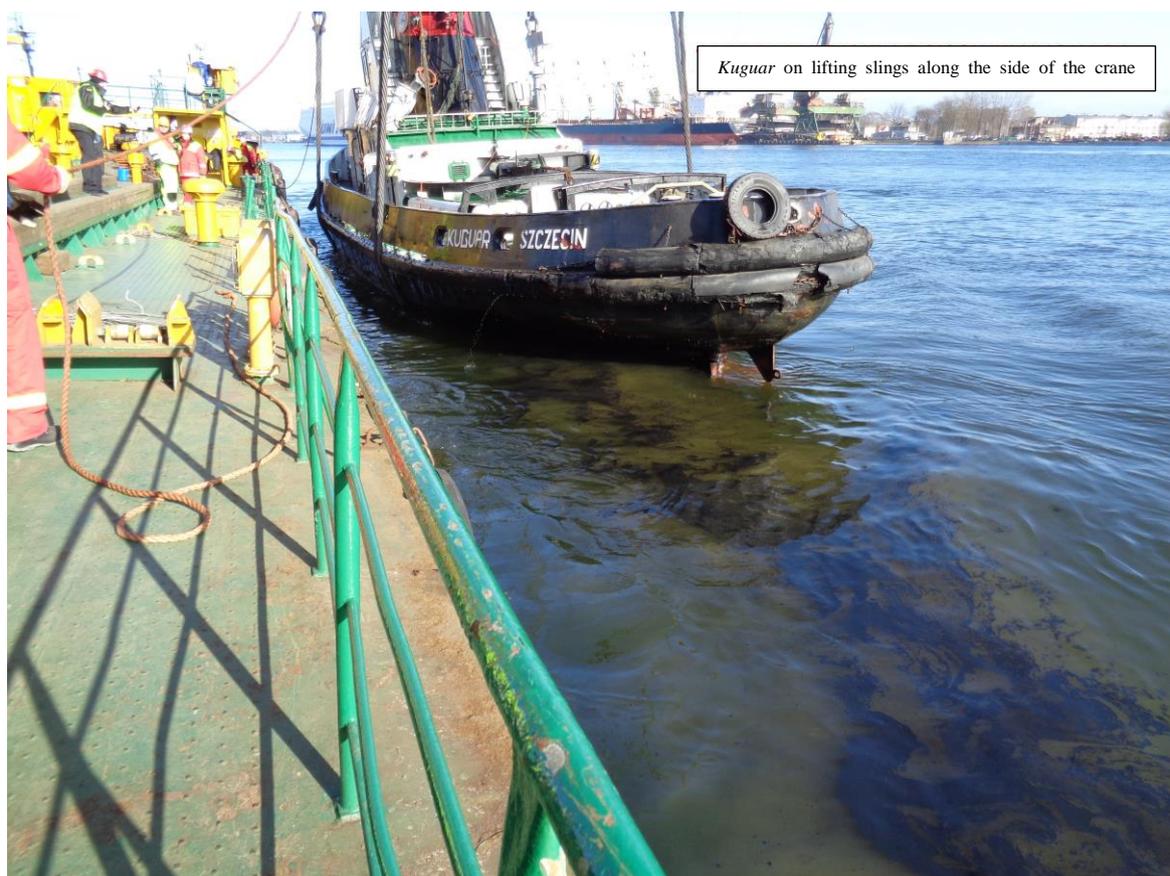
Photograph 4: Oil from the wreck of Kuguar emanating to the surface of water

After the recovery of *Kuguar* on 11 March, 2015 in the afternoon, the removal of oil pollution emanating from the wreck was being continued.

Kuguar on lifting slings along the side of the crane

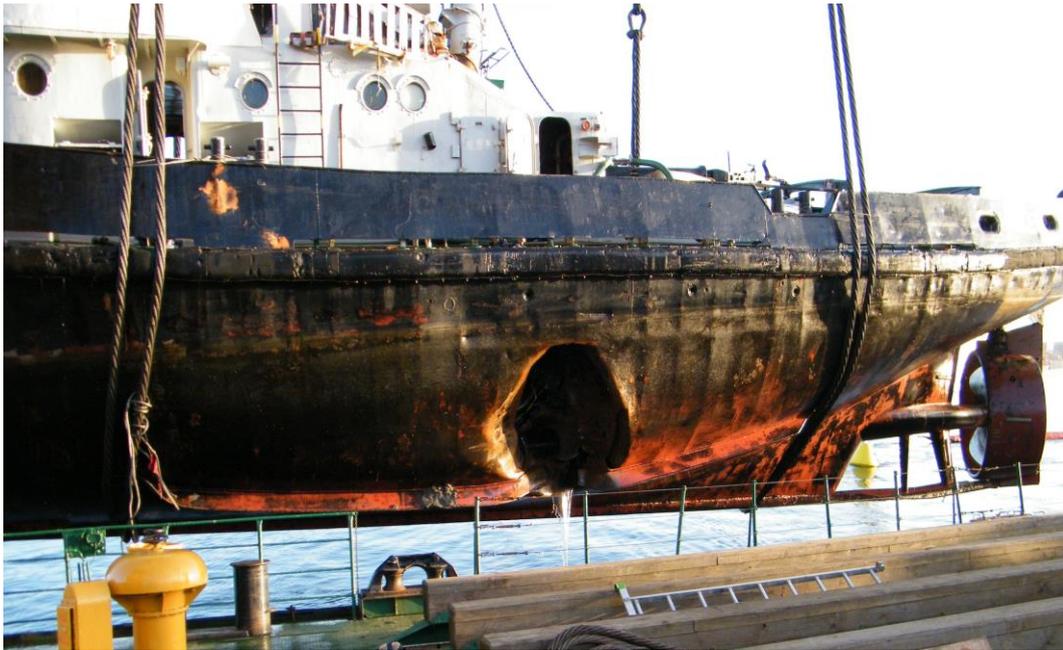
Photograph 5: Damage of the side of Kuguar

At 22:17 *Omskiy-137* proceeding to sea passed the stern of *Transforza*. *Transforza* started turning to port. After a while, the skipper of *Kuguar* heard on VHF channel 12 the call of the *Transforza*'s pilot to turn to starboard. In the course of turning to starboard it came to an impact. *Transforza* hit with her bulbous bow an underwater part of the port side of *Kuguar* beyond the midship (Photograph 5).

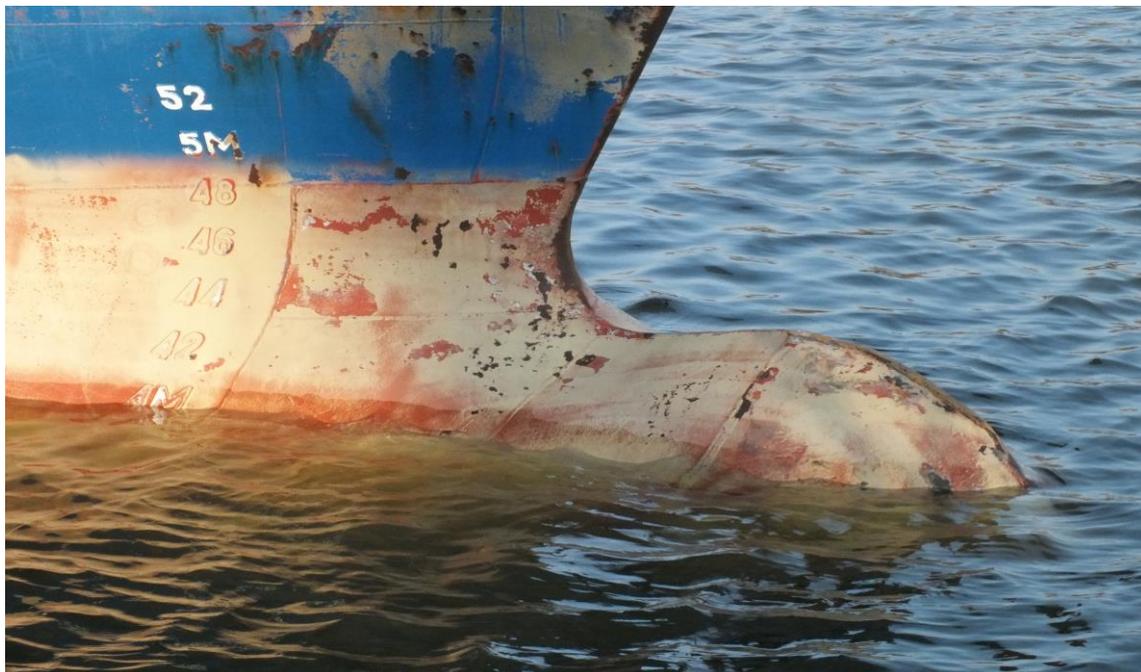
Photograph 6: The bow of Transforza

After the collision, *Transforza* with *Kuguar* stuck on the bulbous bow, started rotating to starboard in the direction of the Kosa Peninsula. The master of *Transforza* ordered full astern. *Kuguar* detached from the bow of *Transforza*.

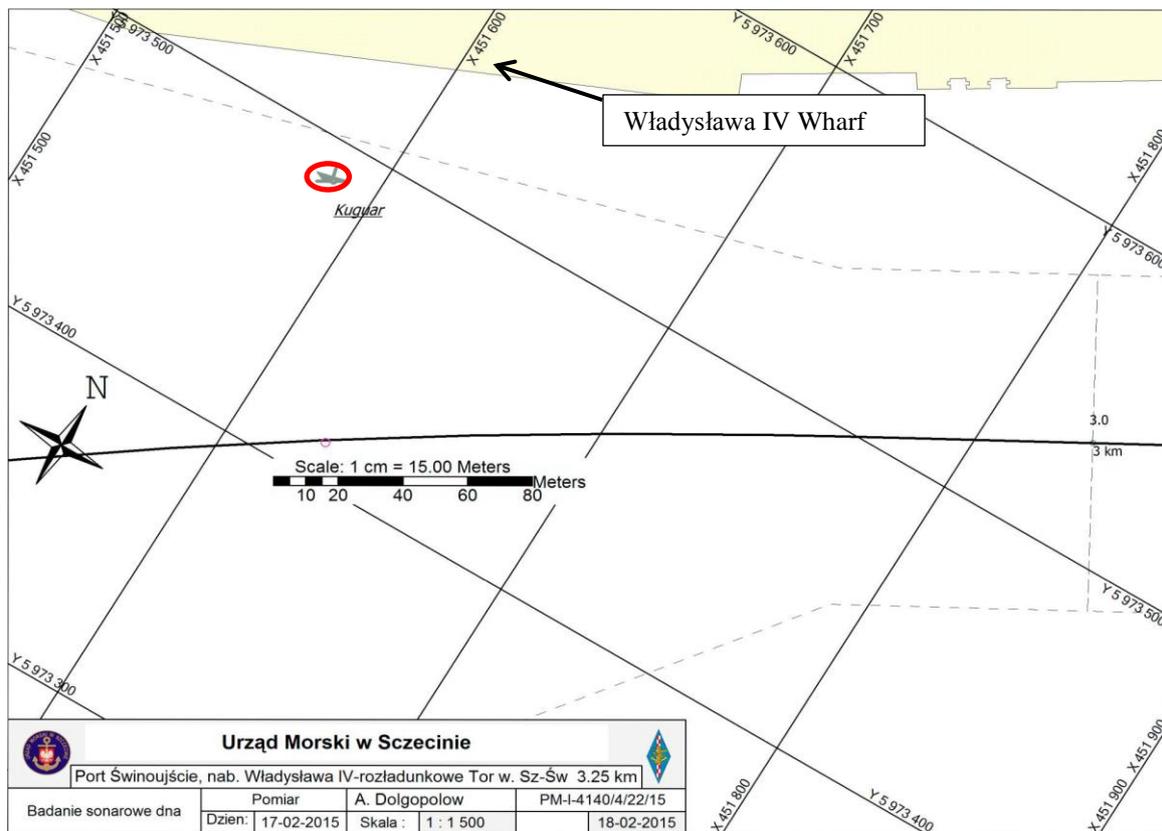
Photograph 7: A place where *Kuguar* sank after sonar investigation of the sea bed

For a few minutes the tug boat was remaining on water and drifting with the current. The crew members and a passenger went up the fender on the bow of the tug boat. Her stern was increasingly immersing in water. The crew and the passenger found themselves in water. *Kuguar* sank in the position of $\phi=54^{\circ}54,4553'N$; $\lambda=014^{\circ}15,7906'E$. She sank on the bottom at a depth of approximately 13.6 m.

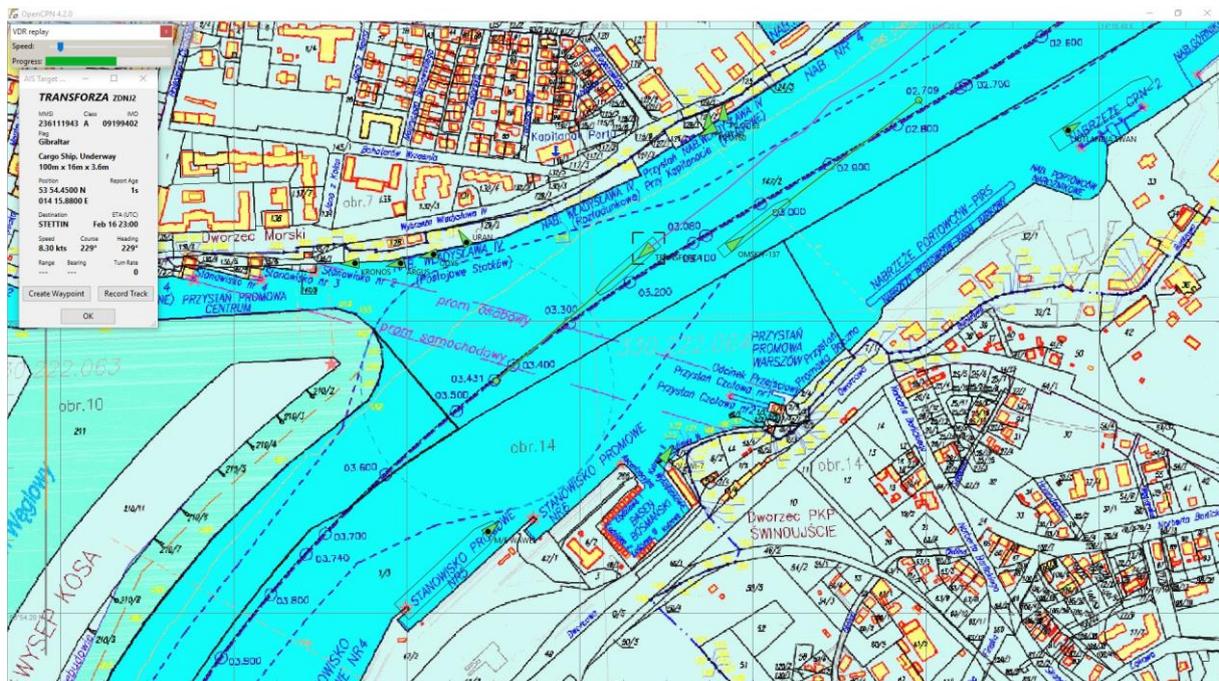
Figure 1: Message and position (T1): *Transforza* after sailing past *Omskiy-137*

Abeam of the Harbour Master's Office in Świnoujście *Transforza*, going at a speed of 8.3 *kn* sailed past a vessel *Omskiy-137*. Each of the vessels was sailing on their side of the fairway and the vessels passed by each other at a distance of about 45 meters (between the sides). Shortly after passing *Omskiy-137*, at 22:17:10 (Figure 1), *Transforza* changed the course again to port. The alteration of the course was slight, but larger than it would appear from the curvature of the fairway in that section.

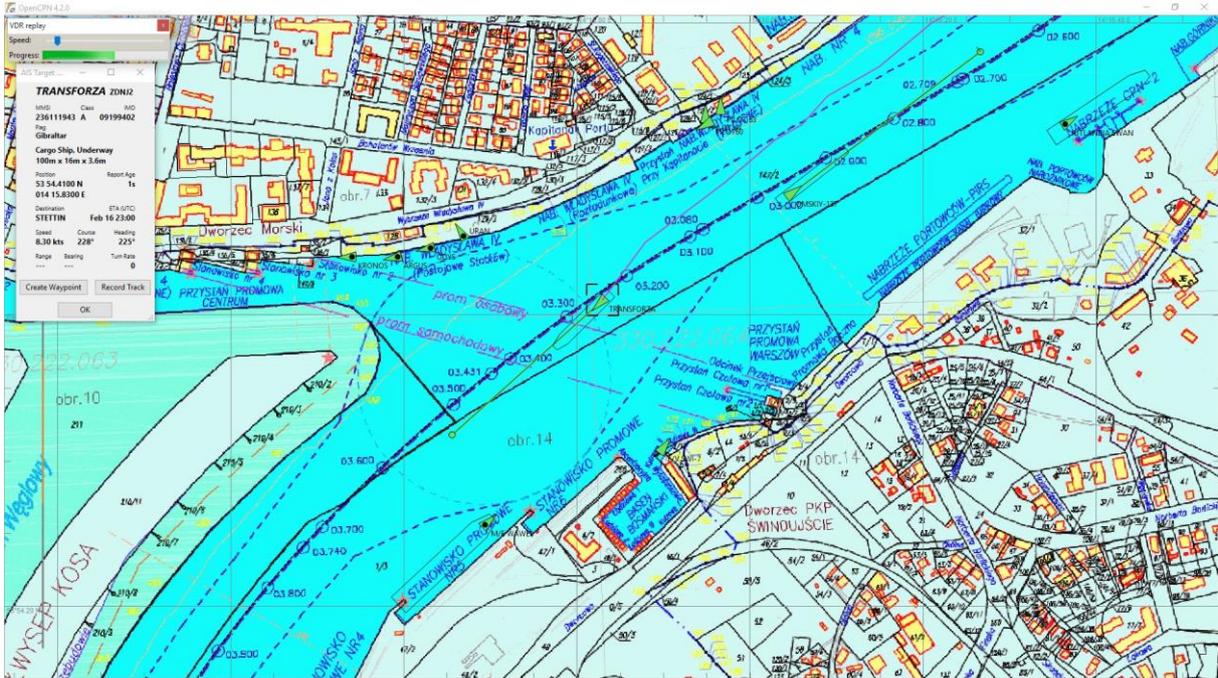
Figure 2: Message and position (T2): crossing of the fairway axis by *Transforza*

Turning action and maintaining the adopted course meant that soon *Transforza* crossed the axis of the fairway (at the position of $\varphi=53^{\circ}54.4221'N$, $\lambda=014^{\circ}15.8467'E$), and went into the east side of the fairway (Figure 2).

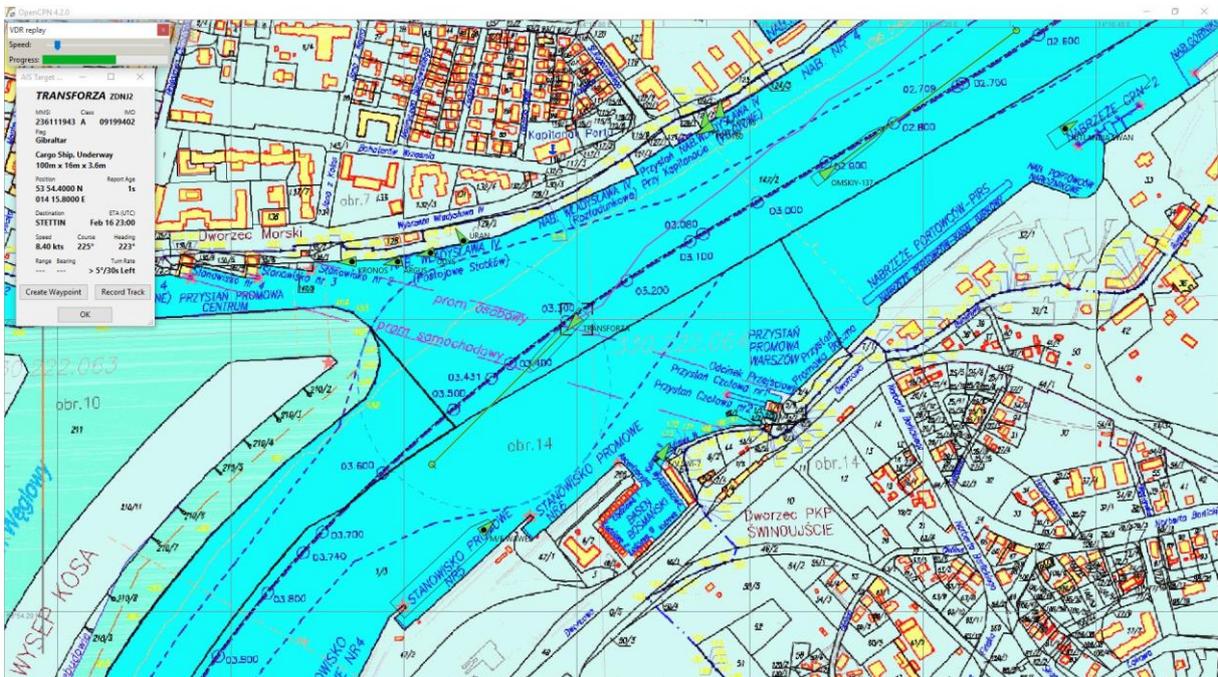
Figure 3: Message and position (T3): reported turning of *Transforza* to port side

When *Transforza* was at ca 1.5 ship's length in front of *Kuguar*, the *Transforza*'s AIS transmitter sent a message about the turn to port being in progress at a speed of at least 5°/30s (Figure 3 and line (T3) in Table 3)⁵.

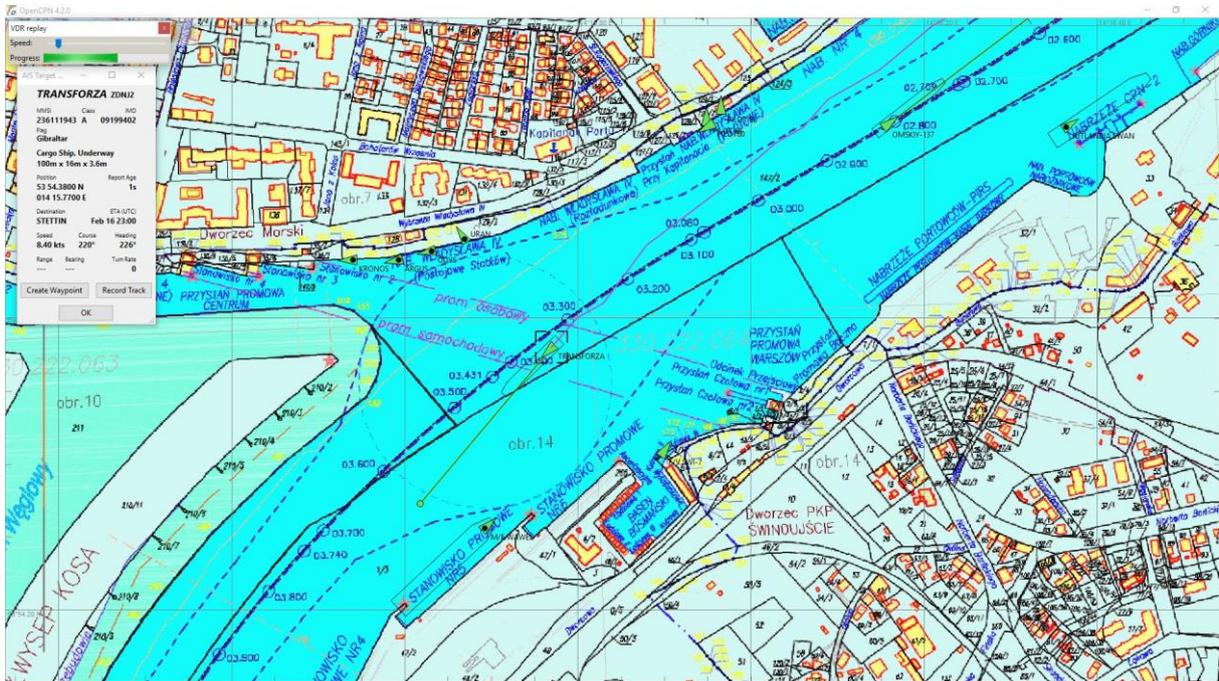
Figure 4: Message and position (T4): navigating of *Transforza* on the eastern side of the fairway

The analysis of the following AIS message did not show further turning by the vessel but it indicated that *Transforza* was navigating on the eastern side of the fairway (Figure 4).

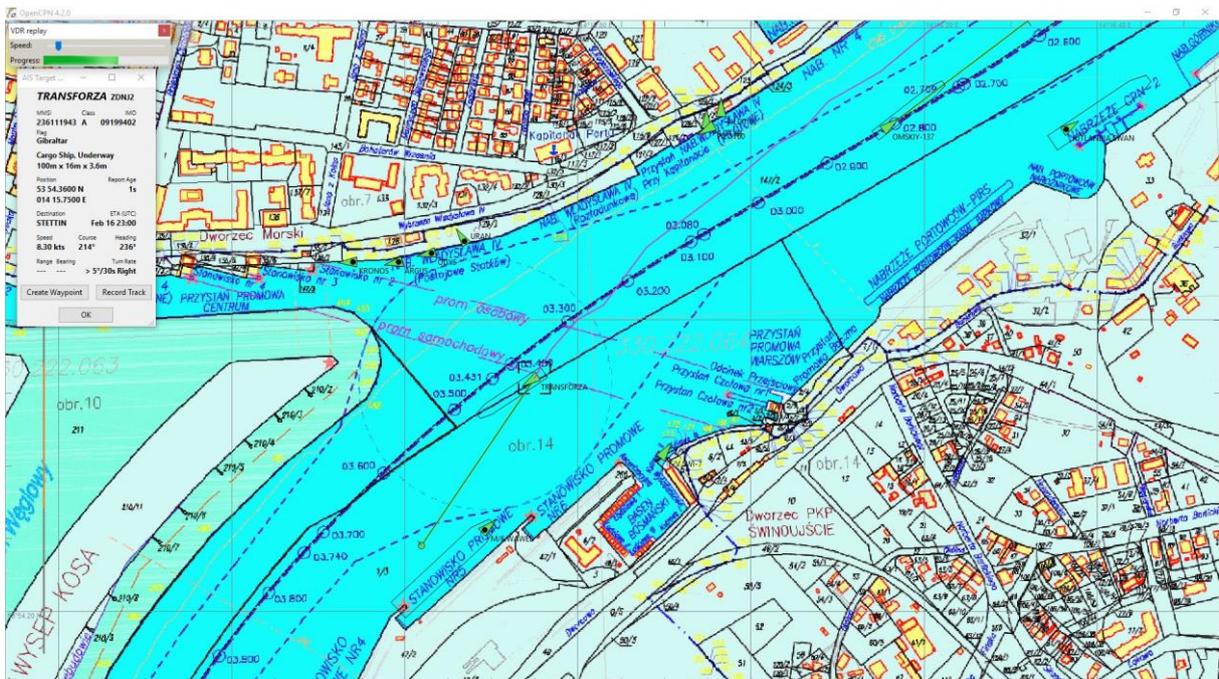
Figure 5: Message and position (T5): positioning of *Transforza* a few seconds after the collision

Another AIS message, sent probably 2-3 seconds after the collision, and subsequent messages indicated a permanent turn to starboard. *Transforza* started turning to starboard as a result of the *hard a starboard* manoeuvre (Figure 5 and Table 3).

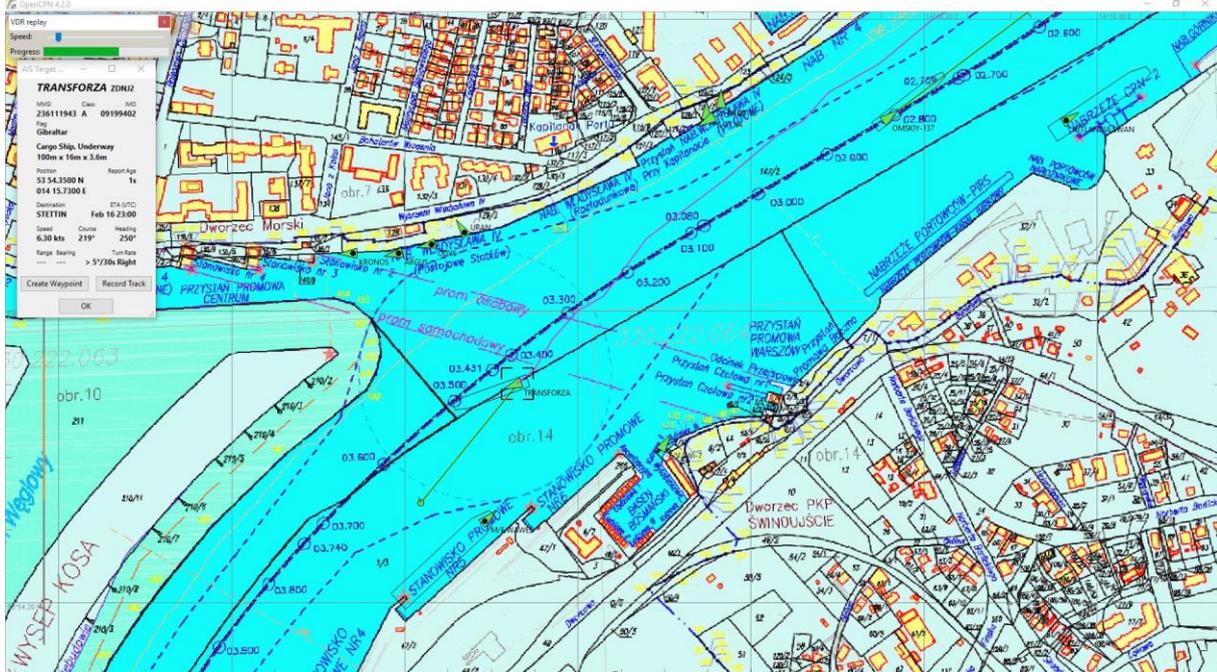
Figure 6: Message and position (T6): *Transforza* when turning to starboard after the collision

Figure 6 shows the situation after the collision of the vessel with the tug boat. The AIS message formulated 10 seconds after the previous message recorded a decrease of speed of *Transforza* by two knots (down to 6.3 kn) as a result of the collision and astern motion of the engine.

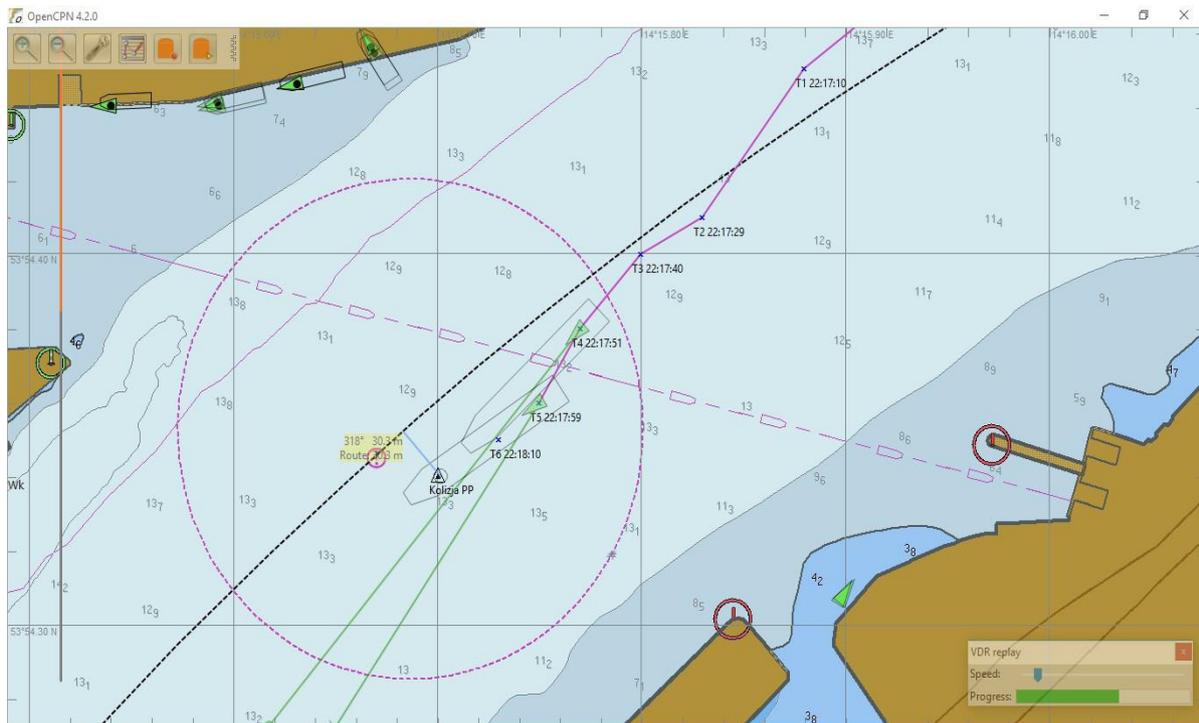
Figure 7: Position where *Transforza* had a collision with *Kuguar*

Special attention should be drawn to the message (T3) containing the ROT_{AIS} report (-127) about the turn > 5° to port when the vessel was already on the eastern side of the fairway. The change of course produced an effective change of COG by 11° to port (225° - 214°). Further messages indicate that there was sudden deceleration and that the turn to starboard was being maintained. The position of *Transforza* at the time (T4) and (T5) and the most likely position of the collision with *Kuguar* is shown in Figure 7.

The axis of the fairway (dotted black line) and the AIS signal path of *Transforza* (dark pink solid line) are marked on the BHMW S-57 chart, shown in Figure 7. According to calculations made by the Commission, *Transforza* hit with her bow the side of the tug boat *Kuguar* which was located about 30 m to the right (eastwards) from the axis of the fairway.

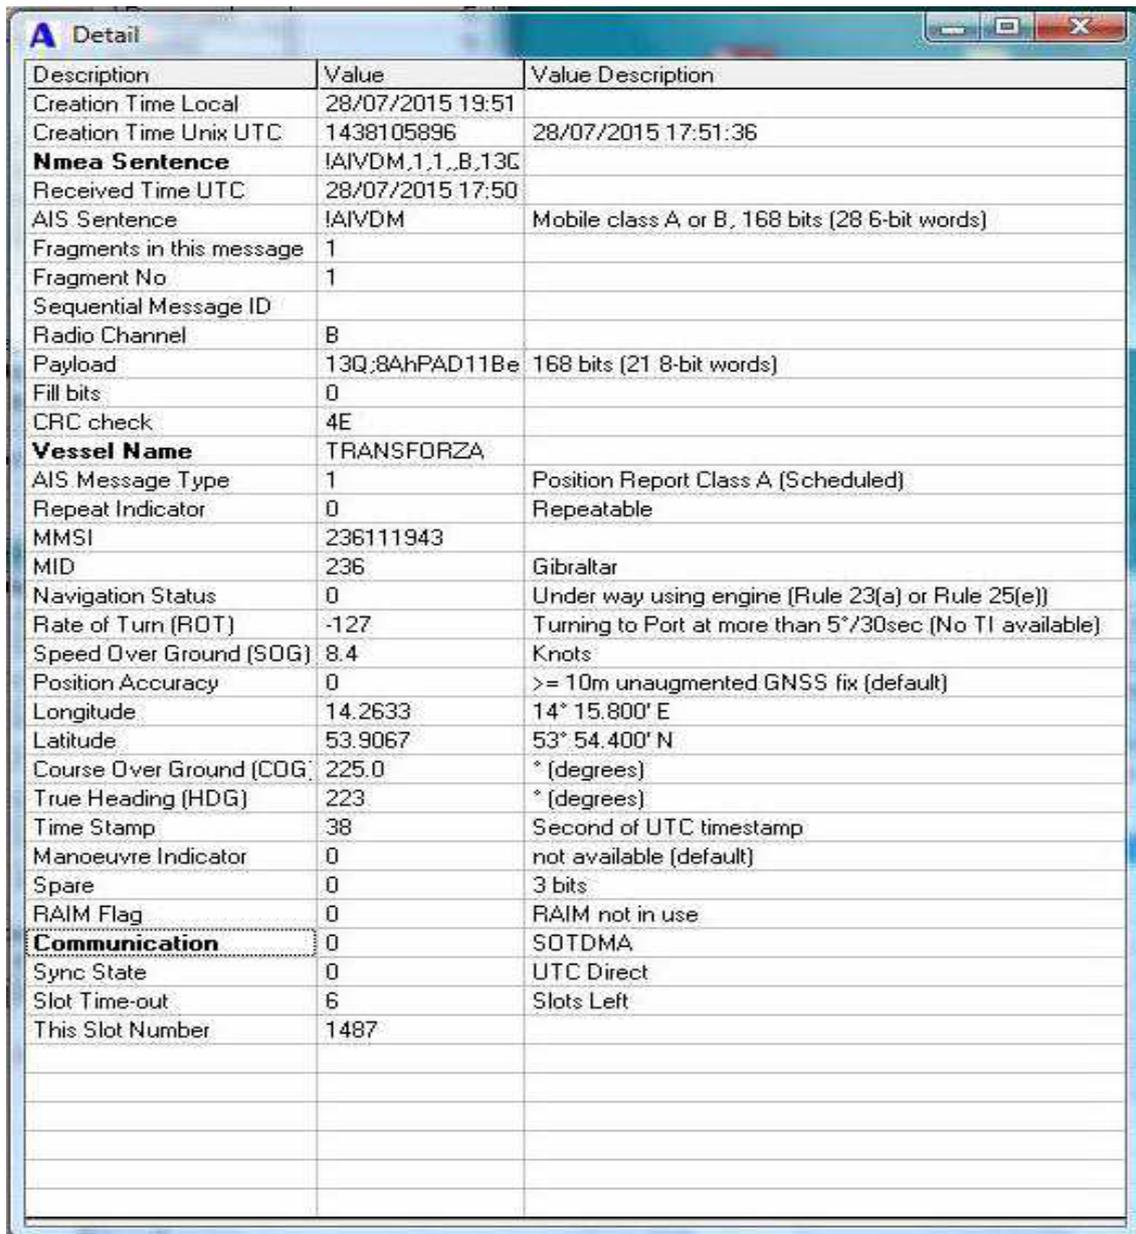
It results from the value =0 for the information contained in the line *Position accuracy* (Photograph 9) which was defined in the AIS message type 1 (position report - dynamic data), that the on-board GPS device was not equipped with a differential adapter. To determine the accuracy of the vessel's position a standard accuracy of about 10 m was adopted.

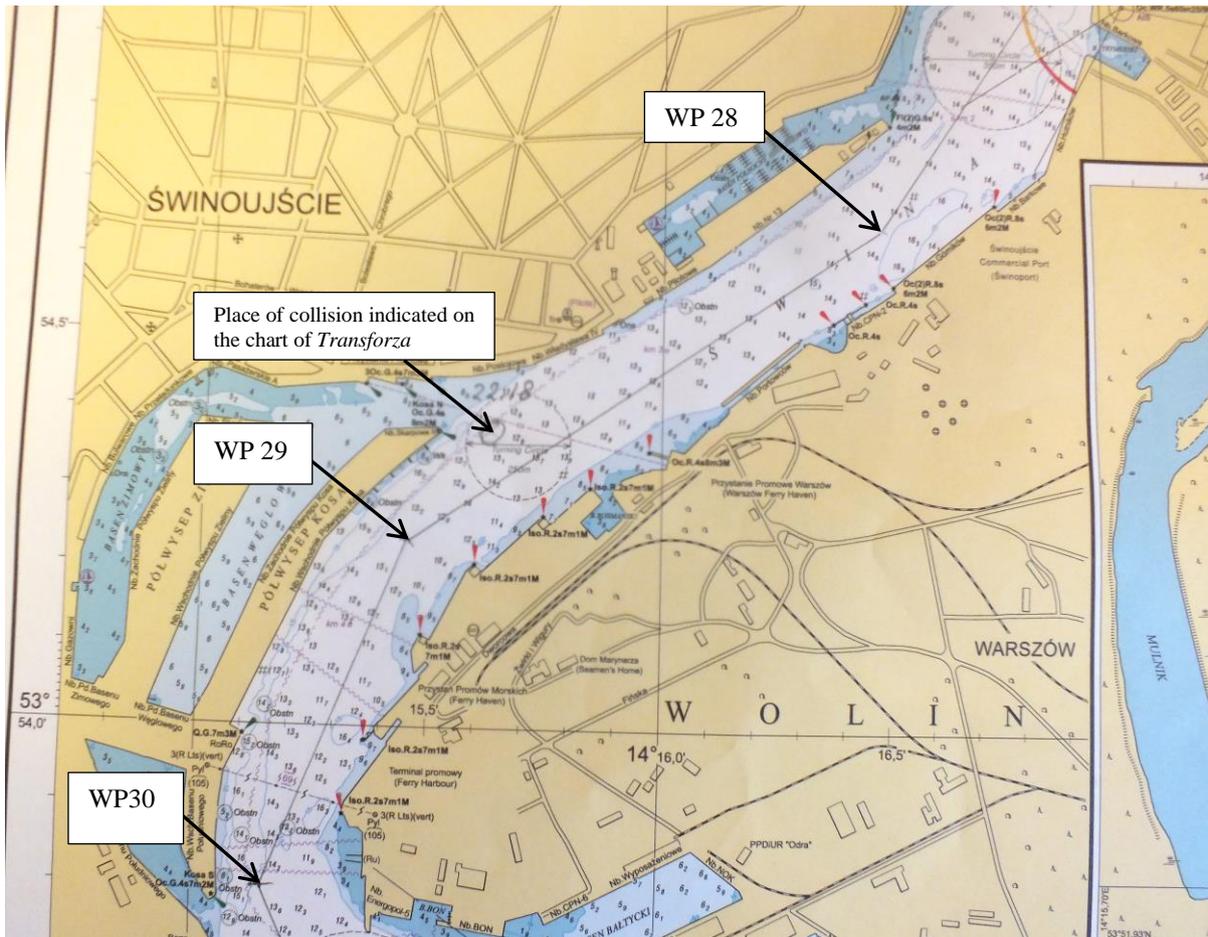
Photograph 11: BA 2686 chart from *Transforza*'s bridge with routes marked out by the crew with three planned points of turn No 28, 29 and 30

The Commission concluded that way points on the BA 2686 chart on the fairway near the scene of the collision, marked in the voyage plan and on the photograph of the chart with numbers 28, 29, and 30, have been marked by the crew incorrectly. The coordinates and the courses laid out on the chart did not correspond to the way points and courses provided for in the journey plan. The navigation officer of *Transforza* laid out the route of the vessels on the fairway in Świnoujście “more or less” in the middle of the fairway which was both inconsistent with the journey plan and contrary to the principle, which required vessels navigating in narrow passages or on fairways to keep as close as possible to the outer limit of such a passage or fairway.

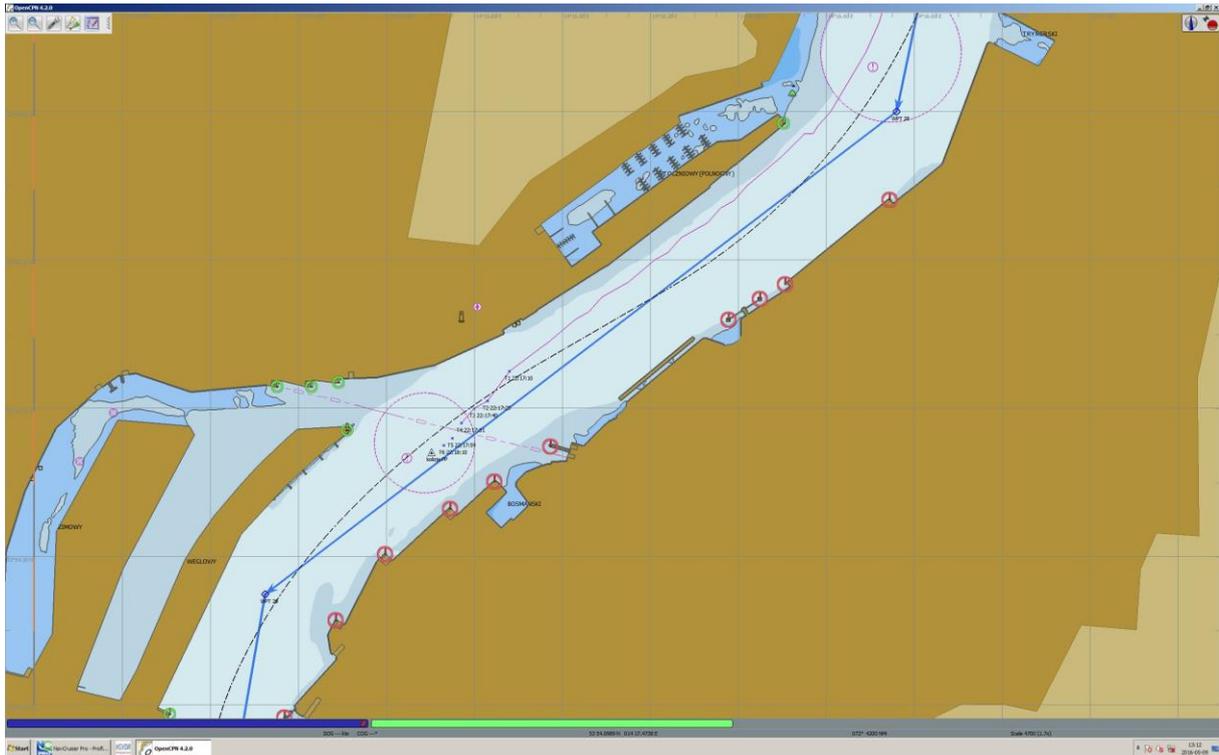
Figure 8: Planned route of *Transforza* on the electronic chart (blue line)

Figure 8 shows the track of *Transforza* planned by the crew (marked with a continuous blue line) between points of turn marked with numbers 27 - 30, according to the data specified in the voyage plan (Photograph 10, WP 27-30). In addition, a black dotted line shows the axis of the fairway.

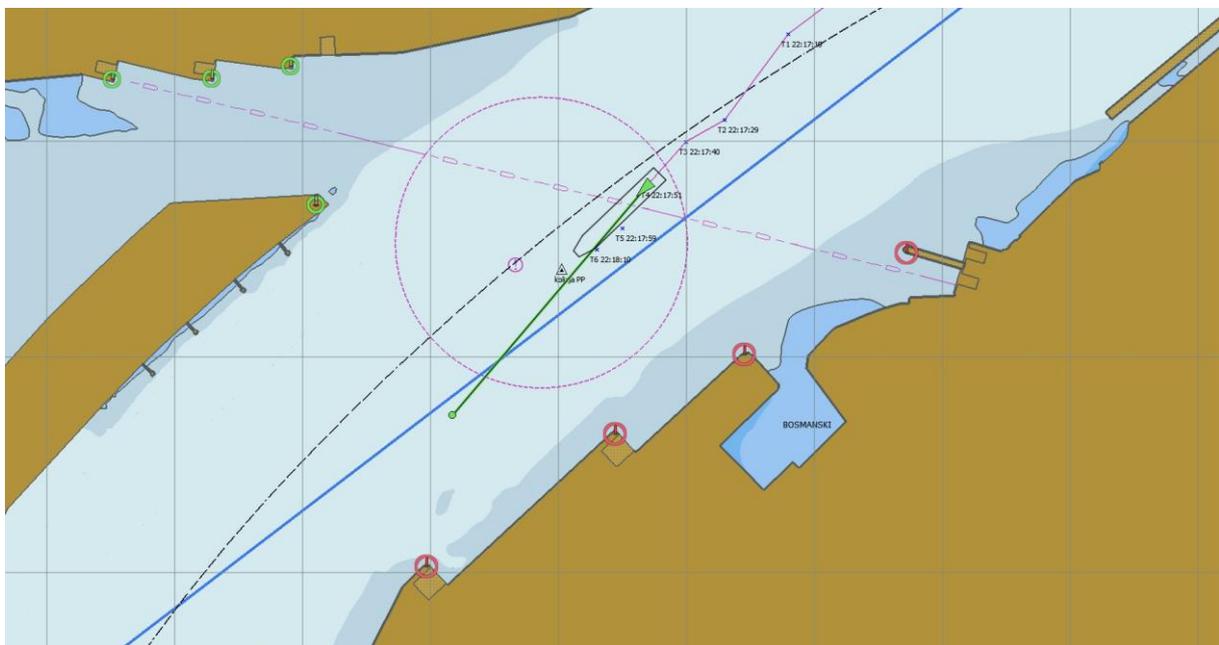
Figure 9: Planned route of *Transforza* in the vicinity of the place of collision

The enlarged image of the chart on Figure 9 clearly shows that the planned route of the vessel in the area where the accident happened, was clearly on the eastern side of the fairway.
