# **STATE MARINE ACCIDENT INVESTIGATION COMMISSION**

## **FINAL REPORT 13/15**

**M/V CORINA**

death of a seaman and carbon monoxide poisoning of four other persons  
during the port call in Hanstholm on 28 April 2015

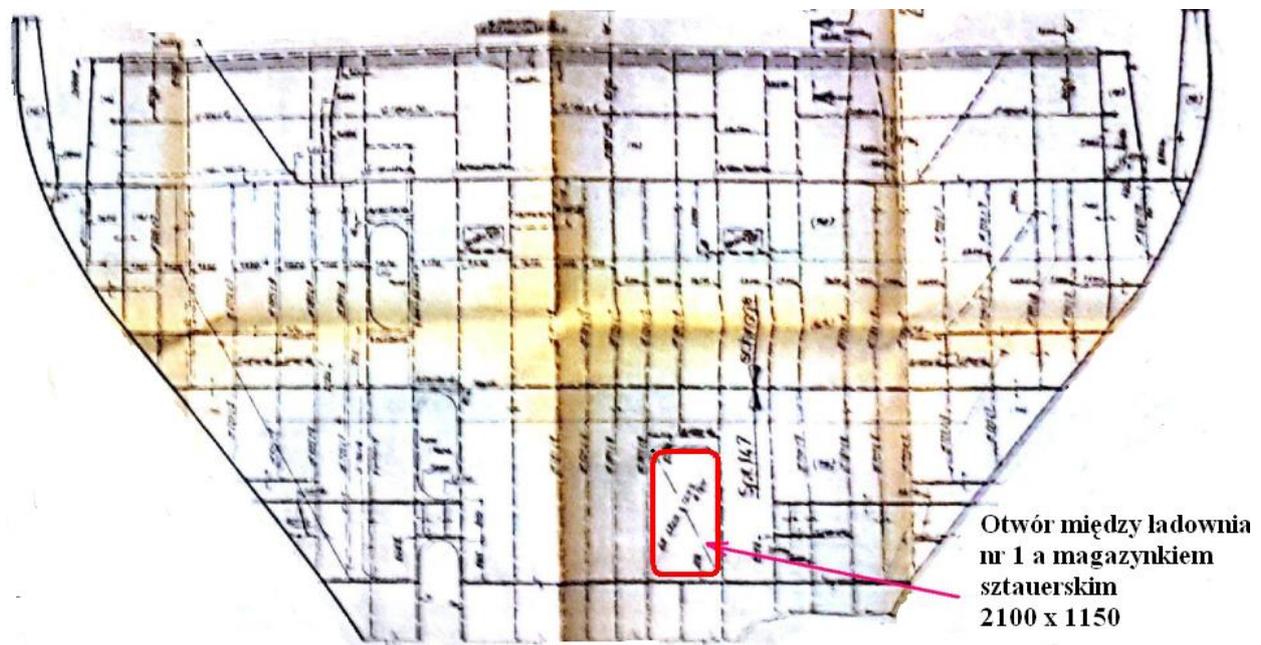
Figure 1. Transverse framing of the hull in the location of the opening between the cargo hold and lashing equipment locker (frame 147)

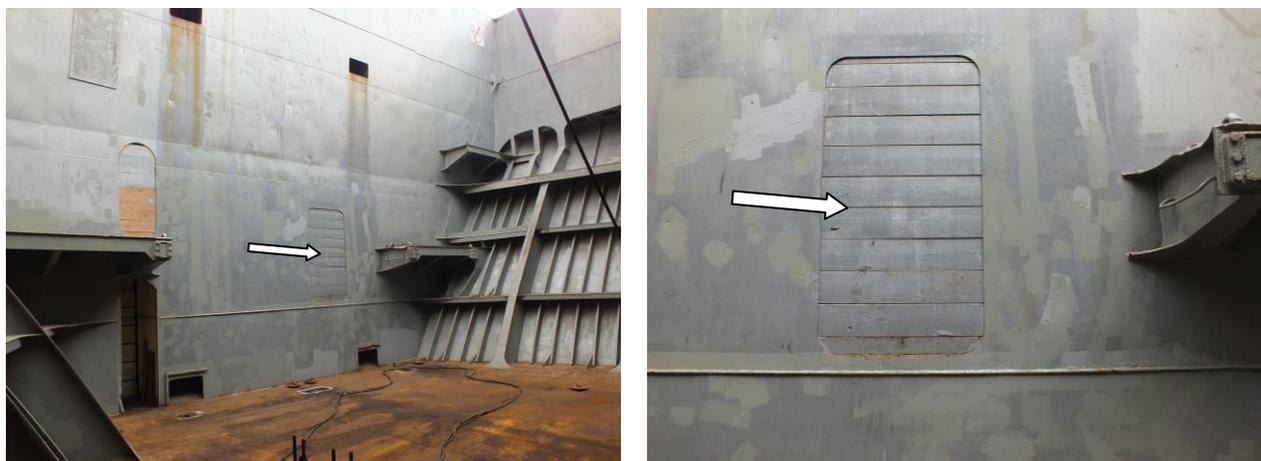
In order to facilitate moving of heavy equipment for lashing containers, an opening with the size of 2100 mm x 1150 mm was designed in the bow bulkhead of cargo hold no I, to the neighbouring storage room, where chains, stacking cones and other equipment for lashing containers were kept.

Photograph 2. The opening in the cargo hold bulkhead to the lashing equipment locker

The design solution applied with the opening in the cargo hold bulkhead had practical advantages when transporting containers, but it turned out dangerous when carrying bulk cargo. The solution complies with the regulations pertaining to construction of ships applied by the class (GL)<sup>2</sup>, but because of unsatisfactory protection of the room adjacent to the cargo hold against entry of a person unaware of the danger inside, entering this room turned out to have had tragic consequences.

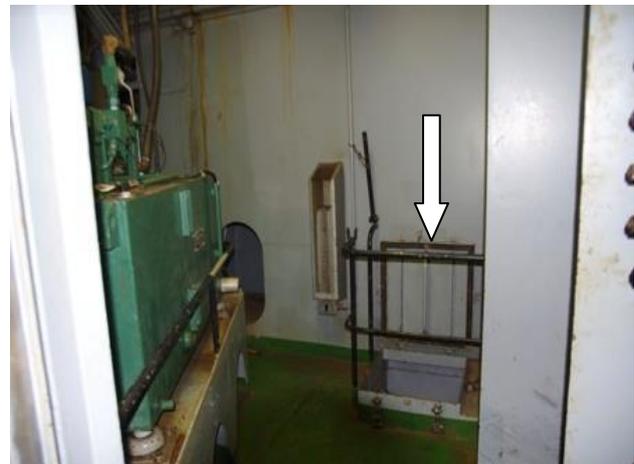
The entrance to the pump room is secured with steel bolted doors (Photograph 5), while the manhole to the lashing equipment locker located below is closed by a cover equipped with a rubber seal and wing nuts (Photograph 6).

*Photograph 6. The hatch cover of the entry to the lashing equipment locker*

- 3) ensure marking with warning signs of spaces, entry to which in specific operational statuses could pose a hazard to health or life of persons, and that entries to such spaces are secured in a manner prohibiting entry without the consent of a person responsible for safety;

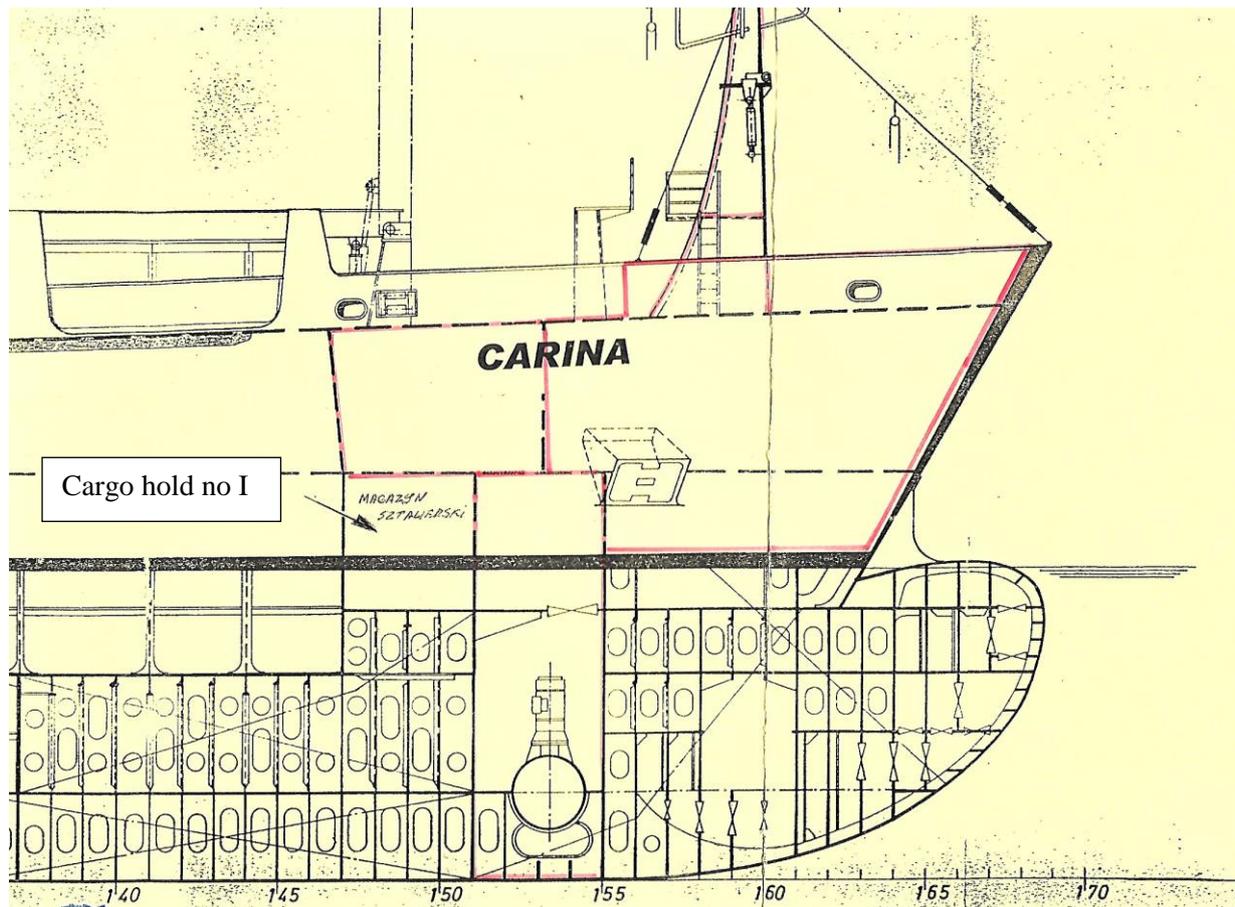
Figure 2. The drawing of the bow part of the vessel - the location of the lashing equipment locker

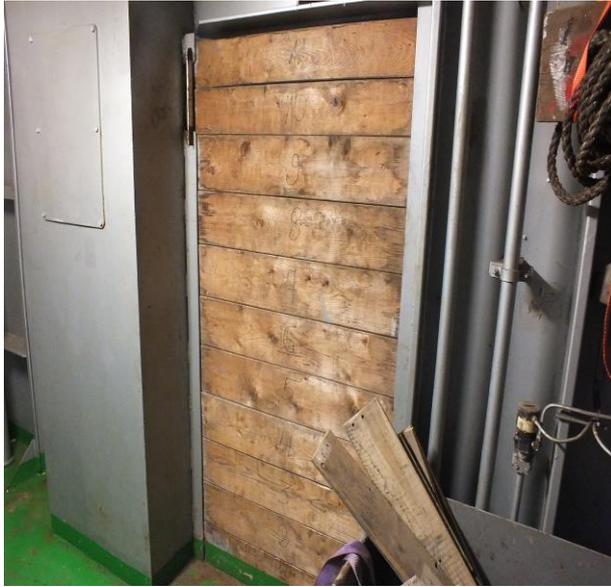
In order to prevent moving of bulk cargo between the cargo hold and the lashing equipment locker, the opening in the bow bulkhead was secured with planks inserted into guide bars (Photographs 2, 7 and 8). However, this type of barrier is not gas tight and provide for the possibility of exchange of atmosphere between the two rooms through slits between the planks.

*Photograph 7. The lashing equipment locker separated with planks from cargo hold no I*

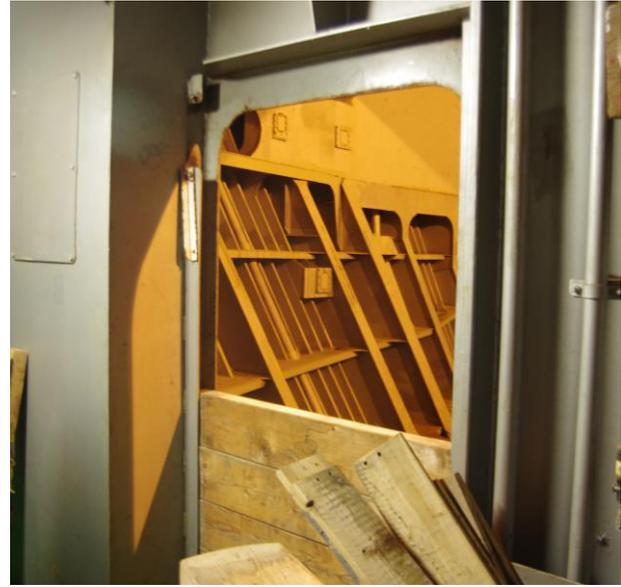
*Photograph 8. The view from the lashing equipment locker to the cargo hold with planks partially removed*
