STATE MARITIME ACCIDENT INVESTIGATION COMMISSION

INTERIM REPORT 22/15

M/V BOMAR VICTORY

Collision during entry to the port of Gdańsk

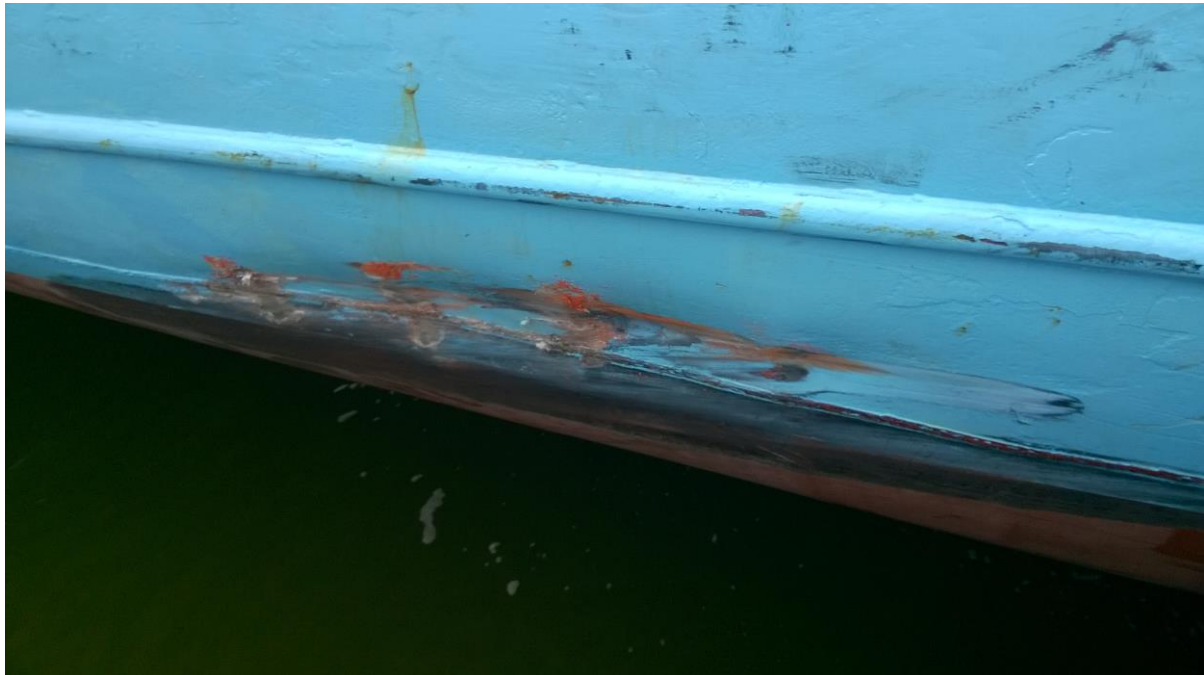
At 8:56 the tug's stern collided with the ship's side causing a dent in the Bomar Victory's plating in the area of the stern sheer beginning.

Photograph 3. Dent in plating of Bomar Victory where it collided with Virtus

At 08:56 the tug's stern collided with the ship's side causing a dent in the Bomar Victory's plating in the starboard part of the sheer. After giving towrope, entry to port continued. At 9:30 am the ship moored at the DCT.

A visual inspection by the classifier upon mooring did not reveal any damages affecting seaworthiness of the ship and its class certificate remained valid. Apart from paint scratches on the stern, the tug was not damaged.

The collision of Bomar Victory with Virtus tug did not result in damages that would exclude any of the vessels from exploitation due to the need for immediate repair. According to preliminary findings of the Commission, the cause of the accident was excessive speed of the ship which, in line with applicable regulations, should not travel faster than 7 kn on the

roadstead¹ and 6 knots when on fairway. Additionally there was no adequate communication between the pilot and tug master.

Considerable speed of Bomar Victory made Virtus increase its speed to be able to approach the ship side closely and catch the heading line thrown from the ship and give towrope from the tug. The tug came too close to the ship and the tug stern hit the ship side due to hydrodynamic interaction forces pulling the tug to the ship.
