# **STATE MARINE ACCIDENT INVESTIGATION COMMISSION**

## **FINAL REPORT 15/15**

### **SAILING YACHT DOWN NORTH**

Capsize and sinking of the yacht with the loss of a crew member  
in the Pomeranian Bay on 30 May 2015

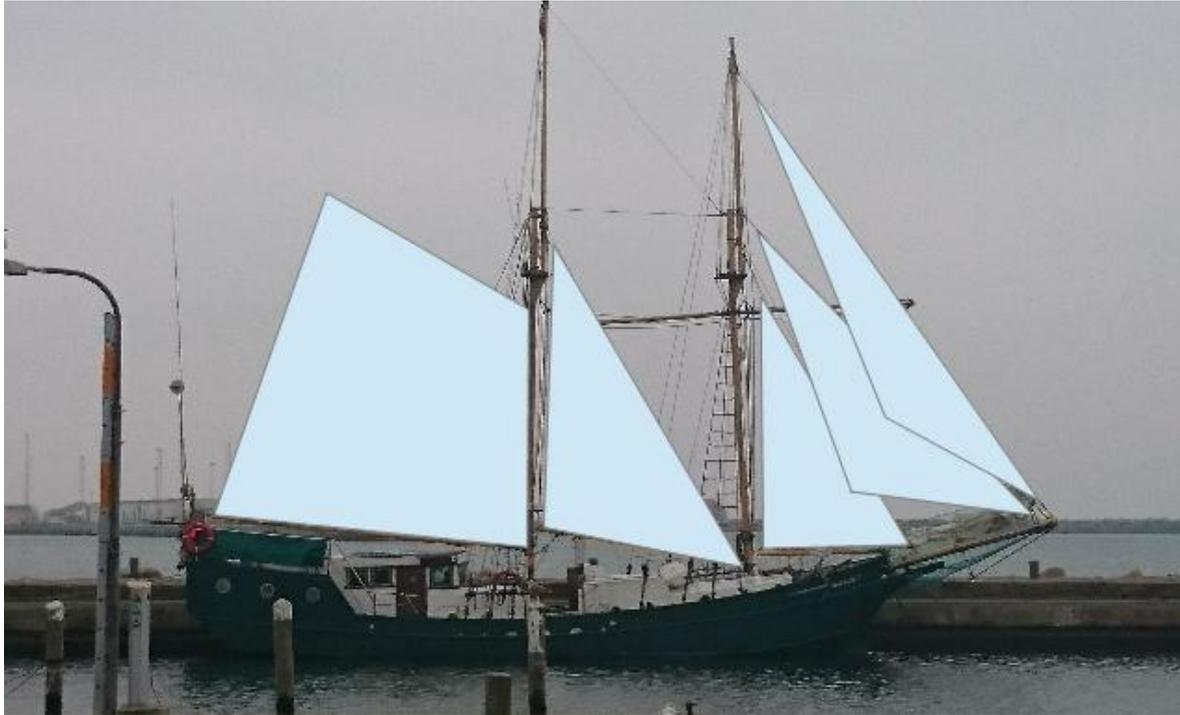
*Figure 1. Down North's sail configuration at the time of accident*

The yacht usually responded poorly to the shallowly immersed rudder and in a deep heel the rudder effectiveness deteriorated additionally. The sheets of all triangular sails were kept fastened, and the mainsail sheet was let go, so the centre of effective sail area moved forward, what assisted in bearing off. However, the deep heel caused that the bottom part of the mainsail entered the water and the sail did not spill, just as the yacht course changed towards a beam reach. In this configuration, the yacht was lying flat on its side.

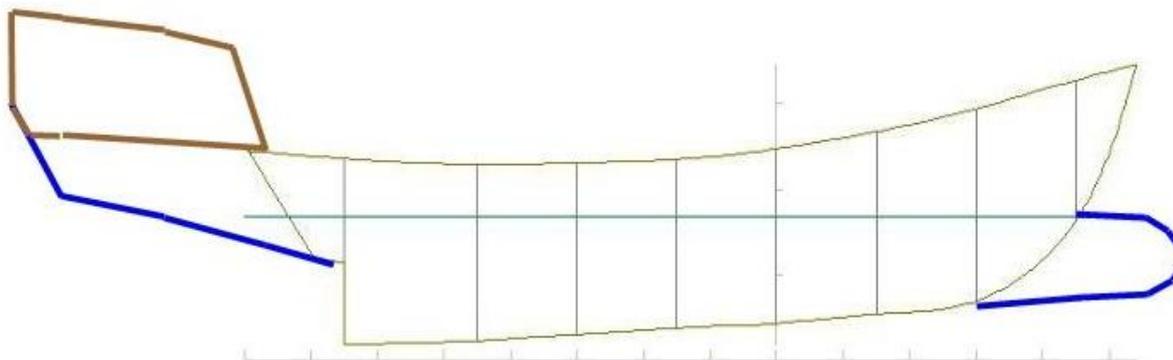
Figure 3. Successive modifications of *Down North*'s hull

A steel superstructure was added at the stern. It extended for the entire width of the hull and provided space for 4 berths. The yacht was now prepared to carry 12 persons. Straight-six Perkins 6354 engine was replaced with straight-four M92B engine, lighter by approximately 100 kg.

In effect of these modifications, the hull length increased from 14.8 m to more than 17 m and the displacement of complete and unladen yacht increased from less than 25 tonnes to more than 35 tonnes.

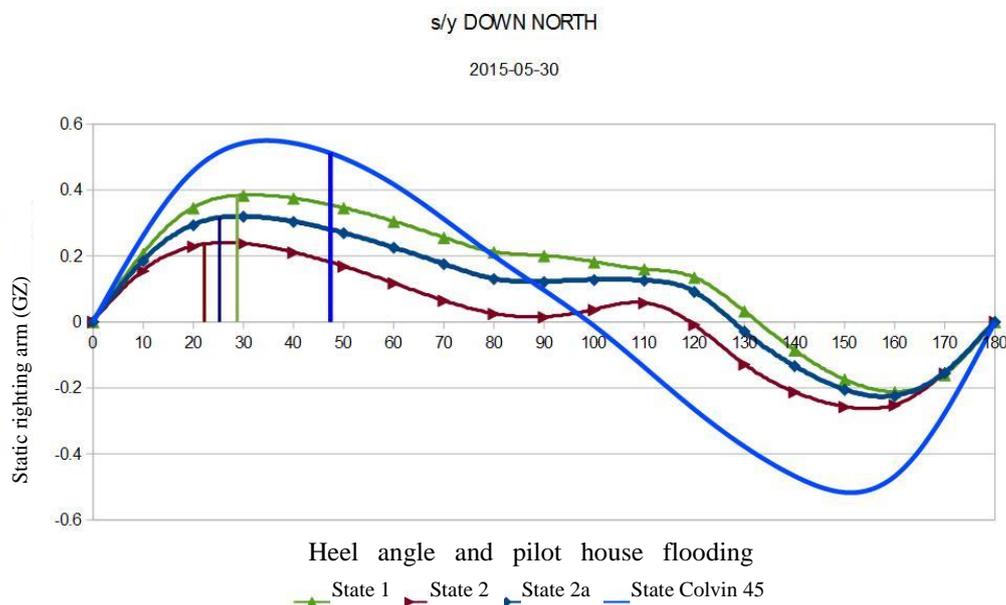
Figure 4. GZ curves and pilot-house flooding angles

The shape of curves illustrating righting arms and flooding angles of pilot house<sup>5</sup> for the analyzed conditions is presented on Figure 4. The figure displays visibly the deterioration of static stability caused by hull modifications and the additional load.

Ad 4. Criterion 4 is not met for any of the analyzed loading conditions. Flooding angles are very low and amount to: for loading condition 2a – 9.9° (deck edge immersion angle) and 25.3° (interior downflooding angle – pilot-house) and for condition 1 (complete unladen yacht) 11.5° and 29.7°, respectively. This criterion had not been met also for the original *Down North* (before the rebuild), which is primarily due to the design of pilot-house located at stern.

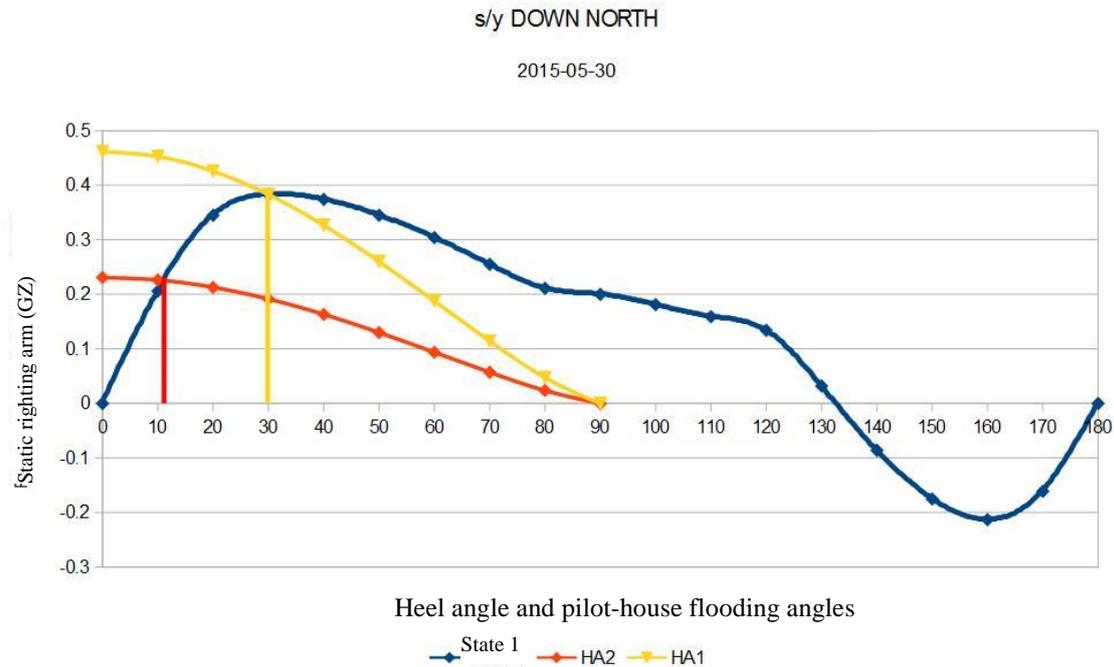
Figure 5. Curve of righting arms for the loading condition 1

On Figures 5 and 6, HA1 (yellow colour) curves correspond to the heeling moments caused by wind pressure on sails, determined in heel angle function and balancing the righting moment at the pilot-house flooding angle. HA2 curves (red colour) determine the half of HA1 value. The crossing point with the static stability arm curve (GZ) indicates the maximum steady heel angle. For the loading condition 1, this angle amounts to 12° (Figure 5). For comparison, the maximum steady heel angle for the original *Colvin 45* hull is 18°.

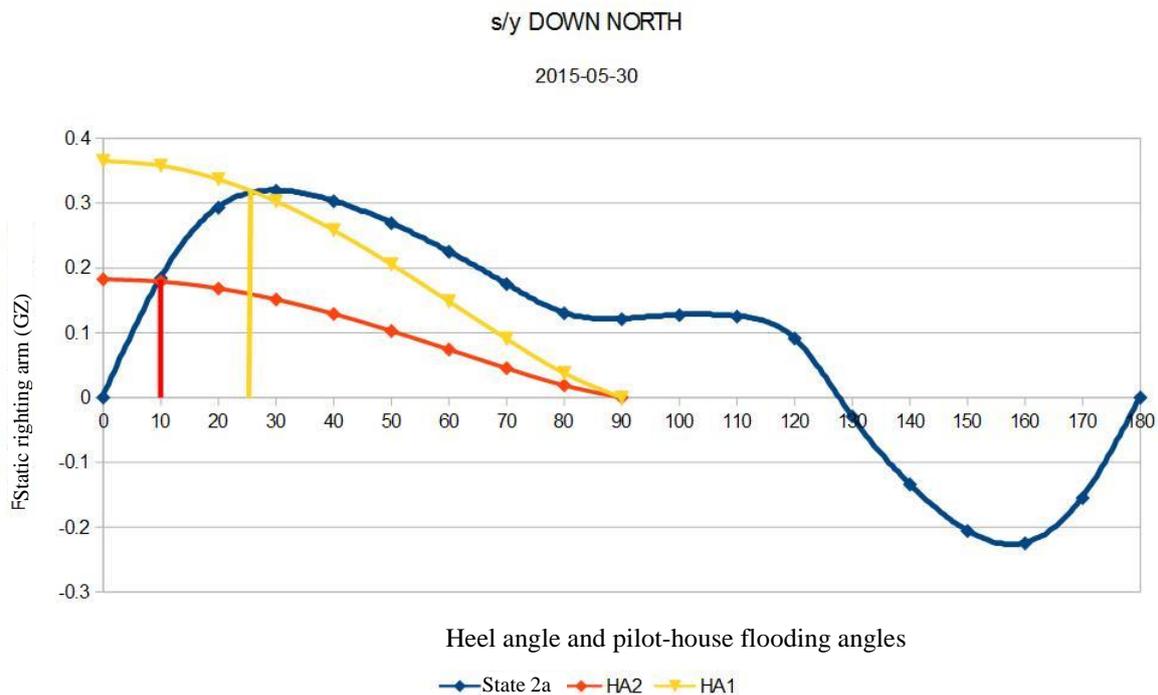
Figure 6. Curve of righting arms for yacht in the loading condition 2a

For the condition 2a i.e. the loading state approximate to the one from the day of the accident, the resistance to gusts is poorer. In this case, the maximum steady heel angle is only 10° (Figure 6).

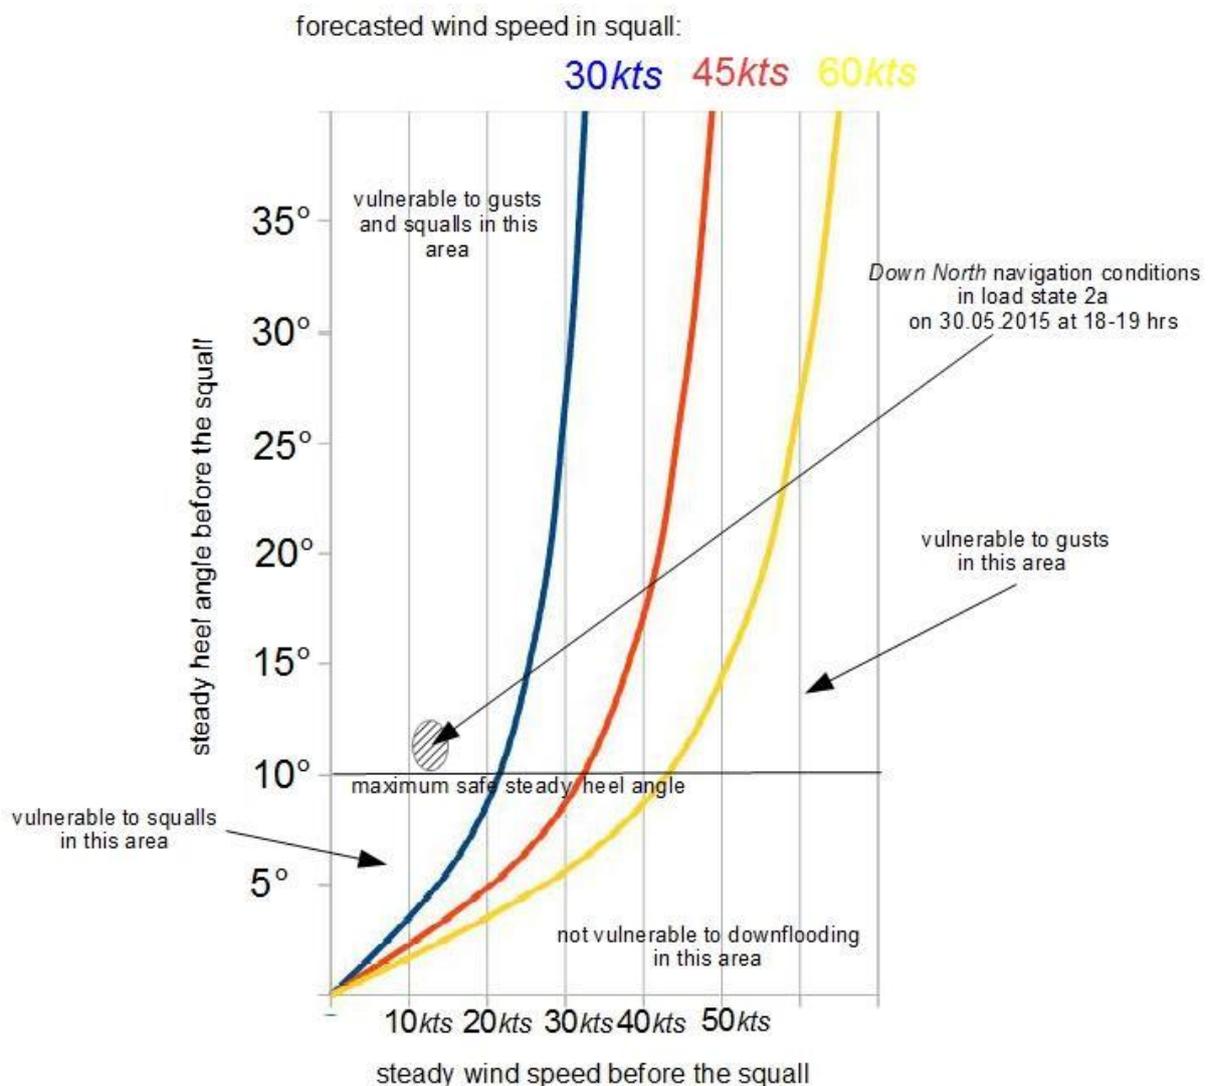
Figure 7. Vulnerability to squalls according to the MCA

Wind that knocked-down the yacht *Down North* in the evening of 30 May 2015, was – according to the crew members – in the category of gusts (up to 1.4 increase of steady wind speed) rather than squalls (exceeding the steady wind speed by any factor). The graph presented on Figure 7 demonstrates that a gust hardly stronger than these that actually took place was able to heel the yacht above the interior downflooding angle.

<sup>11</sup> Each curve at Figure 7 for specific wind strength in squalls (usually drawn for 30, 45 and 60 knots) divides the area into the safe part (below the curve or to its right side) and the unsafe part (above the curve or to its left side). In the unsafe part the heel (induced by squall) exceeding the interior flooding angle is possible. The yacht, which at the given steady wind strength sails with steady heel exceeding the angle that is indicated by the curve on the graph (above the curve corresponding to the forecasted speed of possible squall) for actual wind strength should reduce sail in order to decrease the steady heel to a safe level. Selection of the suitable curve is made with consideration to the weather forecast and meteorological conditions. In the time and place of *Down North*'s accident, one should consider the forecasted wind above 30 knots, i.e. at wind speed of 10 – 15 knots the steady heel during navigation should not exceed 5°.

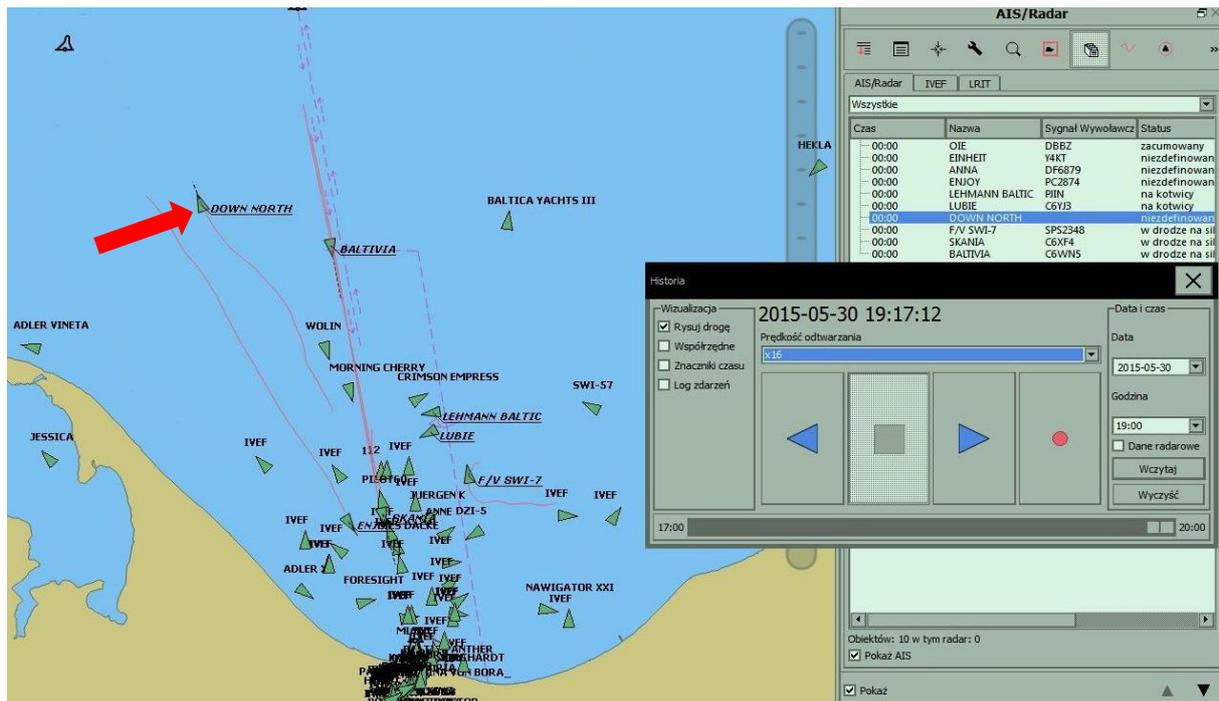
Figure 10. Part of SWIBŻ system screen showing the archive record

8. The MRCK Gdynia duty inspector failed to examine the SWIBŻ system indications thoroughly. Even for a wrongly positioned object it could be noticed that the information displayed on the screen originated from several hours before. The history of the object and position archive data from the previous hours including the last 24 hours could also be checked. Data recorded in the SWIBŻ system archive demonstrates that AIS transponder of yacht *Down North* transmitted the position correctly until the sinking (Figure 10).

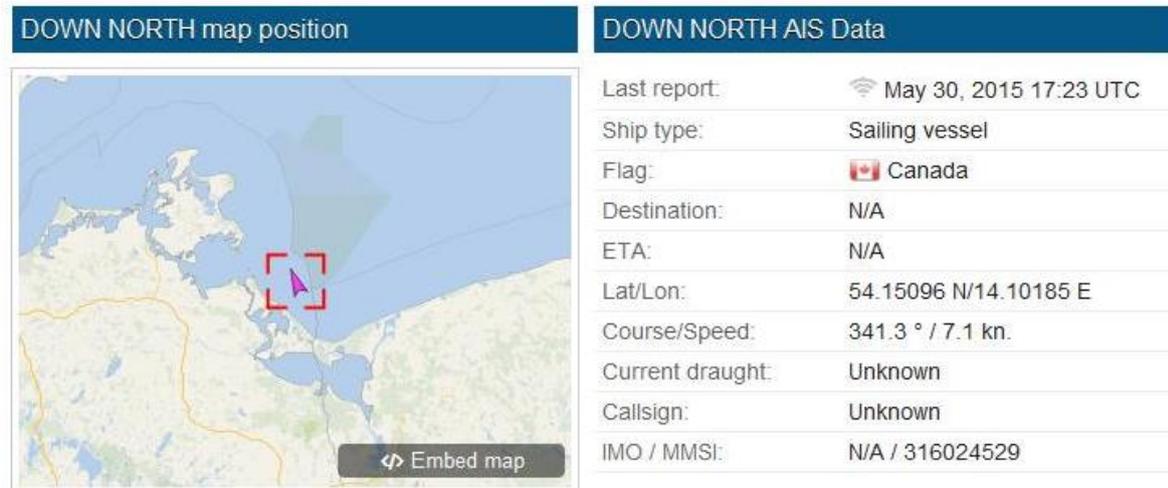
Figure 11. Last position of Down North according to Vessel Finder

9. The MRCK Gdynia duty inspector did not use any publicly accessible system for tracking the vessel movement. The last position of yacht *Down North* was visible in the *Vessel Finder* system (Figure 11) approx. 30 minutes before the inspector received the message on detection of yacht's EIPRB signal from JRCC Halifax.
