Investigating Authority: Directorate for State Maritime and Inland Waters Supervision of the Federal Service for Supervision of Transport of the Russian Federation (Rostransnadzor).
Established by Decree of the Government of the Russian Federation No. 398 of 30 July 2004.

Pursuing to Regulation 6 of Chapter XI -1 of the International Convention for the Safety of Life at Sea (SOLAS) and the Code of the International Standards and Recommended Practices for a Safety Investigation into a Marine Casualty or Marine Incident (Casualty Investigation Code) (resolution MSC.255(84), the Federal Service for Supervision of Transport of the Ministry of Transport of the Russian Federation has investigated the casualty involving the *ODISSEY* Sea-Going Tugboat.

BRIEF DESCRIPTION OF THE ACCIDENT

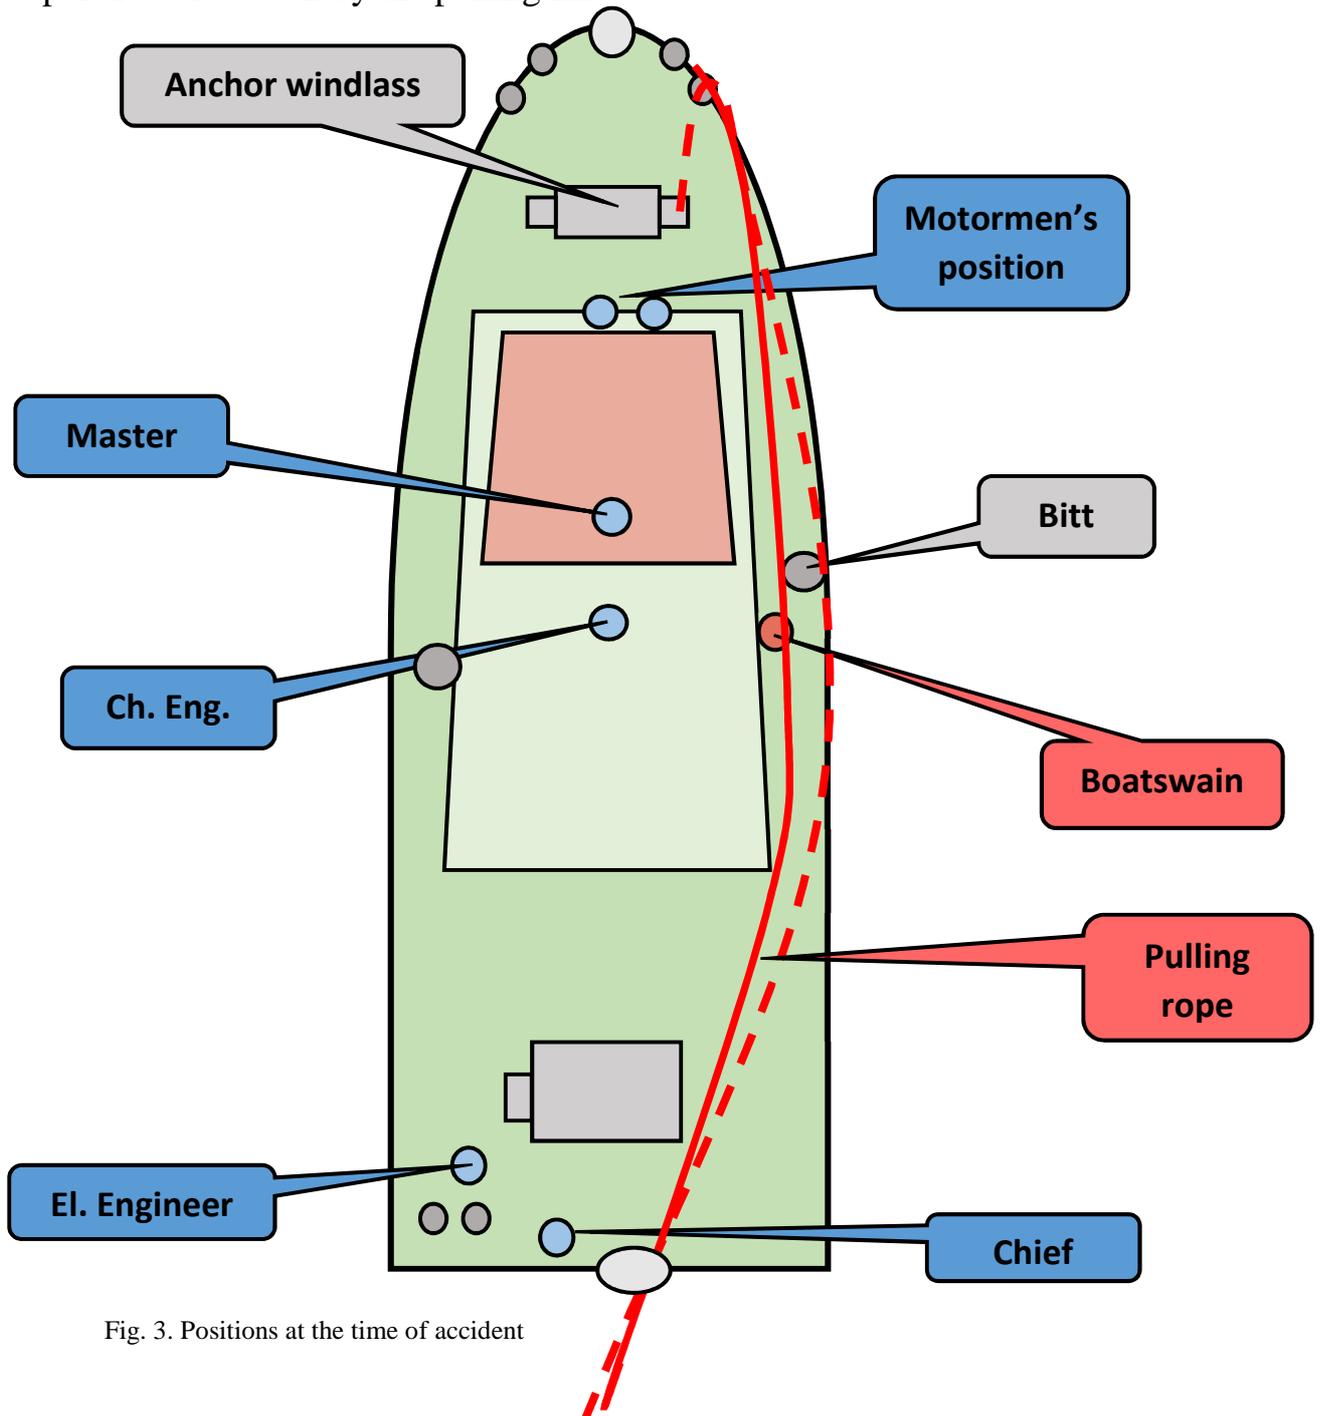
Fig. 3. Positions at the time of accident

thimble eye's wire rope, the Boatswain moved the rope over the starboard bitt. The motormen considered such position of the pulling line as dangerous, as it could slip from the bitt, warned the Boatswain accordingly and removed the pulling line from the bitt. At 14:55, having returned to the anchor windlass, they continued with pulling the rope in. From their position at the anchor windlass, the starboard bitt was not visible, as it was overshadowed by the tug's superstructure.

Shortly afterwards, in 15 to 20 seconds, the motormen heard the sound of a rough shock against the bulkhead. Having stopped heaving of the rope and taken a look over the superstructure's corner, they found the Boatswain with his back pressed against the superstructure's wall by the pulling line.

While carrying out works on hauling the thimble eyes' wire ropes, the Boatswain, without informing the Head of works, led the rope over the bitt for the second time, while staying in the vicinity of the tight pulling rope, within the angle formed by the rope, at the side where the rope was heaved. The pulling rope slipped from the bitt and, having hit the Boatswain against his chest, pressed him to the tug's superstructure.

In carrying out mooring, cargo and other operations it is recommended that the locations of every member of the deck team should be arranged in such a way as to ensure that potentially dangerous areas remained visible by at least one member of the team, while all team members shall have communication with the person in charge of the operation carried out.

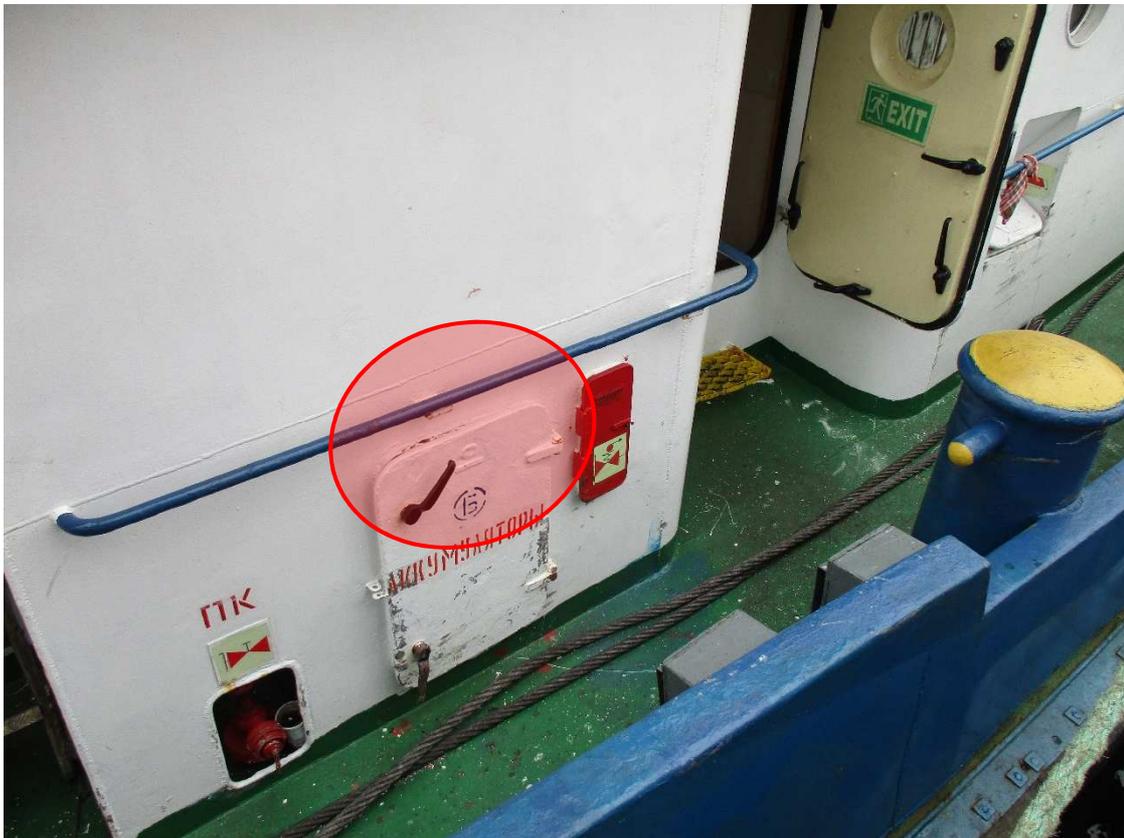
Fig. 4. Location of the fatal accident

The polypropylene mooring rope lay alongship on the main deck, extending from the tug's stern to the forecastle, with one of its ends on the gypsyhead of the anchor windlass. The fatal accident occurred in the area of frames 33 to 35, between the exit from the superstructure and inner ladder leading to the upper deck. The width of the main deck at the accident location equals to 117 cm, bulwark height 93 cm, the bitt's height 117 cm, diameter 38/44 cm. The width of the companionway of the door leading to the superstructure equals to 119 cm and depth 74 cm. The distance between the companionway of the door and platform of the ladder accessing the upper deck is 205 cm, platform width equals to 85 cm and depth 80 cm.
