STATE MARITIME ACCIDENT INVESTIGATION COMMISSION

FINAL REPORT 48/14

M/V ACHILLES

Grounding of the ship

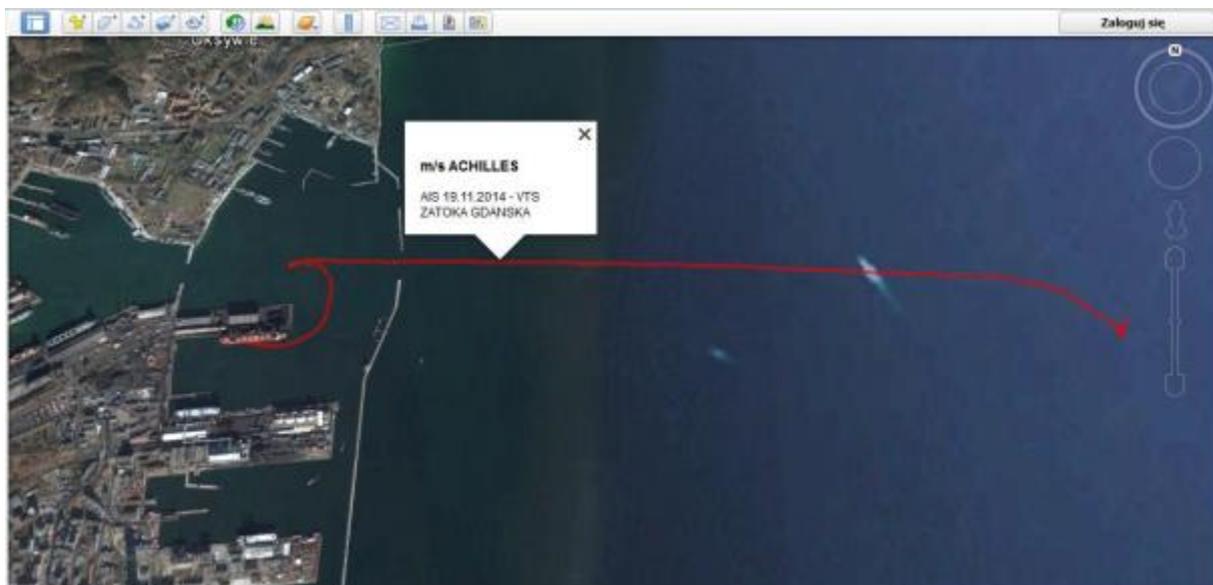
The following figure shows the trajectory of the vessel from the Holenderskie quay to the shoal, determined on the basis of data obtained from the Gdansk Bay VTS, on a satellite map.

Figure 1. The trajectory of Achilles from the quay to the shoal.

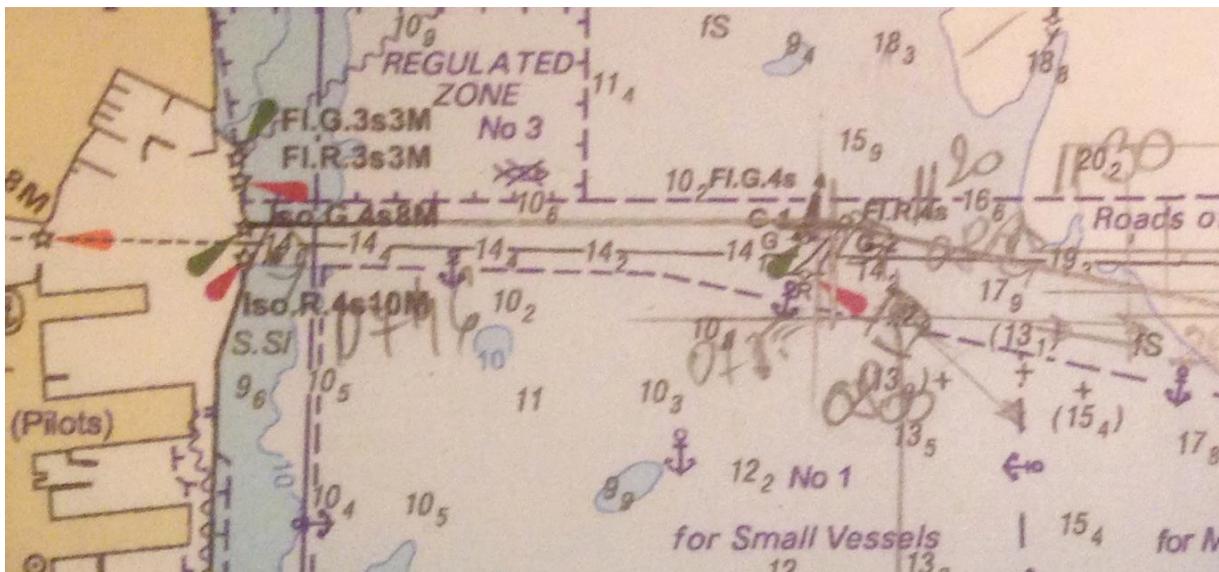
Achilles did not complete the manoeuvre that was started and planned. The ship lost speed and ran aground 2.8 cables southeast of the red G2 buoy, on course 092,5°.

Photograph 2. Ship navigation chart BA 2688 (Approaches to Gdynia and Gdańsk) with the place where m/v Achilles ran aground marked by the crew (at 8:00 a.m.)

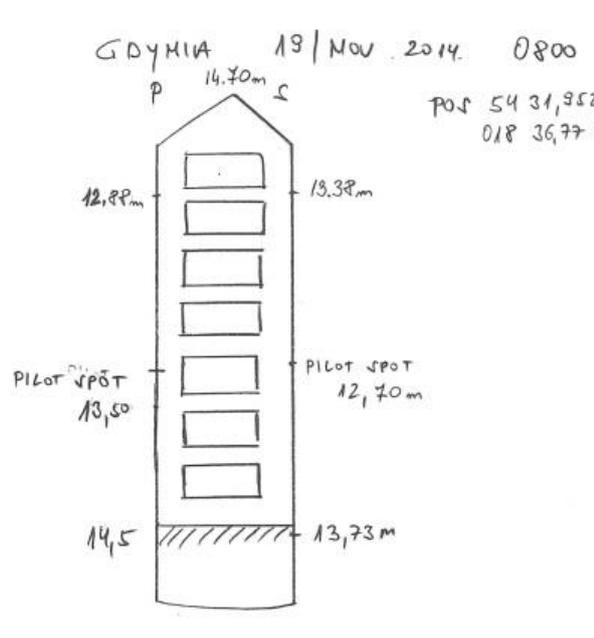
Measurements revealed that the ship ran aground at the starboard side near the midships, but the hull remained tight.

Figure 2. Plan of sounding around Achilles on a shoal.

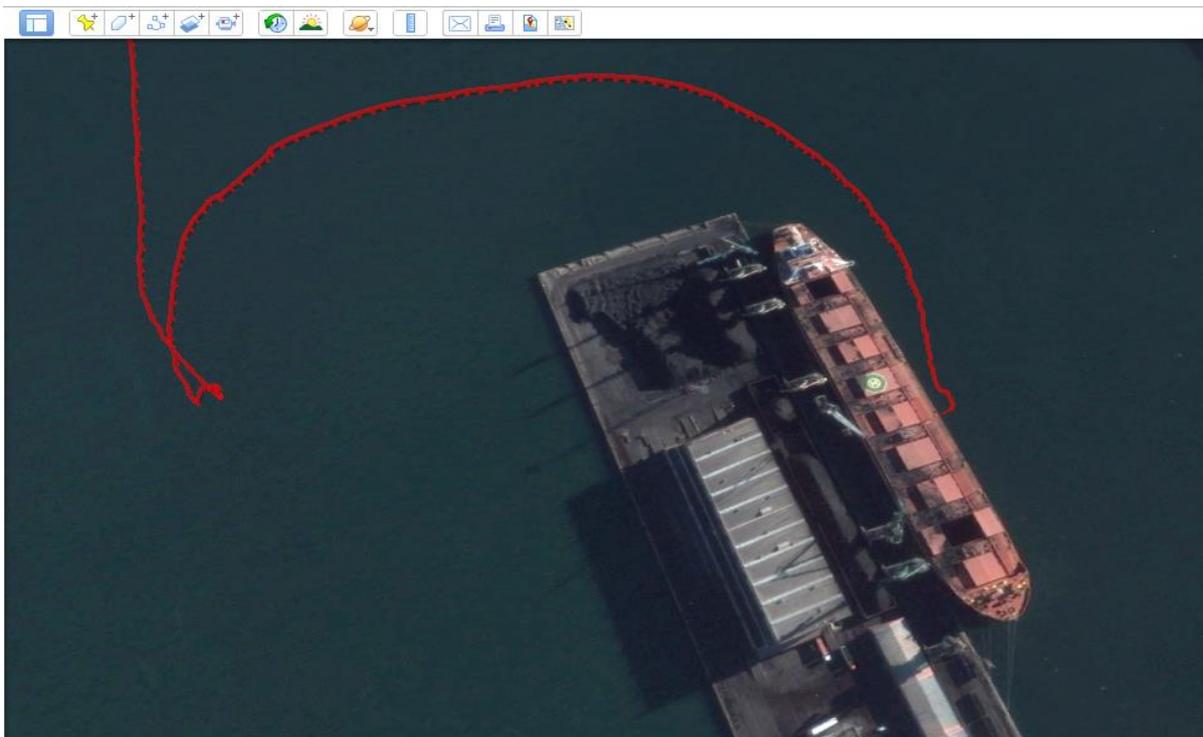
As proven by the trajectory of the ship on a satellite map, shown in Figure 3, and the screenshot from the VTS, shown in the Figure 4, the manoeuvres of unmooring from

Figure 3. Trajectory of Achilles – departure from the quay and a turn at the avantport.

the Holenderskie quay in the Coal basin, turn at the outlet, and passing entrance heads to buoy pair G1-G2 were smooth and undisturbed.

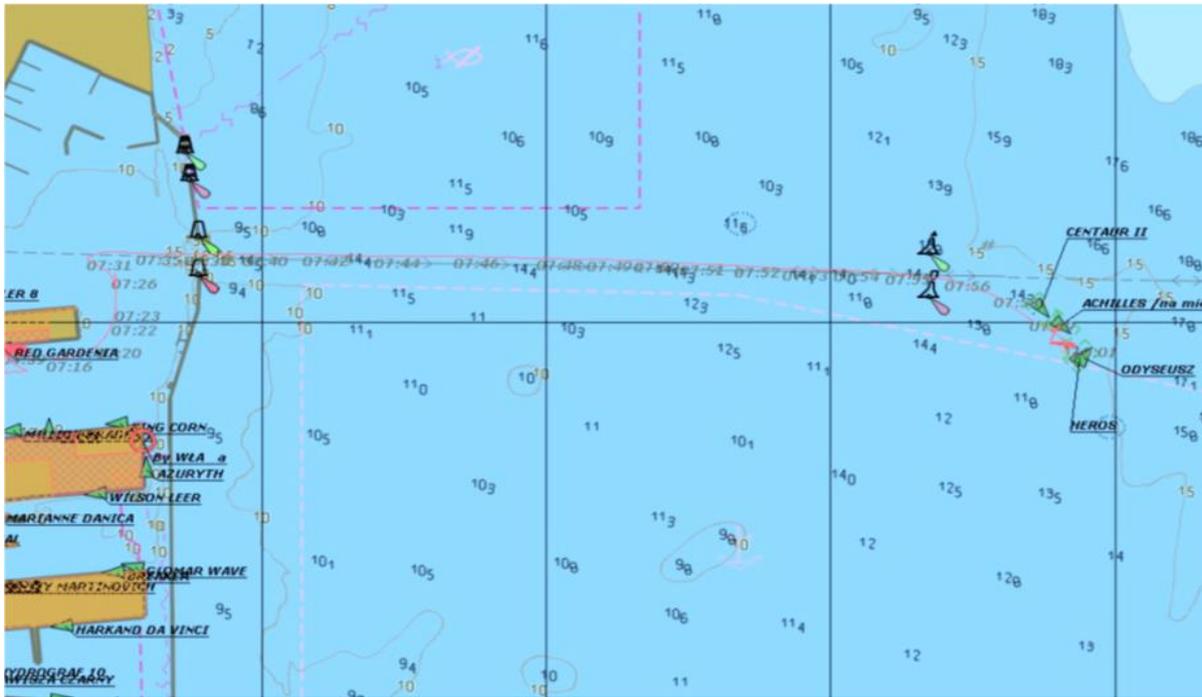
Figure 4. Trajectory of the ship demonstrated by using the AIS Radar.

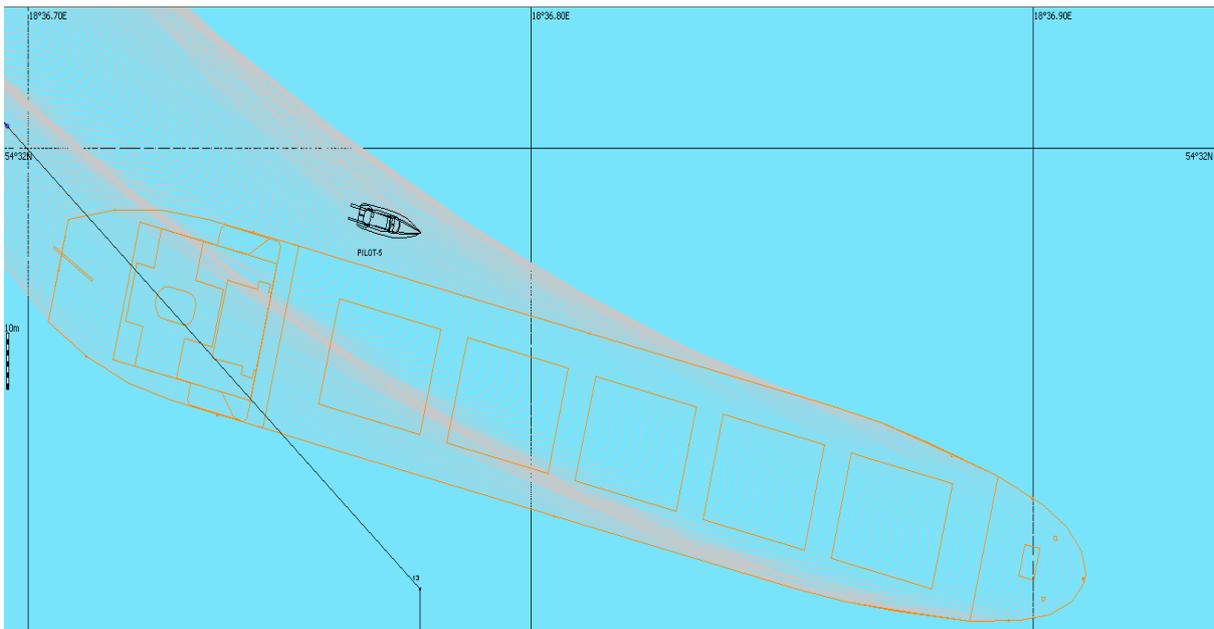
To show the intention of the pilot, the Commission simulated the presence of a pilot boat on the port side of Achilles during giving a lee to the pilot boat planned by the pilot through initial change of course to the right (deviate from the fairway to the south), and then a left turn (shifting the stern to the right) and shielding the pilot boat from waves and eastern wind.

Figure 5. The pilot boat at the side of Achilles in the course of giving a lee (reconstruction from the simulator).

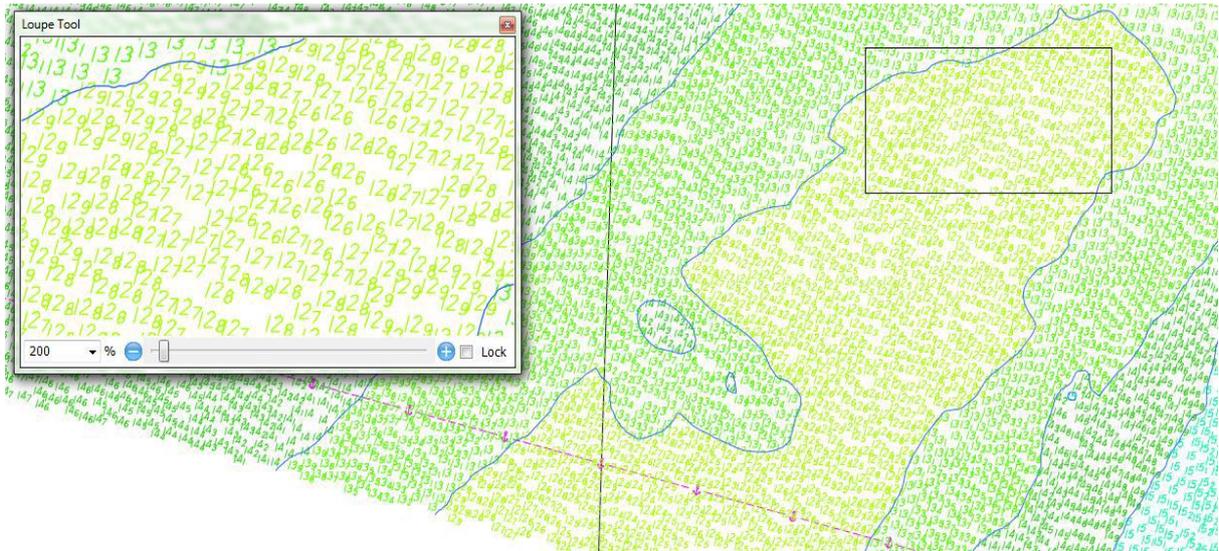
Figures 6 and 7 show a fragment of the bathymetric plan with depths less than ship draught (12.70 m), inside the 13 m isobath (depths marked with yellow and green) where Achilles ran aground (the shoal is marked with a rectangle).

Figure 6. A fragment of bathymetric plan of a part of the fairway where Achilles ran aground.

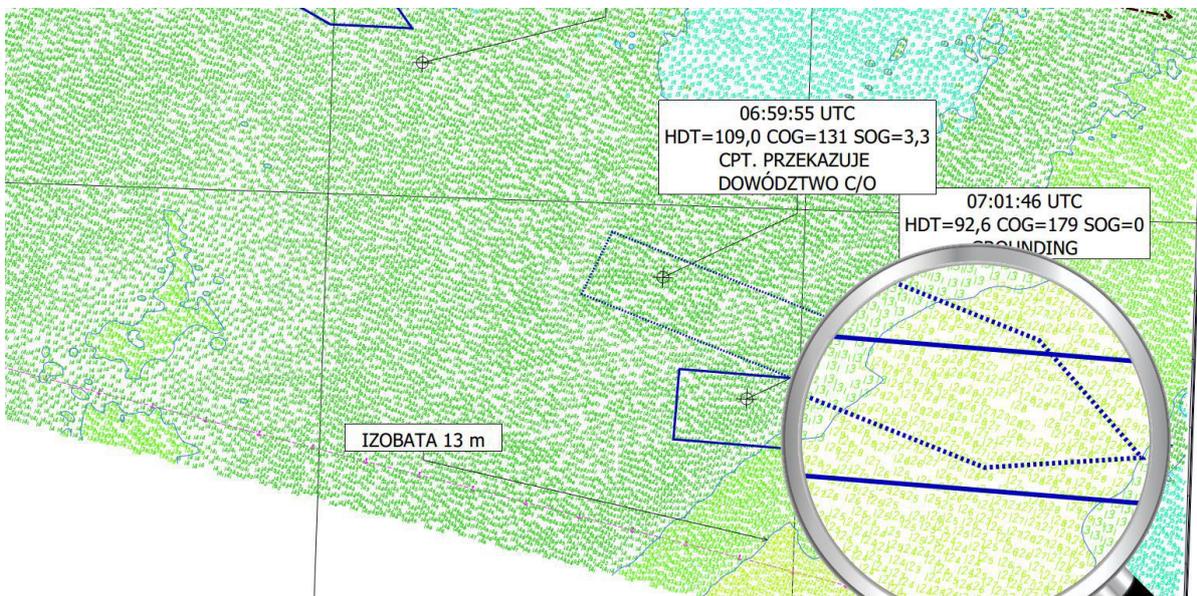
Figure 7. Plan fragment with two positions of Achilles on a shoal (enlarged).

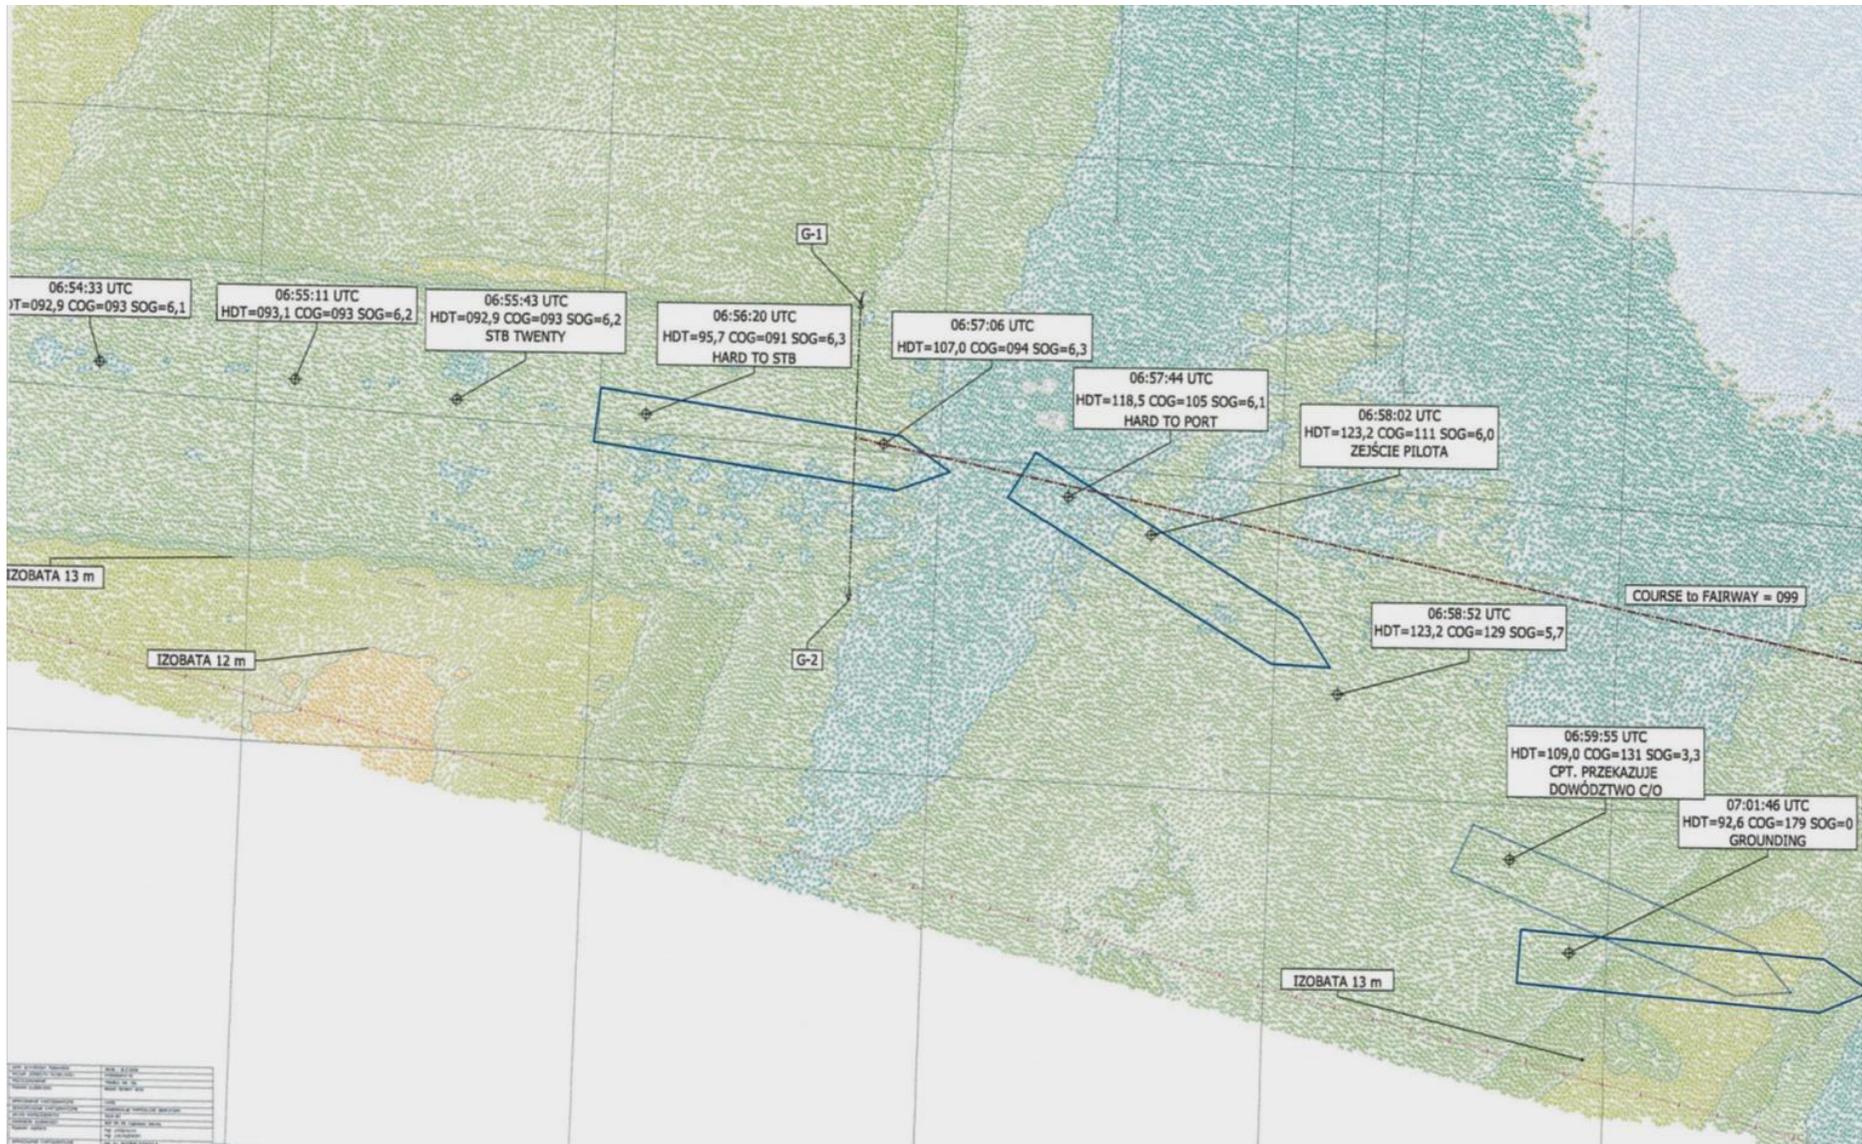
Figure 8. Manoeuvres of Achilles before running aground on a bathymetric plan of Gdańsk Bay.

The above map presents the most important information on ten subsequent positions of the ship before running aground (GPS antenna location in function of UTC), basic dynamic parameters (actual course, angle above sea bottom and speed above sea bottom), and commands to the helmsman.

Analysis of positions in the figure above and of audio tracks from ship S-VDR shows that before the bow entered gate G1-G2 the pilot issued command “20 to starboard” to the helmsman at 6:55:43 a.m. When the bow passed the gate buoy line, the pilot ordered “hard-a-starboard” and after two minutes from the start of the manoeuvre to the starboard the pilot decided to counter to port by issuing a command “hard-a-port” at 6:57:44 a.m. Then, without waiting for the response of the ship, he left the bridge.

The ship whose helm was tilted to starboard for 2 minutes (with “hard-a-starboard” for nearly 1.5 minutes) departed from the course leading to the traffic separation scheme by 30° to starboard and acquired such considerable rotation to starboard that counter to port, even by issuing the command “hard-a-port”, did not prevent further tilt of the bow to starboard for the next minute (HDT revision from 118.5° to 123.5°) and movement of the entire ship (constant change of course relative to the bottom) further south (COG changed from 091° to 179°) until running aground.

The ship began to respond to “hard-a-port” and changed its course to port only after about 1 minute since when the pilot left the bridge. The ship’s rotation to port was additionally slowed down by the chief officer of Achilles who, after the pilot left the bridge and despite the arrangement between the pilot and the master that after the ship turned to starboard the lee for the pilot boat would be made by turning to port by holding the helm “hard-a-port”, “not less”, reduced the helm tilt at 07:00:20 a.m. from “hard-a-port” to “20 to port”. However, it did not have a significant impact on the entire accident, since when the order was changed the ship was moving in very shallow water at the speed slightly exceeding 2 knots.

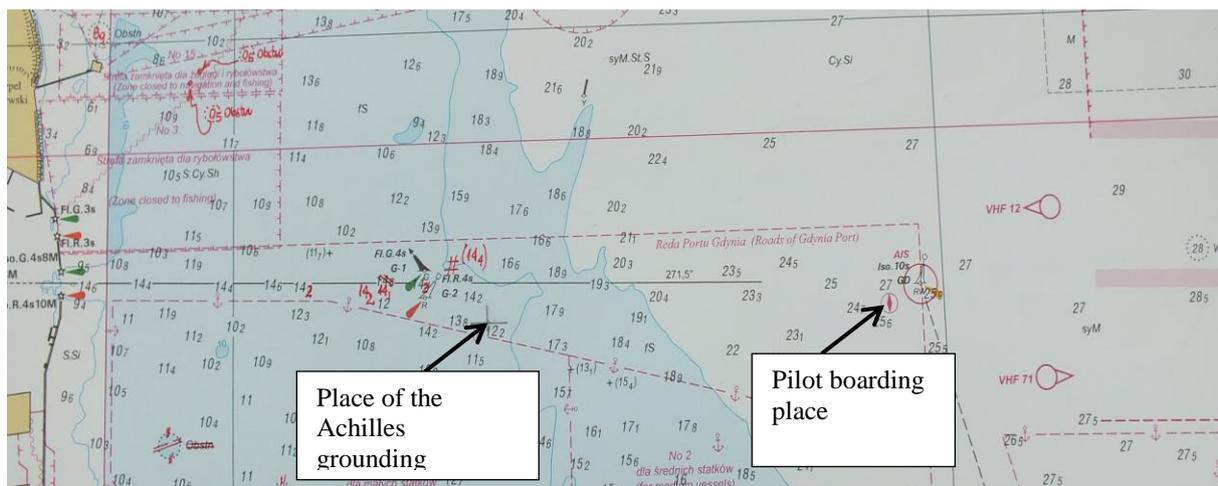
Pursuant to § 129(2) of the Regulations, “ships of draught of more than 9 m shall embark the pilot at GD buoy or at the appropriate anchorage.” Similar provisions are included in Chapter 9.61 of *Baltic Pilot (NP 19 Vol. II)* and in *ALRS Vol. 6(2)* on page 285, and stipulate that for ships of draught of more than 9 m the pilot embarks the ship near GD buoy ($\varphi = 54^{\circ}32,07'N$ $\lambda = 018^{\circ}39,77'E$). At this position, in both British Admiralty and BHW charts, there is a symbol

Photograph 3. Fragment of BHMW chart No 44

State Maritime Accident Investigation Commission recommends that the Director of the Maritime Office in Gdynia should amend § 129 of the Standing Order No 5 of the Director of Maritime Office in Gdynia of 20 February 2013 – Port Regulations so that it clearly specified the place of pilot disembarkation for ships of large draught. The Commission recommends that the place should be located at least 5 cable lengths from the G1-G2 buoy pair.
