MARINE ACCIDENT REPORT

Collision between

“CORVUS J” and “BALTIC ACE”

in the North Sea on 5 December 2012

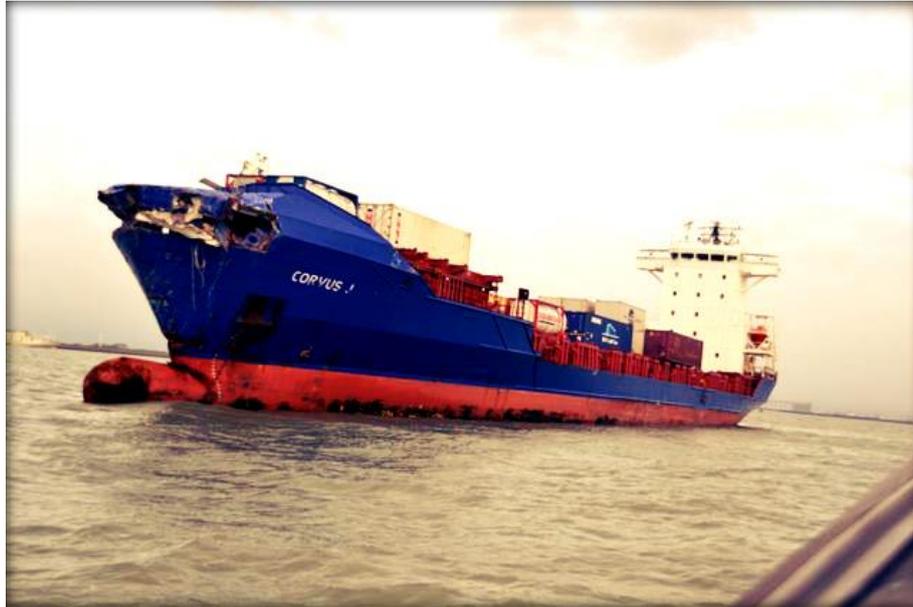
Picture 3.1 : The CORVUS J after the damage

The Corvus J suffered damages on the bulbous bow, a store on the port side above the bulb and in the bow structure above the main deck.

The steering system of the ship was tested and found working properly. The navigation equipment and the navigation lights were also found working properly. The ship was provided with authorizations to proceed to yard where repairs were carried out.

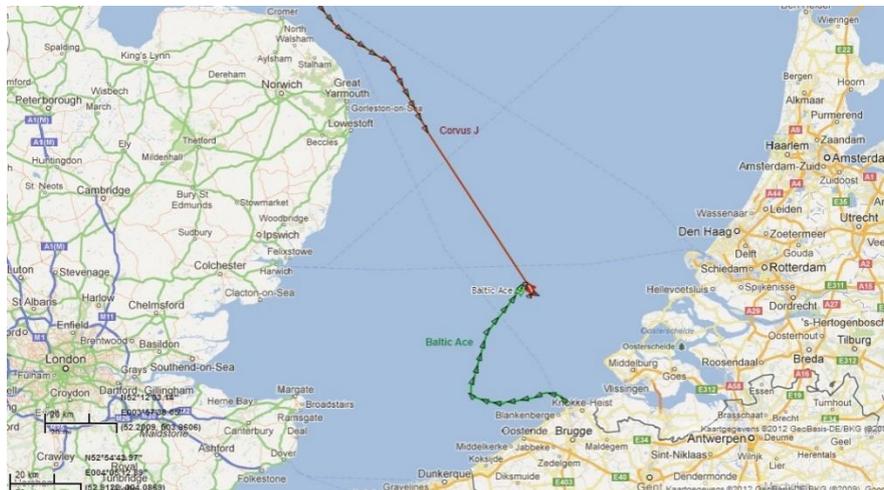
Picture 3.3 – Position of the collision

With the given speeds and courses the distance between the two ships was decreasing. The Baltic Ace OOW changed ship's control to hand steering and turned the rudder hard to port while the Corvus J OOW turned the rudder hard to port and set the propeller to full astern. At 6.15pm Corvus J collided with Baltic Ace at position 51 deg 51,9' North 002 deg 53,9' East.

The angle of collision between the two ships was estimated 45-90 degrees while the Baltic Ace was heading at 330 deg and Corvus J at 225 deg. The collision caused damage to both ships.
