STATE MARINE ACCIDENT INVESTIGATION COMMISSION

INTERIM REPORT 39/15

M/V GREEN EGBERSUND

oil spill at Gdynia harbour due to damaged shell plating
of the vessel during docking on 27 August 2015

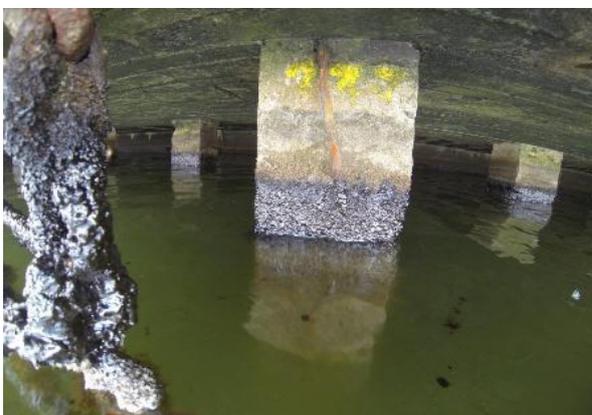
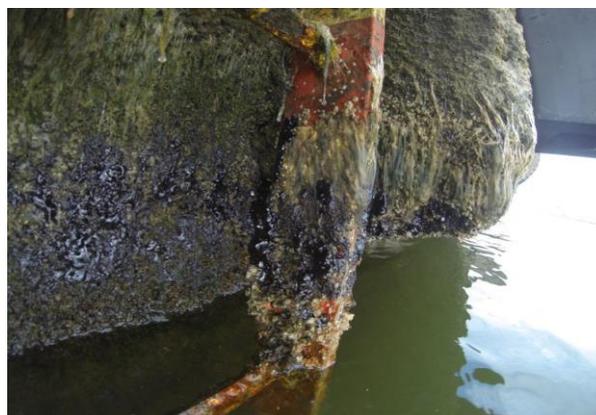
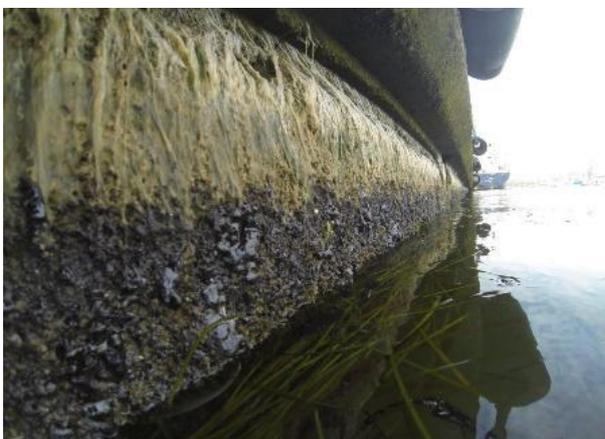
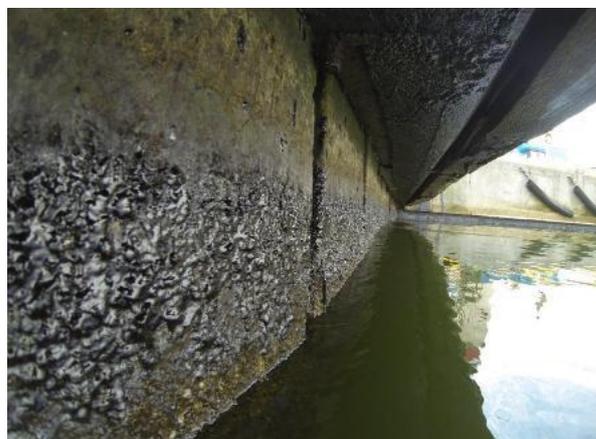
Type:	very serious marine accident
Date and time of event:	27.08.2015 at 17:14:09 LT
Geographic position at the time of the accident:	$\varphi = 57^{\circ} 32' 16'' \text{ N}$; $\lambda = 18^{\circ} 32' 21'' \text{ E}$
Geographical area of the accident:	Gdynia harbour
Nature of the water region:	internal waters
Weather at the time of the accident:	wind SW 3° B, very good visibility, air temperature 21,6° C, water temperature 18° C
Operational status of the ship in the course of the accident:	undergoing special class survey, without main engine, ballasted, towed to the dock from the stern by tugs
Location of the accident on board:	starboard side near the stern, shell plating of the heavy fuel service tank
Environmental impact of the accident:	harbour and wharf waters at Gdynia harbour contaminated with 0.5 – 2.5 cm thick layer of an oil-based substance

Photograph 3. Gdynia internal harbour wharfs contaminated with fuel

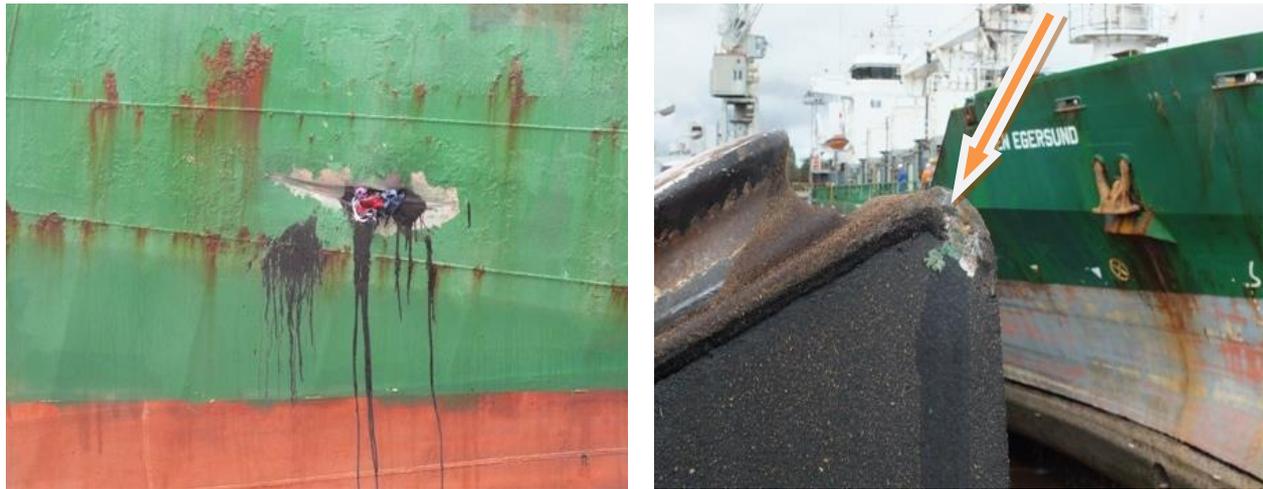
After the vessel was turned in the manoeuvring basin so that the stern faced the dock, the docking operation began. The tugs kept the vessel in line with the dock axis until the ship passed the fore line of the side walls. When the stern entered a few meters into the dock, the vessel deviated from the axis, the stern drifted towards the southern side wall and at 17:14 the starboard side of the stern hit the edge of the foundation of a pedestal fairlead located at the head of the southern side wall.

The impact damaged the vessel’s shell plating at the point where heavy fuel service tank no 15 was located and caused a spill. The dock master reported the spill to the shipyard dispatcher, who respectively notified the Rescue Team of Stocznia Marynarki Wojennej, Gdynia Harbour Master’s Office, Harbour Fire Service (Portowa Straż Pożarna Zarządu Morskiego Portu Gdynia S.A.), as well as Bonex and Delfin companies in charge of cleaning harbour waters upon the Shipyard’s request in the case of an oil spill.

Photograph 4. Damaged hull plating of “Green Egersund” and foundation of a pedestal fairlead including the edge hit by the vessel.

The Commission recognised that the accident resulted from a mistake made during the manoeuvring, which led to a loss of control of the hull side motion after part of the vessel had entered the floating dock.
