**M.V. STENA SPIRIT**

**Report of the marine safety investigation into a  
fatality of a Passenger on a Passenger/Ro-Ro vessel on  
20 September 2018**

## M.V. Stena Spirit– Marine Safety Investigation Report

Date of Issue: 26 March 2019  
Bahamas Maritime Authority  
120 Old Broad Street  
LONDON  
EC2N 1AR  
United Kingdom

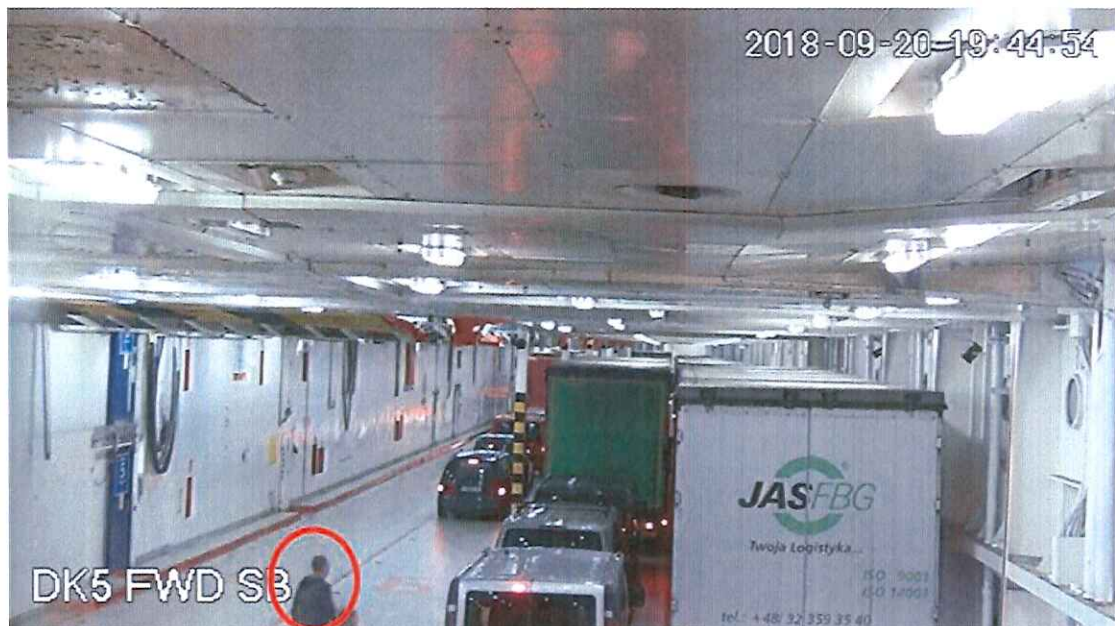
Figure 3: CCTV footage screenshot with the appearance of the passenger on deck 5

- 4.4 At 1946 hours the passenger appeared at the port side of car deck 5, towards lane 6 (figure 3).
- 4.5 A moment later the passenger was observed to go in the space between the car and an HGV in lane 7 towards lane 8.

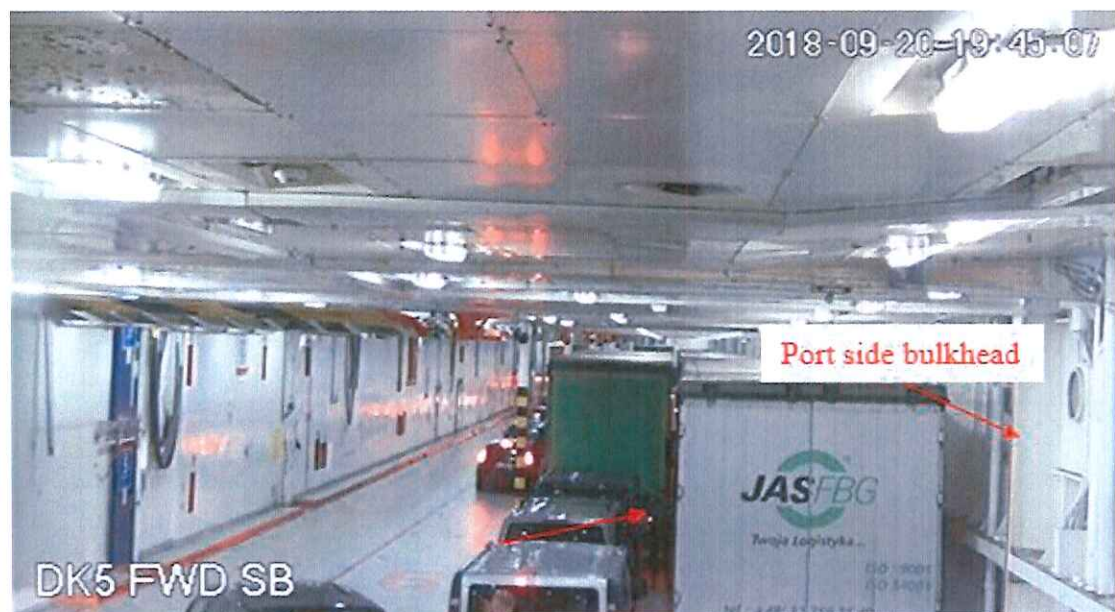
Figure 4: CCTV footage screenshot with the passenger going in between the two HGVs towards the port side bulkhead

5.3.4 The distance between the vehicles at the time of the incident remains unknown. From the CCTV camera images (figure 4) it can be seen that the

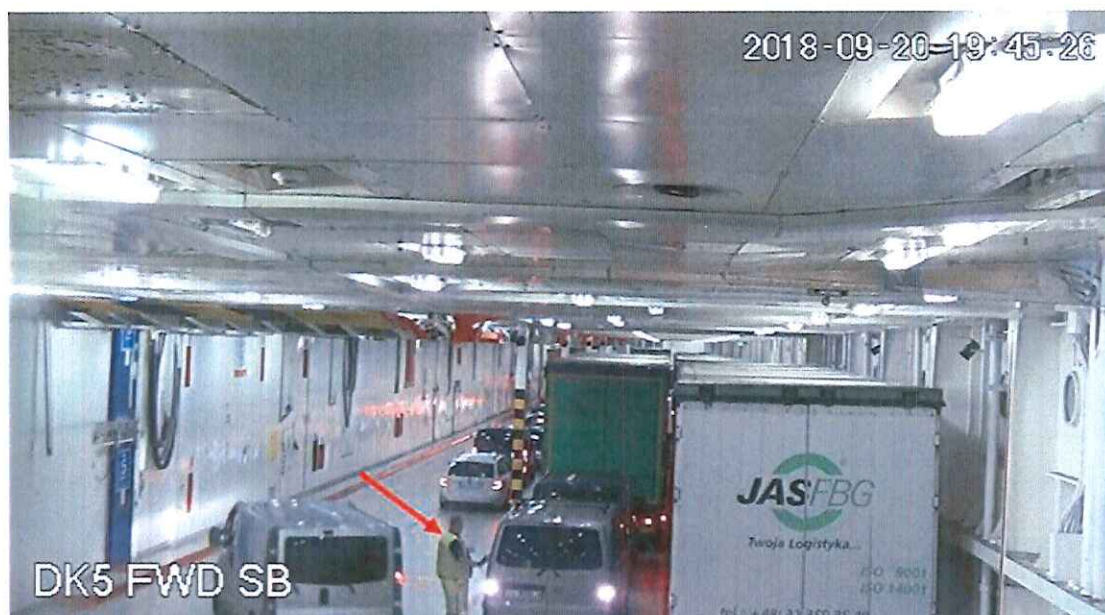
- 4.6 A SOW was guiding cars towards lane 6 for the purpose of unloading (figure 5), while the passenger had gone in the direction of lane 8 towards the port side bulkhead and disappearing from view.

Figure 5: CCTV footage screenshot with SOW guiding the vessel towards lane 6 for unloading

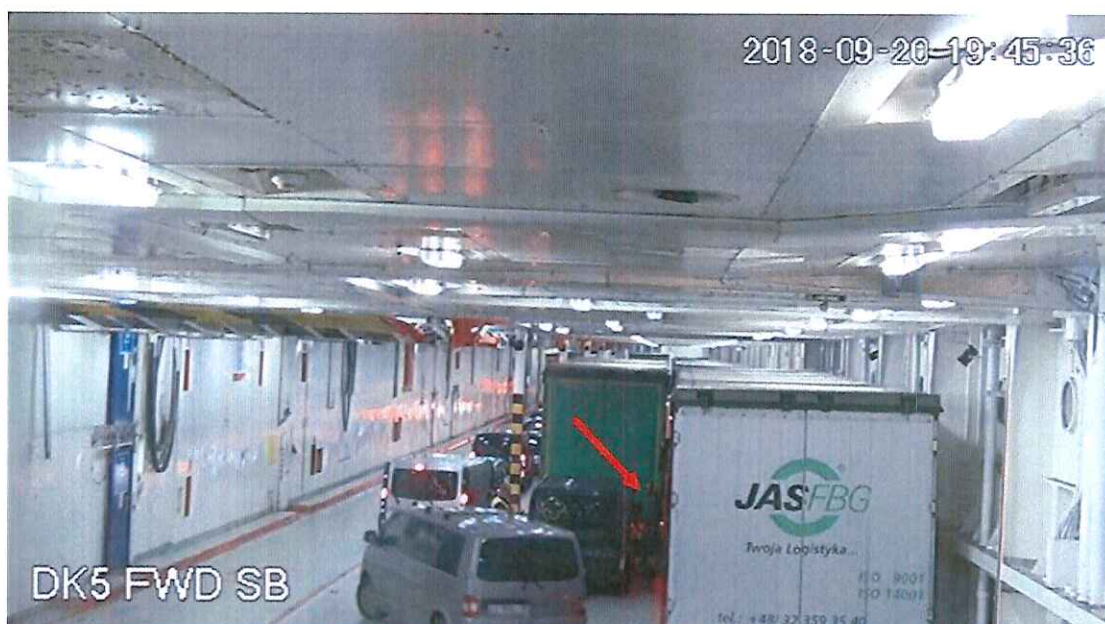
- 4.7 A few seconds later the passenger reappeared in lane 7 between a car and HGV (figure 6) and went around the car and subsequently went in front of the HGV.

Figure 6: CCTV footage screenshot with the passenger reappearing in lane 7

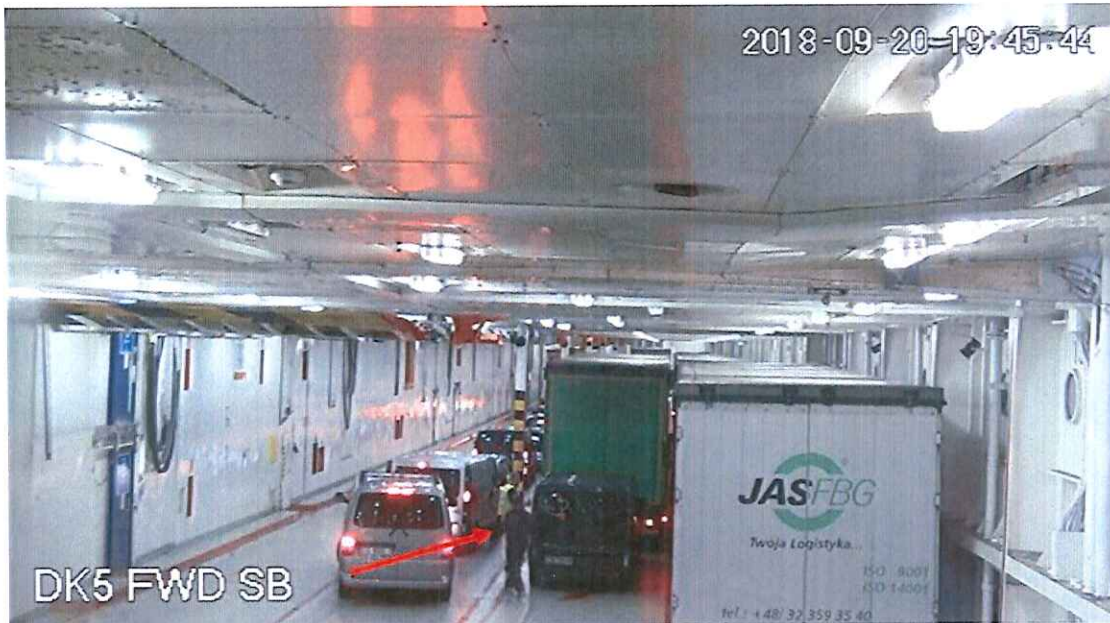
Figure 7: CCTV footage screenshot with the passenger going around the car

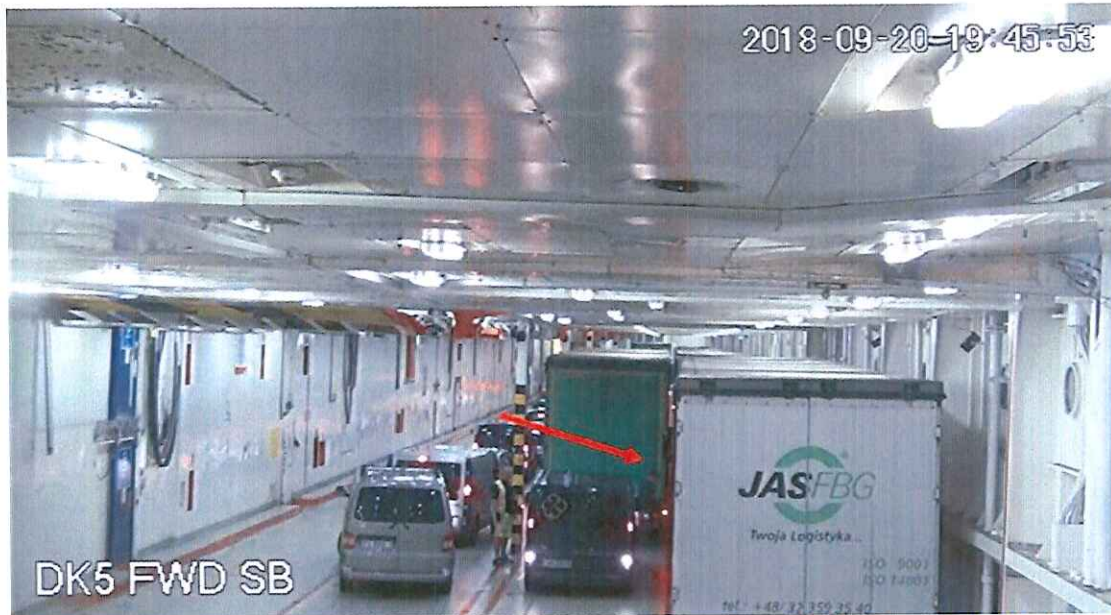
Figure 8: CCTV footage screenshot with the passenger going again in front of the HGV

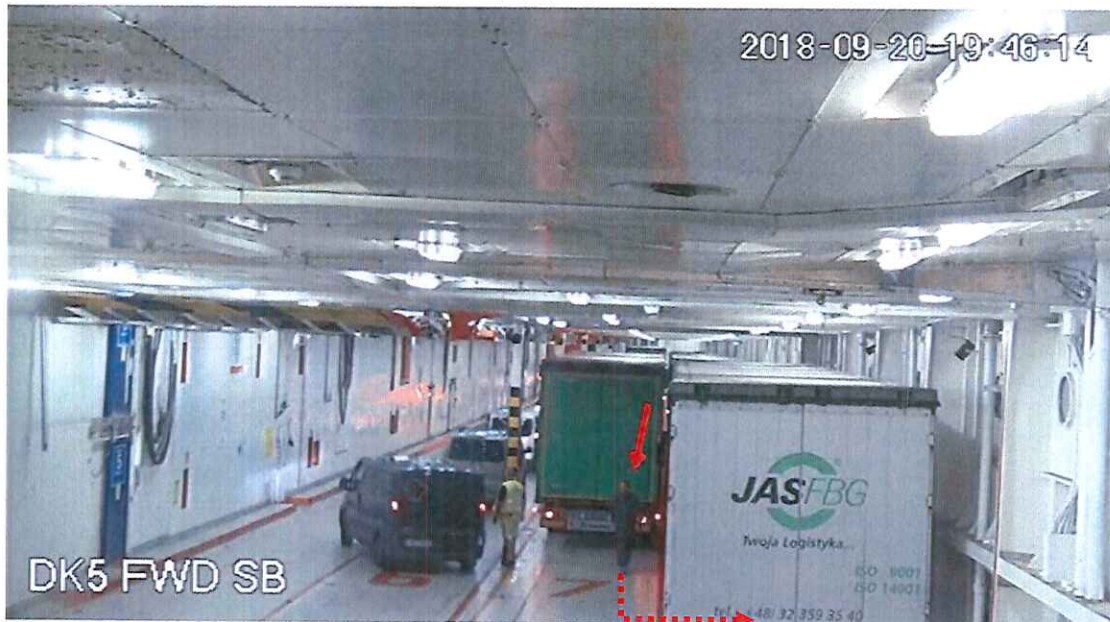
- 4.8 At 1948 hours the passenger reappeared in lane 7 from the space in front of the HGV in lane 8. He walked around the side of the HGV and towards the port side bulkhead of the vessel (figure 9 and figure 10).

Figure 9: CCTV footage screenshot with the passenger reappearing in lane 7

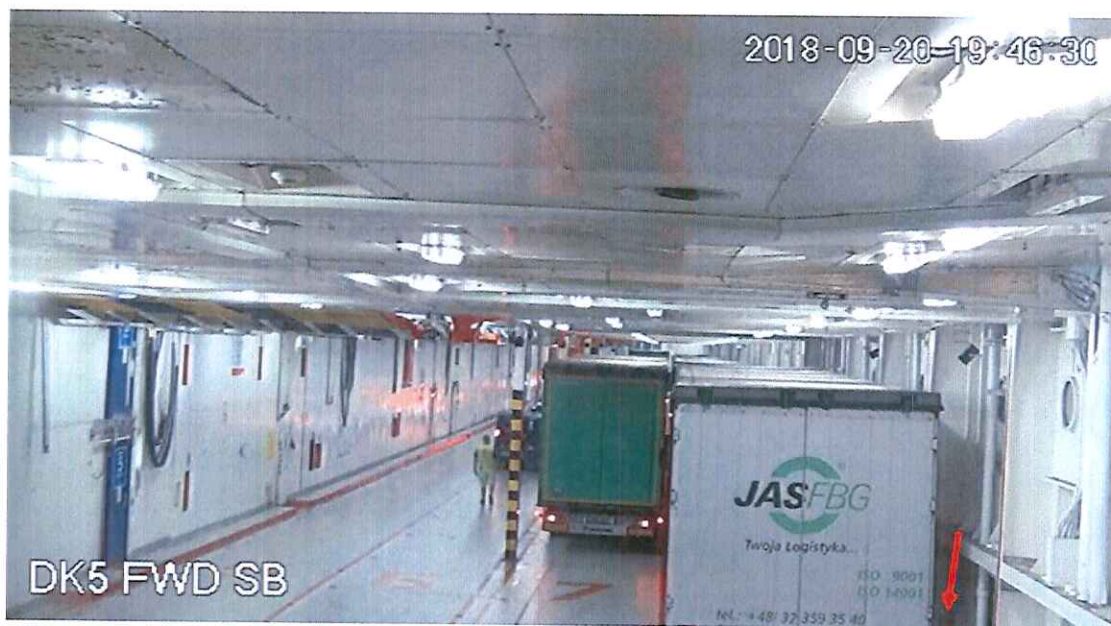
Figure 10: CCTV footage screenshot with the passenger going into the space between the HGV and port side bulkhead

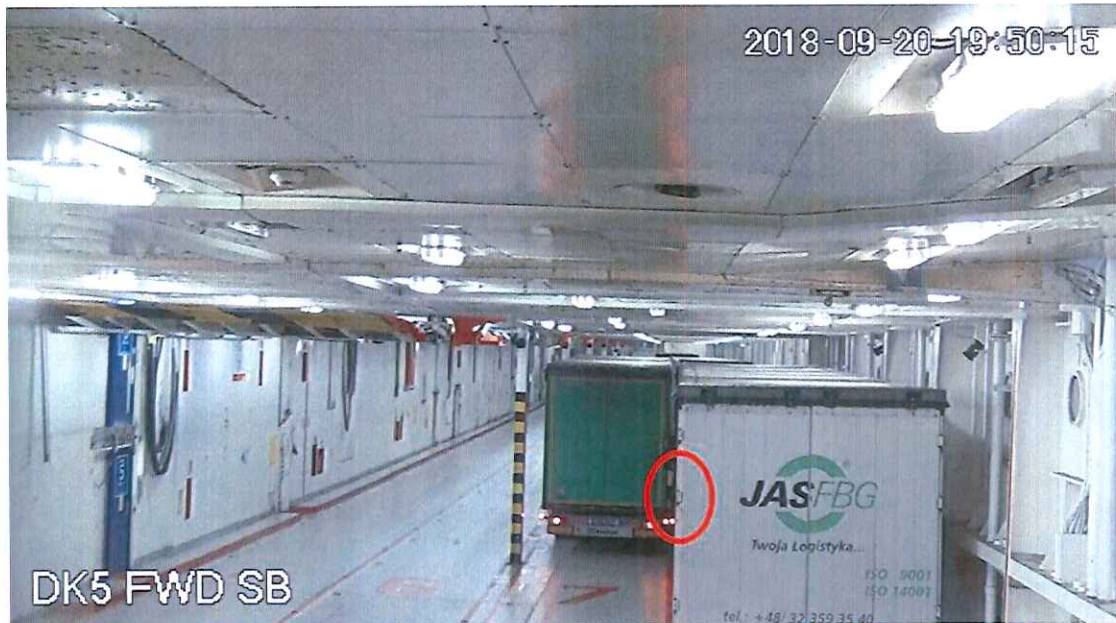
- 4.9 At 1952 hours, the passenger was crawling below the HGV from lane 8 towards lane 7 (figure 11).

Figure 11: CCTV footage screenshot with the passenger crawling below the HGV

- 5.1.4 From the CCTV footage it was observed that the passenger was crawling below the vehicles from lane 8 towards lane 7. At this instant, the vehicle on lane 7 was guided to move forward and the passenger was crushed under the vehicle's left rear tyre.

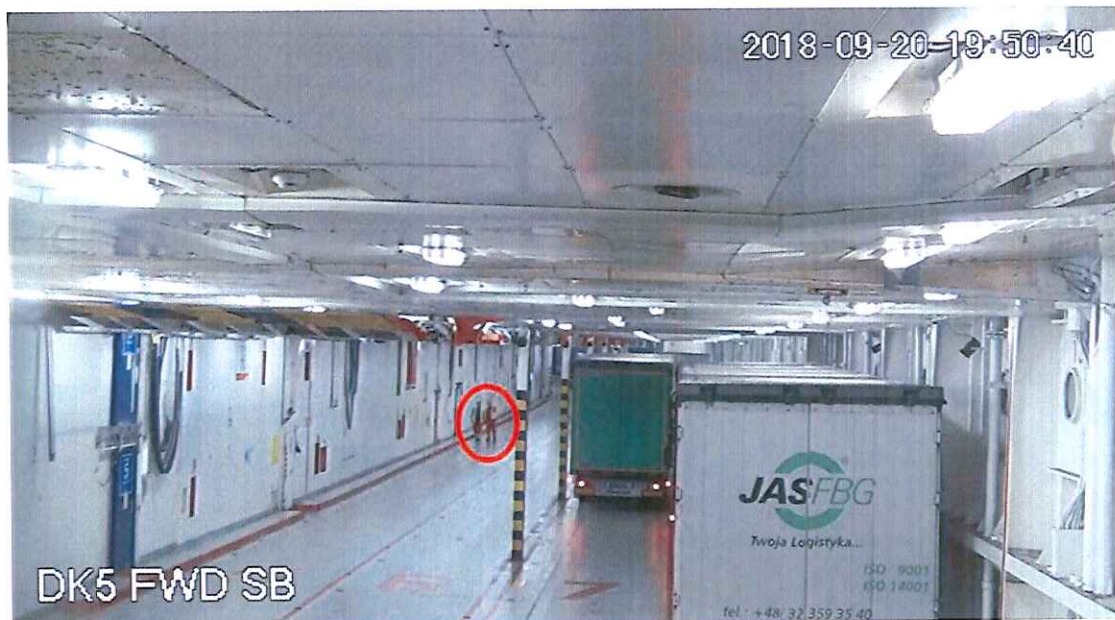
- 4.10 At this time, the SOW was instructing the HGV on lane 7 to move ahead. Unbeknownst to the SOW, the passenger was under the HGV and was crawling in the direction of lane 6, when the HGV simultaneously moved forward, resulting in entire weight of the left rear tyre of the HGV coming into contact with the passenger.
- 4.11 The two SOWs were walking toward the forward section of the vessel when one of them heard the crushing noise and saw the passenger under the rear left tyre of the vehicle in lane 7.

Figure 12: CCTV footage screenshot with location of the SOW at the time of the incident

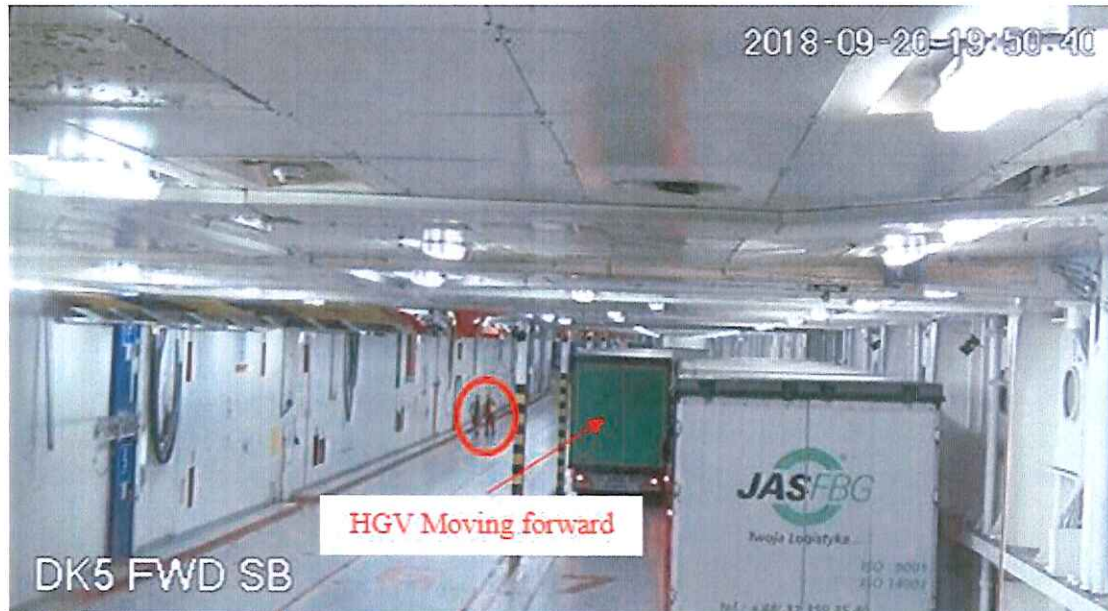
Figure 13: The 2 SOWs walking towards forward of the vessel and HGV moving forward

- 5.2.6 The third SOW was in front of the HGV pictured within figure 13, guiding the vehicle off the vessel.

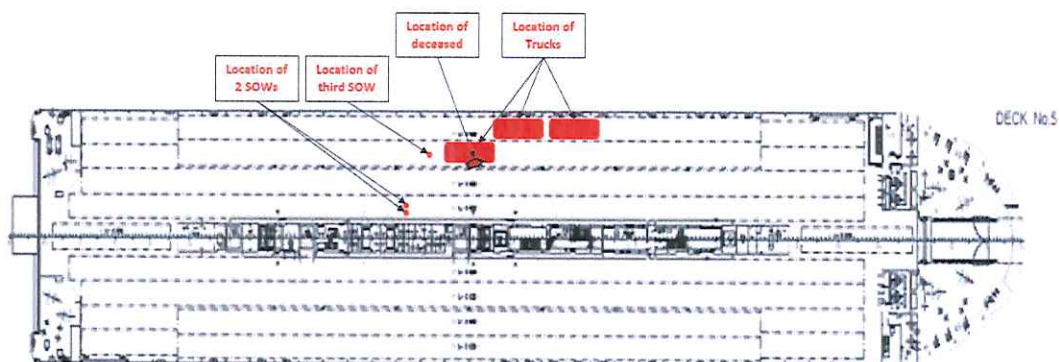
Figure 14: Illustrative diagram<sup>3</sup> with location of SOW, Deceased and Vehicles

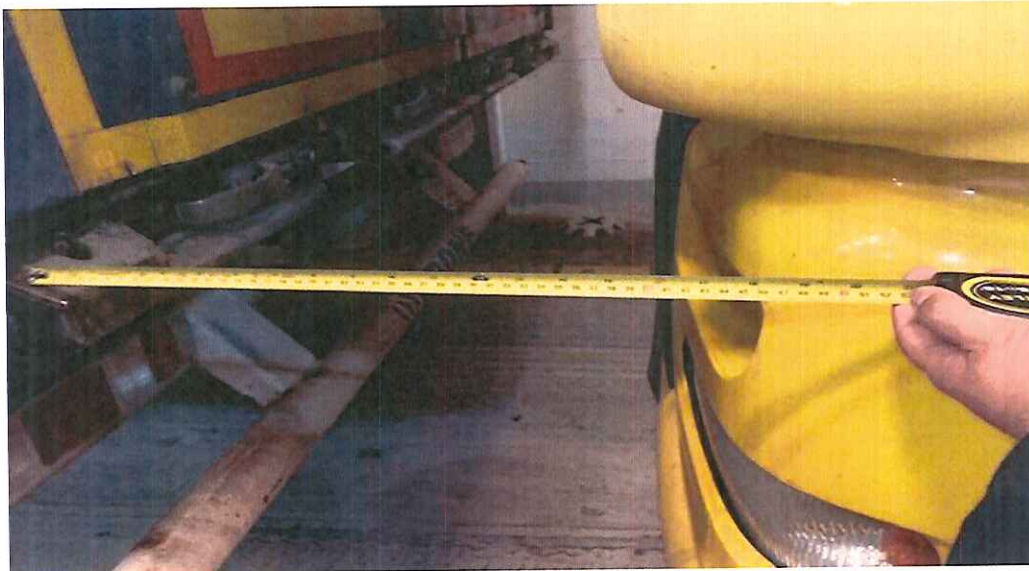
5.3.3 At the time the investigation was conducted (on 7 October 2018) the vessel was not loaded at maximum capacity and it was observed that the vehicles were parked at a distance of 40-45 cm. The Chief Officer informed the investigator that this distance could be less if there were more vehicles onboard.

Figure 15: Distance between the parked vehicles<sup>4</sup>

- 8.1 Although access for emergency response team was not required after the incident. It was identified in the CCTV that access between vehicles was limited when fully loaded. Possibly preventing emergency response personnel wearing breathing apparatus from access between vehicles. The owners should consider developing guidelines to ensure access on deck and between the vehicles in case of an emergency is sufficient for emergency response personnel.
