114/22

Marine casualty

Towing unit – tug Odys and pontoon TRD Voyager

FINAL REPORT

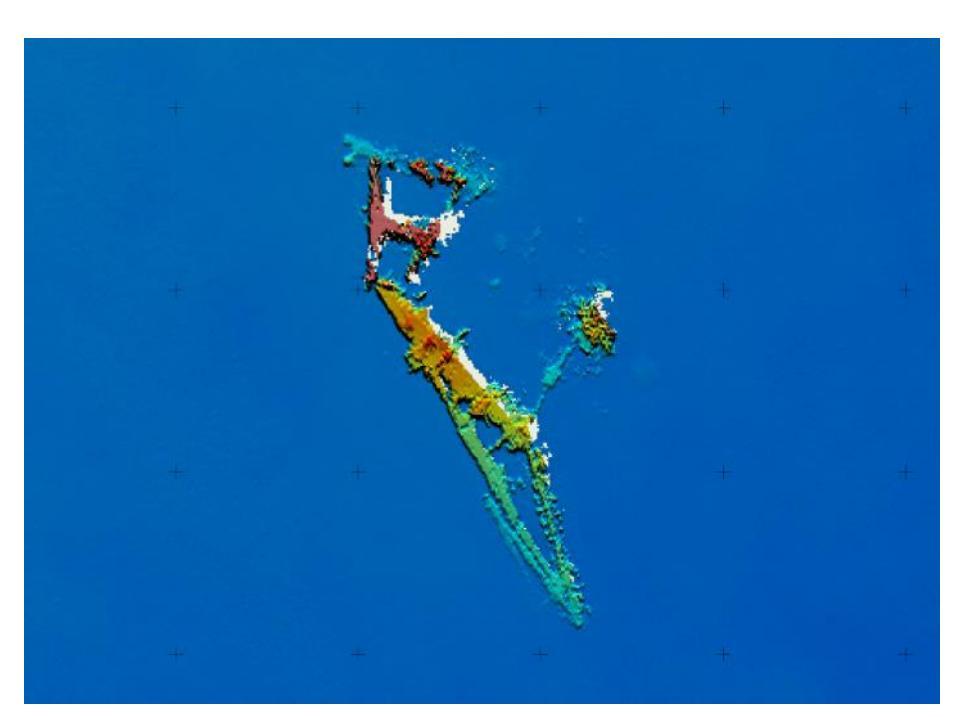
Figure 2. Sunken at the bottom of the Baltic Sea, crane lying on its side, facing SE with its arm.

The found sunken shipyard crane was lying on its side with its arm facing SE^3 . The minimum depth above the object was 15.7 m while the depth of the area was approximately 23 m. In May 2023, the main structure of the shipyard crane (the portal section including the rail mechanism) was picked up from the bottom of the Baltic Sea so that it would not pose a navigational hazard to deep-draught ships.

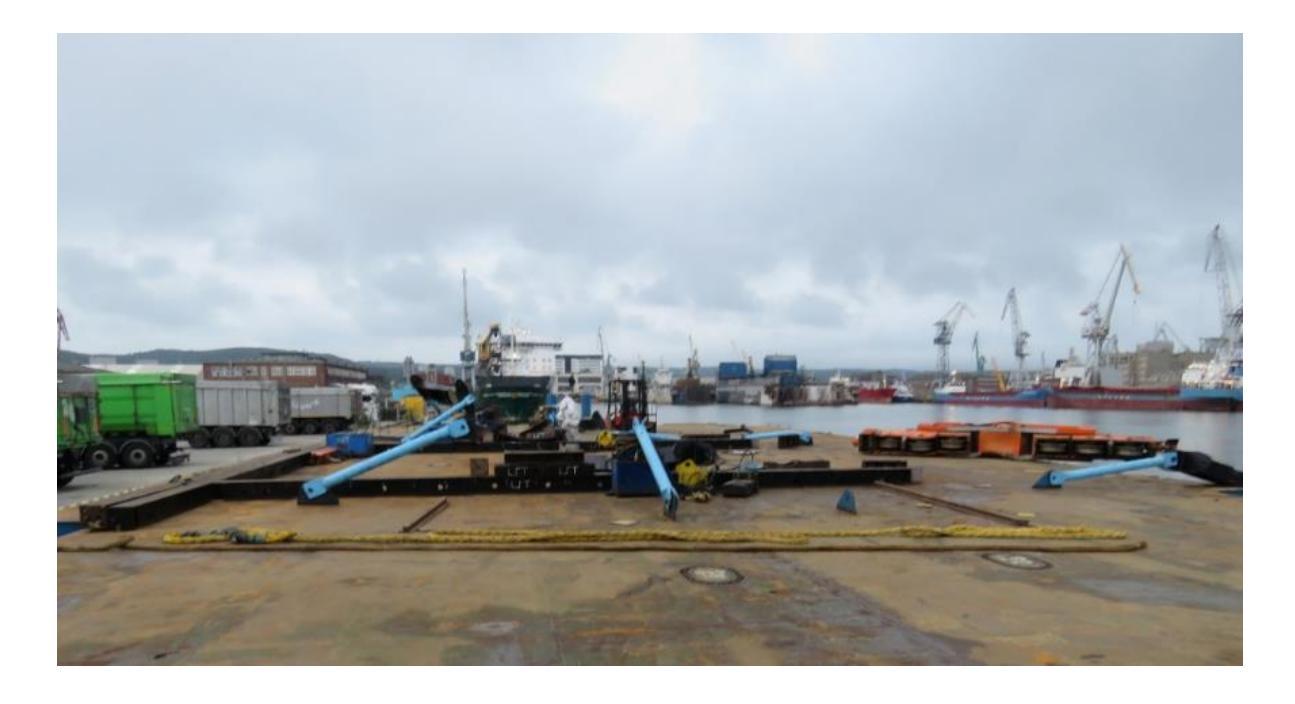
Photo 7. View of the TRD Voyager deck when moored at Hungarian Quay in the Port of Gdynia – 25 August 2022.

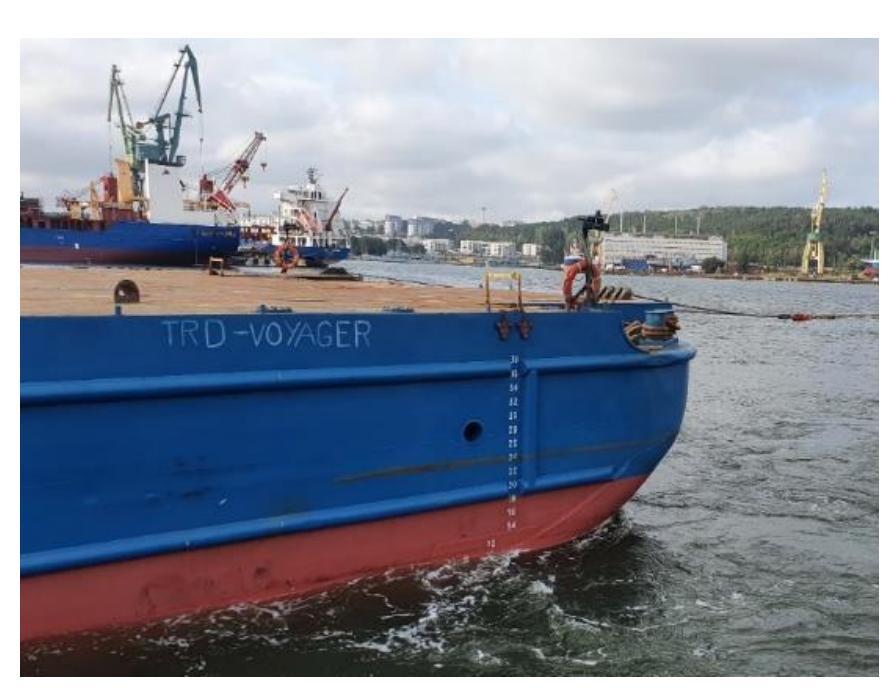
Figure 7. Forward draught of the TRD Voyager

The Commission noted that the forward draught of the pontoon on departure from Gdynia was 1.20 m, which was less than the recommended 1.70 m.⁸ For a wave height of approximately 1.20 m this could have caused the bow to emerge from the water. Maintaining the recommended forward draught would reduce the occurrence of bow slamming. Bow slamming⁹ generates rapid changes in the resistance to motion of the pontoon and thus can create high accelerations in the longitudinal direction.

The recommended trim and draft in DNV guideline ST-N001 indicates that the minimum trim of a 60 m long pontoon should be 0.60 m to the aft and the minimum forward draft of the pontoon should be 1.7 m. ⁹ Bow slamming – the impact of the bow of the ship's hull against a wave.

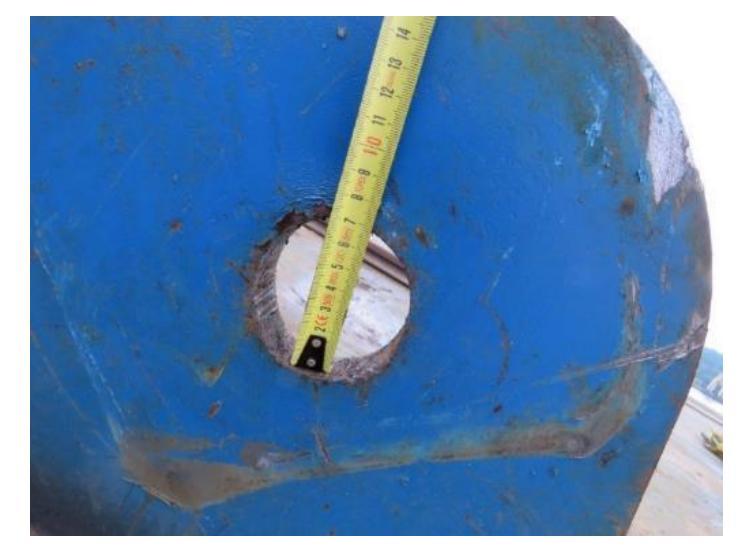
Stress calculations in the hole of the lower fixing plate showed that it exceeded the allowable working stress by 260%. The photo below shows the deformation of the plate eye and the plastic deformation of the plate. The allowable load (MSL) of the plate eye should not exceed 200 kN.

Figure 14. Figure 14: Plastic-deformed fastening hole of the lower fixing plate.

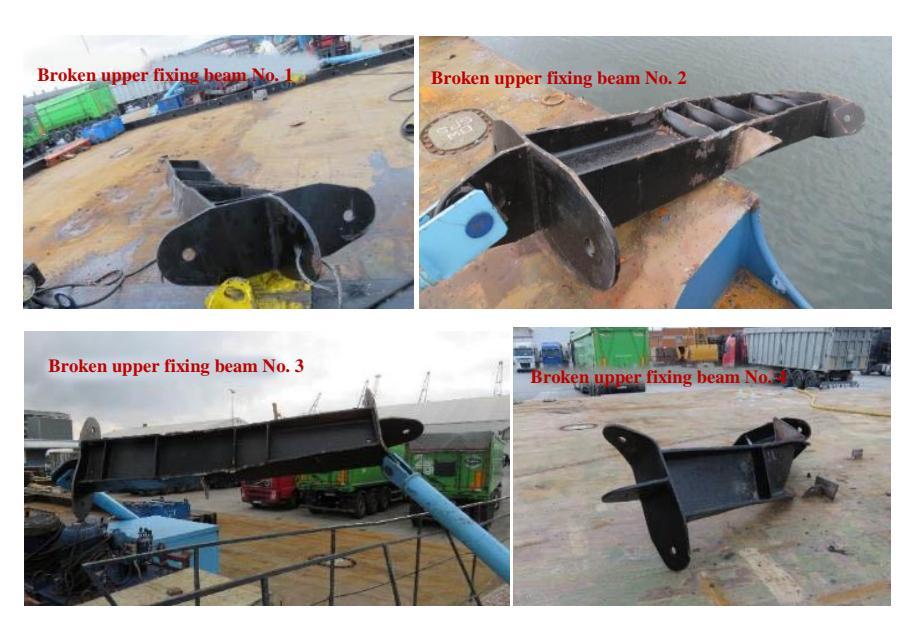
Strength calculations showed that the stresses in the upper fixing plate exceeded the allowable working stress by 144%. The allowable load (MSL) of the beam should not exceed 400 kN. Below are drawings of the broken upper fixing beams.

Figure 16. Broken upper fixing beams No. 1, 2, 3 and 4.

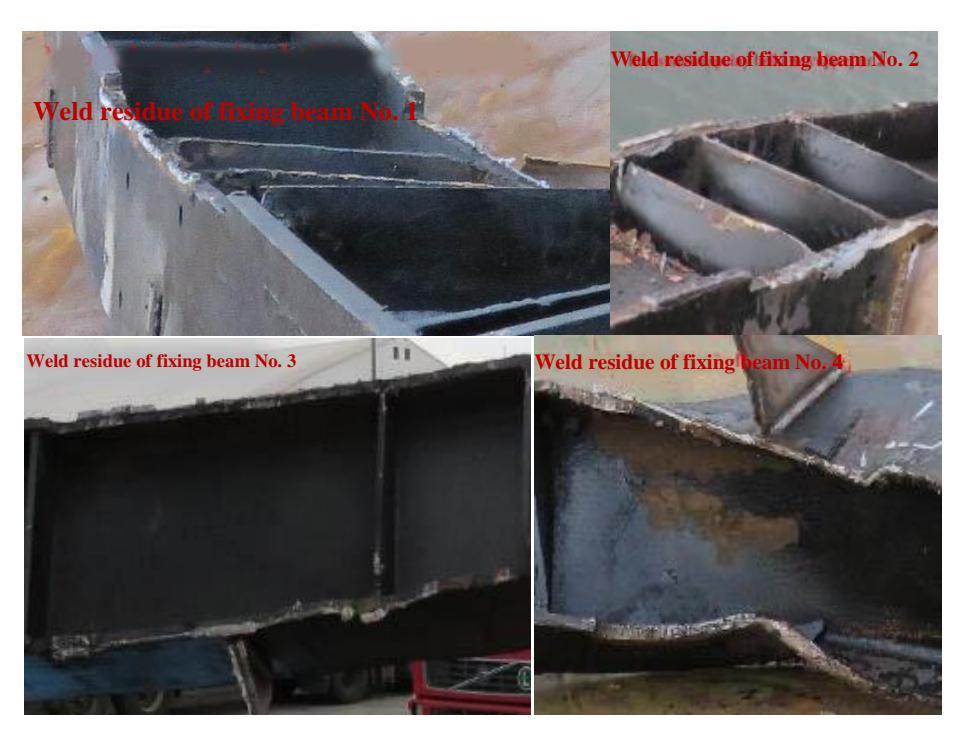
The weld stresses of the upper fixing beams exceeded the allowable working stress by 158%. The allowable load (MSL) of the weld should not exceed 335 kN. Below is a drawing showing the remains of the damaged welds of the upper fixing beams.

Figure 17. Remains of welds of upper fixing beams No. 1, 2, 3 and 4

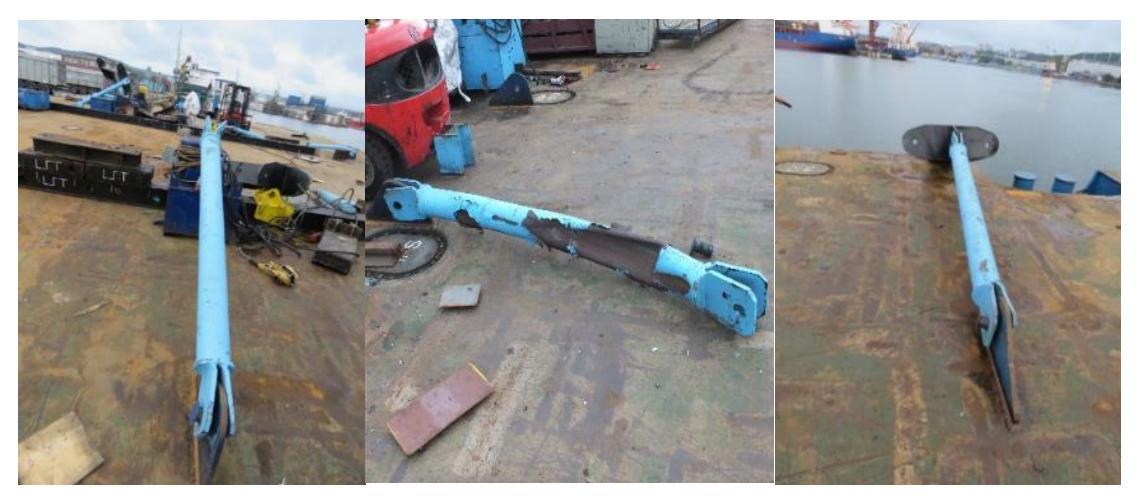
The strength of the cheek plates, due to the forces acting in the lashing, was met with a horizontal working angle of up to 0.5° . During the voyage, the working angles of the lashing exceeded the allowable load considerably, causing the cheek plates to bend – figure below.

Figure 19. Bent cheek plates of the main lashing system.

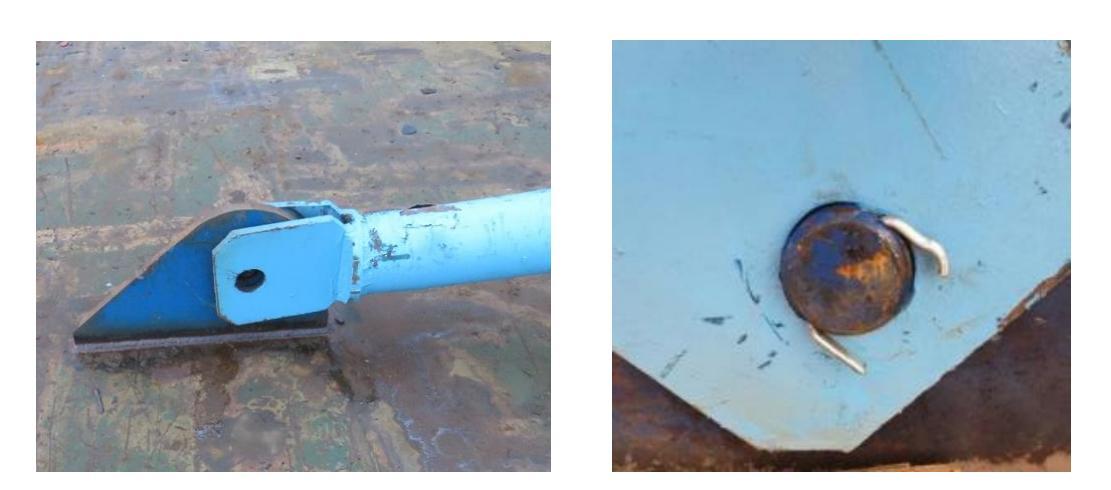
The lashing system provides for 16 mandrels fixing the pipe section with the lower and upper plates. The mandrel can withstand loads for the Maximum Securing Load (MSL) of 60 tonnes. The mandrel was prevented from slipping out by means of a bent steel pin. The strength of the pin was tested assuming a transverse tilt angle of 0.5° . A tenfold excess of the allowable cutting force means that the pin could not block the cheeks of the pipe fitting from swinging out. The pin was sheared or pulled into the centre of the bore when the bore was enlarged.

Figure 20. Broken pin of the mandrel and torn out mandrel securing the bottom plate to the cheeks of the fixing pipe

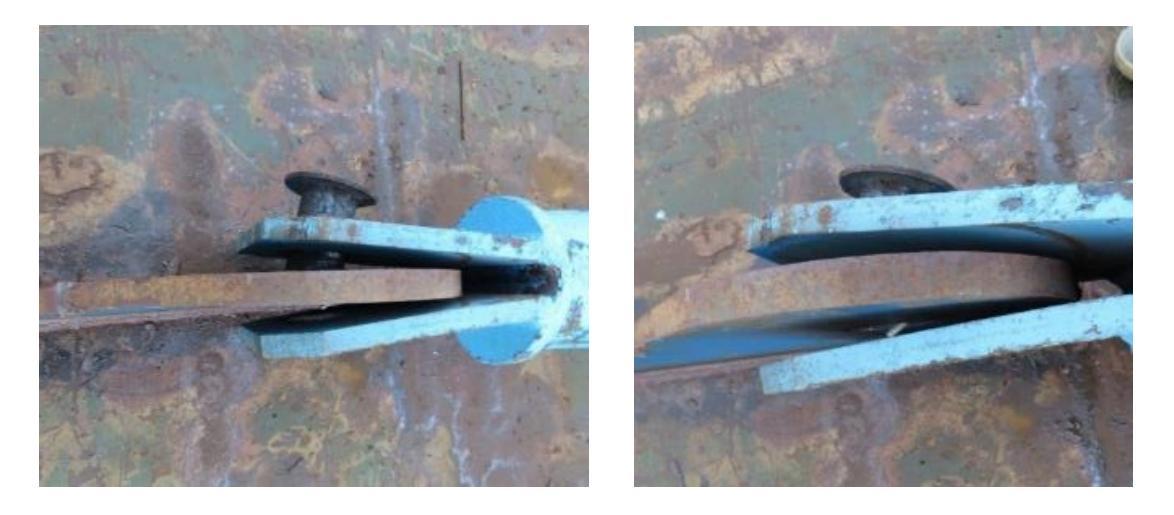
Figure 21. Pin of the mandrel pulled out and sheared through the bent cheeks on the pipe.

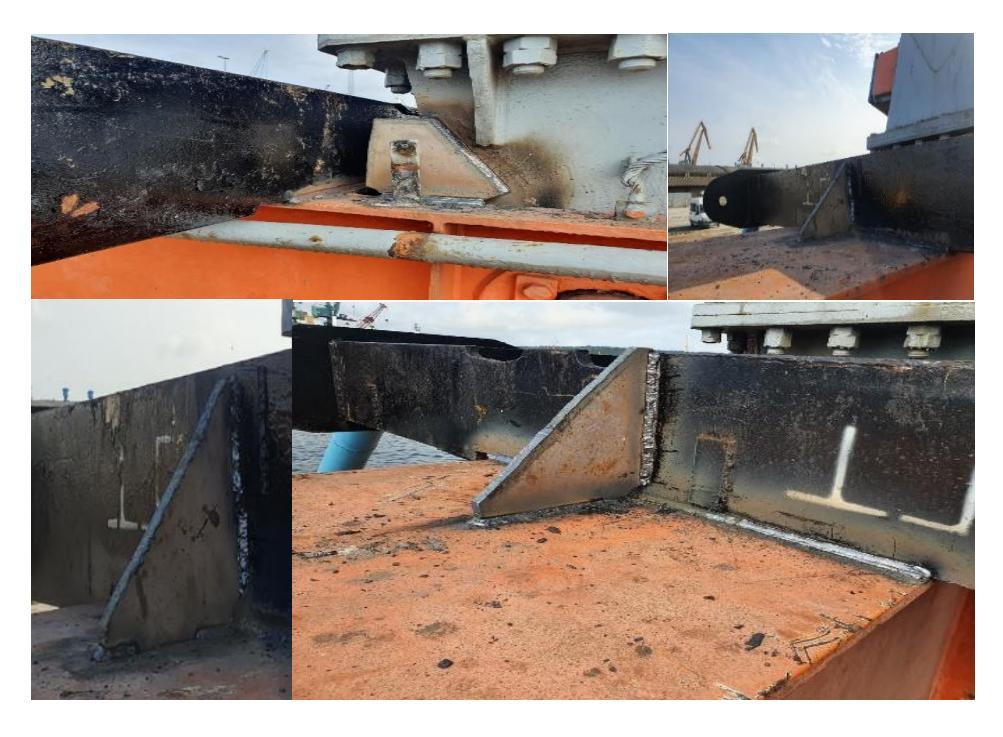
in accordance with PN-EN ISO 17637^{10} and the welded joint assessment standard PN- EN ISO 5817^{11} , by a person certified to Grade 2VT. After VT testing (visual examination), protocol No. 07/08/2022 was prepared, which stated that the welded joints meet the requirements at level C (medium). The report did not include any comments on the quality of the welds, their correction or the welding discrepancies found. The photographs provided, taken before the towing unit departed for sea, show the gussets with a non-continuous weld attaching them to the crane chassis. The weld did not have the correct shape and profile, the weld surfaces were not uniform throughout, and a full weld was missing.

Figure 24. Fixing beam – additional gussets of fixing beam (incomplete lower weld)

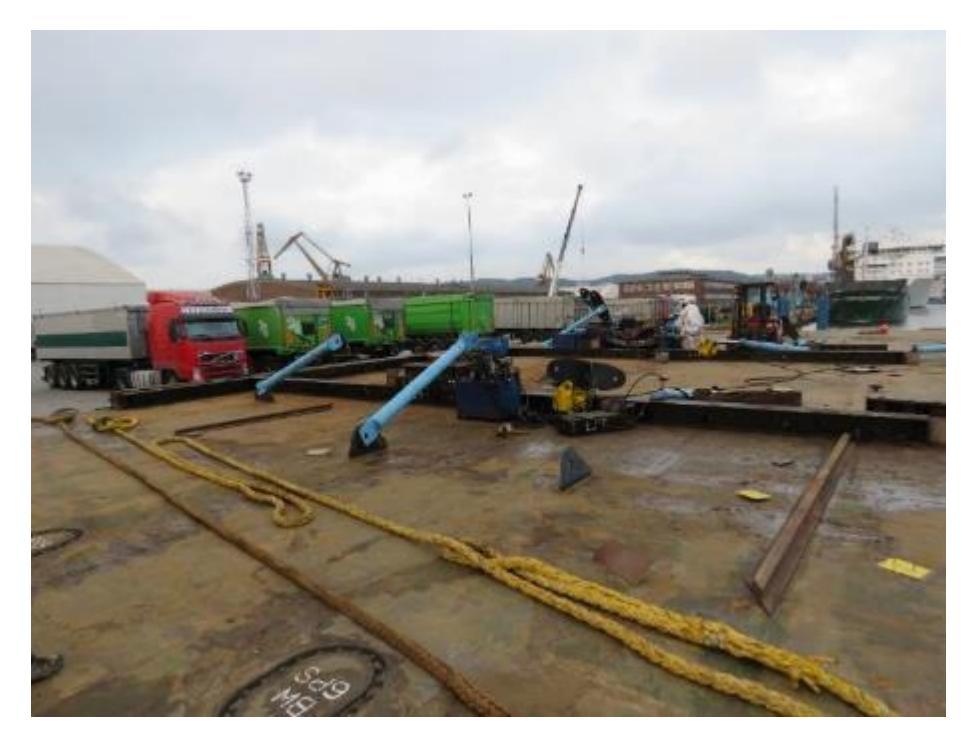
Figure 25. Remains of the shipyard crane main lashing system on the pontoon after the accident.

The Commission believes that the primary cause of the loss of the crane from the TRD Voyager deck, was the use of the lashing system with limited strength. The critical factor was transverse capsizing, against which the shipyard crane was secured at only 7%. The transverse capsizing moments and the inertia of the crane's mass generated loads in the lashing system that exceeded its strength and caused plastic deformation and ultimately, rupture. This was evidenced by the bending of the cheeks on the pipes and the breaking of the mandrels' pins. The essential components of the lashing system carrying the greatest loads, were the welds connecting the upper fixing beams to the shipyard crane chassis. During its examination and visual inspection of the remains of the main lashing system on TRD Voyager, the Commission noted that the welds of the fixing beams were failed most probably as one of the first components of the entire lashing system.

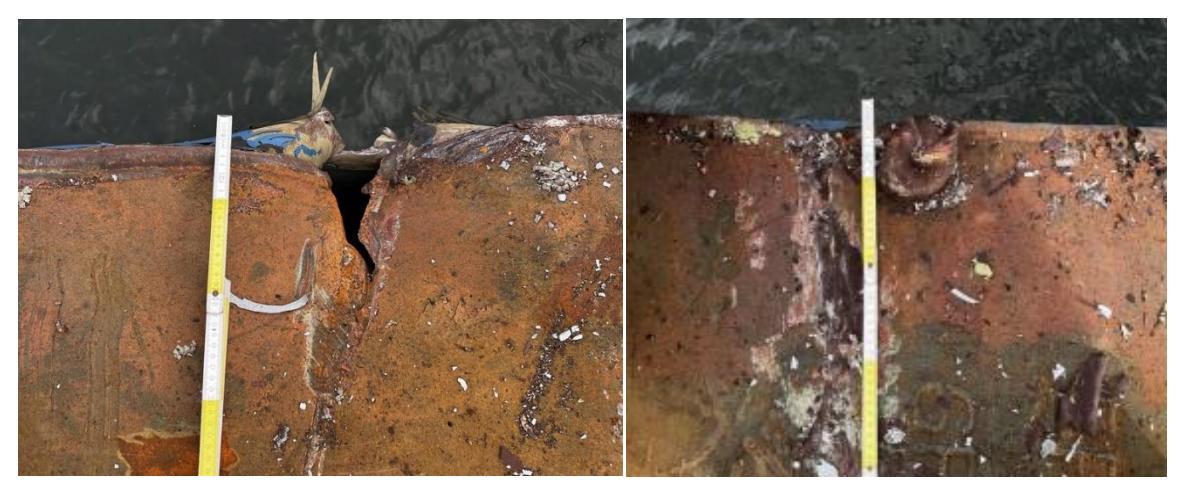
The crane was rigidly fixed to the deck of the pontoon, according to the designed lashing system, with the arm folded and the mechanism locked to prevent it from rotating. The voyage plan assumed that the towing unit's sea voyage will take approximately 34 hours at the speed of 6.5 knots. Marine casualty, the loss of the shipyard crane, occurred approximately nine hours after the beginning of the voyage. The crew of the tug did not observe the crane fall from the pontoon. During the voyage, the pontoon was not manned or self-propelled. Neither the integrity of the pontoon nor the tug was compromised during the voyage, the pontoon did not suffer any loss of stability or buoyancy. There was no breakage or damage to the towline. After the accident, the towing unit safely returned to the Port of Gdynia. The collapse of the crane caused minor damage to the deck of the pontoon where it fell and where the fastenings hit the deck, visible on the photo below.

Photo 9. Damage to the deck of the TRD Voyager

Any damage on board the TRD Voyager following the collapse of the shipyard crane was repaired by the charterer under the supervision of the PRS classification society.

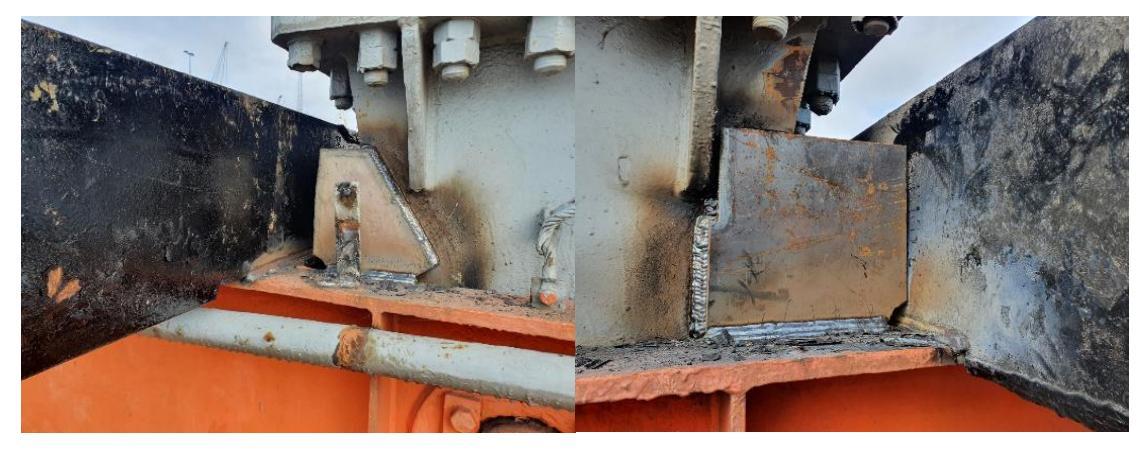
c. some of the stoppers securing the cargo were not in contact with it and there were gaps between the stoppers and the cargo (Figure 29),

Figure 29. Stoppers fixing the cargo – no contact.

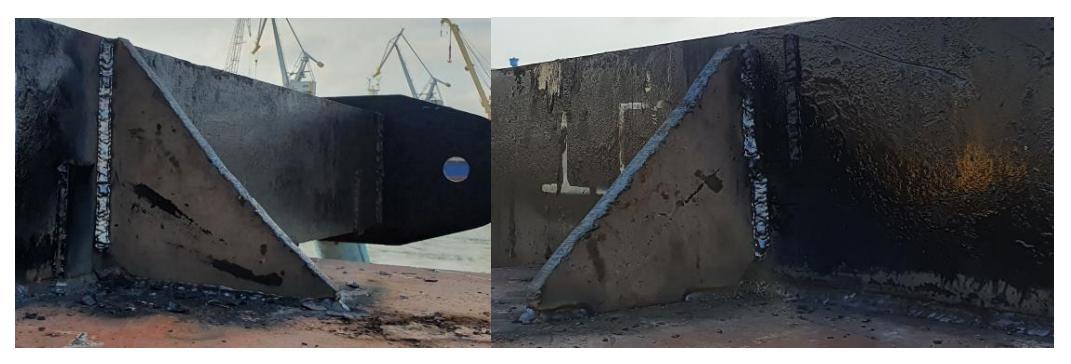
d. preparation of the material for welding – none of the photographs show surface preparation (grinding) of the material before the weld was placed. The welds were welded on paint and dirt (Figure 30),

Figure 30. No visible signs of material preparation for welding.

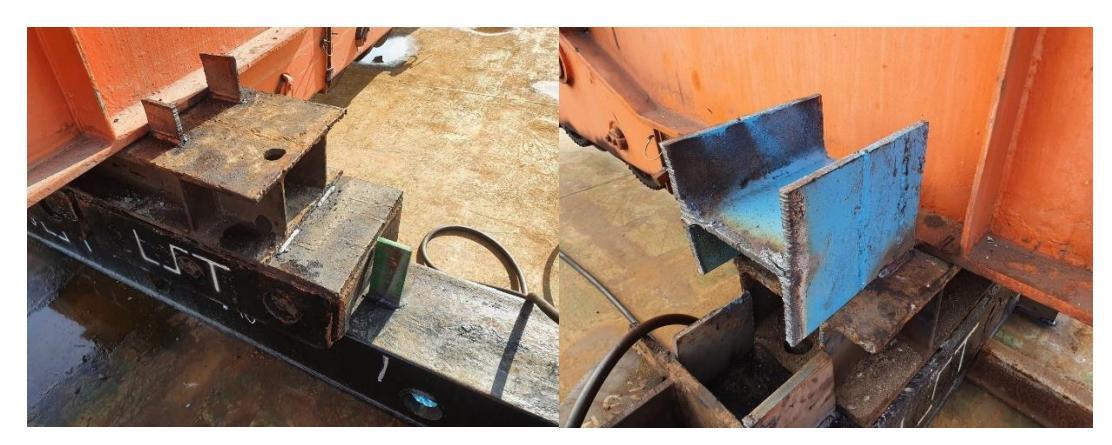
e. there is a lack of information in the documentation about the number (length) of welds made and their continuity. The photographs show discontinuous welds or welds of variable thickness (fig. 32),

Figure 31. Lack of full weld.

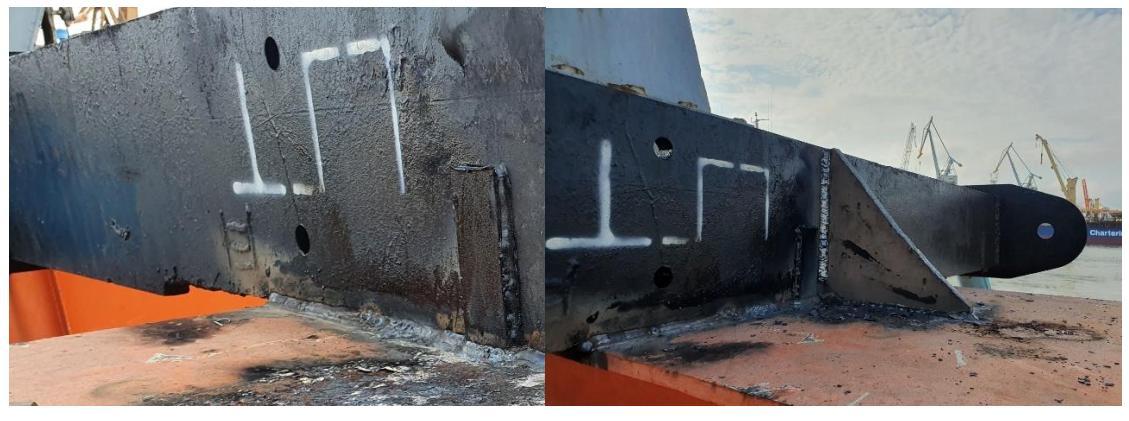
f. fig. 32 shows significant differences in weld thickness. In the documents submitted after the accident there is no information about other tests of weld quality being carried out apart from the visual examination e.g., magnetic testing. There is also no confirmation of the weld thickness of the main fixing elements,

Figure 32. Differences in weld dimensions.

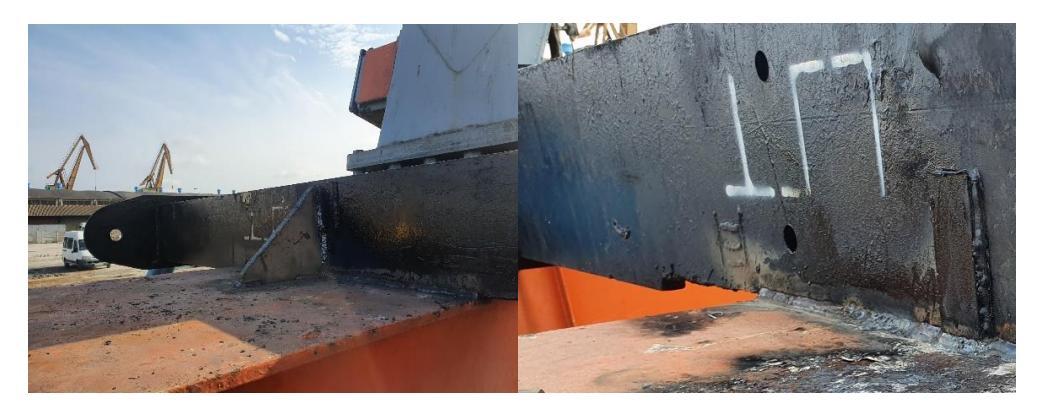
Figure 33. No visible signs of grinding the weld ends.
